Incident Summary #II-1647394-2023 (#42298) (FINAL)

SUPPORTING INFORMATION	Incident Date	December 9, 2023	
	Location	Mission	
	Regulated industry sector	Electrical - Low voltage electrical system (30V to 1000V)	
	Impact	Qty injuries	0
		Injury description	N/A
	Damage	Injury rating	None
		Damage description	Fire damage to the exterior wall and the attic space in an existing single-family dwelling. Fire damage to the consumer service conductors and conduit for the service between the meter enclosure and the connection to the electrical supply authority.
		Damage rating	Moderate
	Incident rating	Moderate	
Incident overview	The conduit containing the service conductors may have been tampered with causing damage to the service conductors. When the insulation on the service conductors failed, arcing occurred, which melted the service conduit. Molten metal dripped from the service conduit into the attic and igniting the wood.		
INVESTIGATION CONCLUSIONS	Site, system and components	<p>The 100 amp, 120/240-volt consumer service line conductors installed in electrical metal tubing (EMT) carry current (amps) from the supply authority to the meter enclosure. The supply authority meter reads th

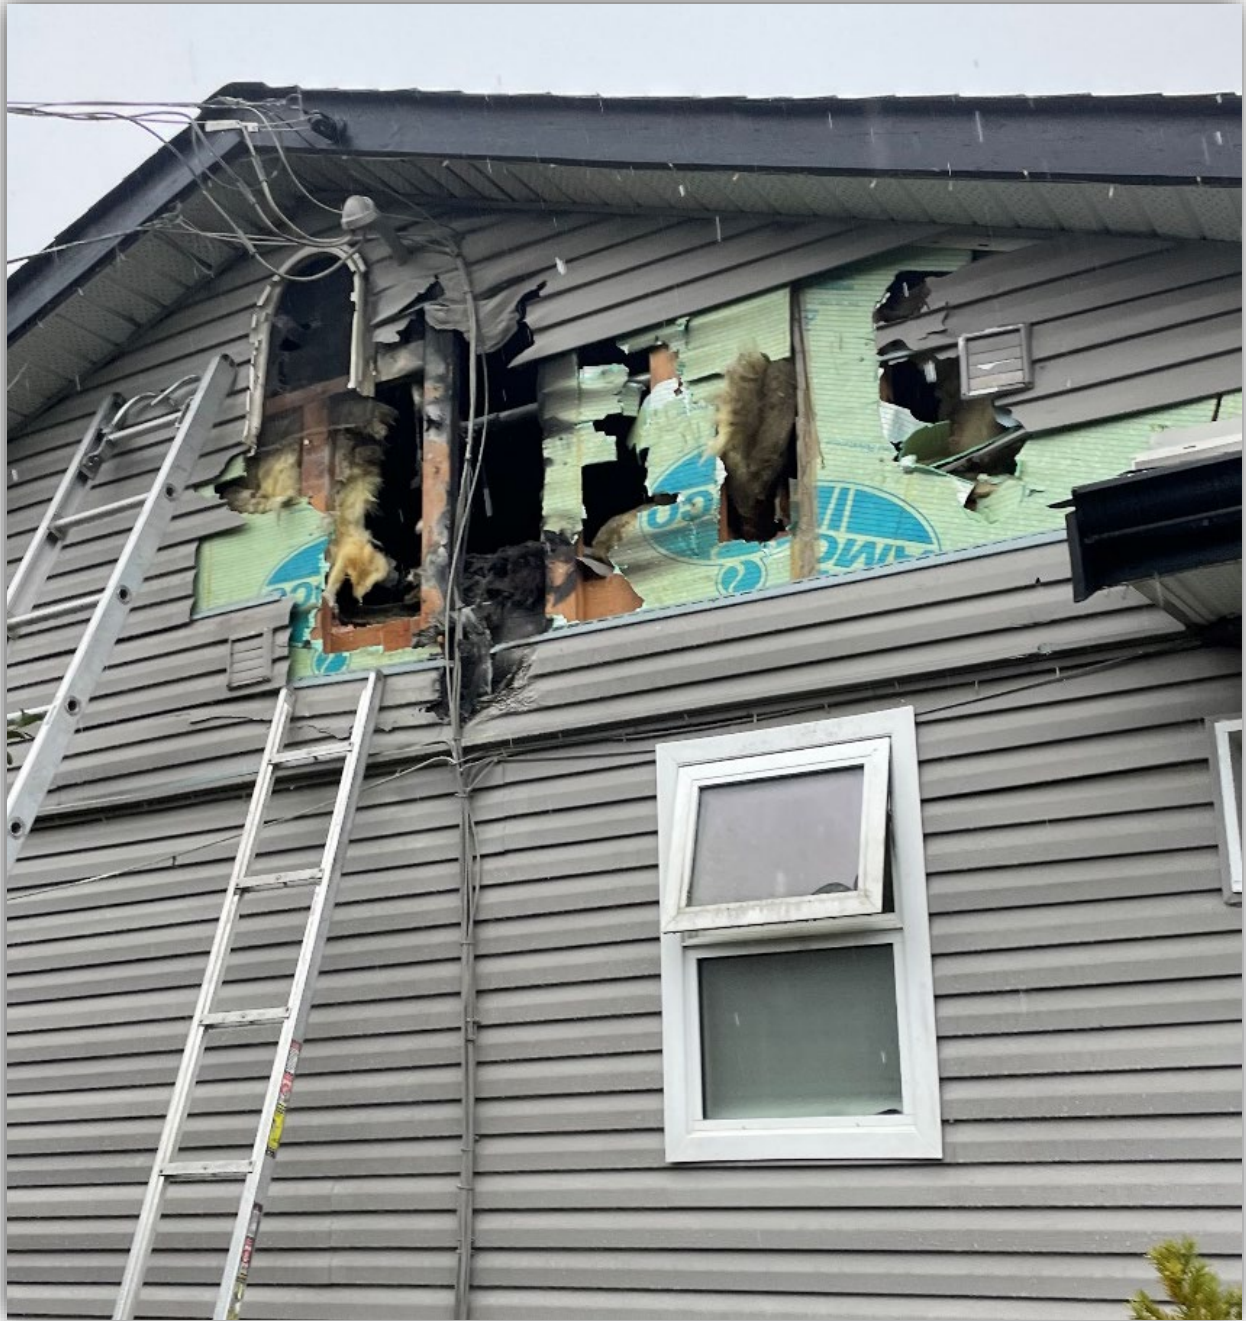
Image 1 - Fire in the attic and on exterior of the single-family dwelling.

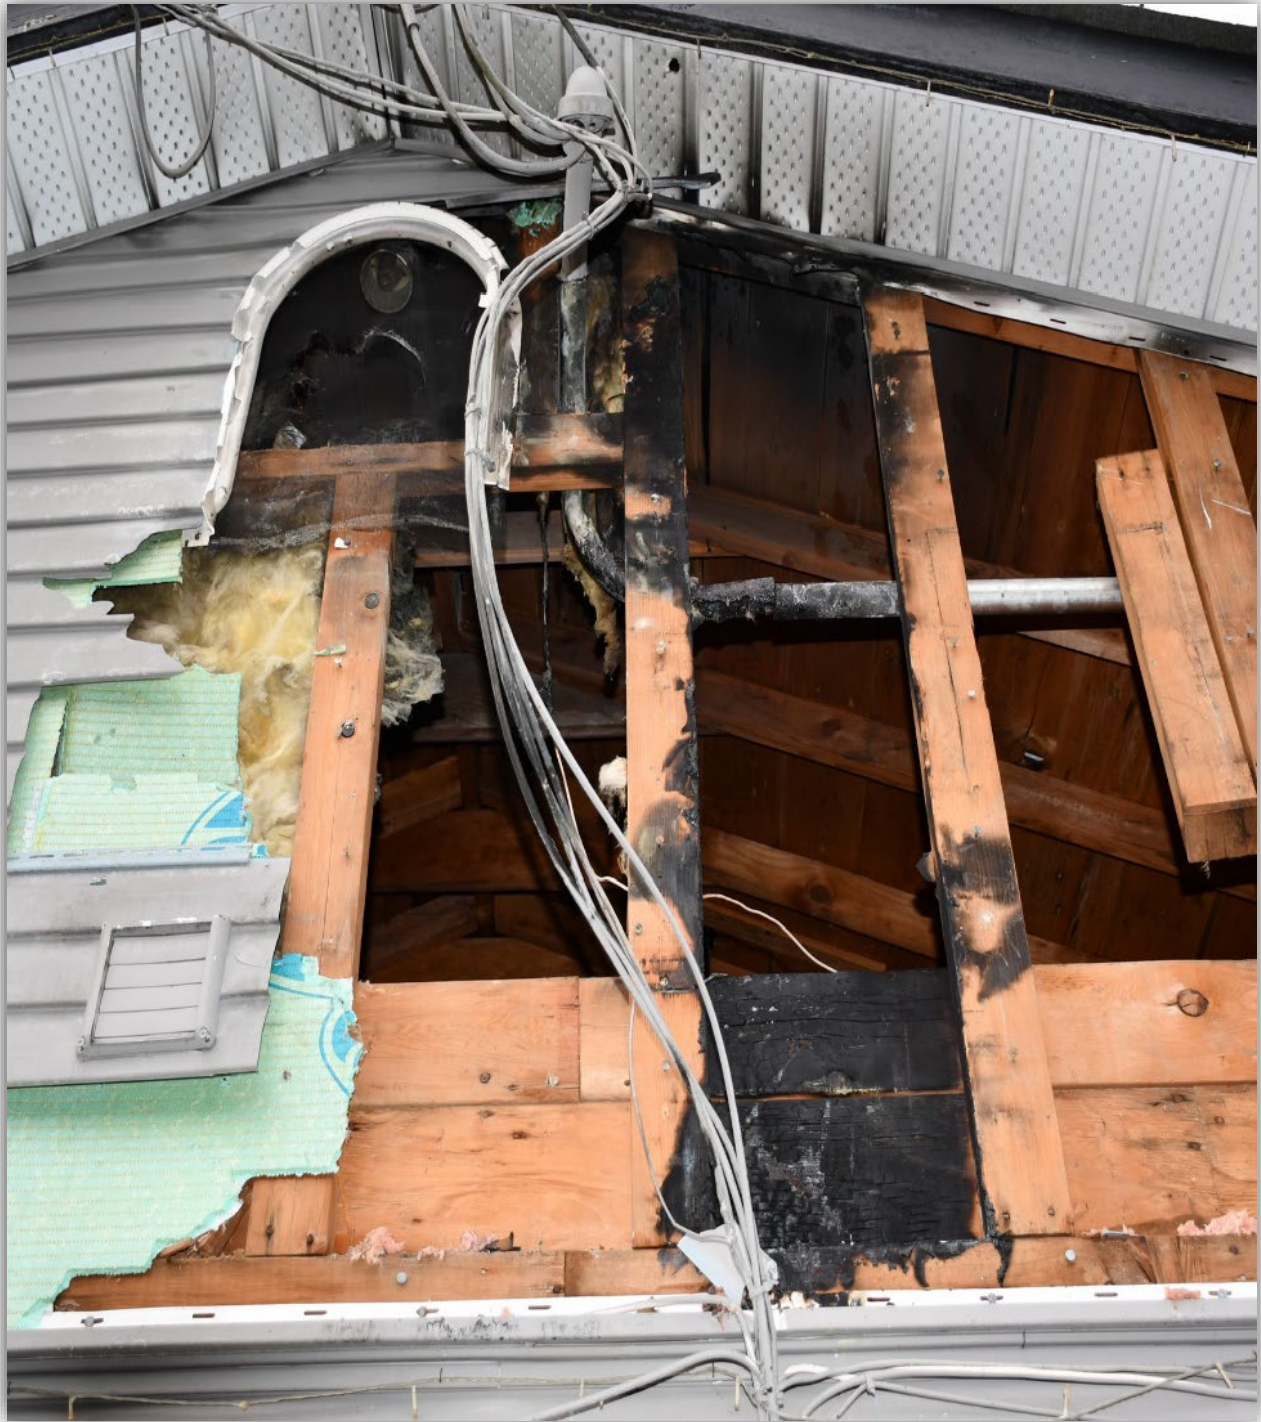
Causes and contributing factors	<p>The consumer service conductor's insulation was possibly tampered with. Over time, the insulation may have failed, causing a short circuit between the conductors and the metallic service raceway. The failure of the insulation combined with lack of overcurrent protection on the consumer service conductors may have caused the electrical metal tubing EMT to melt and possibly drip molten metal into the attic space below the EMT. The fire was located directly below where the EMT shows signs if dripping.</p>

Image 2 - Fire started by molten drips. This is thought to be the area of origin.

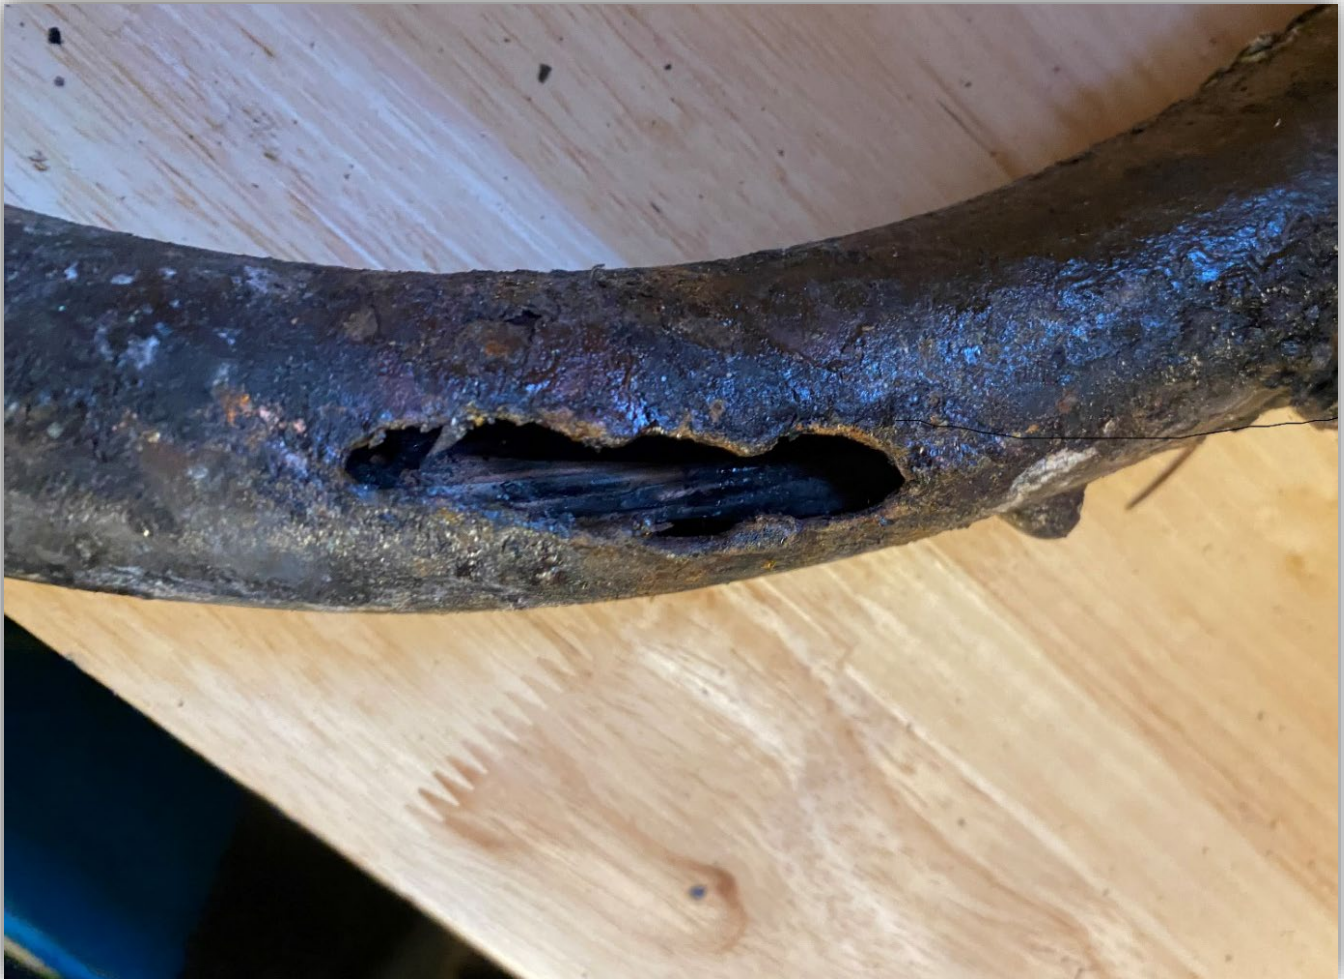
Image 3 - Bare conductors in the service conduit. The service conductor arced through the metallic service conduit in the attic.

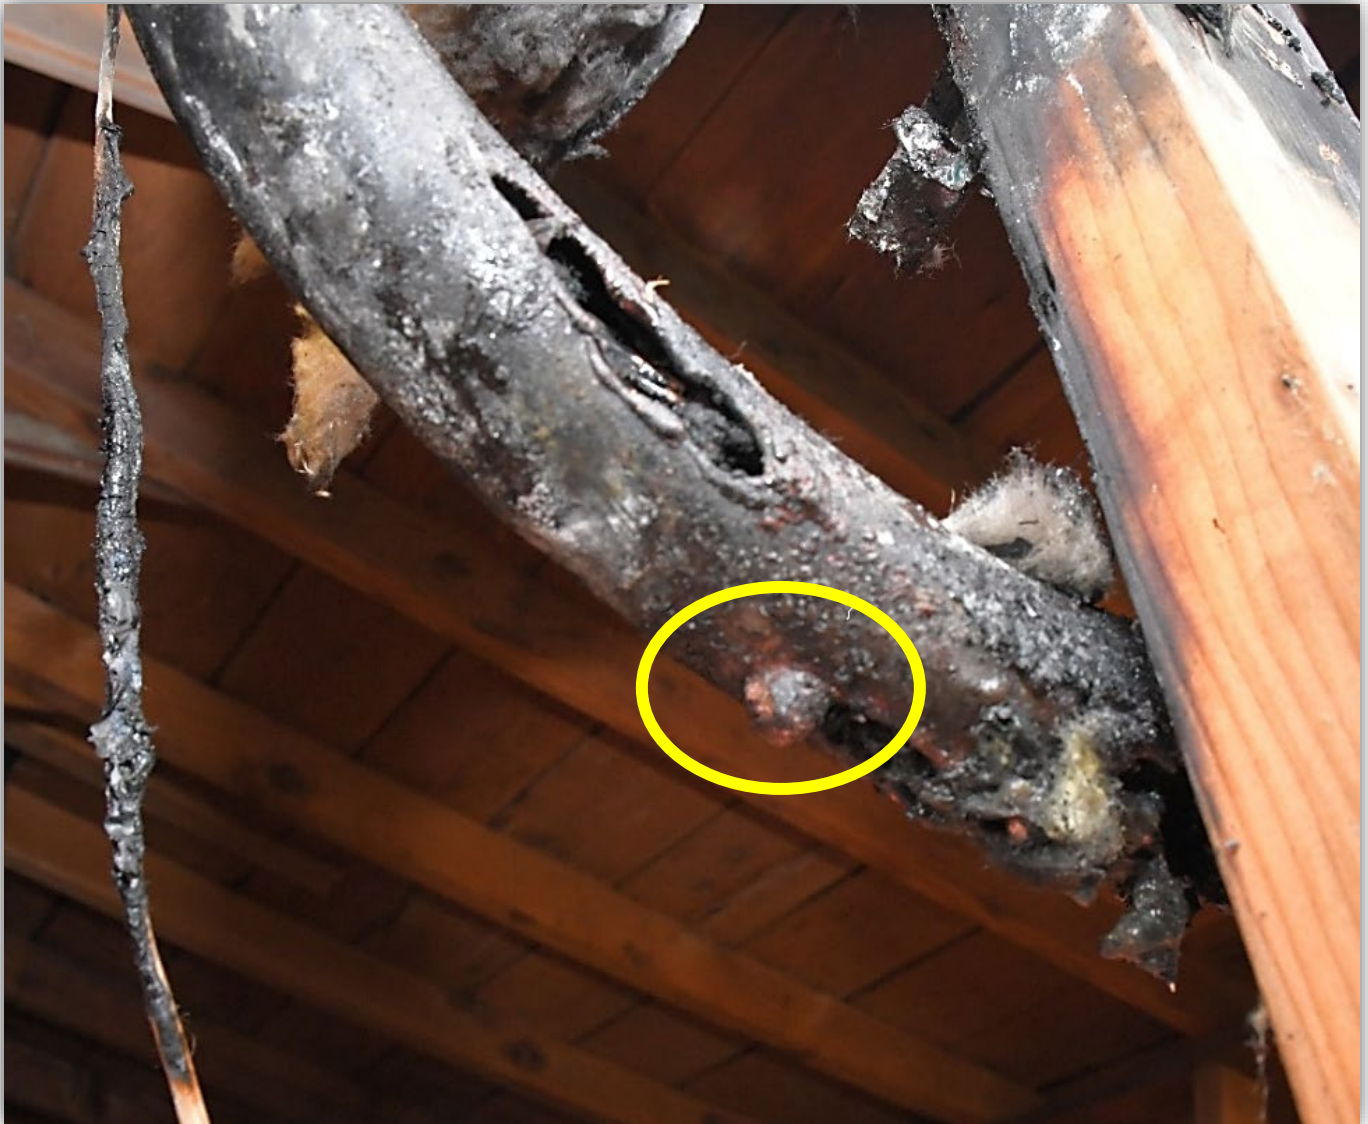
Image 4 - Bare conductors in the service conduit. The service conductor arced through the metallic service conduit in the attic. [Circle] Molten drip.

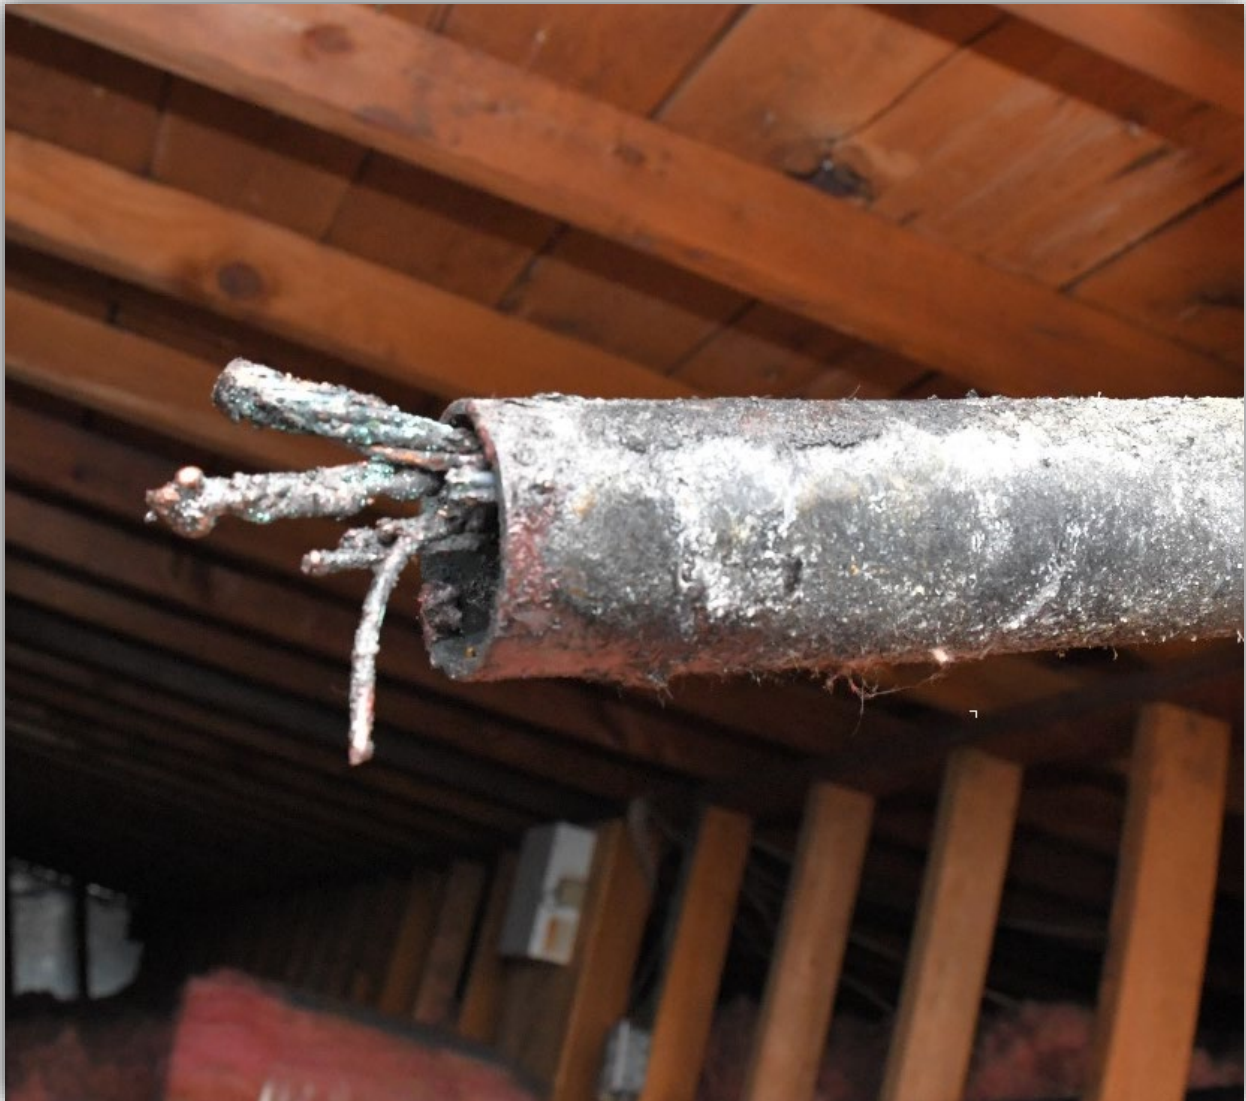
Image 5 - The service conductors with their insulation burned off and arcing at the ends of the conductors.

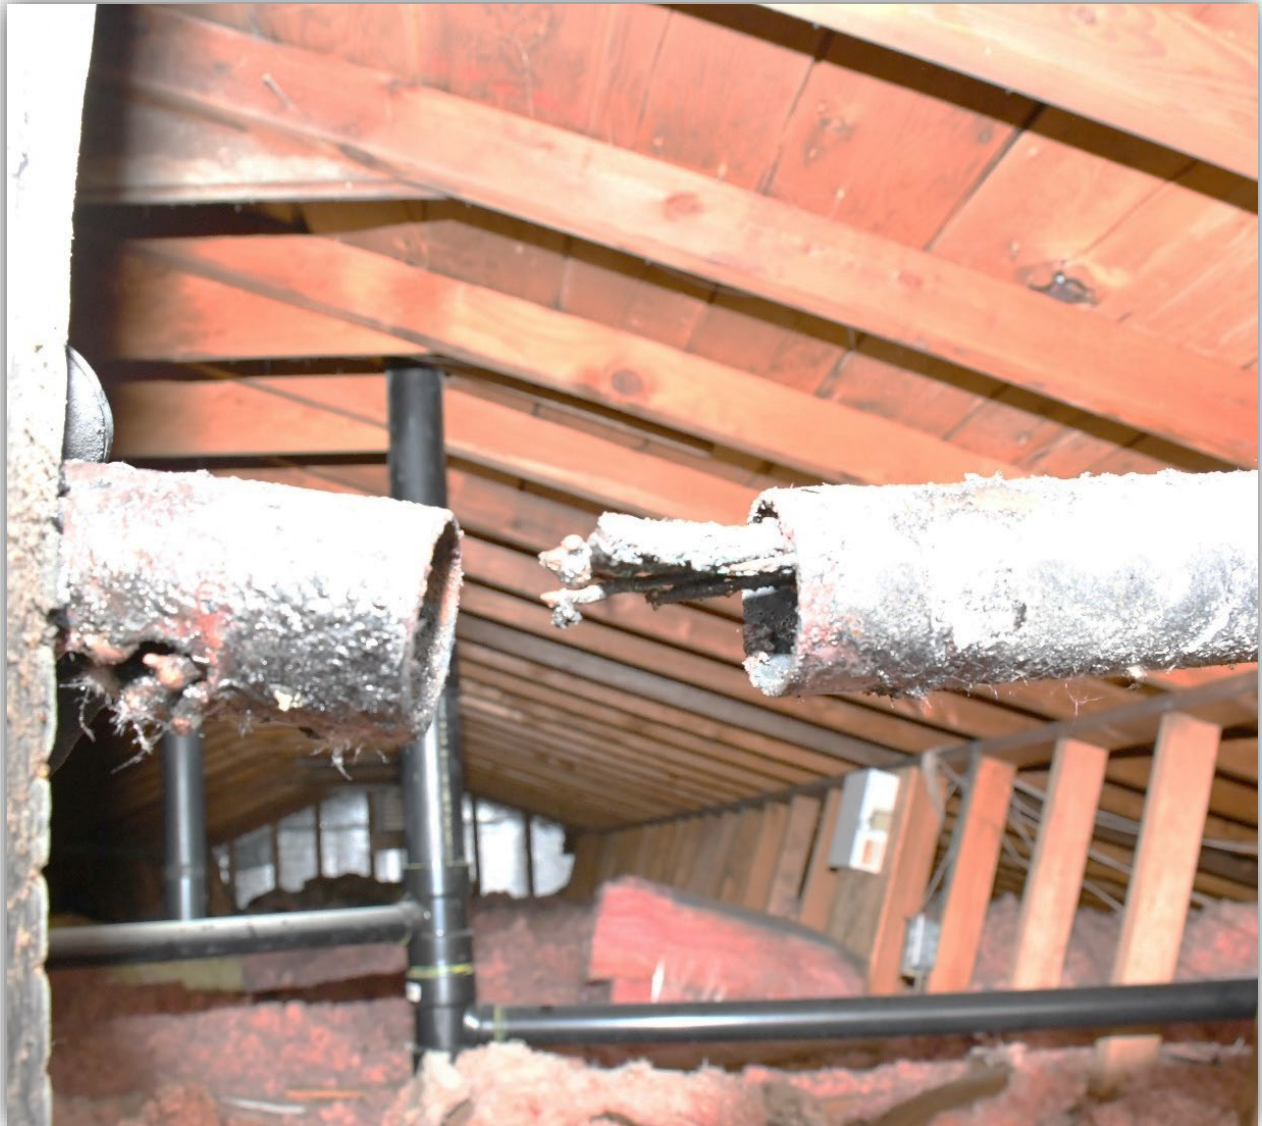
Image 6 – No evidence of a service conduit coupling.

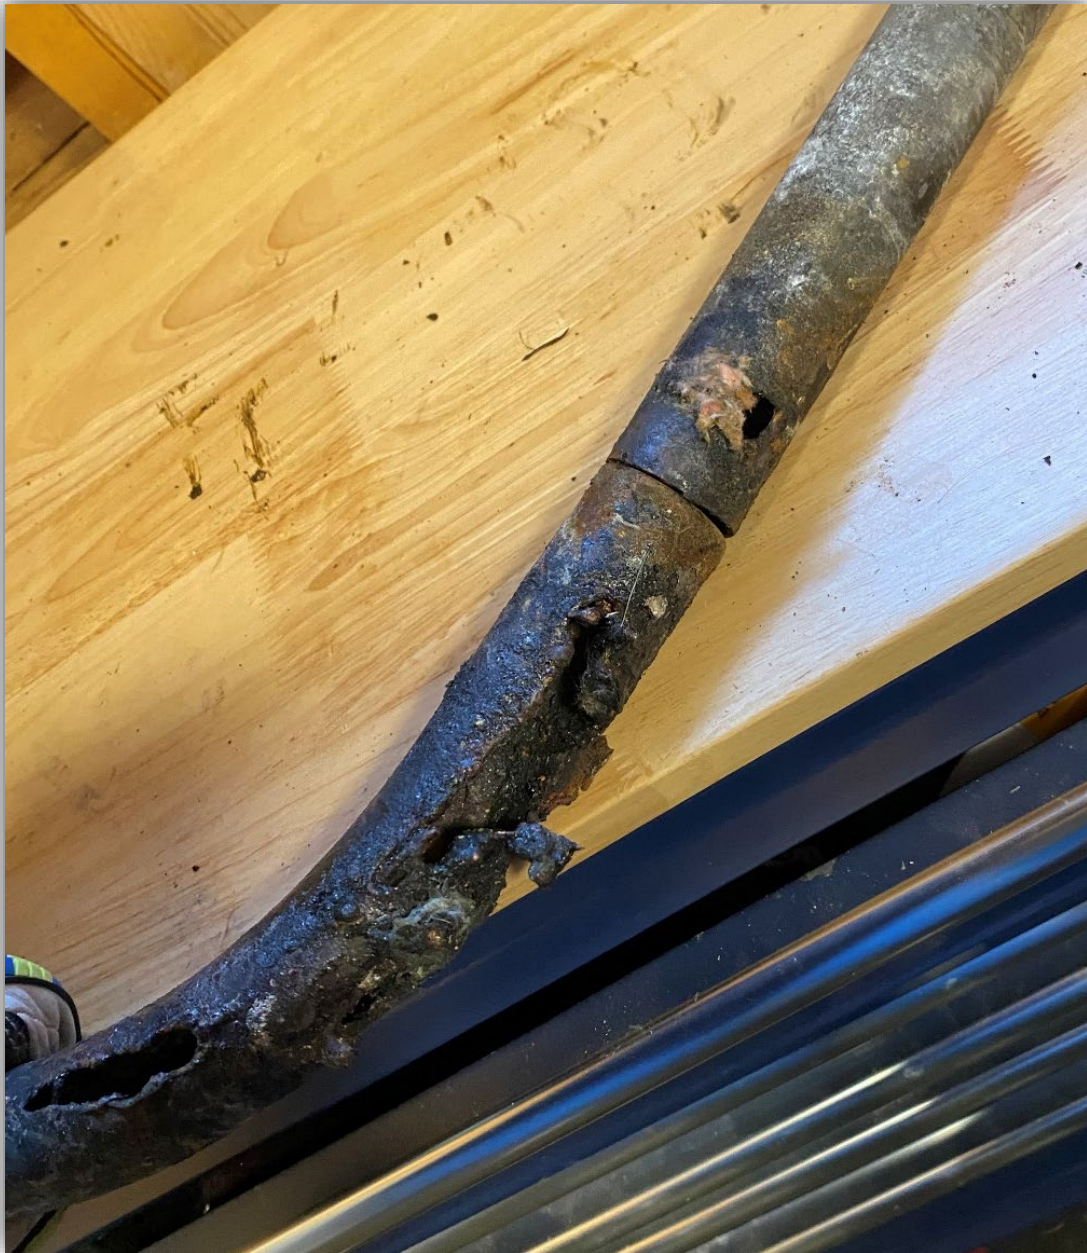
Failure scenario(s)	The electrical metal tubing (EMT) housing the consumer service conductors from the meter enclosure to the connection point of the supply authority appears to have been previously tampered and possibly separated for the purpose of bypassing the electrical supply authority's metering. The conductors may have been previously tampered with, which likely caused a failure, over time, in the insulation. The failed insulation on the service conductors melted allowing contact between the bare copper conductors and the EMT resulting in a short circuit between the other service conductors. With no overcurrent protection, the EMT melted causing molten metal to fall onto the wood framing in the attic space, igniting the wood.

Image 7 - No evidence of a coupling, possible tampering.

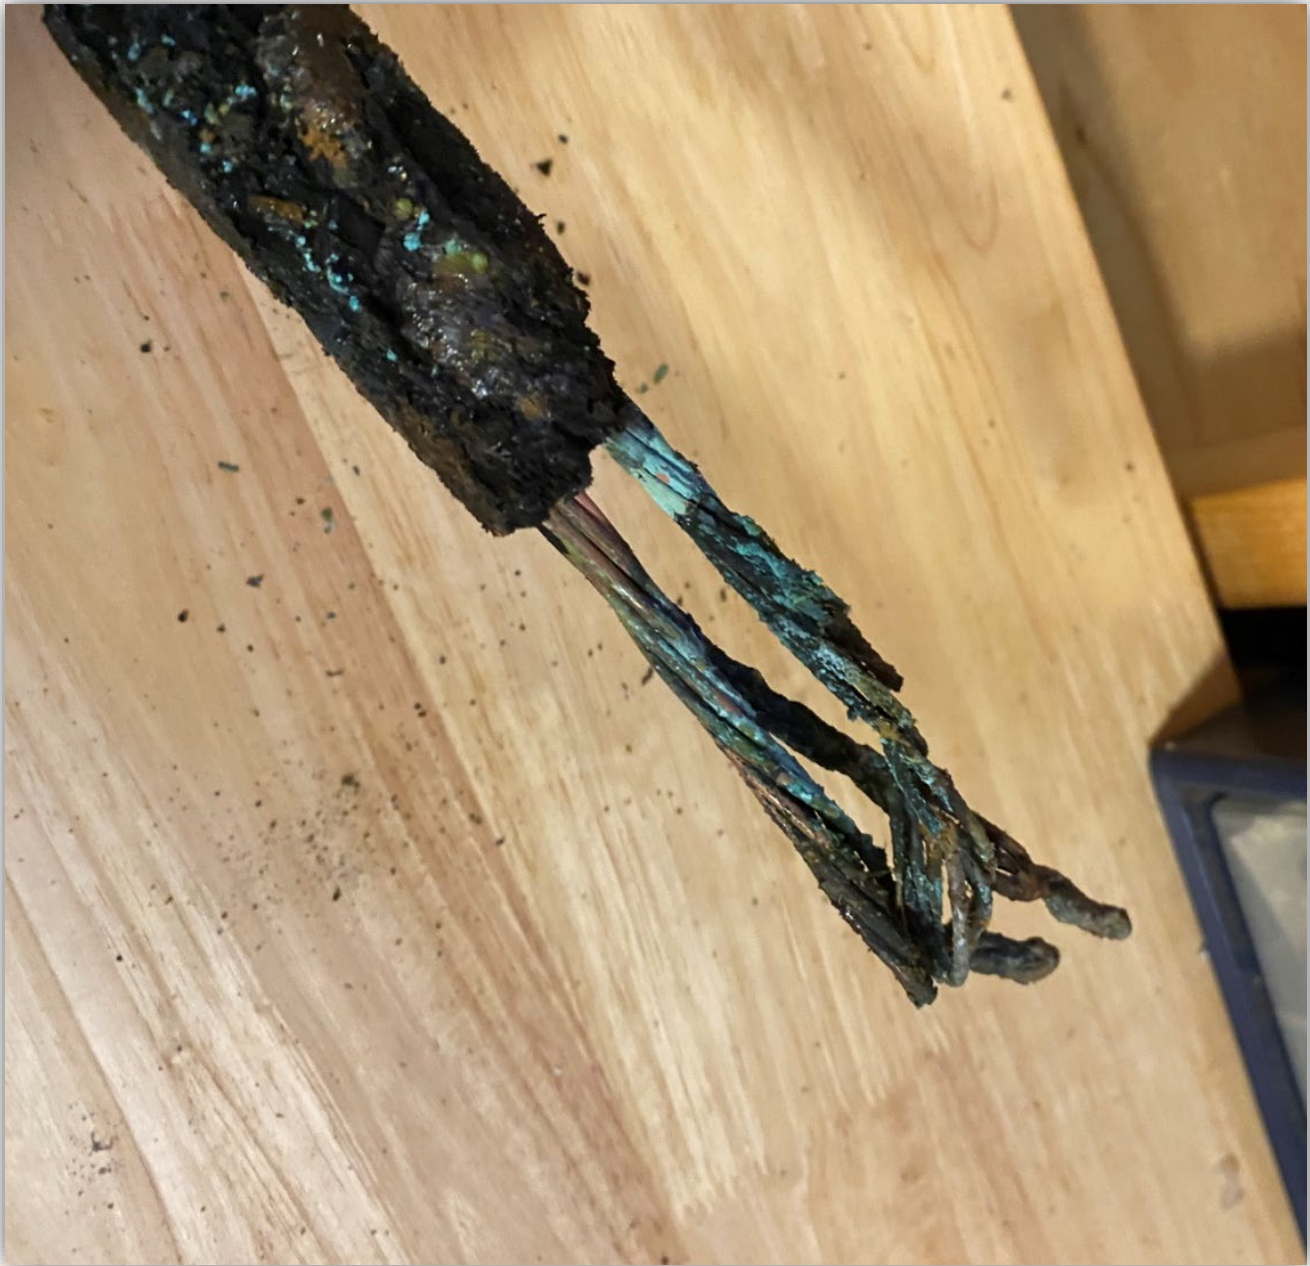
Image 8 - Insulation failed, bare consumer service conductors.
