Incident Summary #II-1401094-2022 (#28618) (FINAL)

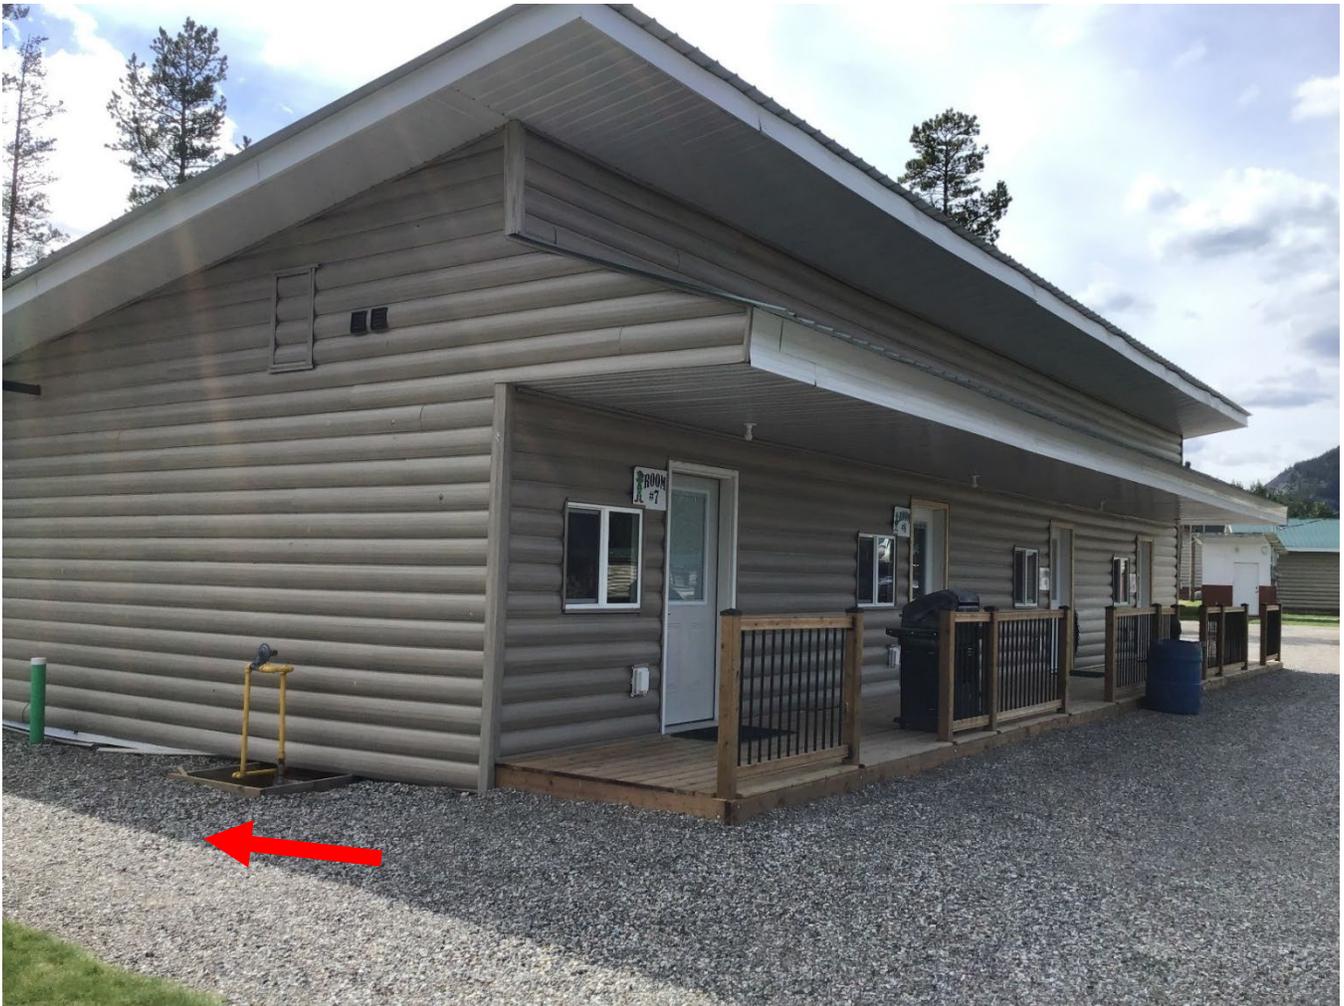
Image 1 - Exterior of four-plex accommodation. Red arrow showing the approximate location of the underground gas leak.

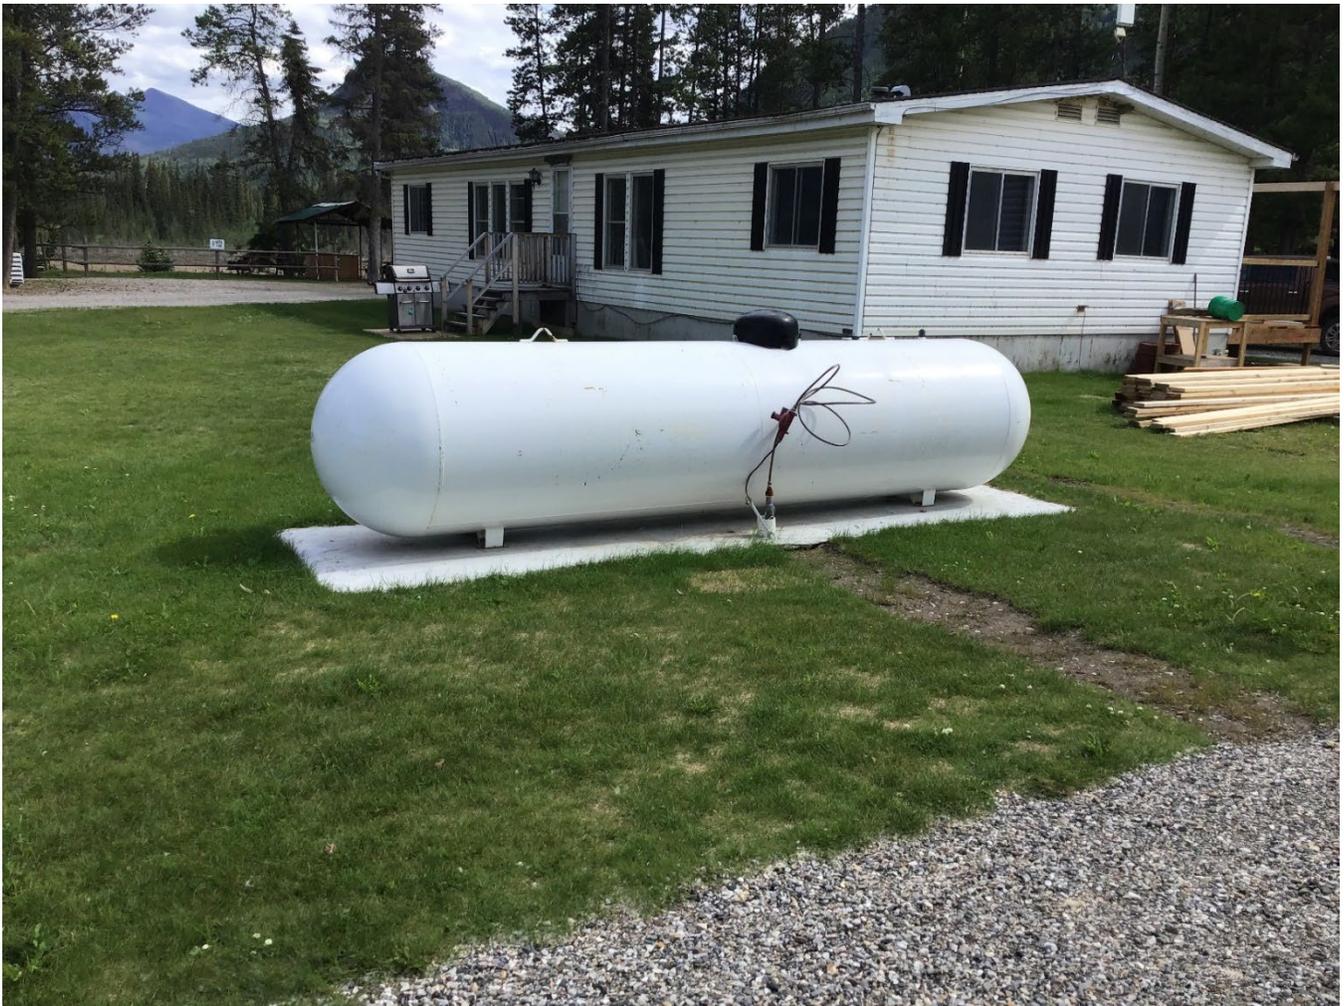
Image 2 - 1000 USWG propane tank supply for the four-plex. Piping had been disconnected from the tank after the incident.

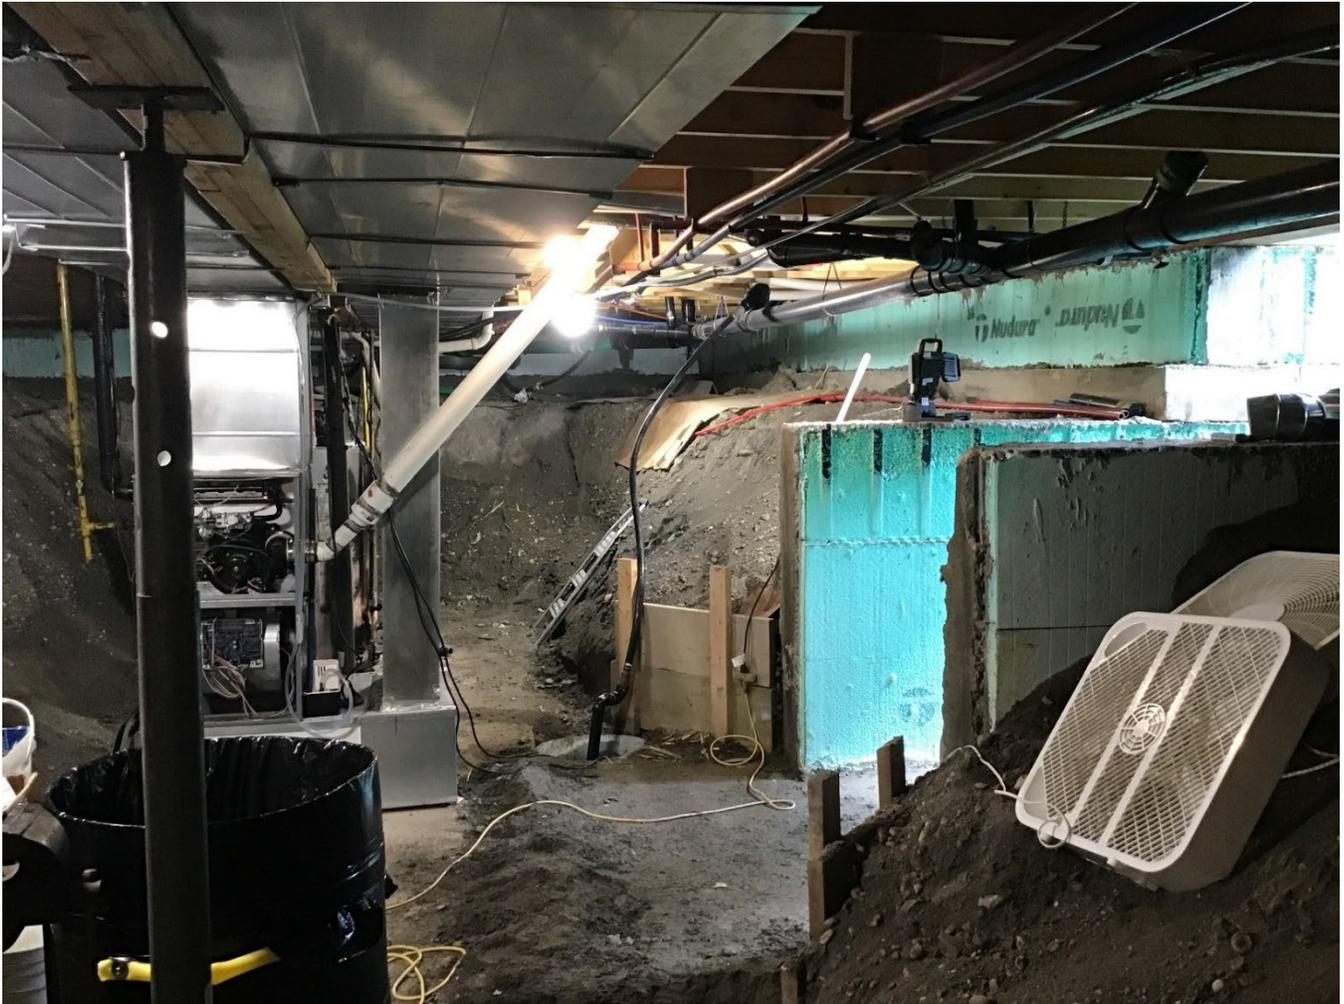
Image 3 - Crawlspace under four-plex. Heat damage found on all surfaces in the crawlspace, including melted Styrofoam concrete forms and all wiring, piping, and wood.

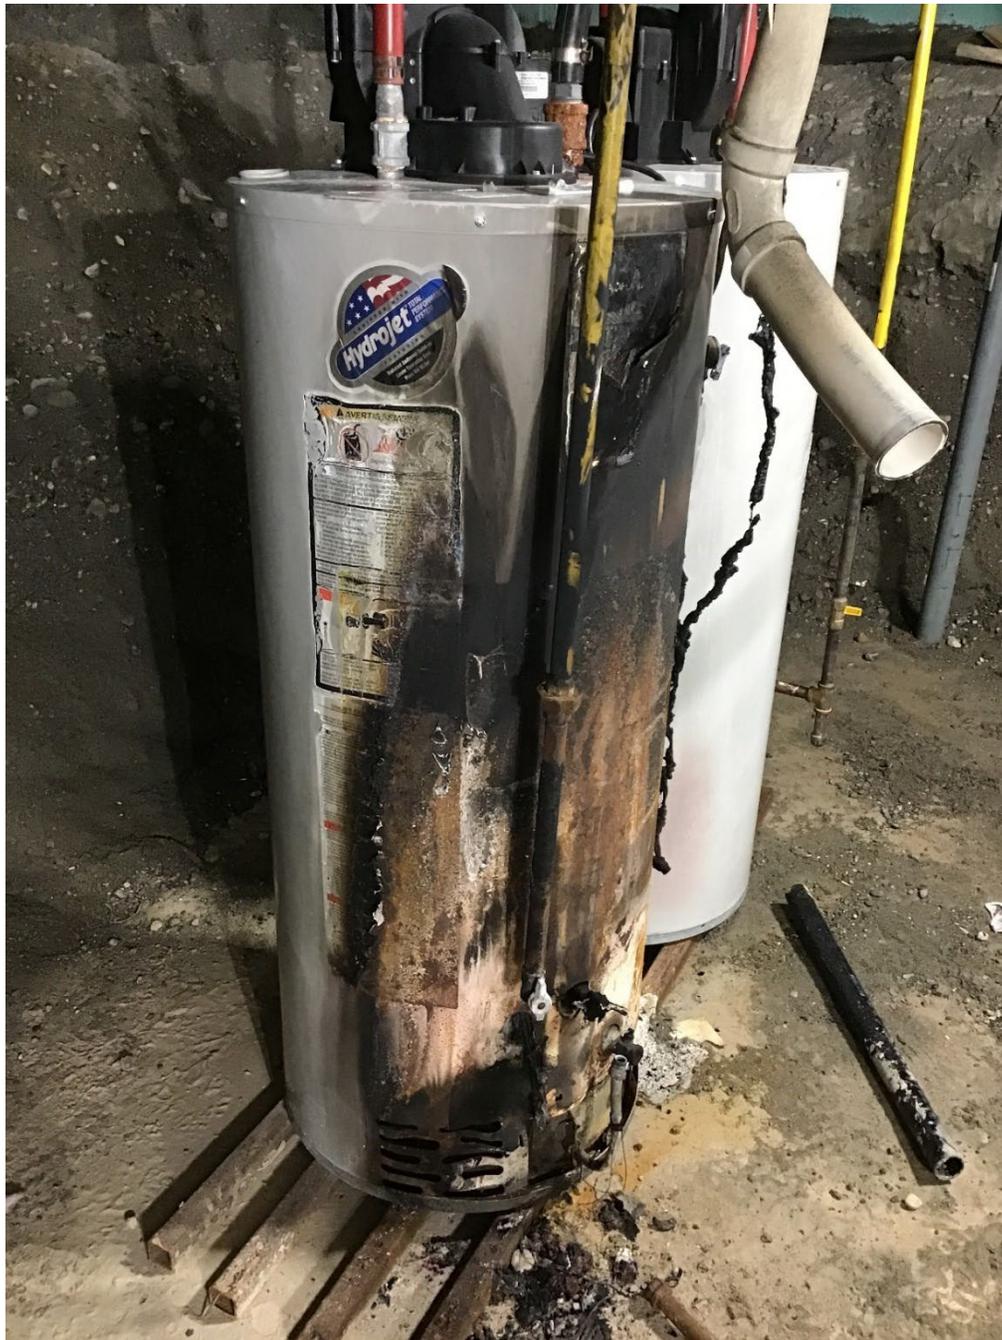
Image 4 - Fire damage to Hot Water Heater #1

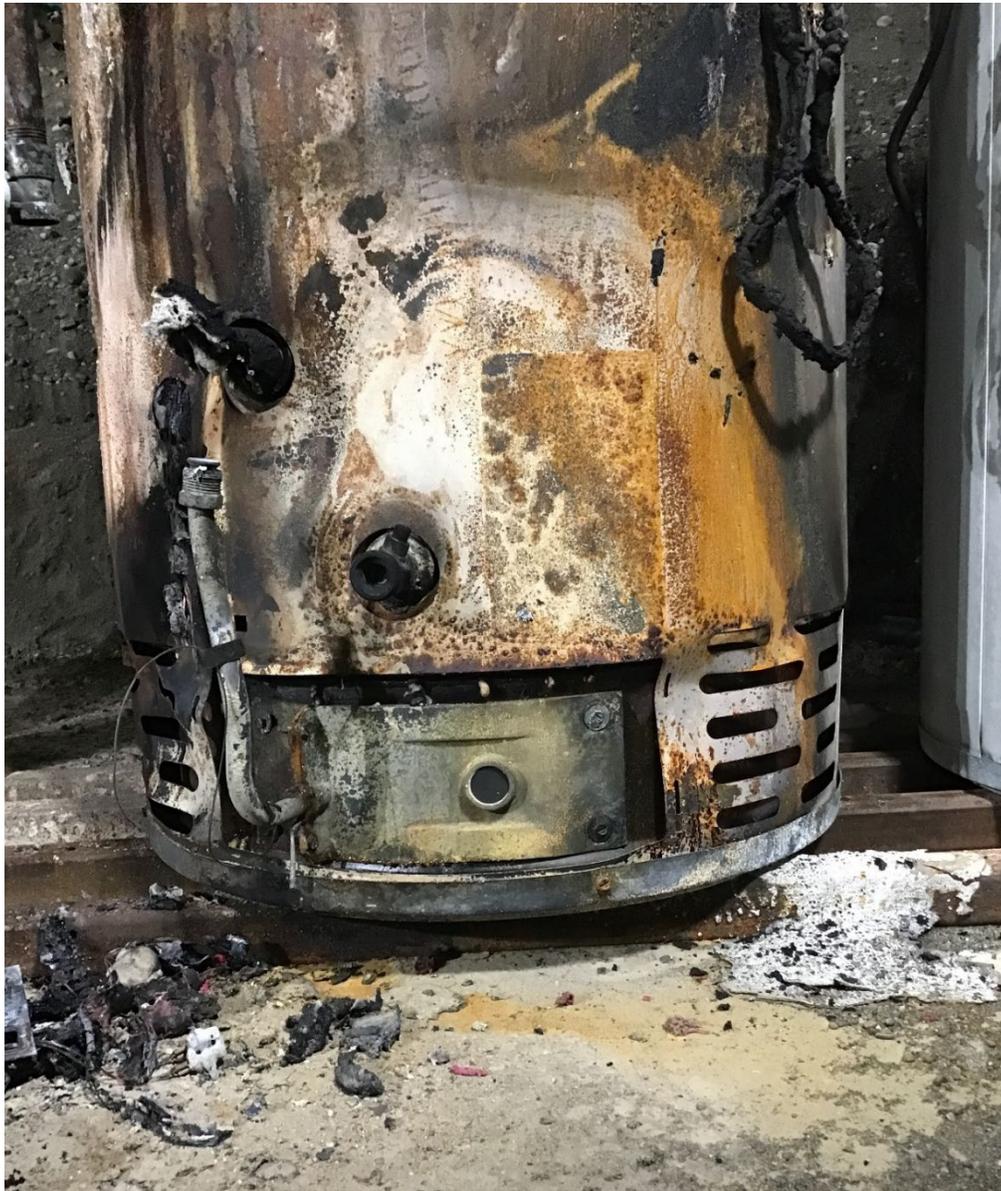
Image 5 - Hot Water Heater #1. Source of ignition in the four-plex crawl space

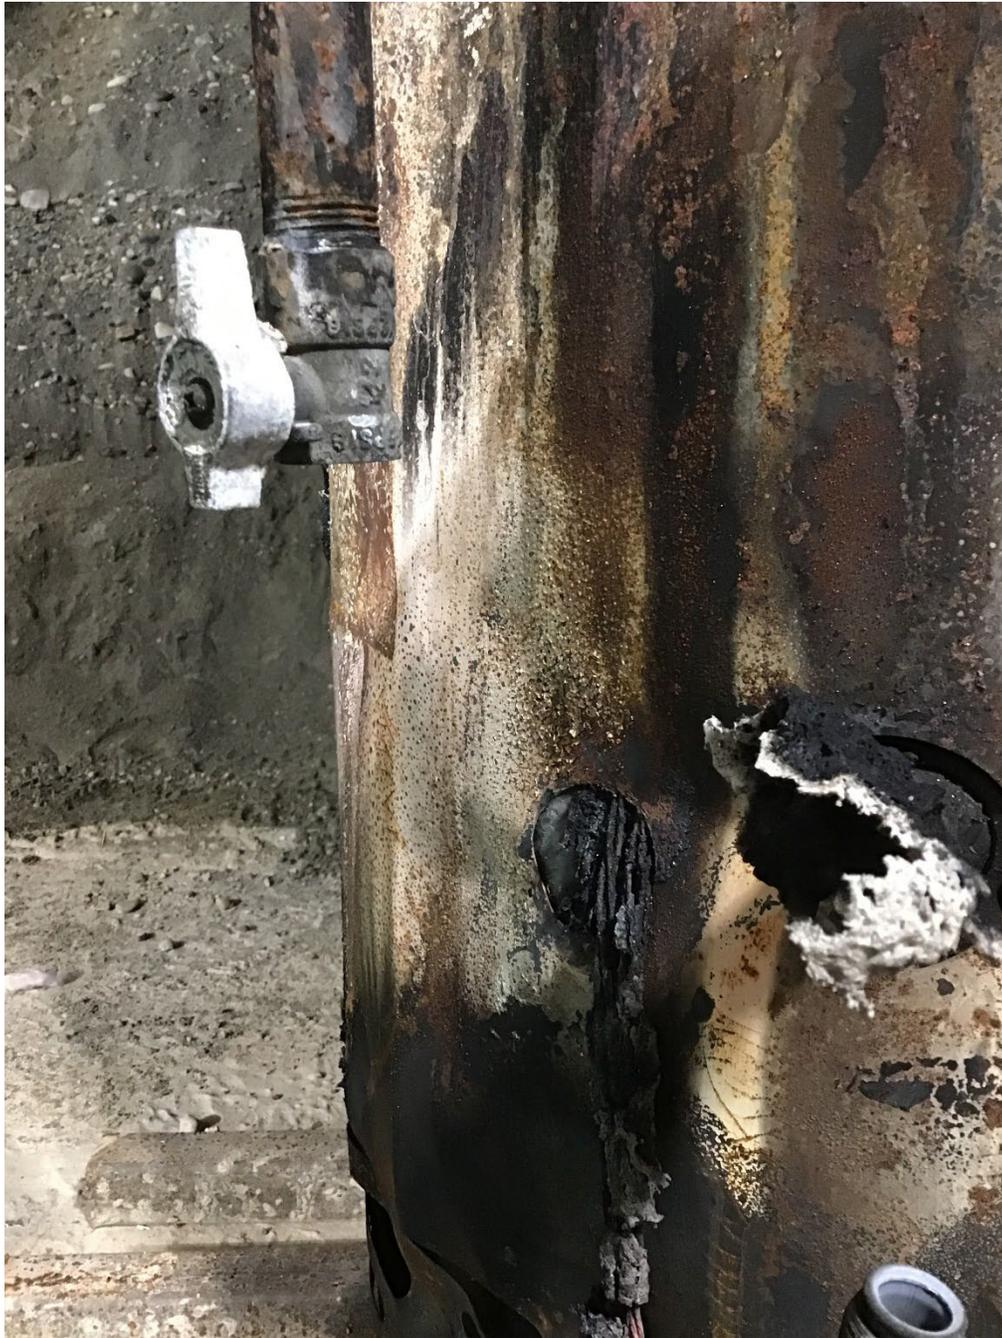
Image 7 – Damaged gas ball valve with the handle in the open position.

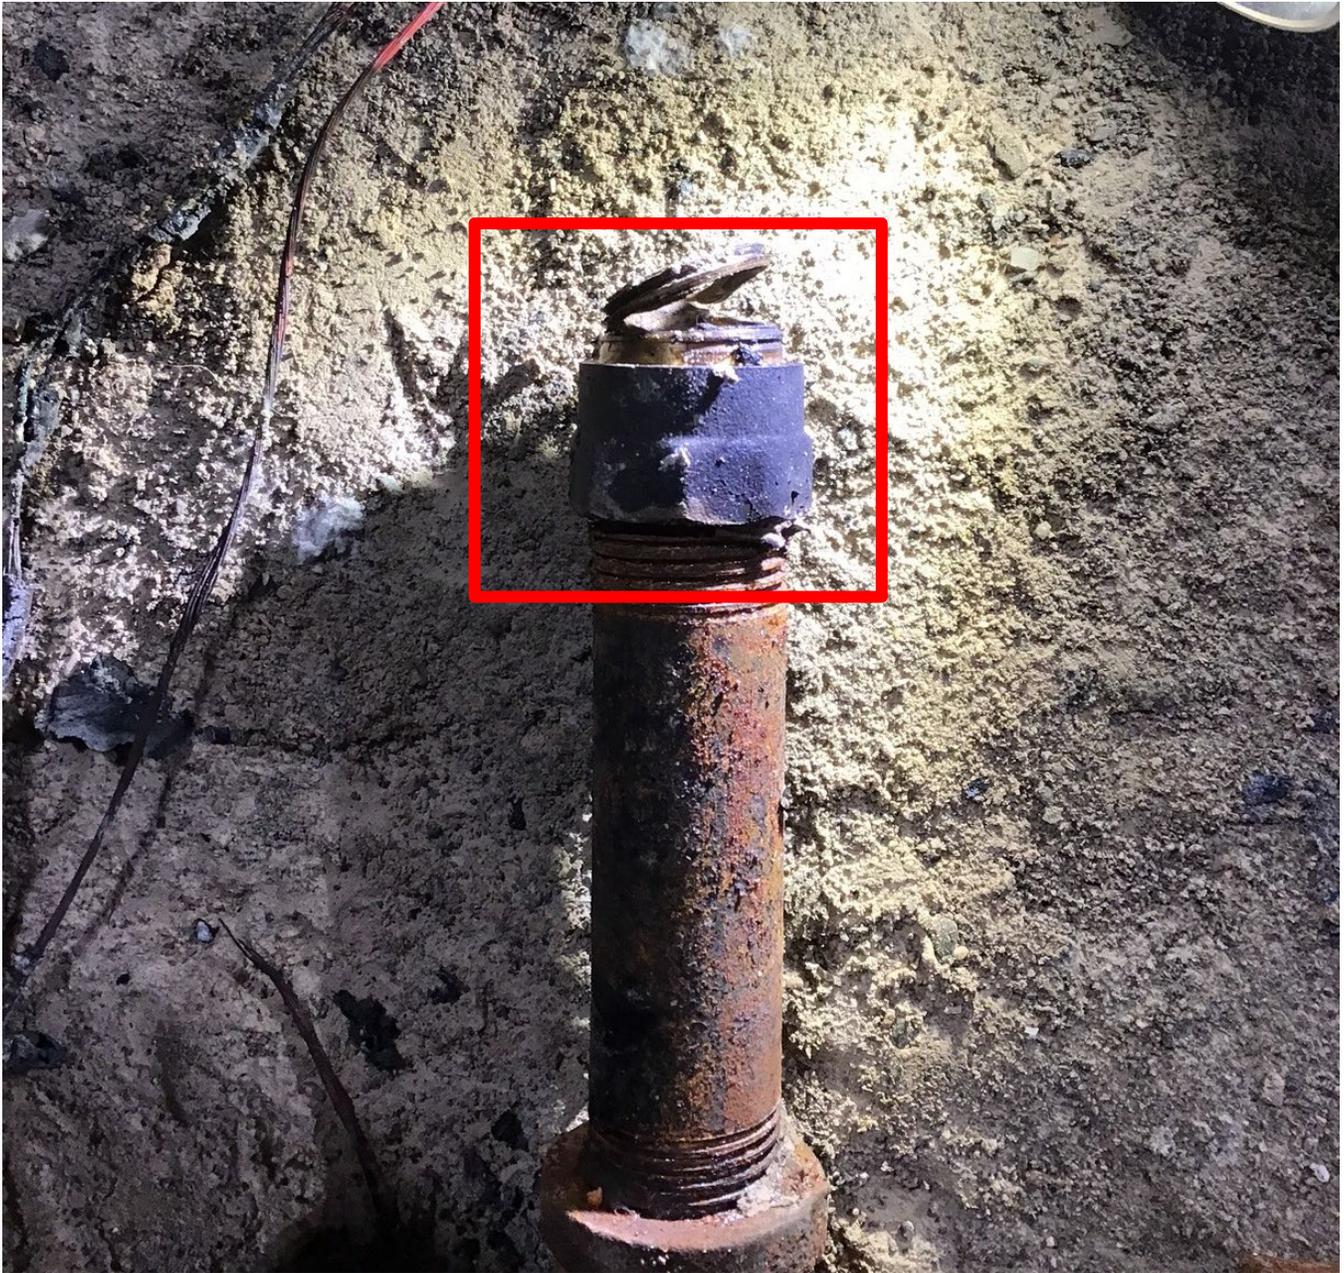
Image 8 – Red box second part of ball valve showing damaged threads where it had separated.

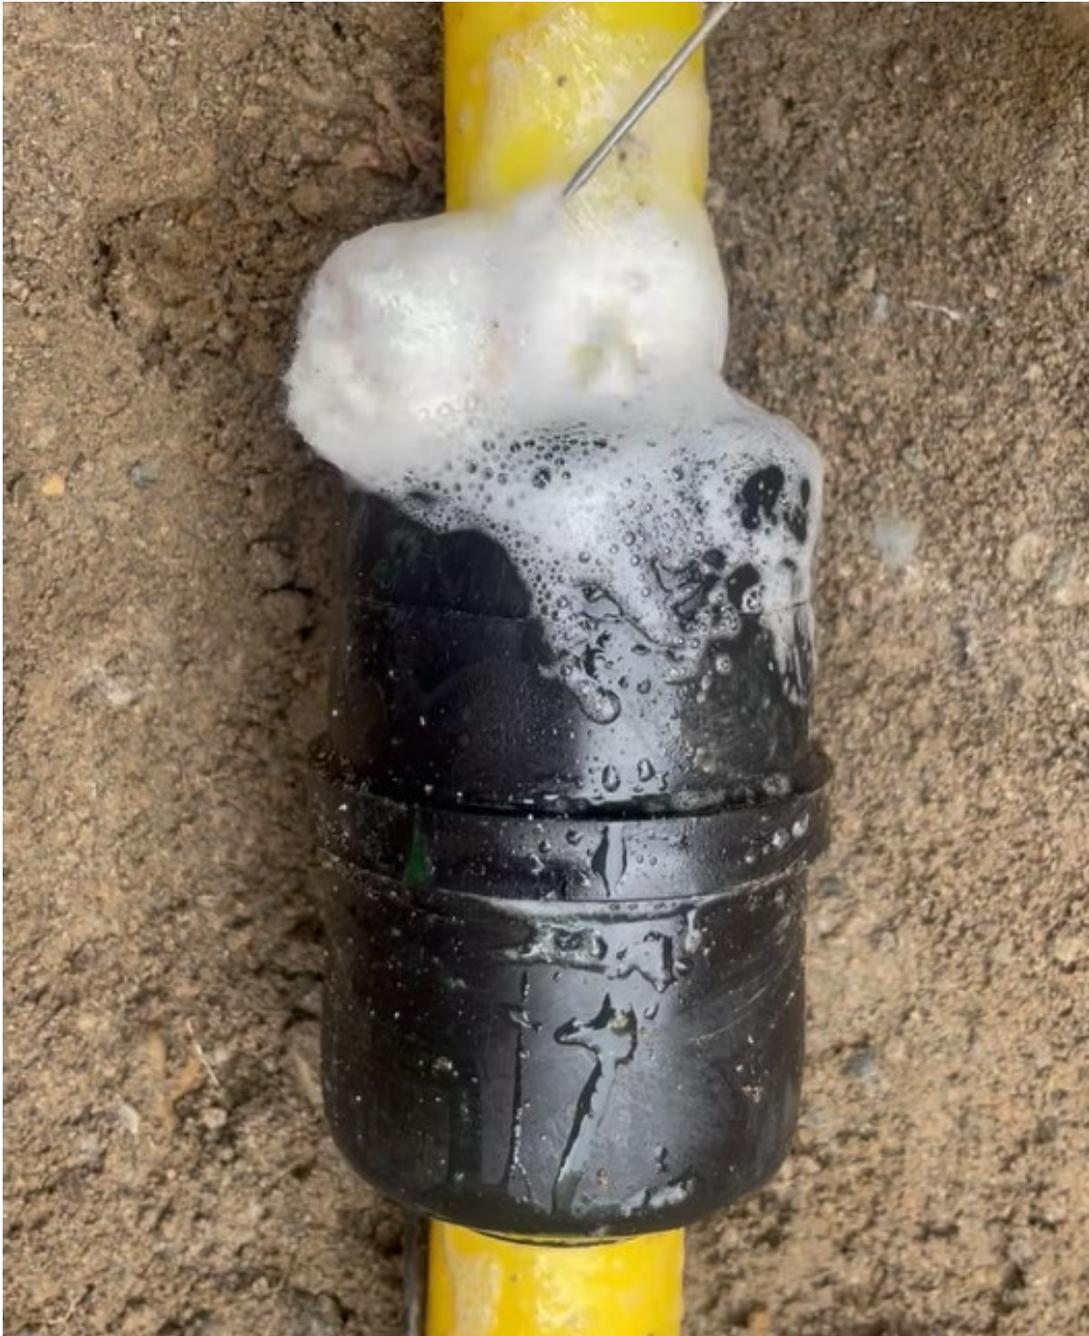
Image 9 – Leaking coupling on underground gas line exposed after incident.
