## Incident Summary #II-1047453-2020 (#18954) (FINAL)

SUPPORTING INFORMATION	Incident Date	August 2, 2020	
	Location	Dawson Creek	
	Regulated industry sector	Gas - Natural gas system	
	Impact	Qty injuries	0
		Injury description	None
	Damage	Injury rating	None
		Damage description	A hole in a gas line inside the house allowed gas to escape and caught fire. There was minor damage from the fire to wood framing and to a plastic water line in close proximity. There was water damage to the ceiling, walls, and flooring of the basement.
		Damage rating	Moderate
Incident rating	Moderate		
Incident overview	A lightning strike to a house occurred, and immediately after a gas leak from corrugated stainless steel tubing (CSST) ensued and caused a minor fire.		
INVESTIGATION CONCLUSIONS	Site, system and components	<p>Corrugated stainless steel tubing (CSST) is flexible gas tubing that conveys natural gas or propane to gas appliances.</p> <p>Black iron gas piping is steel pipe also used to convey natural gas or propane to gas appliances. The house contained both black iron and CSST as part of its gas piping system.</p> <p>Metal gas piping can offer a path for electrical current to flow to all pa

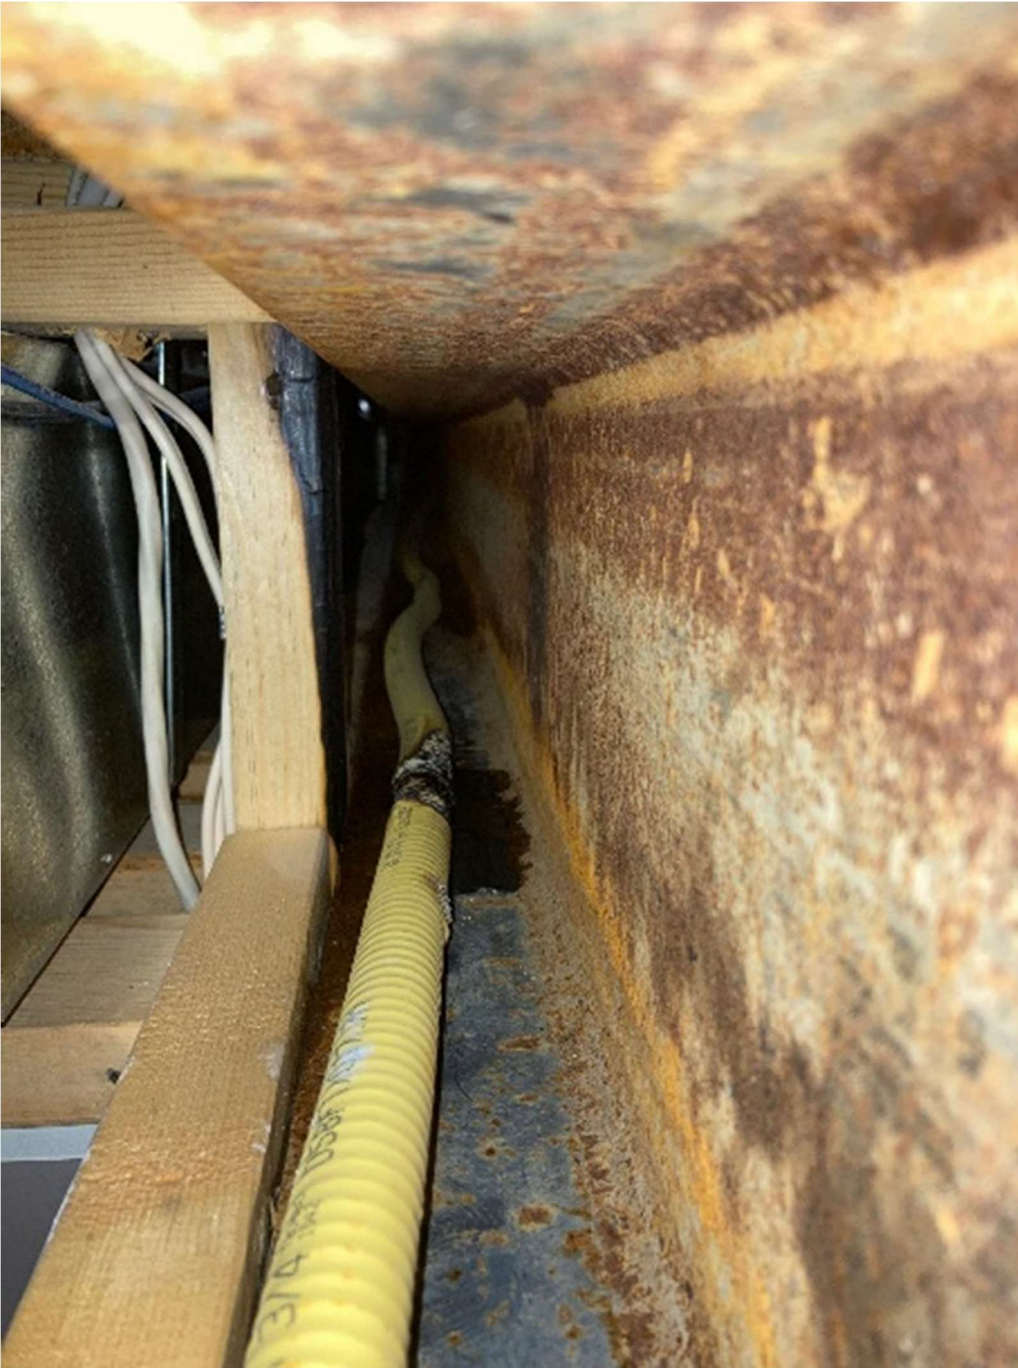
It is probable that the incorrectly installed CSST that was run along the steel beam allowed the lightning to arc across and created the hole which allowed the gas to escape and be ignited, causing the fire.

Image 1 - CSST run along structural steel beam.

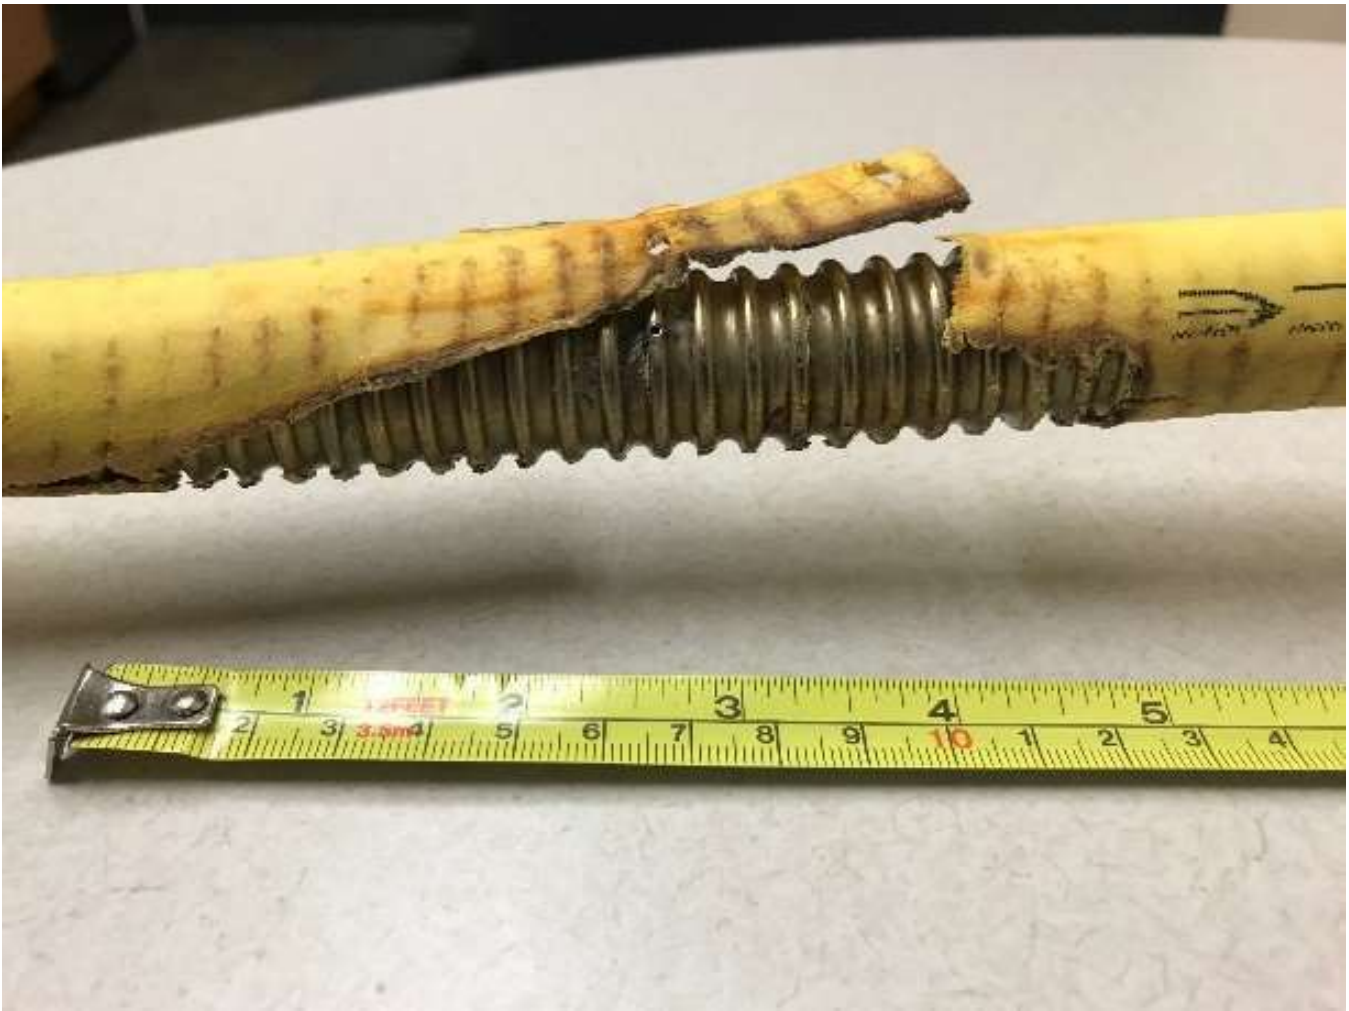
Image 2 - Damaged section of CSST

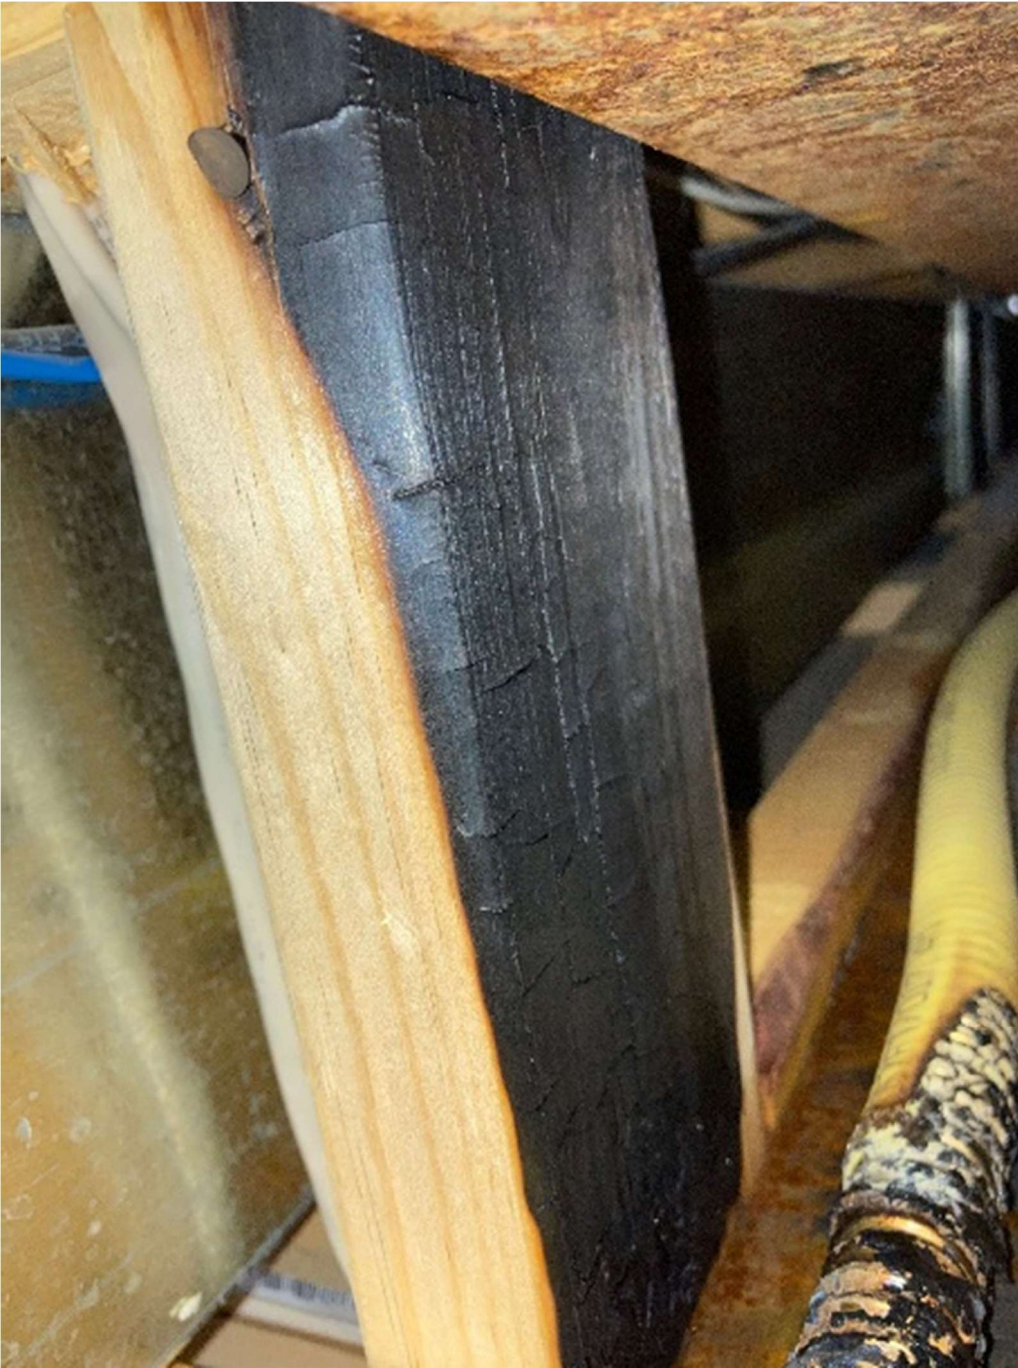
Image 3 - Fire damage to wood framing next to hole in CSST

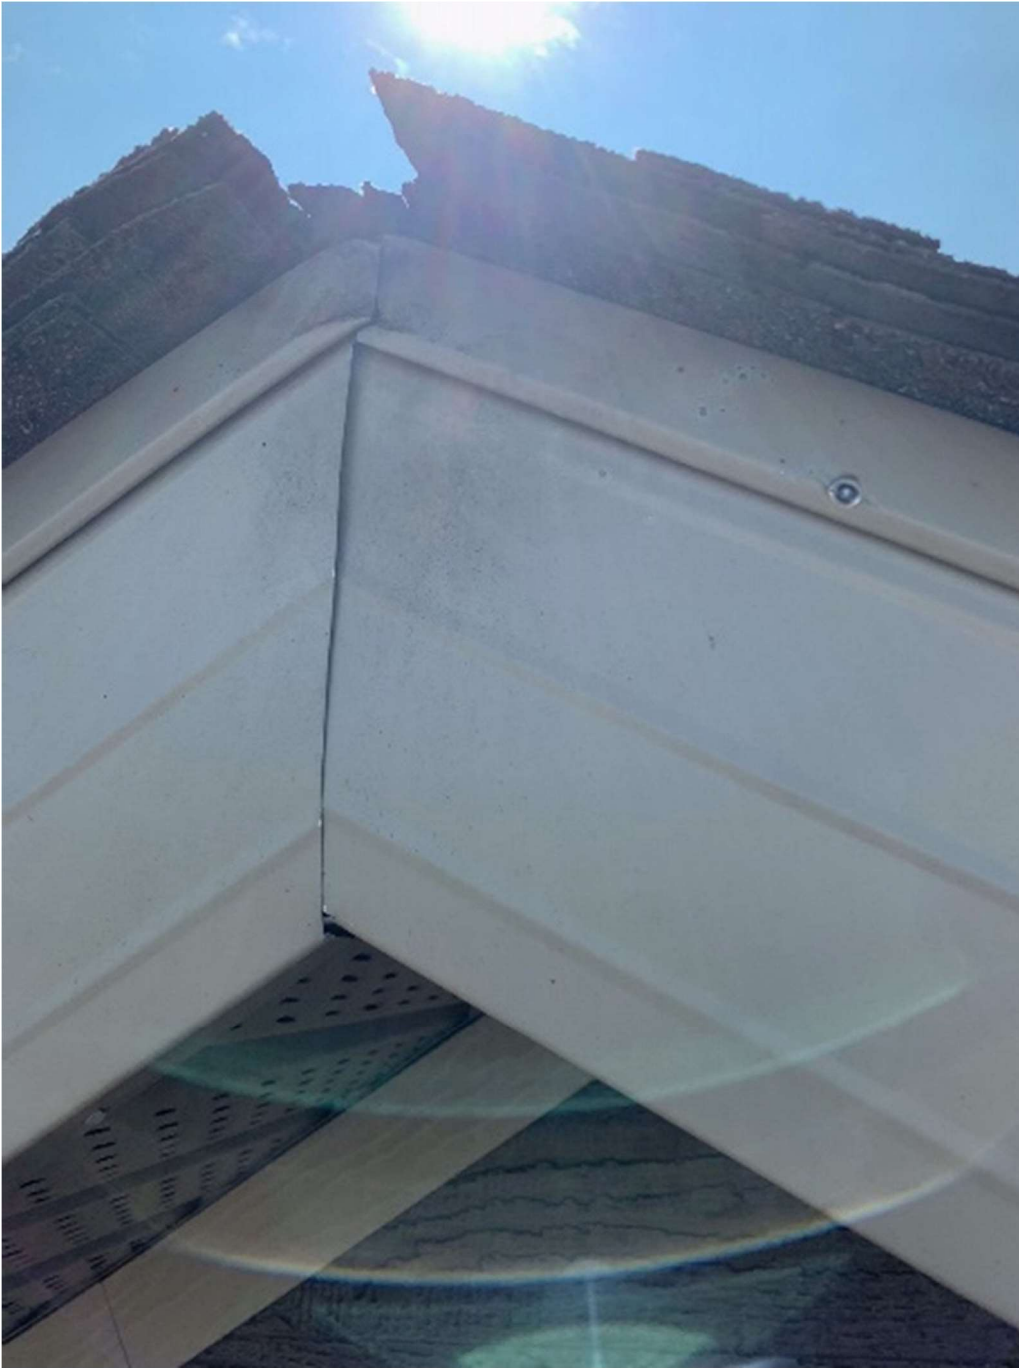
Image 4 - Roof peak where lightning hit the house

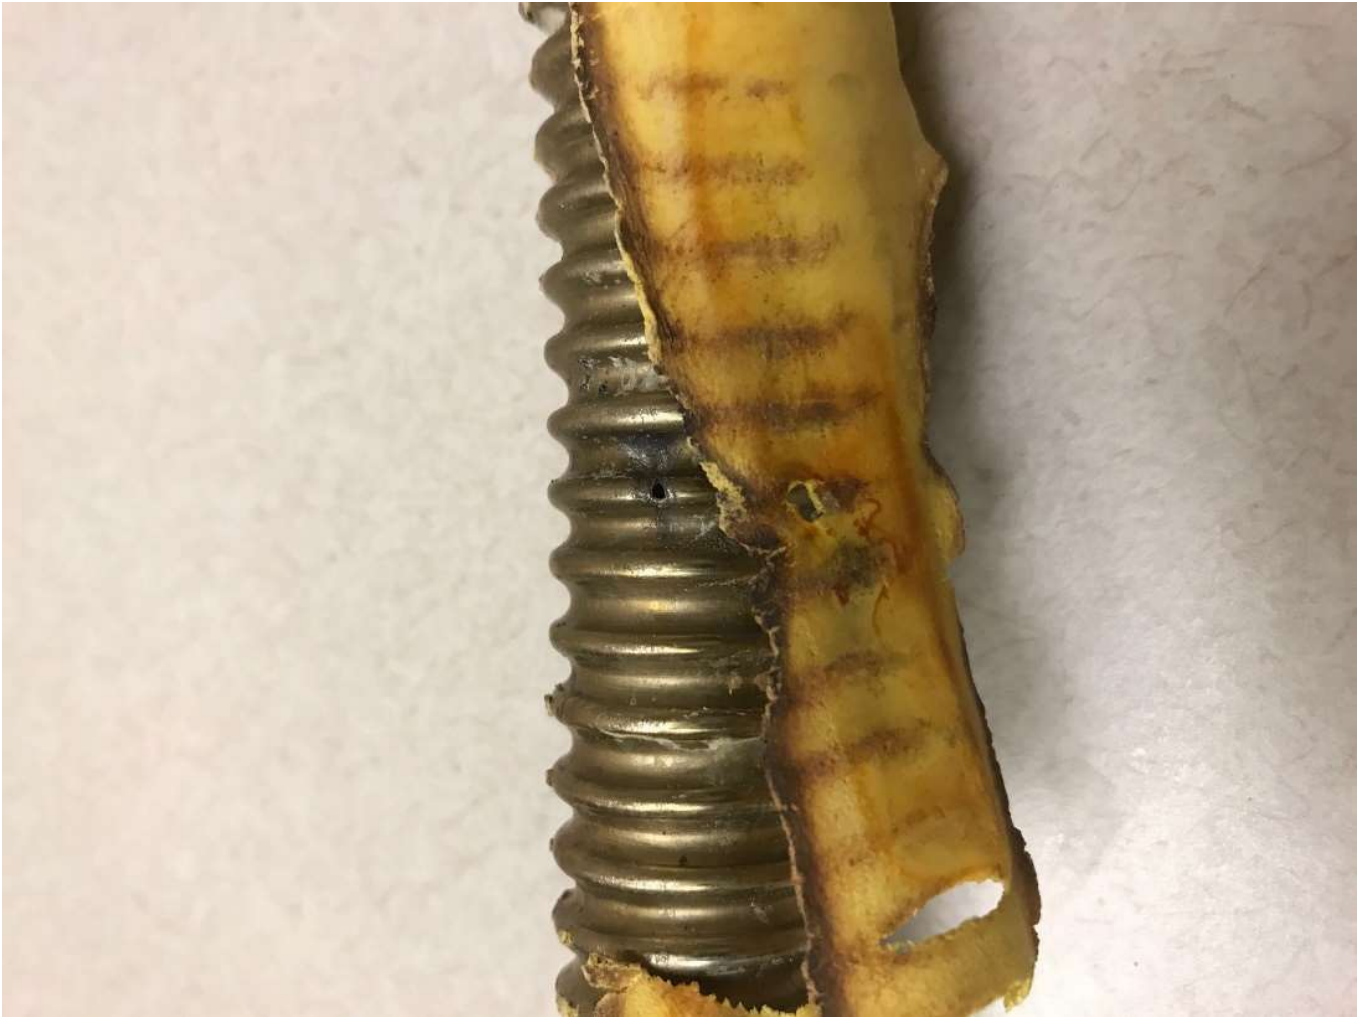
A small hole was found in the CSST at location where fire occurred, and the CSST plastic jacket melted at the location of the hole.

Image 5 - Hole in CSST
