Incident Summary #II-1700480-2024 (#45699) (FINAL)

SUPPORTING INFORMATION	Incident Date	April 22, 2024	
	Location	North Vancouver	
	Regulated industry sector	Boilers, PV & refrigeration - Refrigeration system	
	Impact	Qty injuries	1
		Injury description	Multiple workers and members of the public were in the area at the time of the leak. One bystander experienced symptoms of ammonia exposure and was treated by emergency services on site.
		Injury rating	Minor
	Damage	Damage description	Up to 100 pounds of ammonia was released into the atmosphere outdoors. The immediate area around the facility was cordoned off, neighbouring companies were alerted, and the facility, a nearby condo building and children's daycare were instructed to hold in place until the leak was stopped.
		Damage rating	Moderate
	Incident rating	Moderate	
	Incident overview	An uncontrolled ammonia leak occurred outside of a public athletic club with indoor ice facilities. The leak happened during decommissioning work of an ammonia refrigeration condenser by a refrigeration contractor and resulted in the facility enacting their Ammonia Release Emergency Protocol.

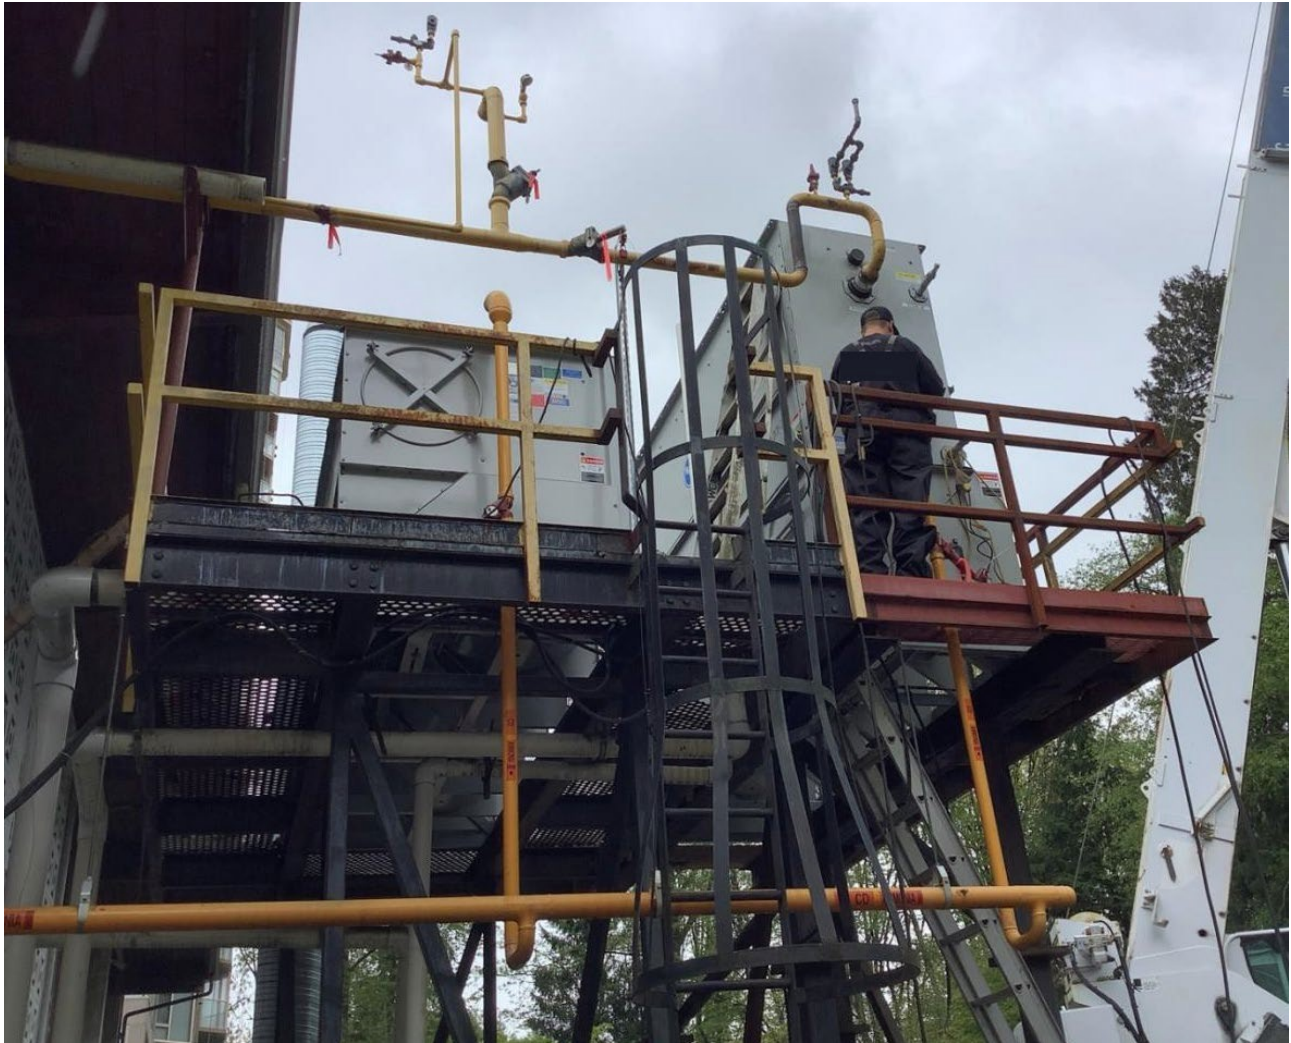
Image 1 - Ammonia condensers installed on the raised metal structure with connected yellow ammonia piping.

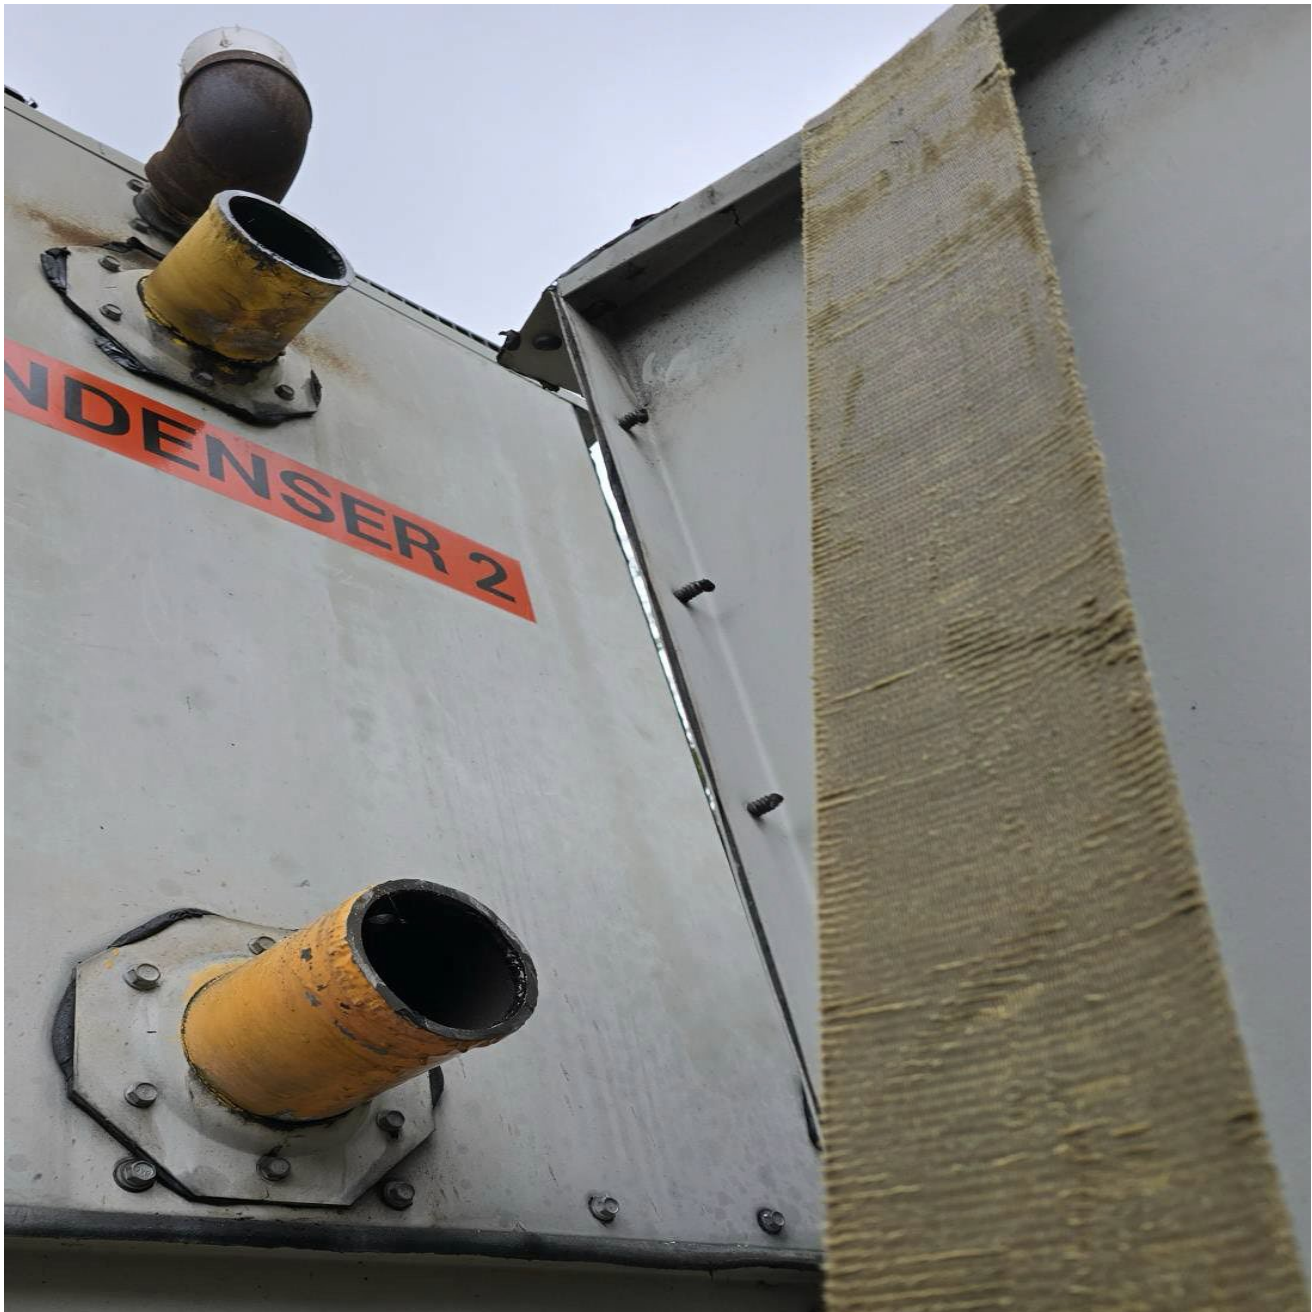
Image 2 - Condenser # 2 after removal from the structure.

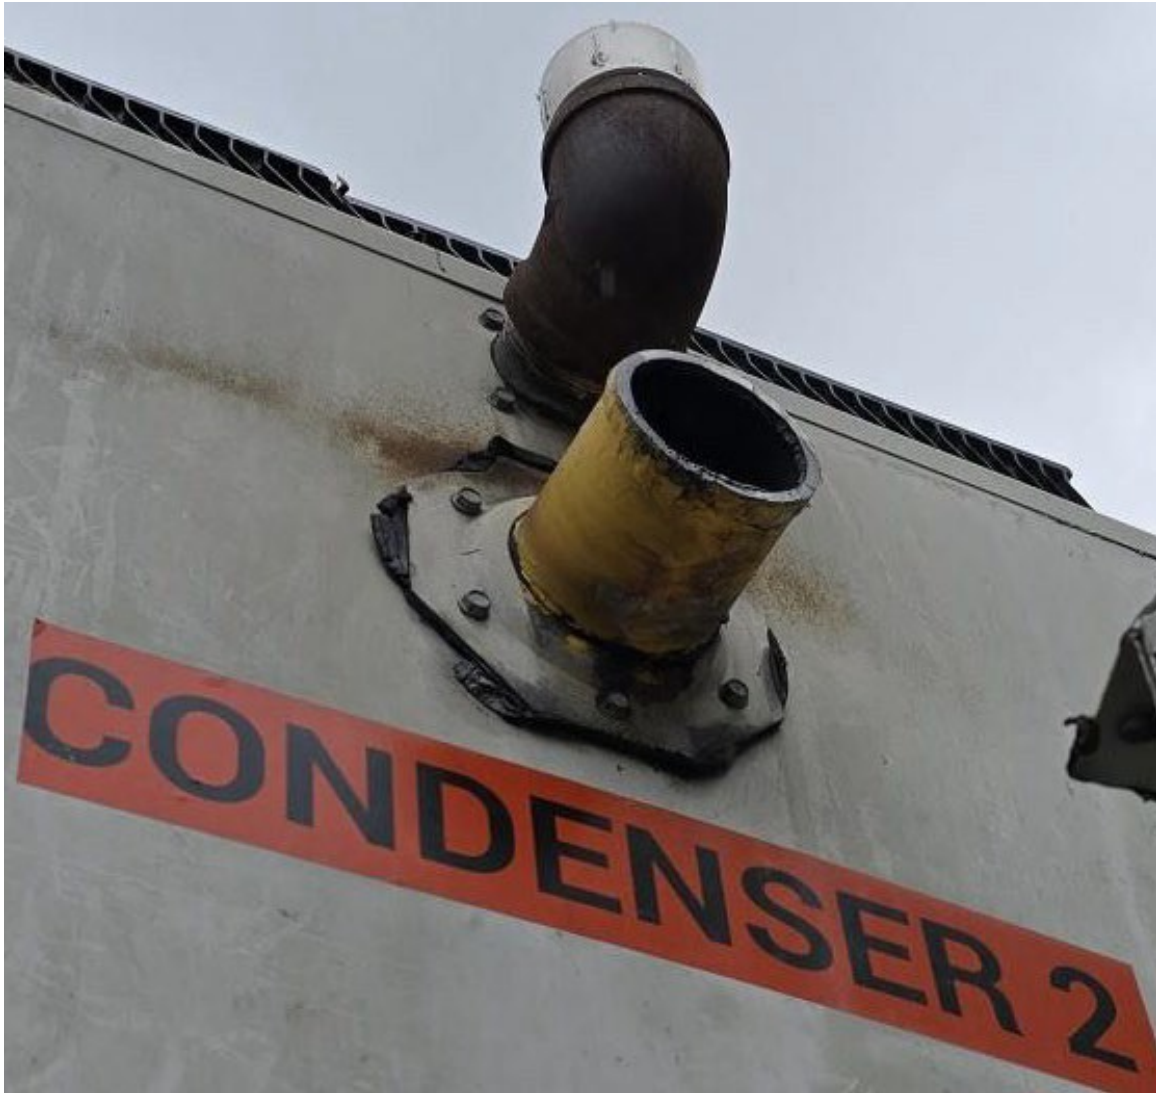
<ul style="list-style-type: none"> • The apprentice had been employed by the contractor for over two years. • The hole in the piping made by the grinder was approximately ¼" long. <p>Refrigeration apprentice statements:</p> <ul style="list-style-type: none"> • He was late to the job site. • He was directed by the site foreman to cut the welds on the condenser. • He saw felt marker lines on the ammonia piping and thought they were marks for cutting. • Once he cut into the pipe and the leak began, he stopped cutting and informed the foreman. • The they went and closed the ammonia valves to isolate the leaking piping to the condenser. <p>Timeline of events submitted by the Chief Engineer:</p> <ul style="list-style-type: none"> • The ammonia isolation valves were shut after the ammonia pipe was cut. • The area was cordoned off with caution tape. • The leak stopped approximately 1 hour after the pipe was cut.

<p>Causes and contributing factors</p>	<p>It is highly likely that failure to isolate and remove ammonia from the refrigeration system prior to, or during disassembly was the primary cause of the incident.</p> <p>Contributing factors to the incident include:</p> <ul style="list-style-type: none"> • Ineffective communication between the qualified foreman and the apprentice led to the incorrect cutting of the live ammonia line resulting in the leak. • The apprenticed not participating in the pre-job safety meeting before starting work allowed him to begin work without a full understanding of the potential works hazards. • The apprentice working without direct supervision from a qualified person authorized to do the work allowed the work to proceed without the hazard being identified.

Image 3 - Ammonia Vapour Piping (yellow) after being completely cut.
