## Incident Summary #II-1570402-2023 (#36471) (FINAL)

SUPPORTING INFORMATION	Incident Date	June 14, 2023	
	Location	New Westminster, BC	
	Regulated industry sector	Elevating Devices	
	Impact	Qty injuries	1
		Injury description	Worker stated they had a panic attack, pain on right leg and feeling pressure on head.
		Injury rating	Minor
	Damage	Damage description	2 suspension ropes severed.
		Damage rating	Moderate
Incident rating	Moderate		
Incident overview	While a person was travelling in an elevator in a retail business, 2 suspension ropes severed causing the elevator to engage the safeties which stopped and secured the elevator car. The person in the elevator car lost balance and fell onto a shopping cart in the elevator car and was trapped and rescued by fire department.		
INVESTIGATION CONCLUSIONS	Site, system and components	<ul style="list-style-type: none"> <li>The elevator type is 2-stop Savaria/Concord LULA (Limited Use, Limited Application).</li> <li>The LULA is a hydraulic lift utilizing two 3/8inch steel suspension ropes attached to the elevator car and the guide rail pit steel that is fastened to the pit floor (<a href="#">Image 1</a>).</li> <li>A hydraulic cylinder is

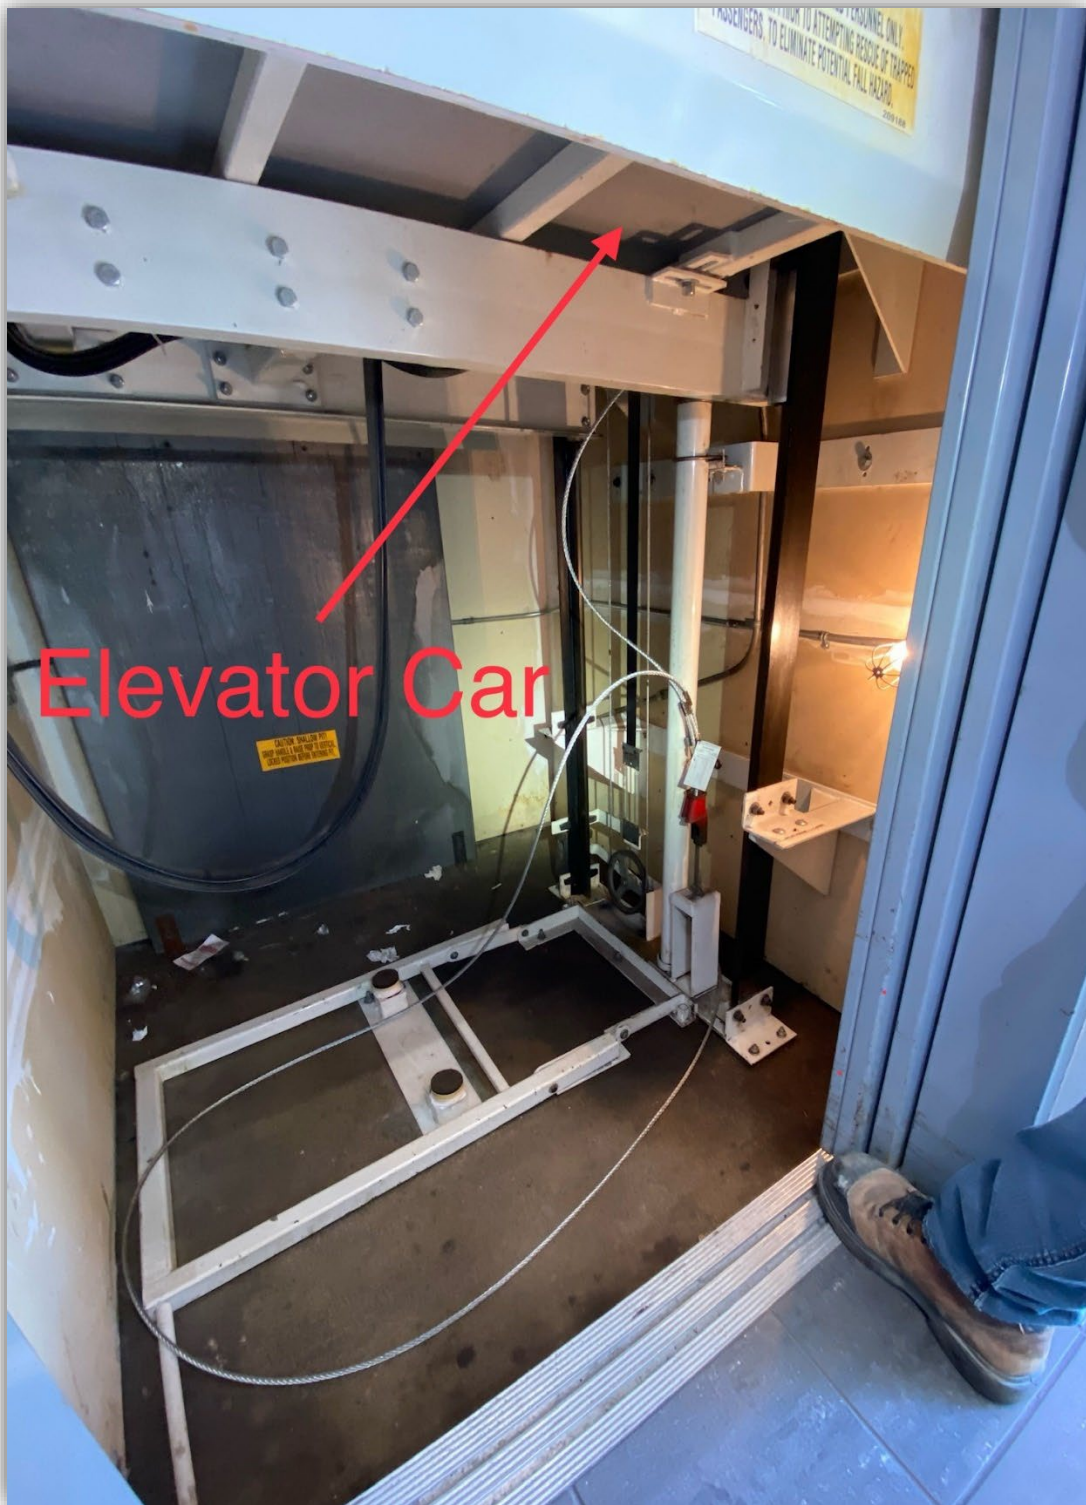
Image 1 - Elevator car from below.

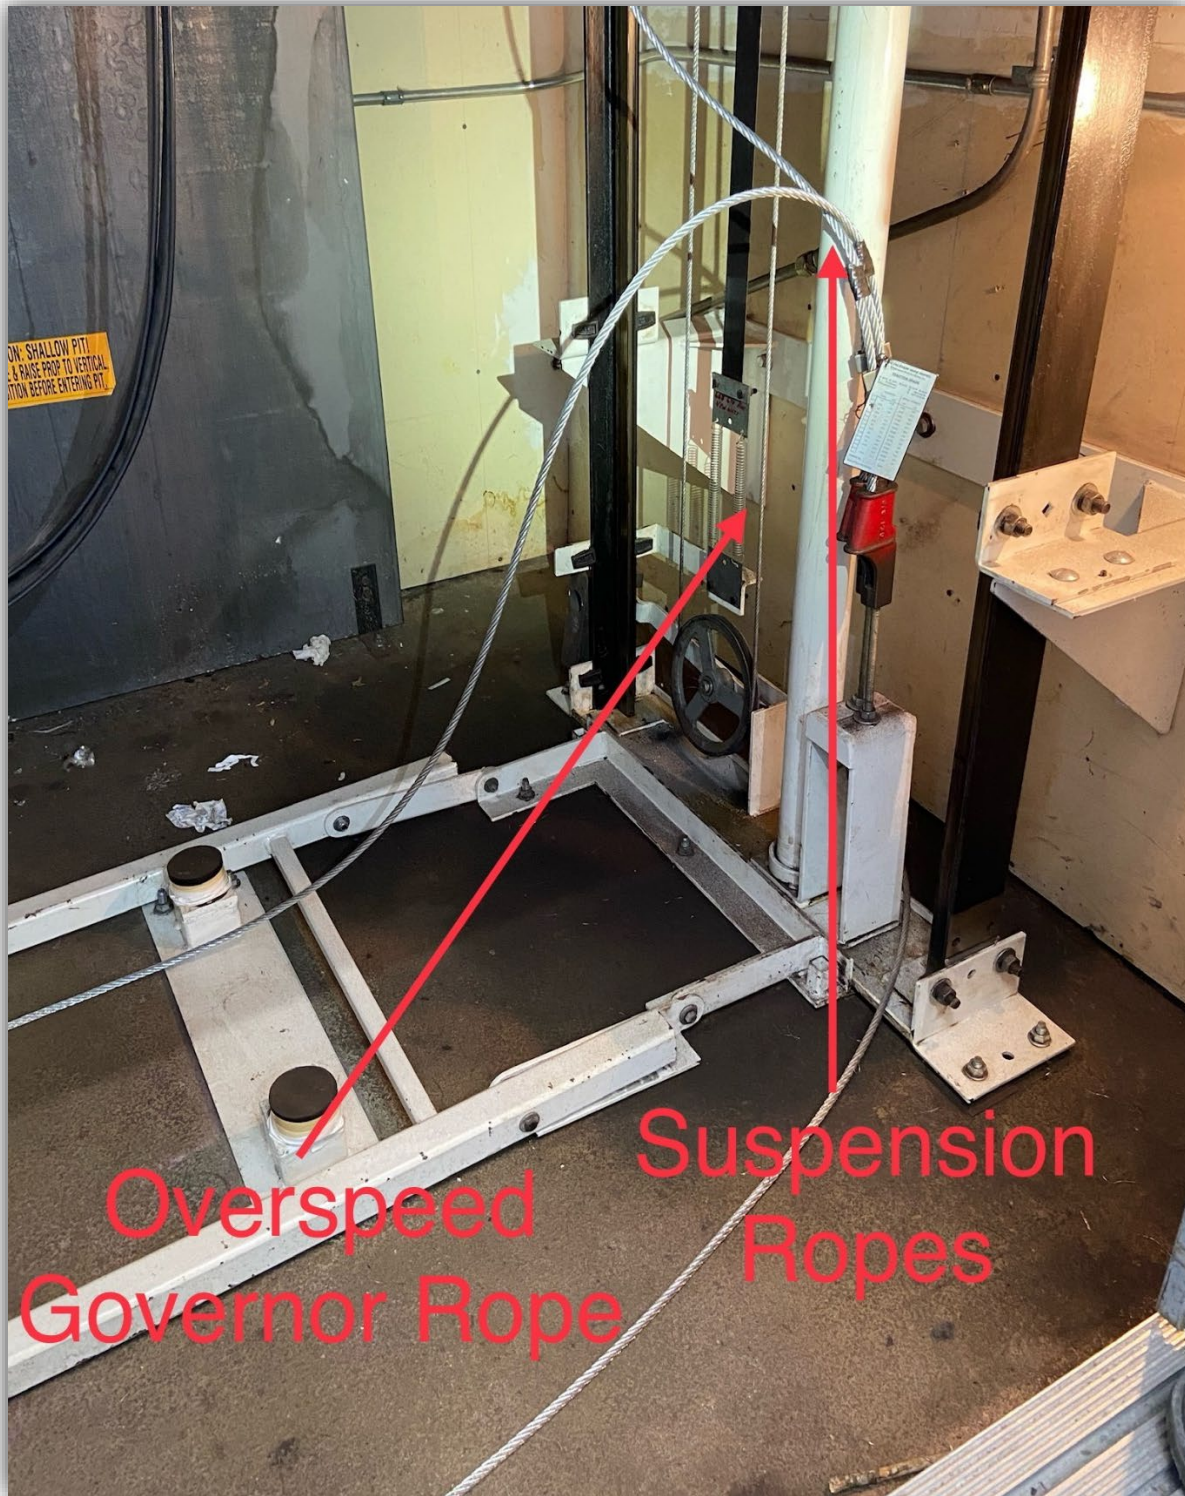
Image 2 - Overspeed governor rope & suspension rope.

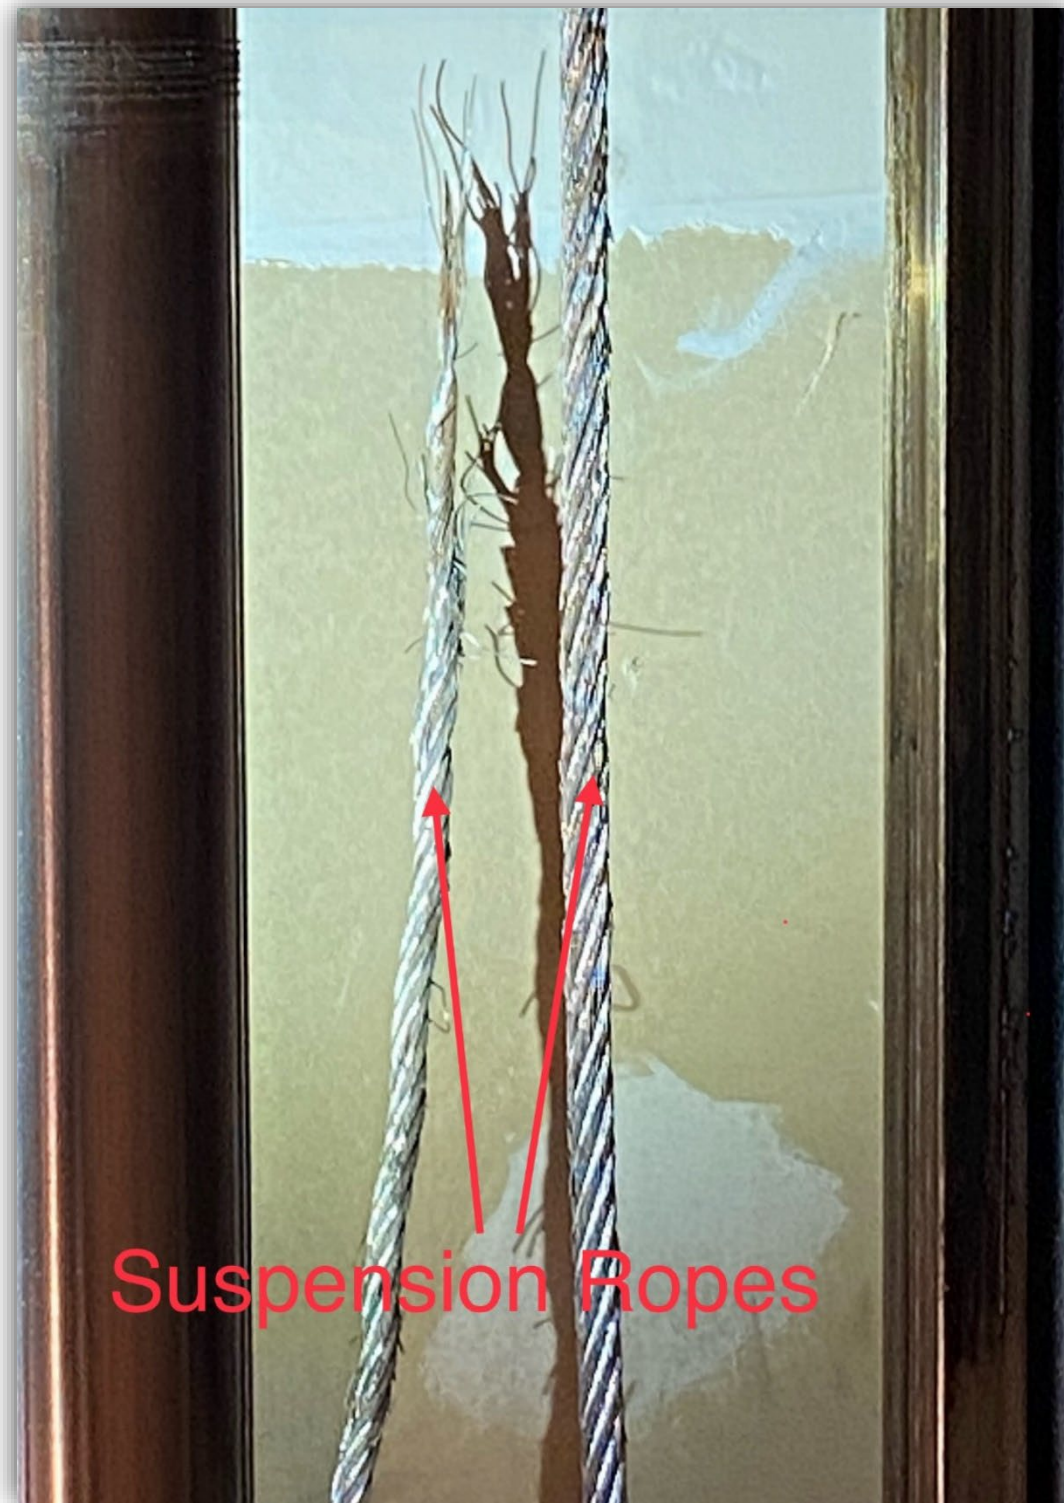
Failure scenario(s)	<p>Over time the steel ropes began to corrode, and no warnings or indications were found during routine elevator maintenance. While the elevator was traveling in the up direction, both 3/8inch suspension ropes (<a href="#">Image 3</a> and <a href="#">image 4</a>) were severed allowing the elevator car to fall in the down direction (<a href="#">Image 5</a>). The overspeed governor tripped due to an overspeed fault which engaged the Type A safeties, stopping the elevator car movement. The elevator car was supported by the type A safeties.</p> <p>There was one person in the elevator car during the incident that was reported to have minor injuries as the person in the elevator car lost balance and fell onto a shopping cart in the elevator car and was trapped and rescued by fire department.</p>

Image 3 - Severed suspension ropes.

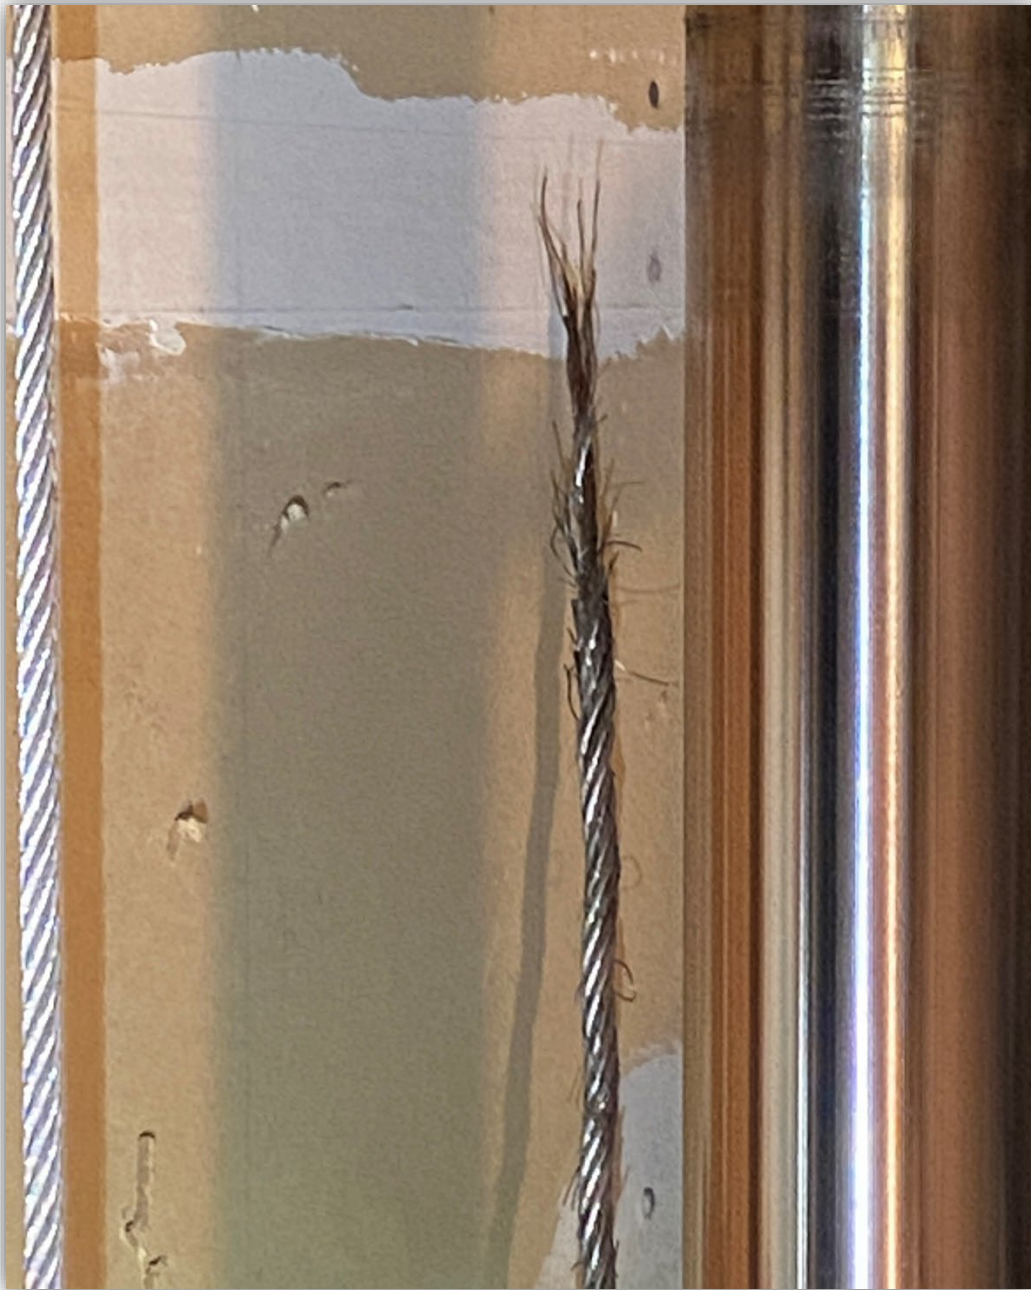
Image 4 - Severed suspension ropes.

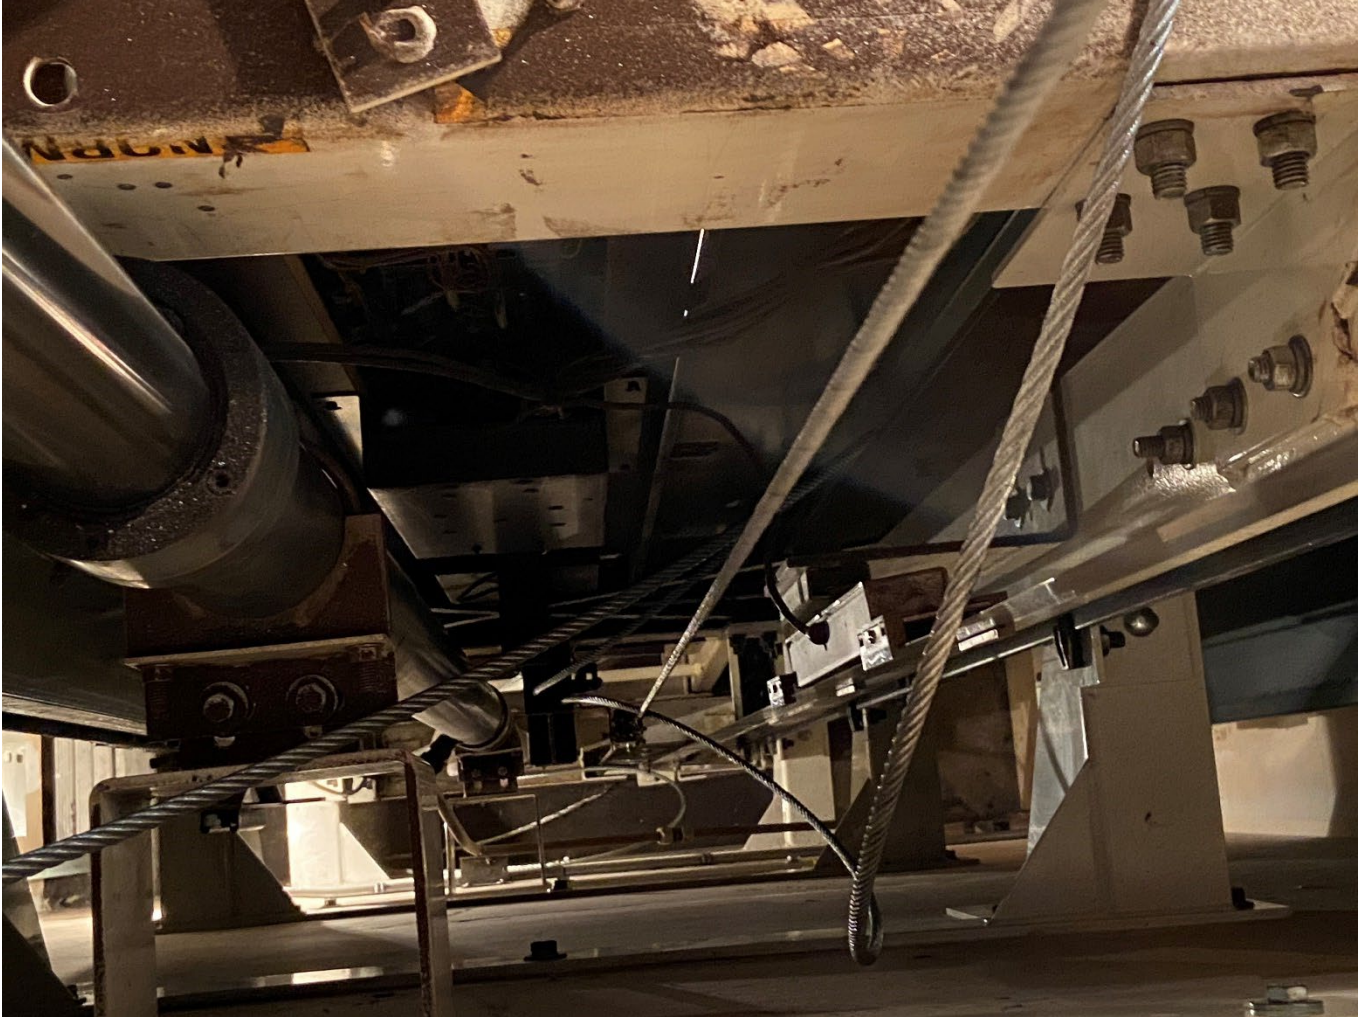
Image 5 - View from car top.

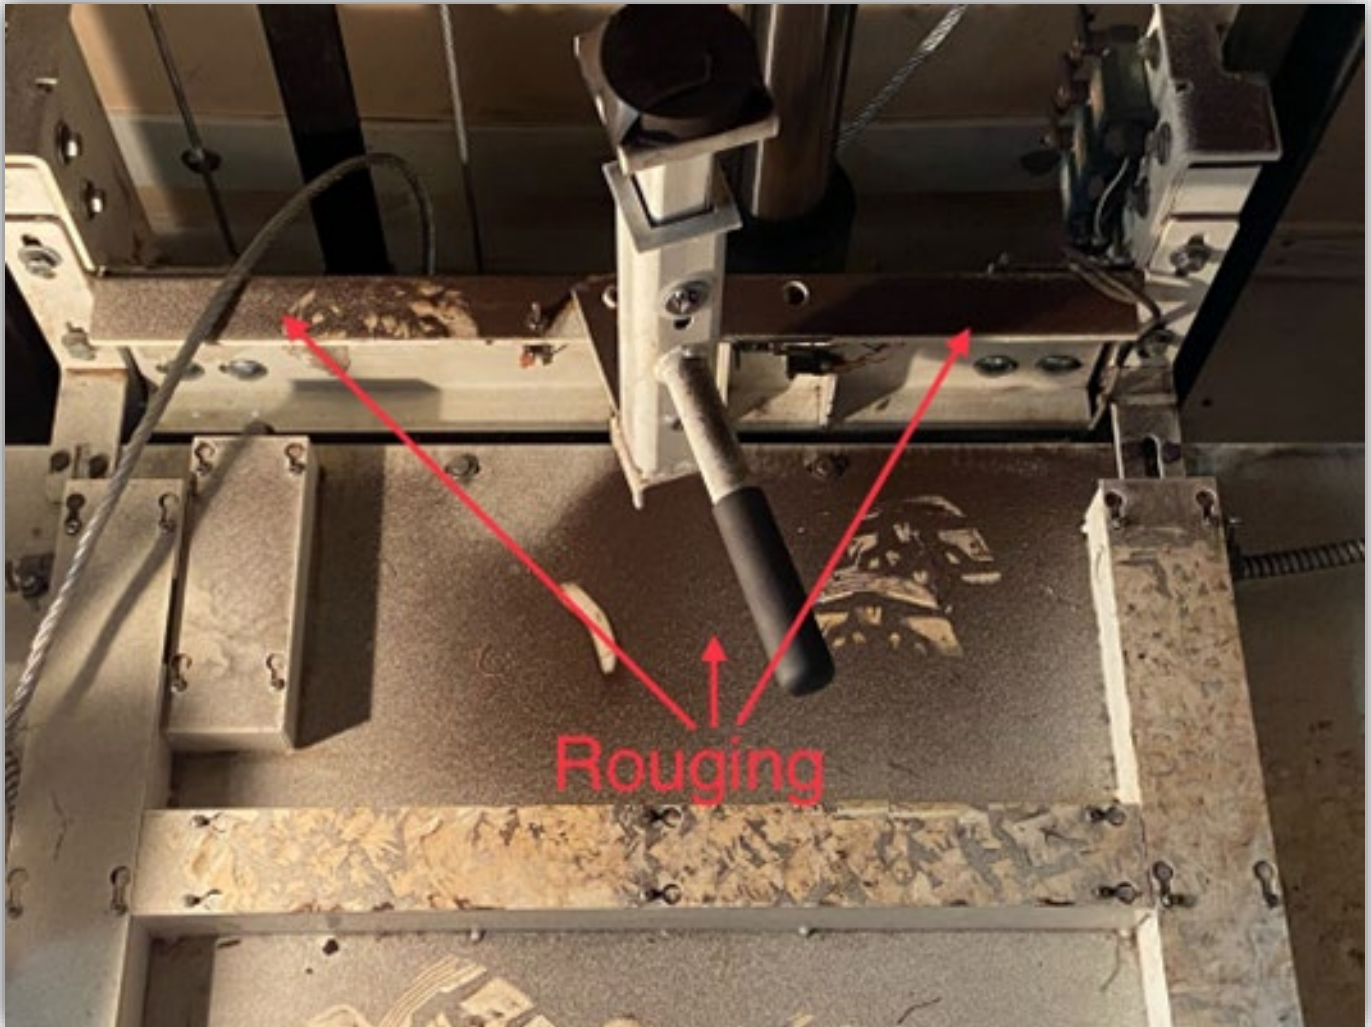
Causes and contributing factors	<p>It is very probable that rouging of the suspension ropes over time led to the failure. It is probable that the car top was not checked during routine maintenance to notice the excessive rust and dust, therefore the suspension ropes were not noticed as deteriorating. It is possible that exposure to weather led to the suspension ropes beginning to rust and rouge from the inside.</p>

Image 6 - Rouging on car top.

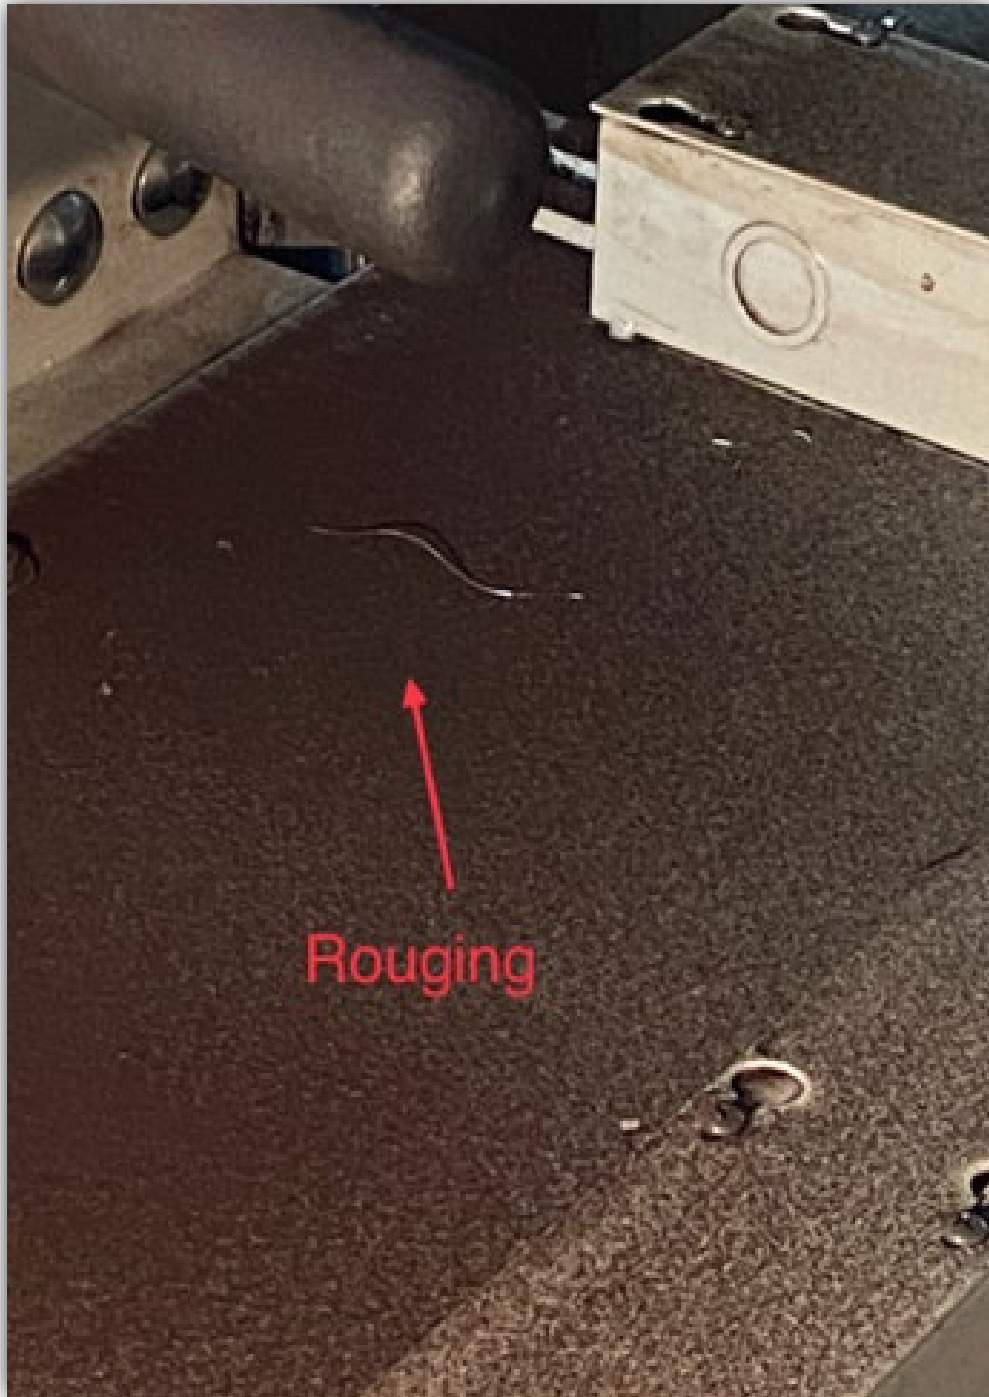
Image 7 - Rouging on car top.

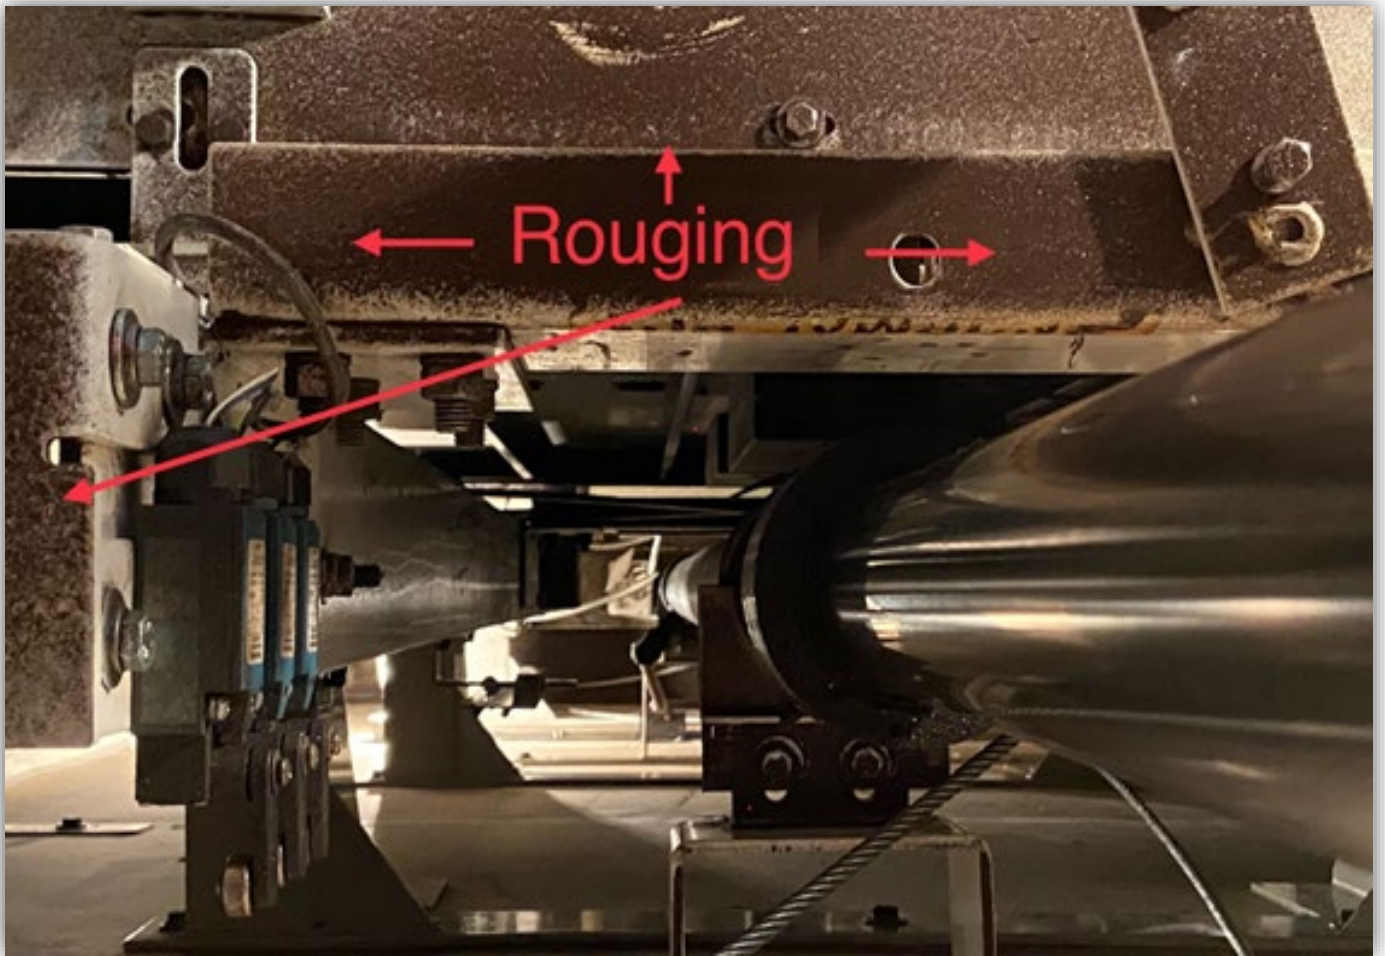
Image 8 - Rouging on car top.

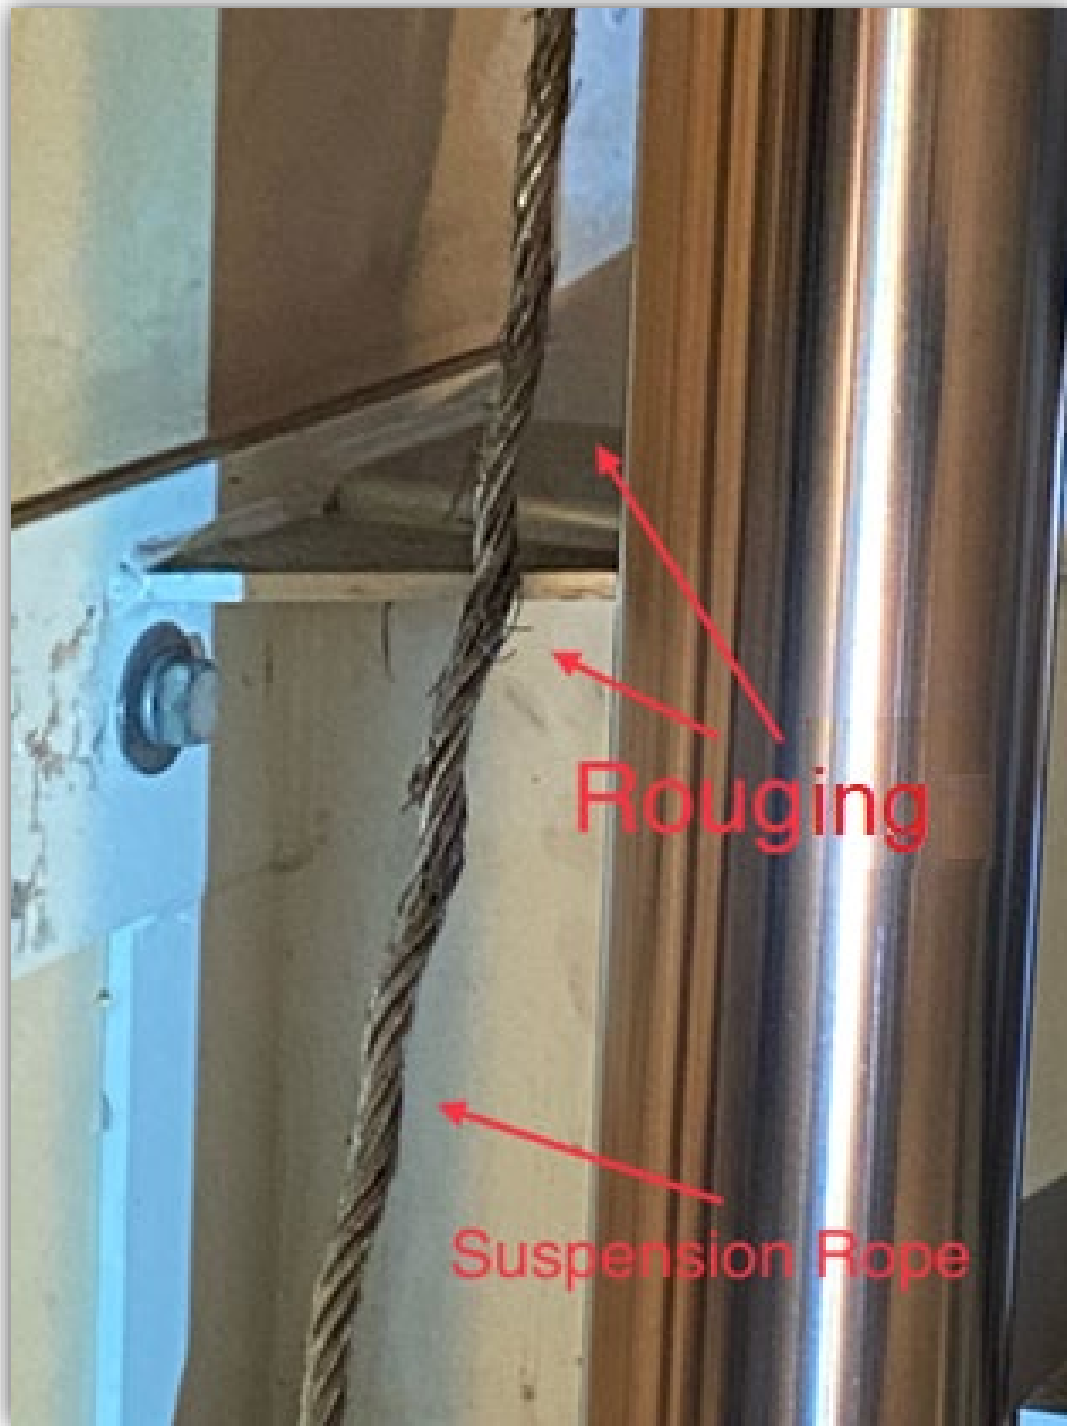
Image 9 - Rouging inside suspension ropes.

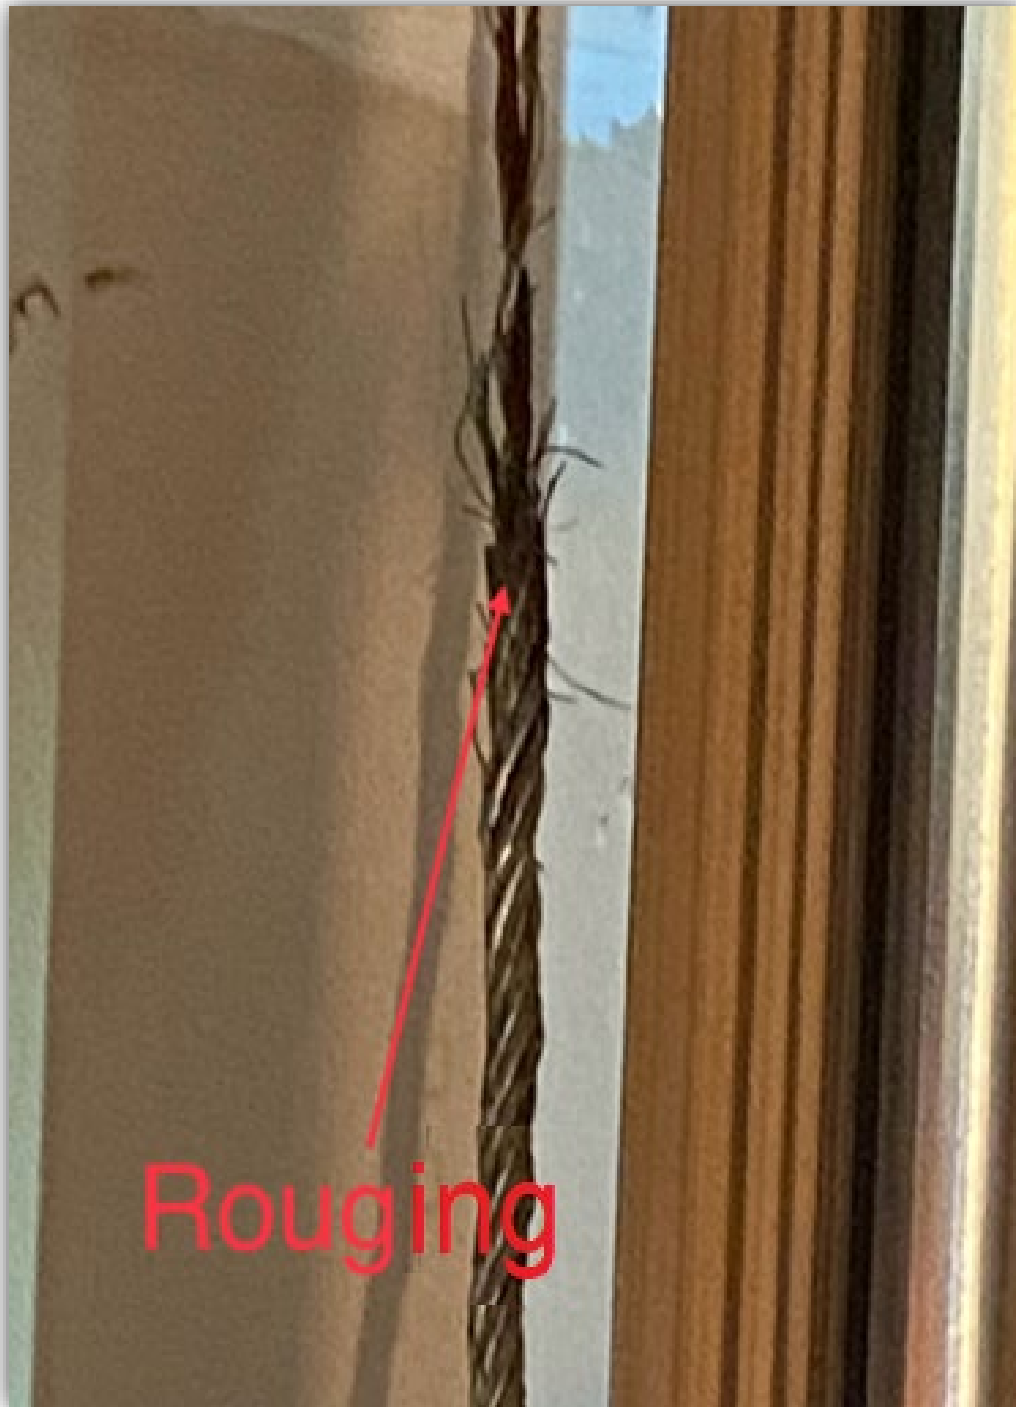
Image 10 - Rouging inside suspension ropes.
