Incident Summary #II-1271688-2021 (#24671) (FINAL)

SUPPORTING INFORMATION	Incident Date	October 19, 2021	
	Location	Coquitlam	
	Regulated industry sector	Gas - Natural gas system	
	Impact	Qty injuries	1
		Injury description	1 open house visitor reportedly fainted.
	Damage	Injury rating	Moderate
		Damage description	Products of combustion including significant levels of carbon monoxide (CO) were exhausted into the residence. The vent system was disengaged from the boiler. The boiler ignitor experienced distortion from heat.
		Damage rating	Minor
Incident rating	Moderate		
Incident overview	Delayed ignition detonations resulted in the exhaust vent being blown off the top of the wall mounted condensing boiler with products of combustion including CO exhausting into the dwelling. One person reportedly fainted from exposure to CO while attending an open house.		
INVESTIGATION CONCLUSIONS	Site, system and components	<p>Site and system</p> <ul style="list-style-type: none"> The house utilizes a wall mounted condensing natural gas hydronic boiler manufactured by IBC Technologies for water heating (Image 1). The heating system includes the boiler, vent system, water tank, pumps, zone valve

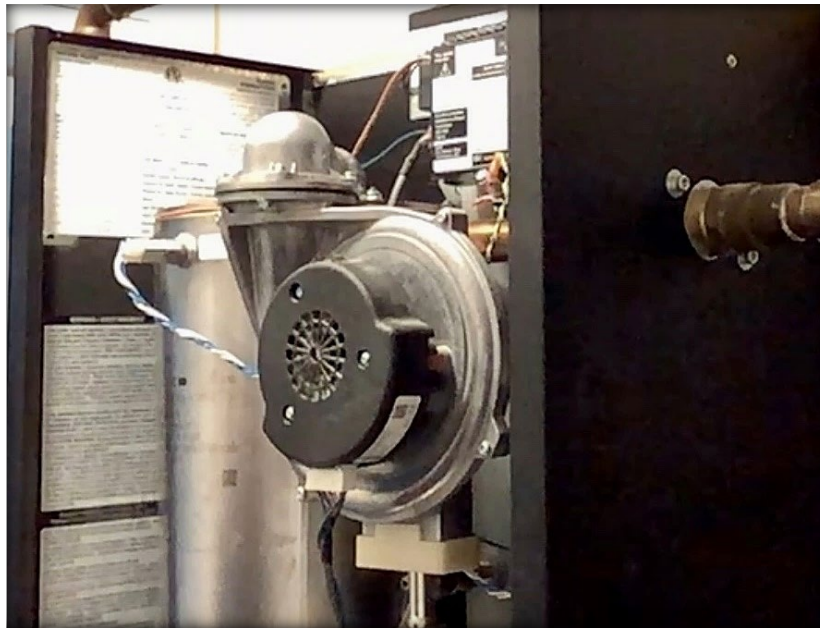
Image 1 – IBC condensing boiler with stainless steel cover off.

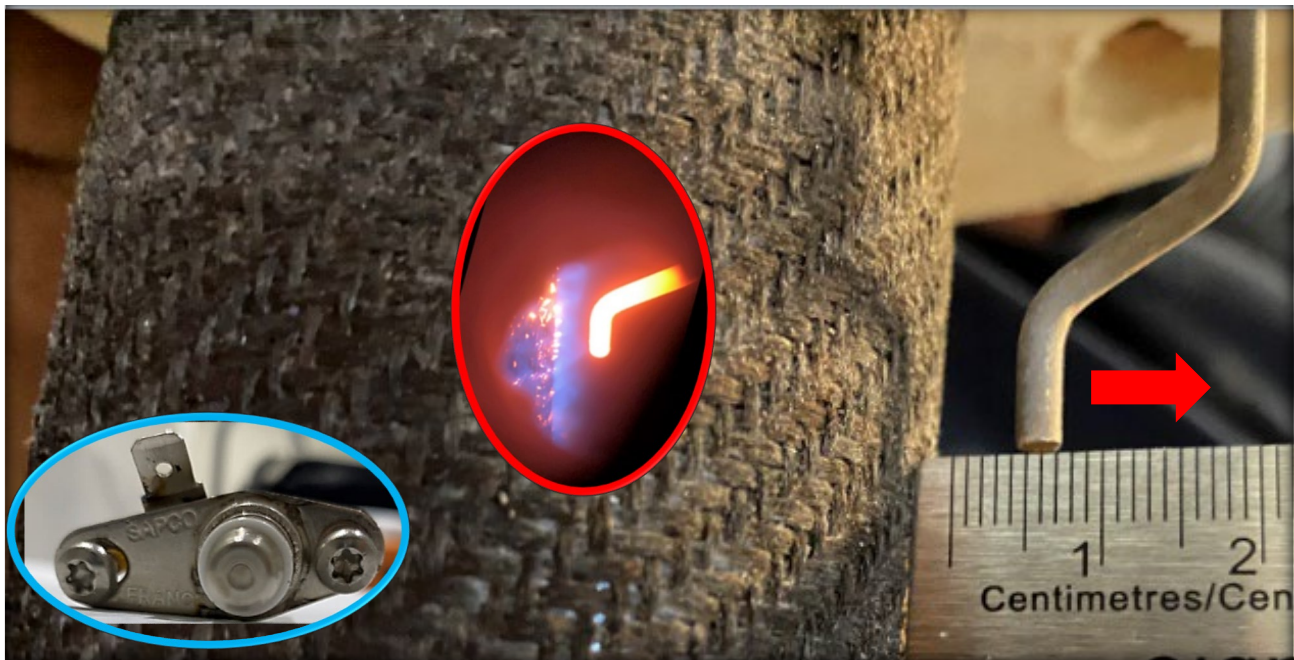
<p>Failure scenario(s)</p>	<p>The boiler was manufactured in 2020 and issued with a single prong ignitor that had residual stress in the metal offset bend (Image 2). During operation, the arc gap between the ignitor prong and the metal burner mesh increased beyond the manufacturer's recommended gap distance from release of the residual stress in the ignitor during exposure to heat.</p> <p>On multiple occasions, the boiler was not initially igniting the natural gas as indicated by multiple major ignition trials exceeded errors (Image 5) in the boiler controller. This delayed ignition led to a build up of unburnt gas and explosive detonations when ignition would finally occur.</p> <p>The vent system used two separate reducers that were incompatible with the PP vent pipe, and glue to connect the reducers to the PP vent, which is incompatible with PP vent pipe. The vent system was originally installed with a 2-inch PP vent glued into a 2x3-inch acrylonitrile butadiene styrene (ABS) reducer. After the vent was dislodged on October 19th, 2021, the ABS reducer was exchanged for a CPVC (chlorinated polyvinyl chloride) reducer. Upon arrival for testing in September 2022, the CPVC reducer was also found to be dislodged.</p>

Image 2 - Single prong ignitor and gap distance shown (approximately 6-7mm), arrow indicating direction of rod distortion away from mesh. Note the manufacturer's manual specifies a spark gap setting of between 3.2 and 4.7mm. Red oval picture shows the ignitor during high temperatures after ignition. Blue oval picture shows the ignitor attachment plate and manufacturer details.

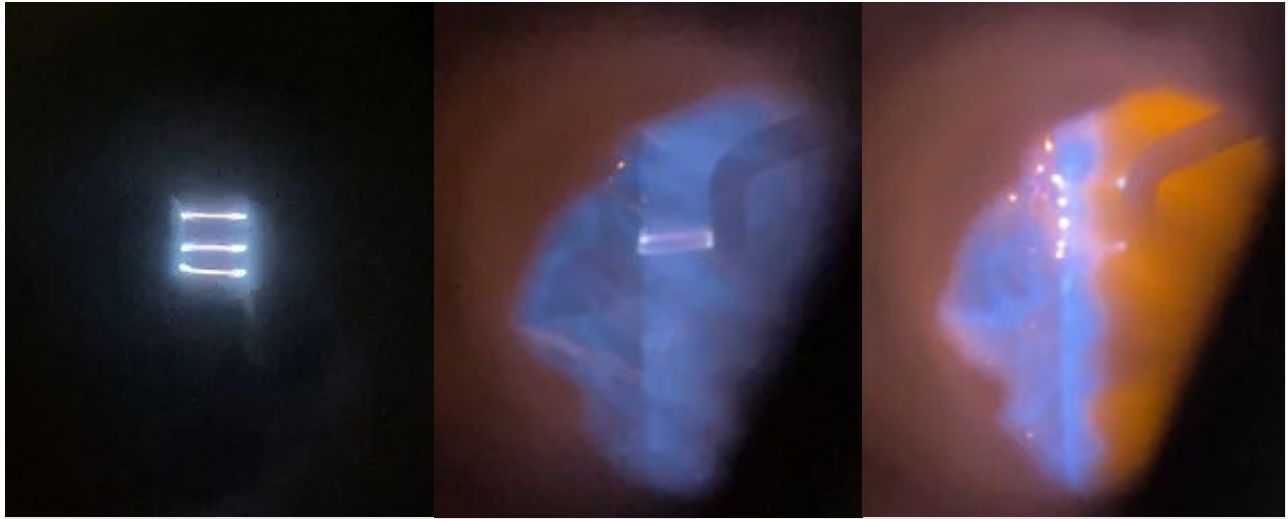
Image 3 - Single prong ignitor arcing to the burner mesh during a 4 second ignition trial during testing.

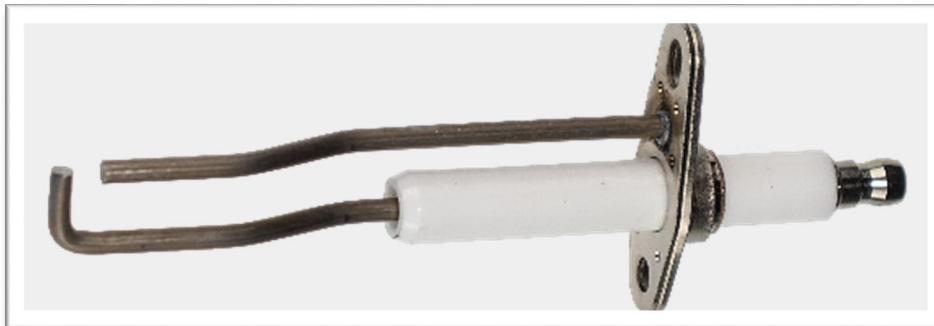
Image 4 - Dual prong type ignitor (P111B) indicated to replace the discontinued single prong ignitor (P-340) in the boiler manufacturers January 2021 product change.

- The boiler manufacturer identified issues with the original ignitors and issued a discontinuation of P-340 single prong ignitors that applies to the SL G3 boiler at this site, as well as other models, on their website on January 22, 2021, including the following wording:
"Effective immediately, the P-111B double-prong ignitor (Figure 1) replaces the P-340 single-prong ignitor. The P-111B is the new standard for the SL-series boilers as it combines an improved metallurgic formula for longevity with the convenience of a factory-set spark gap."
Link: [P-111B change](#)

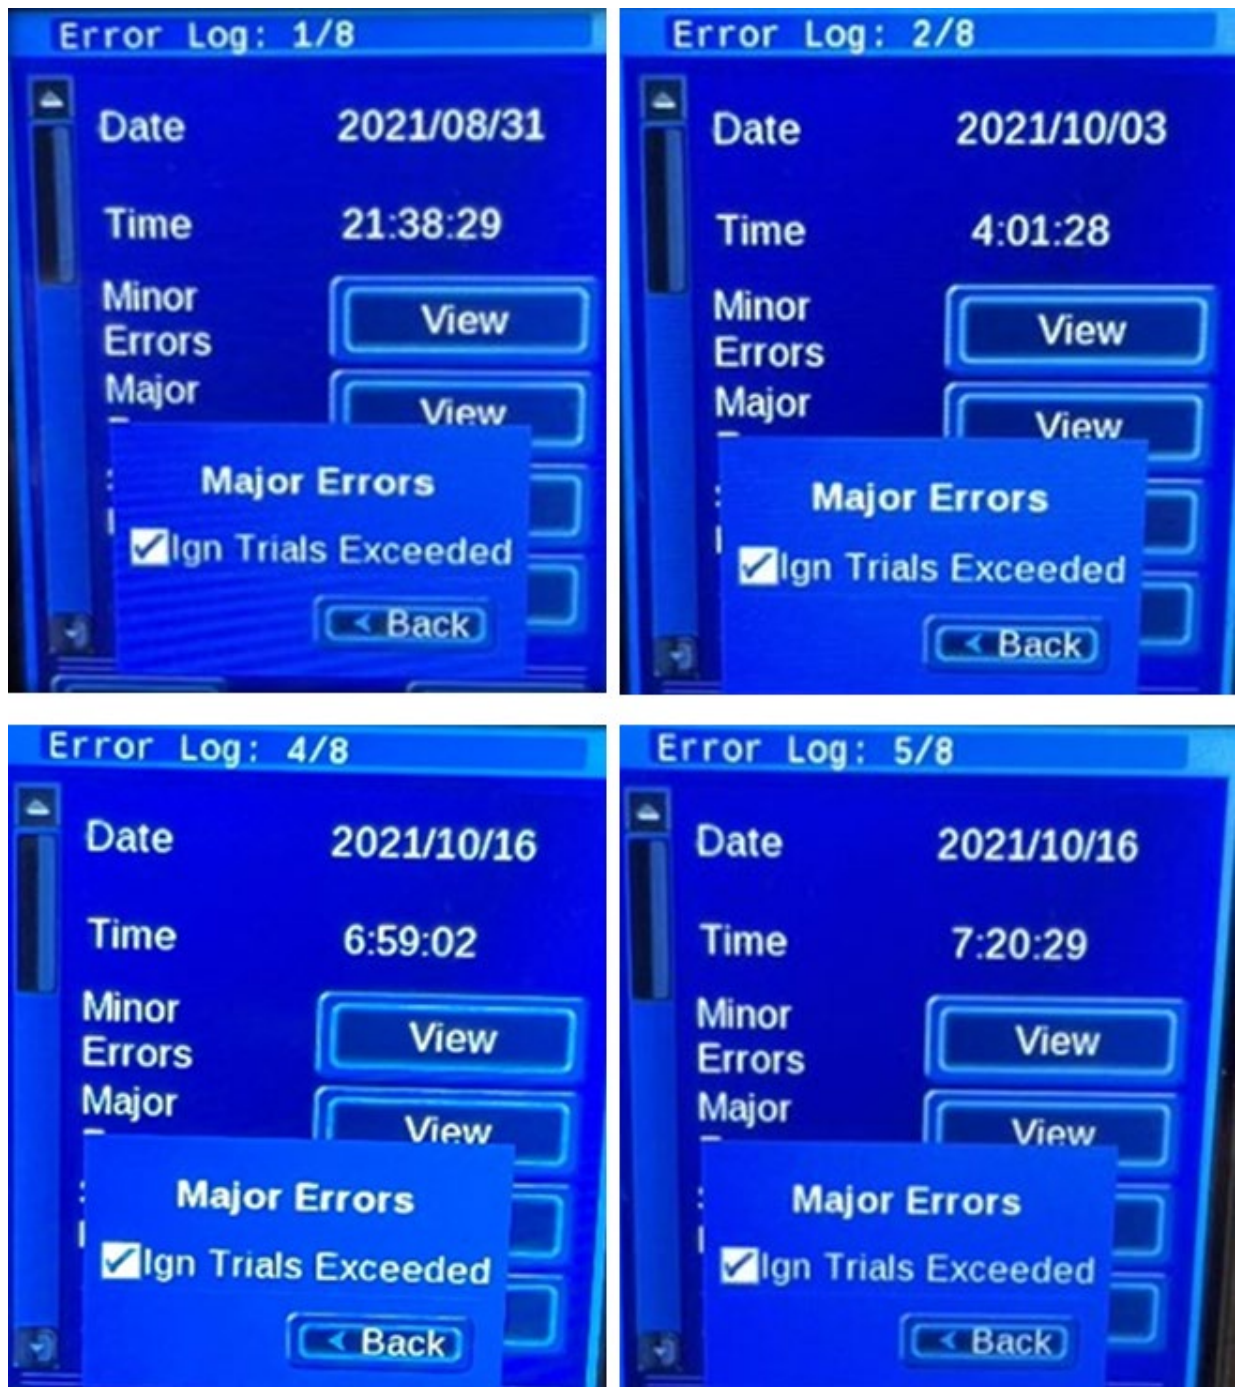
Image 5 - Major ignition trials exceeded errors (4 times) leading up to incident.

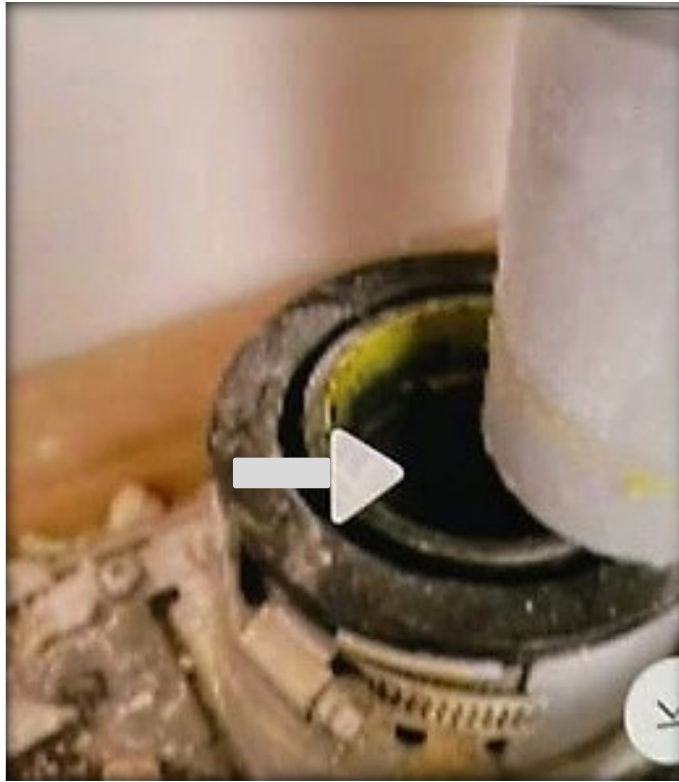
<p>The vent system was dislodged in both cases from the force of the boiler's delayed ignition detonations (Image 6) releasing products of combustion, including CO, into the residence.</p>
<p>Facts and evidence</p>	<p>Site findings</p> <ul style="list-style-type: none"> • The ignitor gap was approximately 6-7mm, which is above the maximum recommended gap setting of 4.5 mm. • The boiler error log had 4 failed ignition major errors before the Oct 19th 2021 incident between Aug 31, 2021 to October 16, 2021. • The 3 inches to 2-inch (ABS) reducing fitting (bushing) from original installation was found disconnected from the boiler exhaust entrance fitting after the Oct 19, 2021 incident. • A 3 inch to 2-inch CPVC reducing fitting installed as a post incident replacement for the previous reducing fitting was found disengaged from the boiler exhaust connector prior to the September 15, 2022 testing. • The boiler exhaust connector has a sealing gasket for CPVC (3.5"/88.9mm outside diameter) venting systems. • There is an adhesive residue ring below the sealing where the original ABS reducer was seated indicating a seal was made (Image 7). • The boiler has a label indicating the year built as 2020. <p>Testing findings by independent gas fitter September 15, 2022. [Additional information on the testing findings in the square brackets]</p> <p>Boiler findings</p> <ul style="list-style-type: none"> • #1 alarm, dated 2021/08/31, through #5 alarm in fault log dated 2021/10/29 07:20:29, all for max ignition trials exceeded. [These errors are indicative of the boiler not initially igniting the natural gas during ignition sequences which is associated with delayed ignition detonations] delayed ignition. • #6 Alarm, dated 2021/10/29 14:13:46, through #8 Alarm in fault log dated 2021/11/03, all for Fan Pressure minor alarm. NOTE these all occurred while boiler is running and firing. [This may be indicative of condensate backup overflow]. • Boiler set to natural gas and 0-4500 Ft altitude, [suitable for the site's fuel type and location]. • Burner in fair condition, gasket in good condition, burner mesh in good condition. • Line voltage measured at 119.2V. [This indicates power quality was not an issue at time of testing]. Wiring and electrical connections [for the ignitor] inspected and in good condition. • Condensate drain connection showing leakage, both inside the boiler and outside showing signs of acidic venting condensate corroding boiler housing. • Heat exchanger in poor condition, visible debris in combustion chamber, with the appearance of coffee grinds. [This likely indicates condensate overflow and debris from corrosion] <p>Vent system findings (in place during Sept 2022 testing)</p> <ul style="list-style-type: none"> • 2" CentroTherm [PP – polypropylene] estimated at 40 feet, glued to a system 636 CPVC 3"x2" bushing [reducer] at unit. Boiler venting joins 2 incompatible materials, using a glue on a product (PP), not intended to be glued. <p>Gas findings</p>

Image 6 - The PP vent dislodged from the black ABS reducing fitting on October 19, 2021.

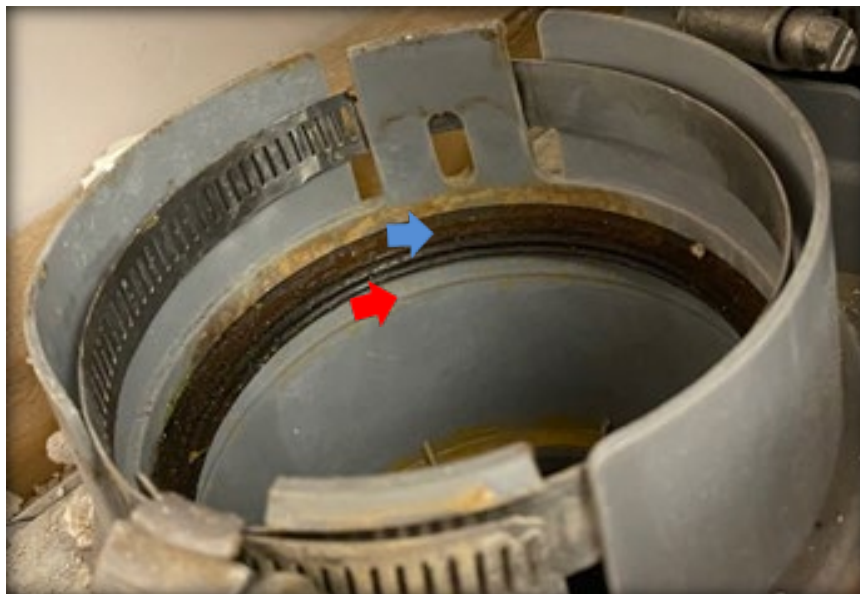
Image 7 – The exhaust vent entrance on the top of the boiler. The gasket (blue arrow) is for sealing around 88.9mm diameter vents. There is a ring from adhesive where the original ABS adapter was seated (red arrow).
