Appendix J - Complete Climate Control Report

COMPLETE CLIMATE CONTROL INC.

Report on findings and work performed at:

Arctic Glacier facility,
790 Sarcee St.
E Kamloops

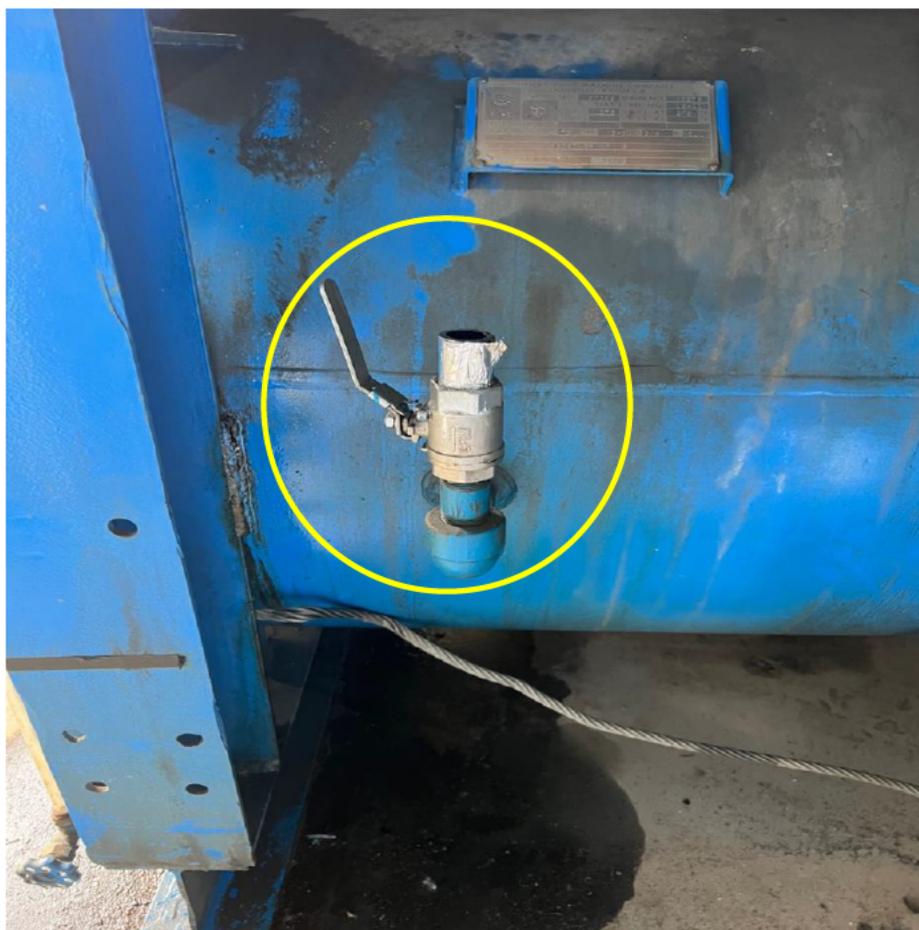
- A lot of cut ammonia piping.
- Valves in use that in my opinion, are not typically ammonia valves. They were Stainless steel ball valves. Refer to picture #1 and #2. (Pictures were taken on the next day.)
Note valve #1 was open.
- Lots of pipe was taken apart and left open.
- Most gauges were not legible.
- An Evap BAC Condenser outside with no valves or piping hooked up to it. (Open to atmosphere)
- Lots of destruction (melting and black burn marks) from a fire.

We first removed the open ball valve installed on the side of the receiver. Refer to Picture #1. We then hooked up the High-pressure nitrogen bottle to receiver at the access port where the ball valve was removed from.

- All valve when checked whether they were open or closed. Were first checked whether they were closed and then cracked open to double check for pressure. Then were fully opened and left open. All valves were found in the closed position. Except for the ball valve in picture #1.
- All component valves of Units #2, 3, and 4. Were left open to atmosphere and no pressure in systems.
- All valves circled in the pictures were left open to atmosphere.

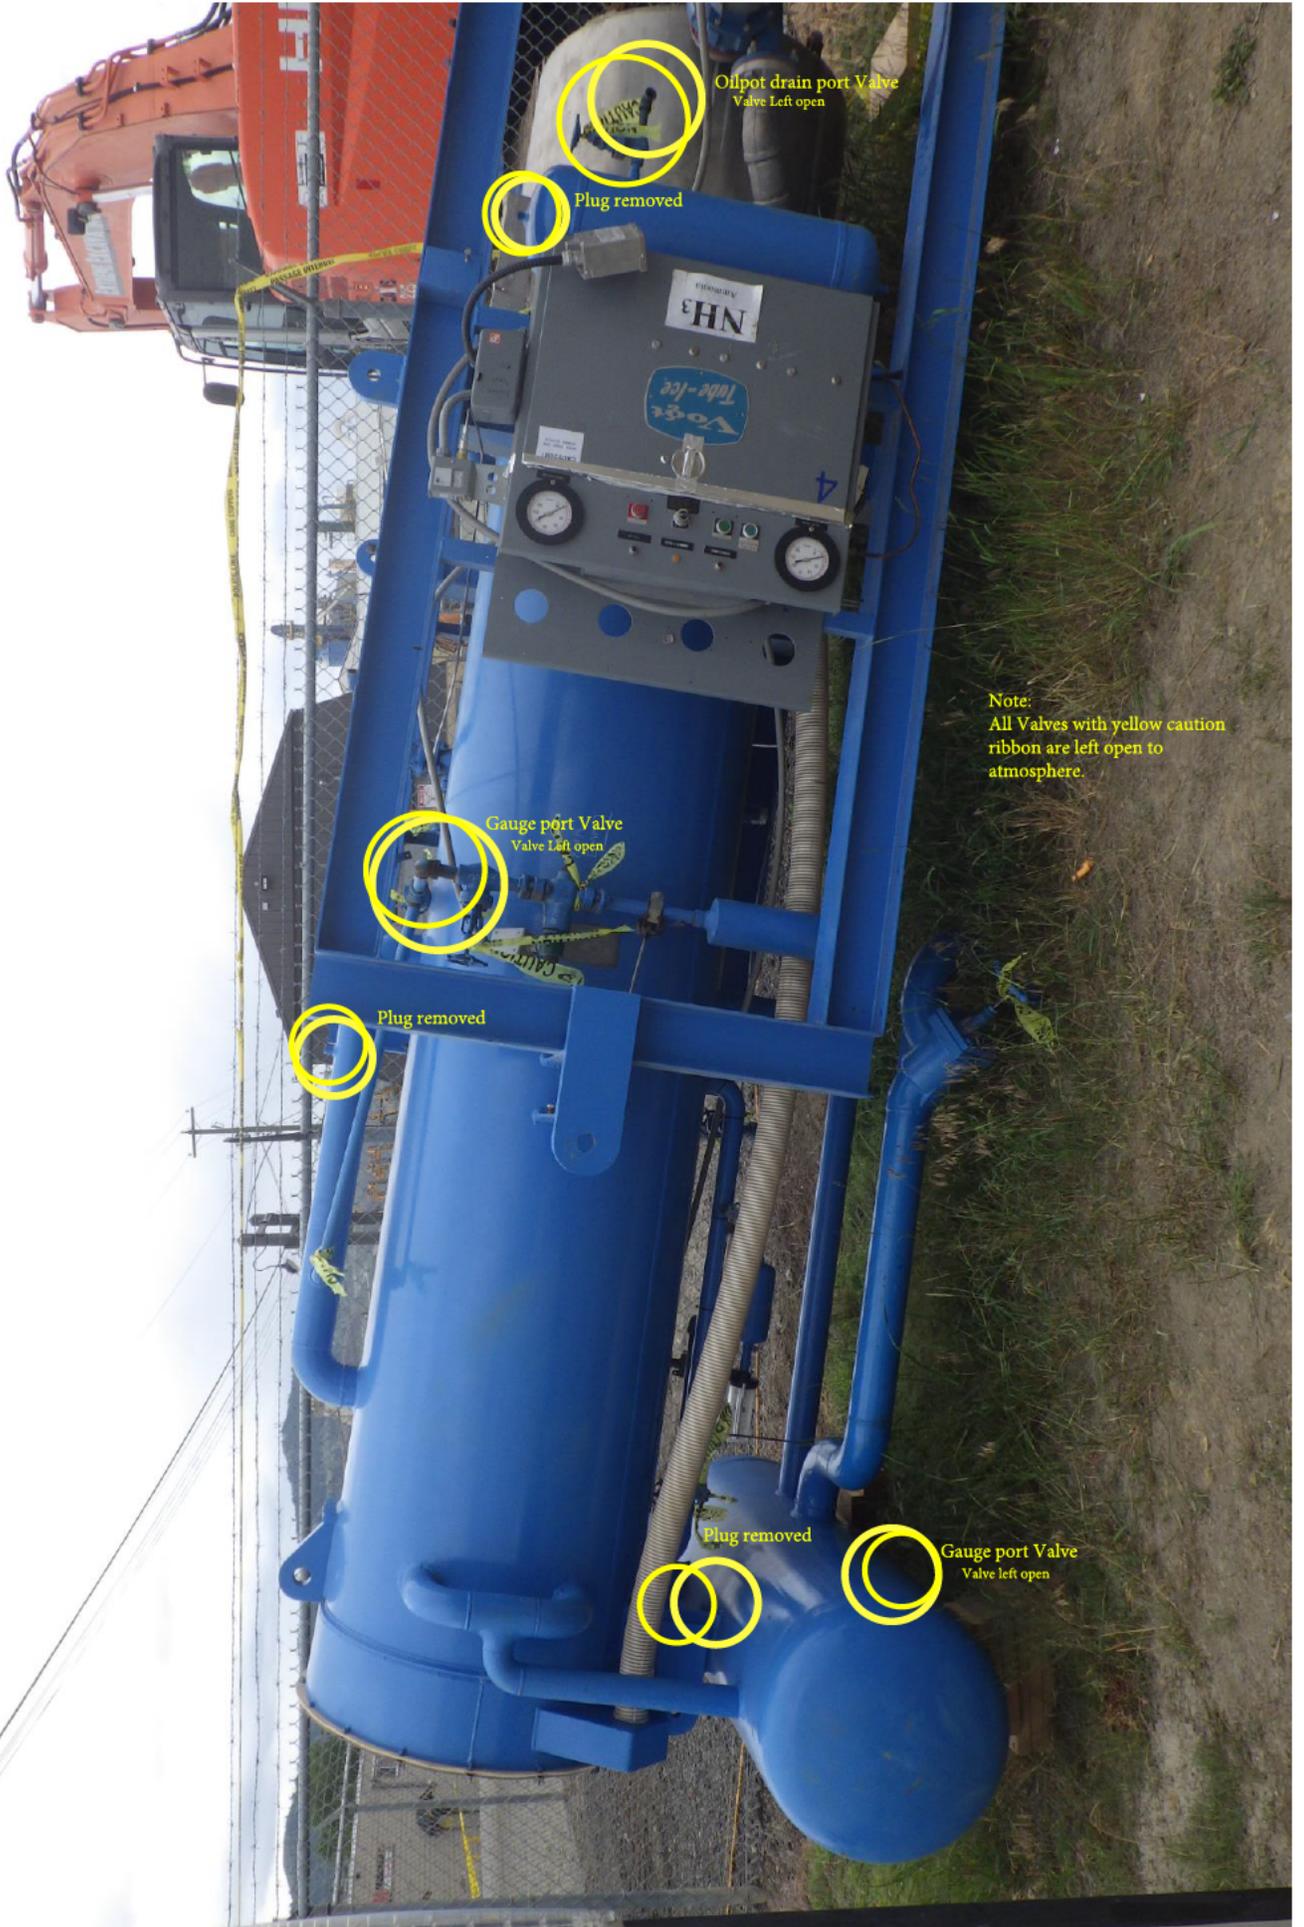
Picture #3

Once it was confirmed that there is no pressure in the system. We removed plugs on the vessels and opened all valve. As shown on picture #3.

Unit # 4
M# P34

Offpot drain port Valve
Valve Left open

Plug removed

Gauge port Valve
Valve Left open

Gauge port Valve
Valve left open

Note:
All Valves with yellow caution
ribbon are left open to
atmosphere.

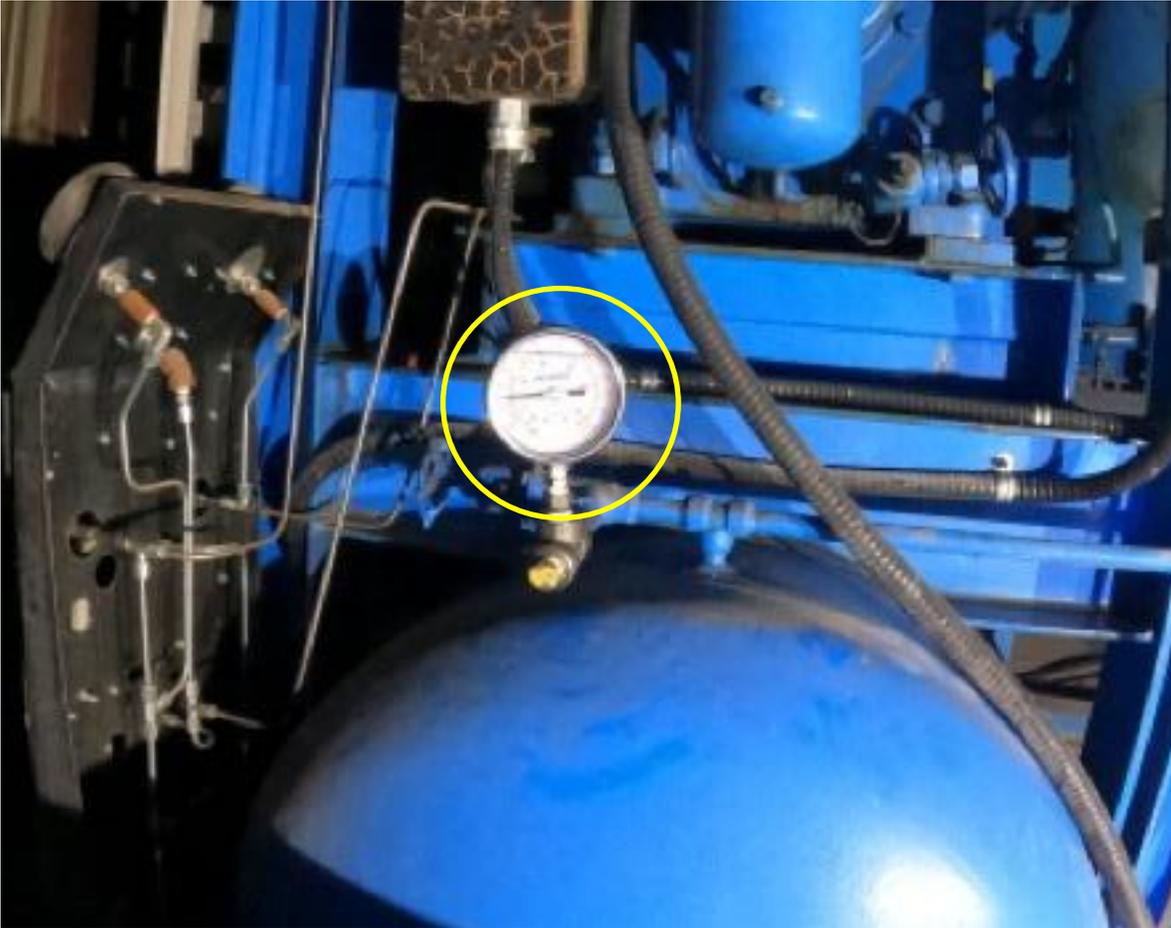
Picture #4

We then pressurized the receiver to 15 PSI with dry nitrogen. Refer to pictures #4 and 14. Someone from TSBC confirmed it held for 10 mins. Refer to Picture #4. At this time, we then unhooked the nitrogen bottle and put the other end of the purge hose in the barrel of water that the Hazmat team supplied. Then proceeded to purge the nitrogen out of the out of the receiver. We then noticed that there was residue NH₃ mixed in with the Nitrogen. As our personal NH₃ monitors were starting to climb around the barrel.

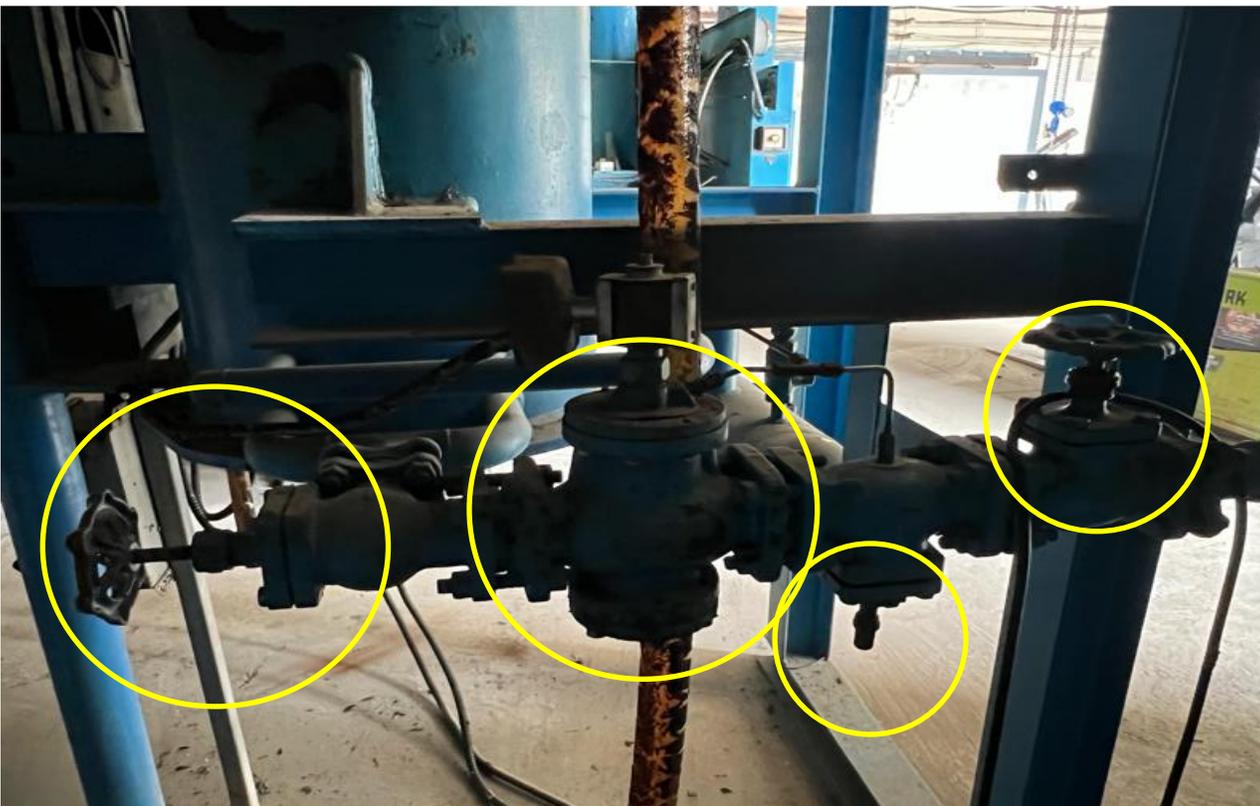
Picture #5

I installed a gauge on a purge valve at the bottom of the Ht exchanger Strainer to verify pressure. There was not pressure (0 PSI) shown on my gauge. I hooked up a purge line from the valve to a 5 Gallon bucket of water. Opened the valve and still no pressure. But did find approximately 1 litre of oil thou. Left valve open and let oil gravity drain out into a bucket. Refer to picture #5.

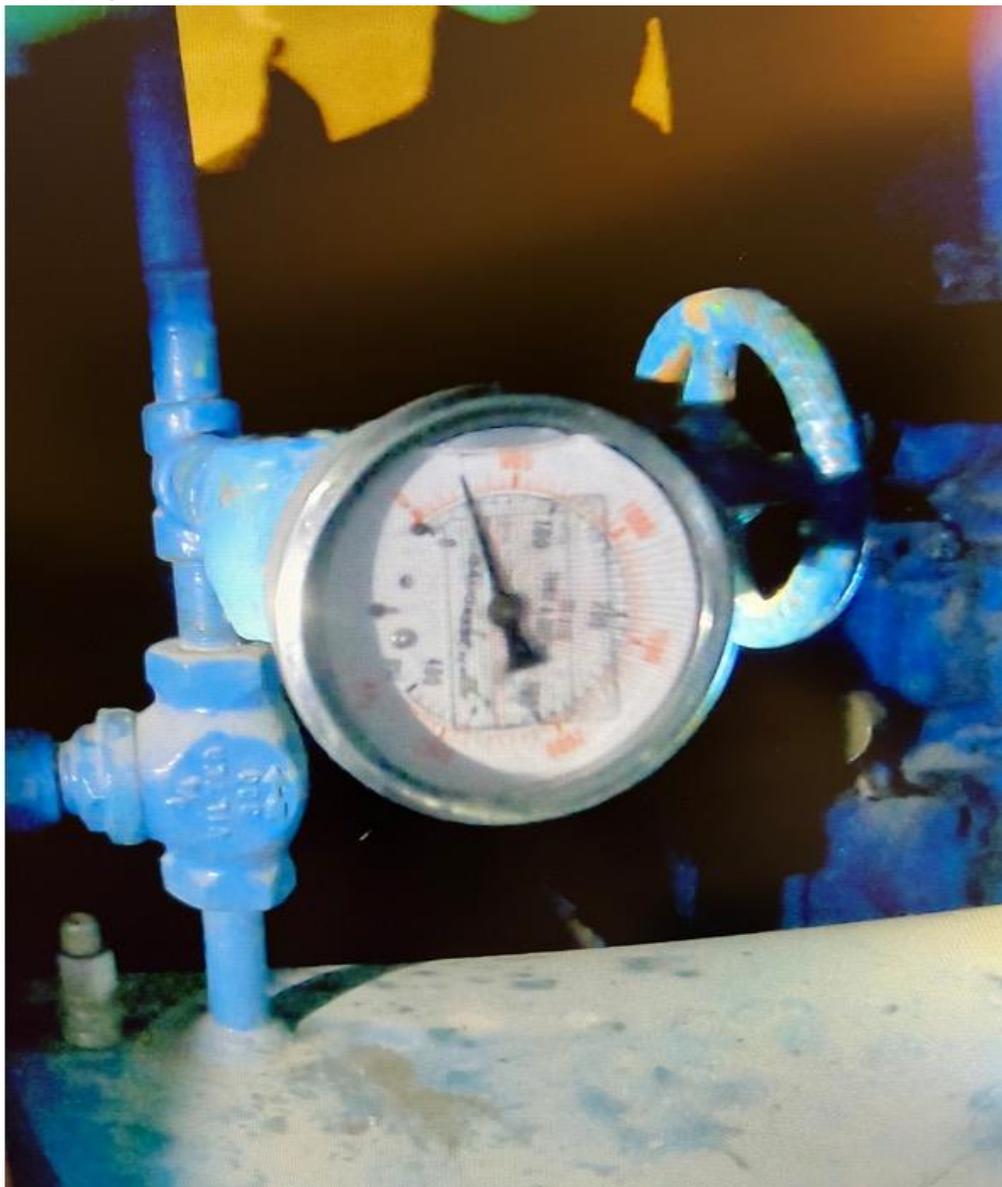
Picture #6

Then installed gauge on liquid line access valve on the Unit #2 receiver. Refer to picture #6. We then opened the valve and found that there was 50 PSI NH₃ pressure in the receiver.

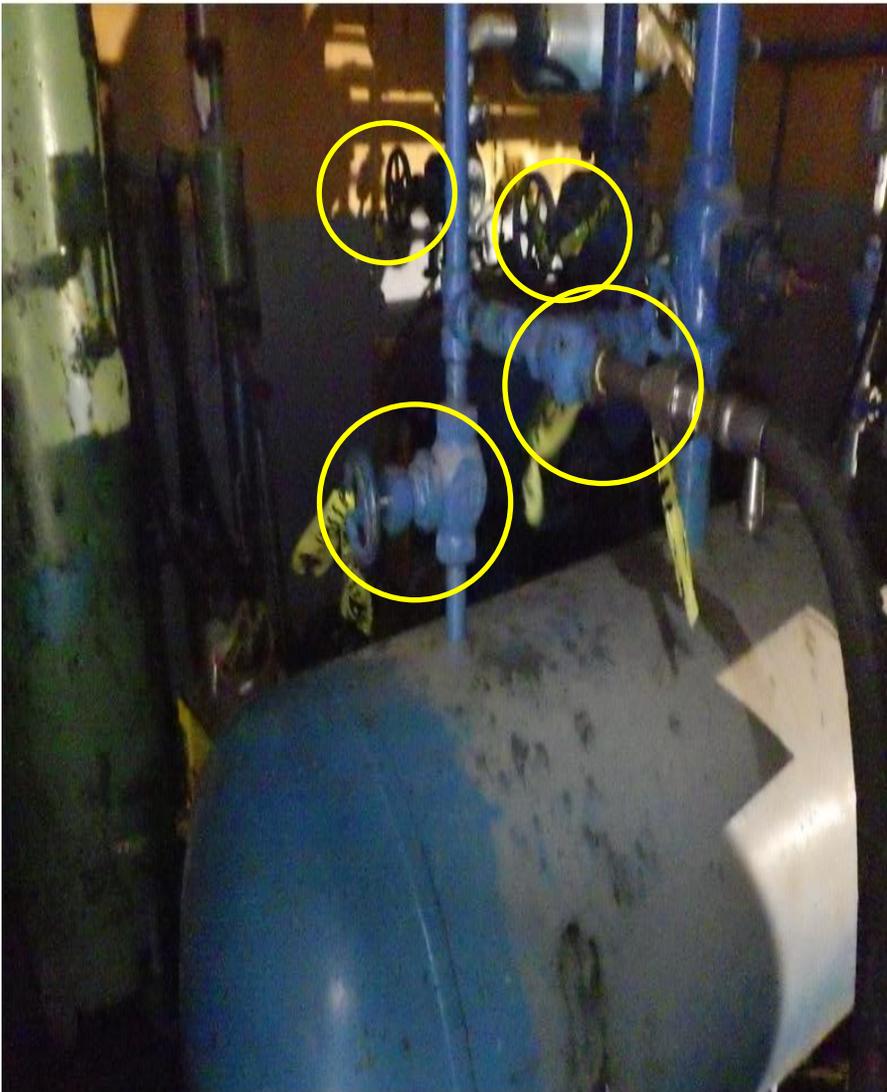
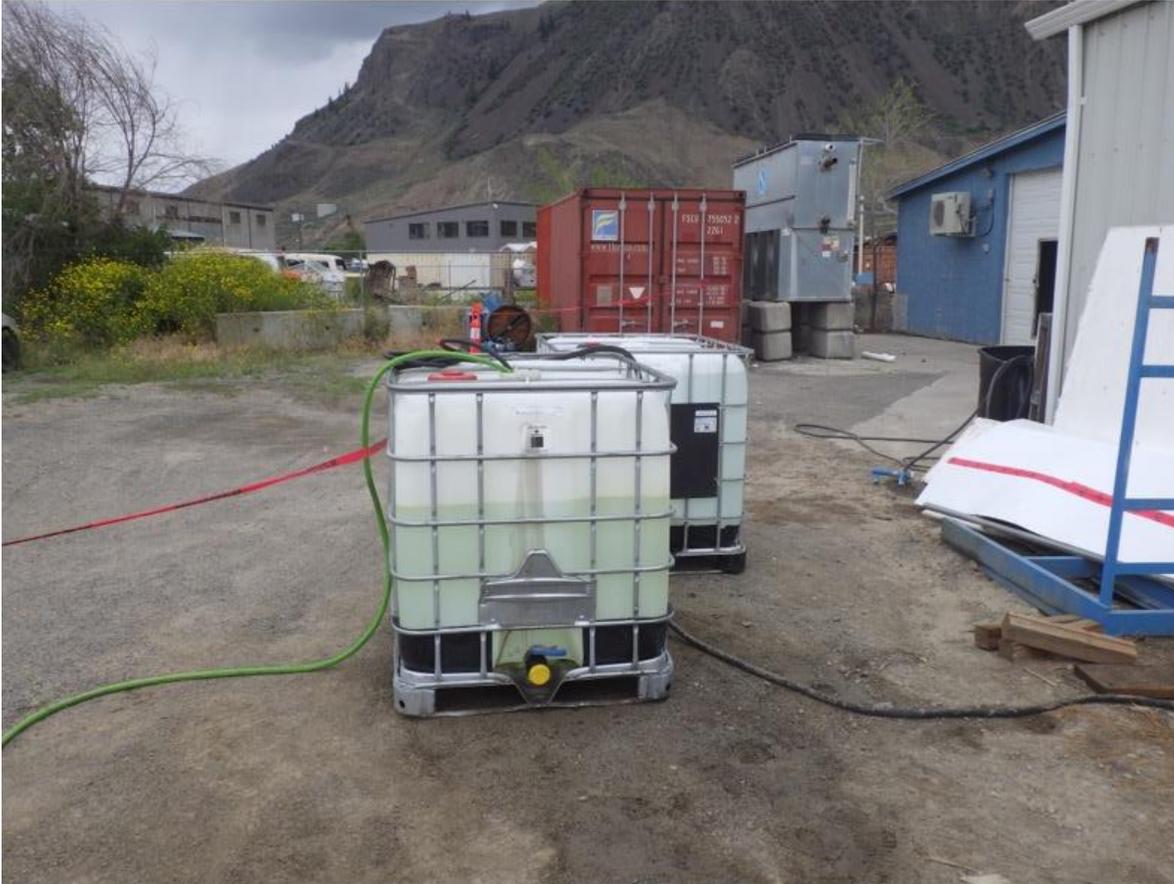
We then removed the gauge on Unit #2 receiver and hooked the purge hose to the same valve. We then started purging Unit #2 receiver into the tank of water. Refer to pictures #7 and 8.

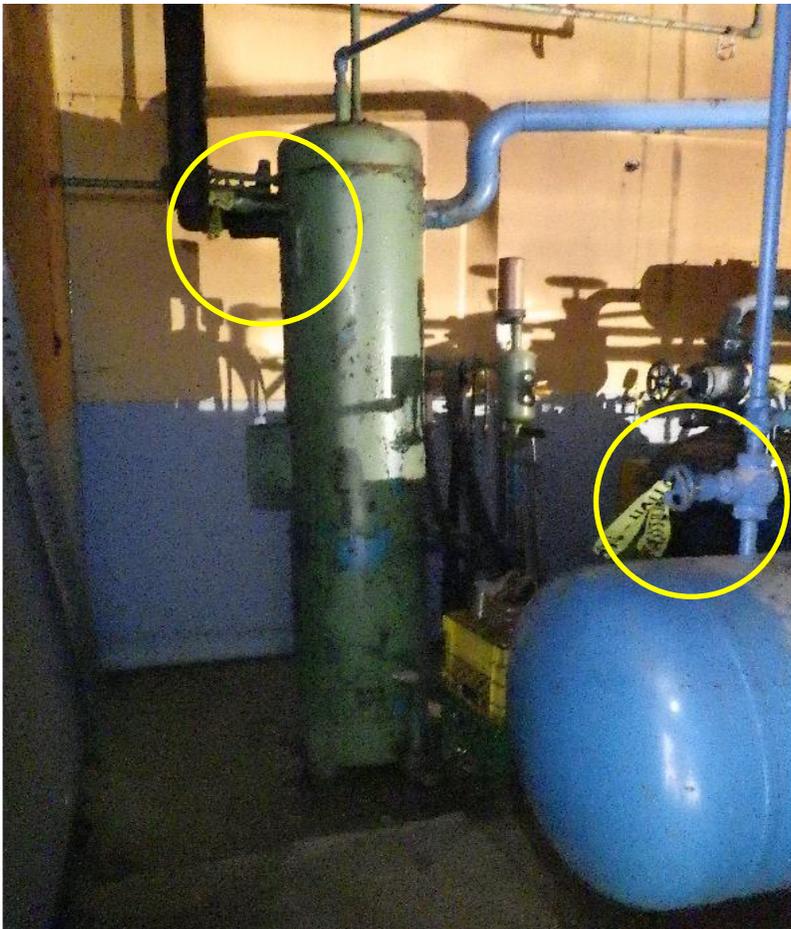
Picture #9

While we were purging, I went to test Unit #2 accumulator and compressor. Tested both components with my gauge. They both registered 0 PSI. I then hooked up my purge line into a bucket of water and tested it that way as well. (No bubbles). Once I confirmed no pressure, I opened all the valves to atmosphere. Refer to picture #9.

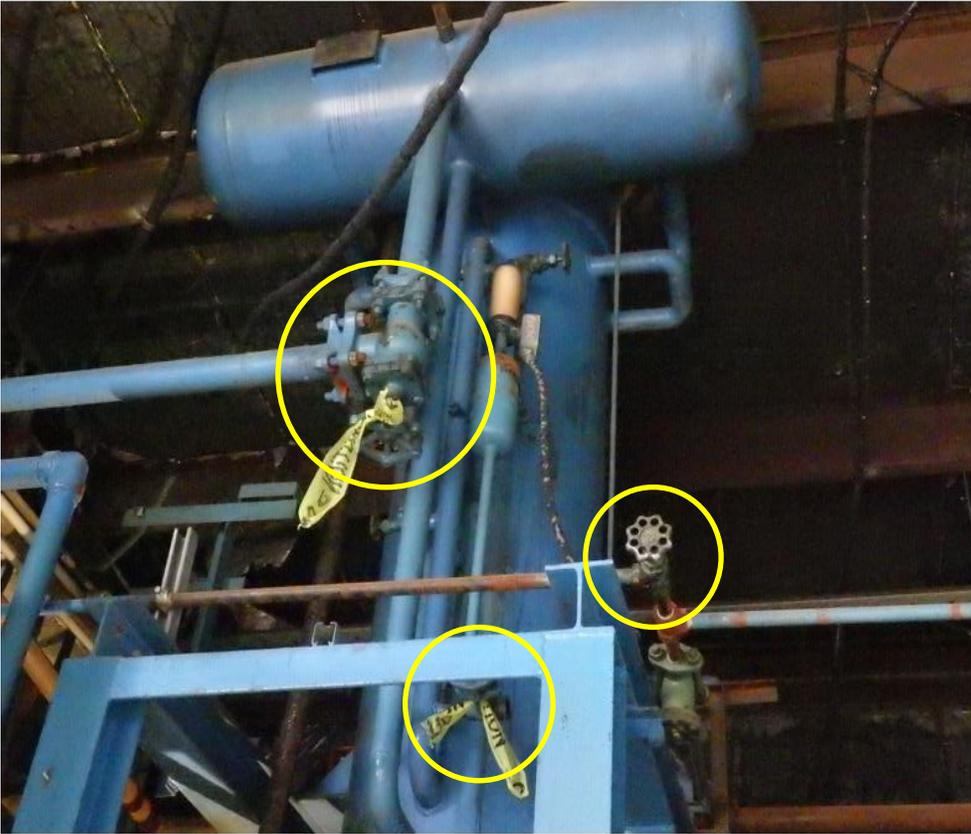
Picture #10

I then started on Unit #2 evaporator again and started testing the upper vessels. Once I confirmed that there was no NH₃ in that vessel I opened all valves to atmosphere. Refer to Picture #10.

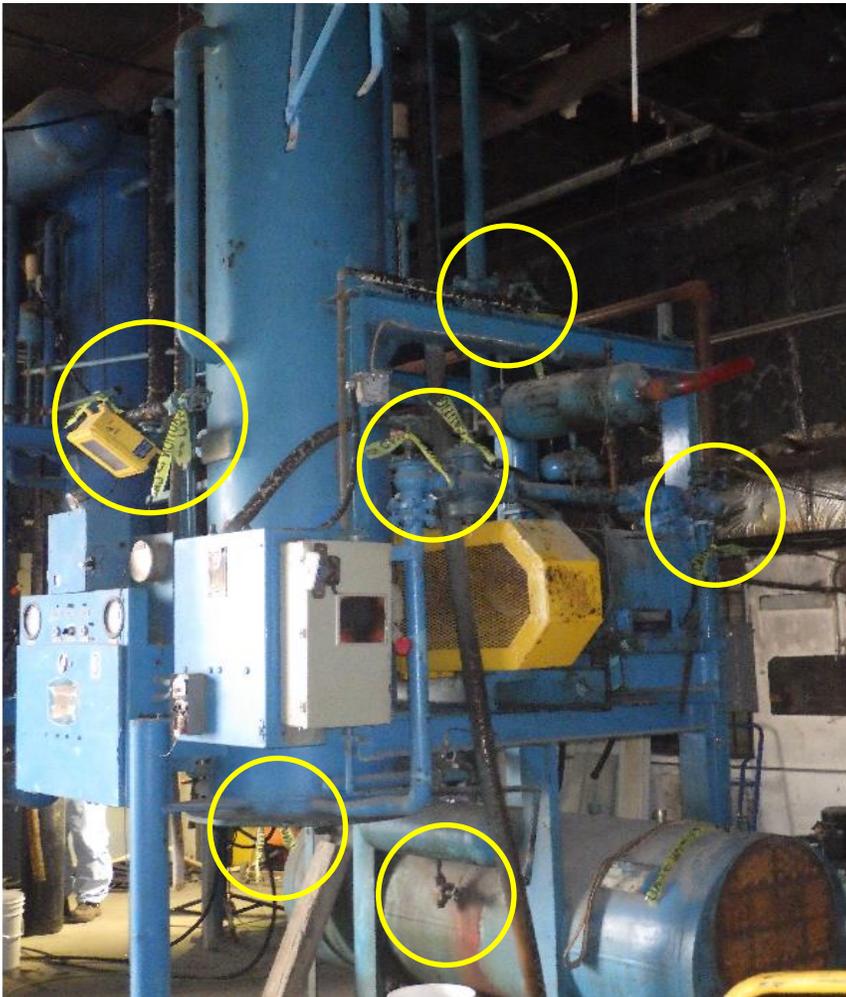
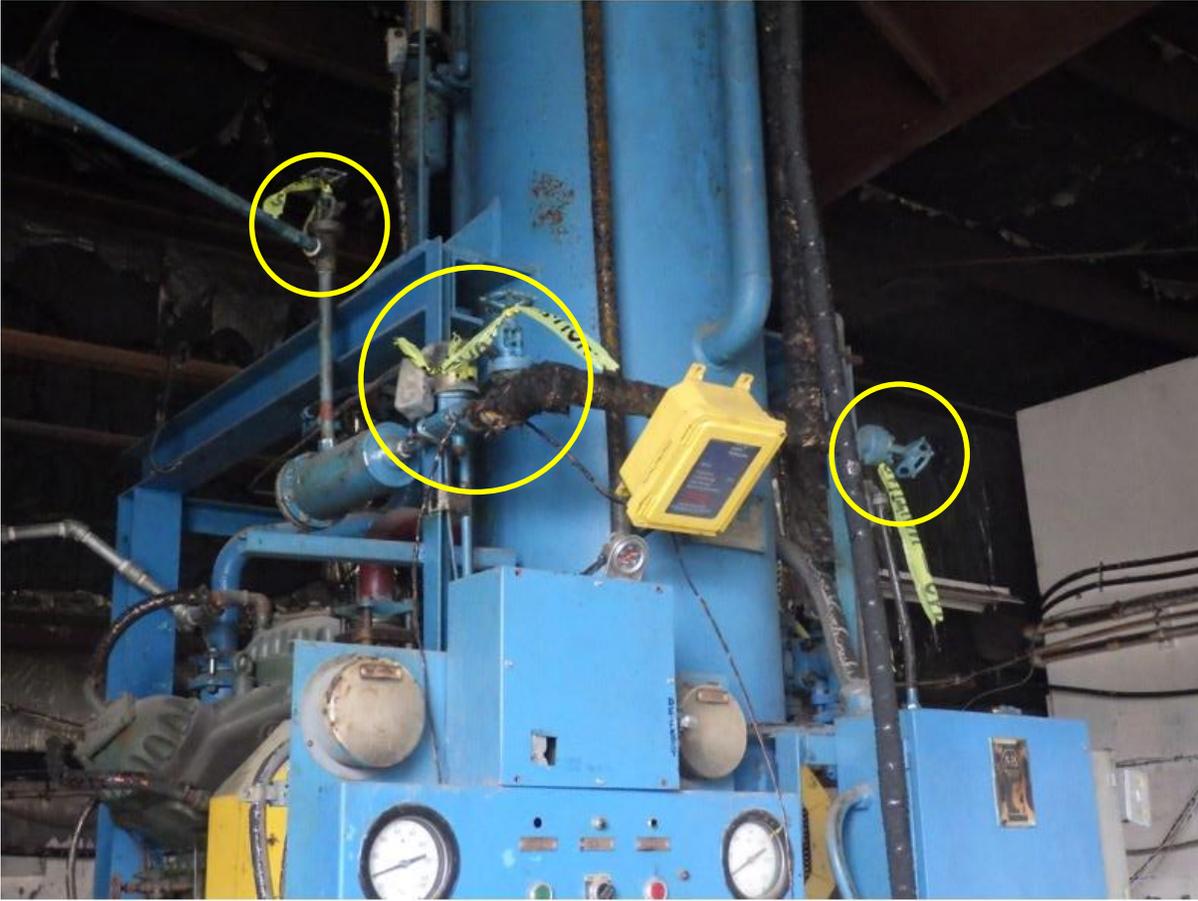
I started on Unit # 3 (P24)

Checked for pressure on the Oil pot, Liquid line, and Compressor. Each using the same procedure as before. Each showing 0 PSI in each and no bubbles. Opened all valves to atmosphere. Refer to pictures #11 and 12
