## Incident Summary #II-1398130-2022 (#28515) (FINAL)

SUPPORTING INFORMATION	Incident Date	May 12, 2022	
	Location	Interior	
	Regulated industry sector	Passenger ropeways - Above surface ropeway	
	Injury	Qty injuries	0
		Injury description	N/A
	Damage	Injury rating	None
		Damage description	Protruding/broken wires on counterweight tension rope, broken roller at front of tension system carriage, and broken carriage limit switch at front stop.
		Damage rating	Minor
	Incident rating	Minor	
Incident overview	Maintenance personnel lost control of ropeway tension system winch while de-tensioning ropeway.		
INVESTIGATION CONCLUSIONS	Site, system and components	Chairlift utilizes a gravity counterweight tension system to achieve the required tension within the haul rope ( <a href="#">Image</a> ). Steel plates combined make up the counterweight, which is suspended by the tension rope connected to a travelling carriage such that it applies the required force onto the haul rope. The carriage consists of the bottom bullwheel, which is the main drive sheave and redirects the haul rope 180 degrees from downhill to uphill haul rope travel. The carriage moves on a set of rails until there is a ba

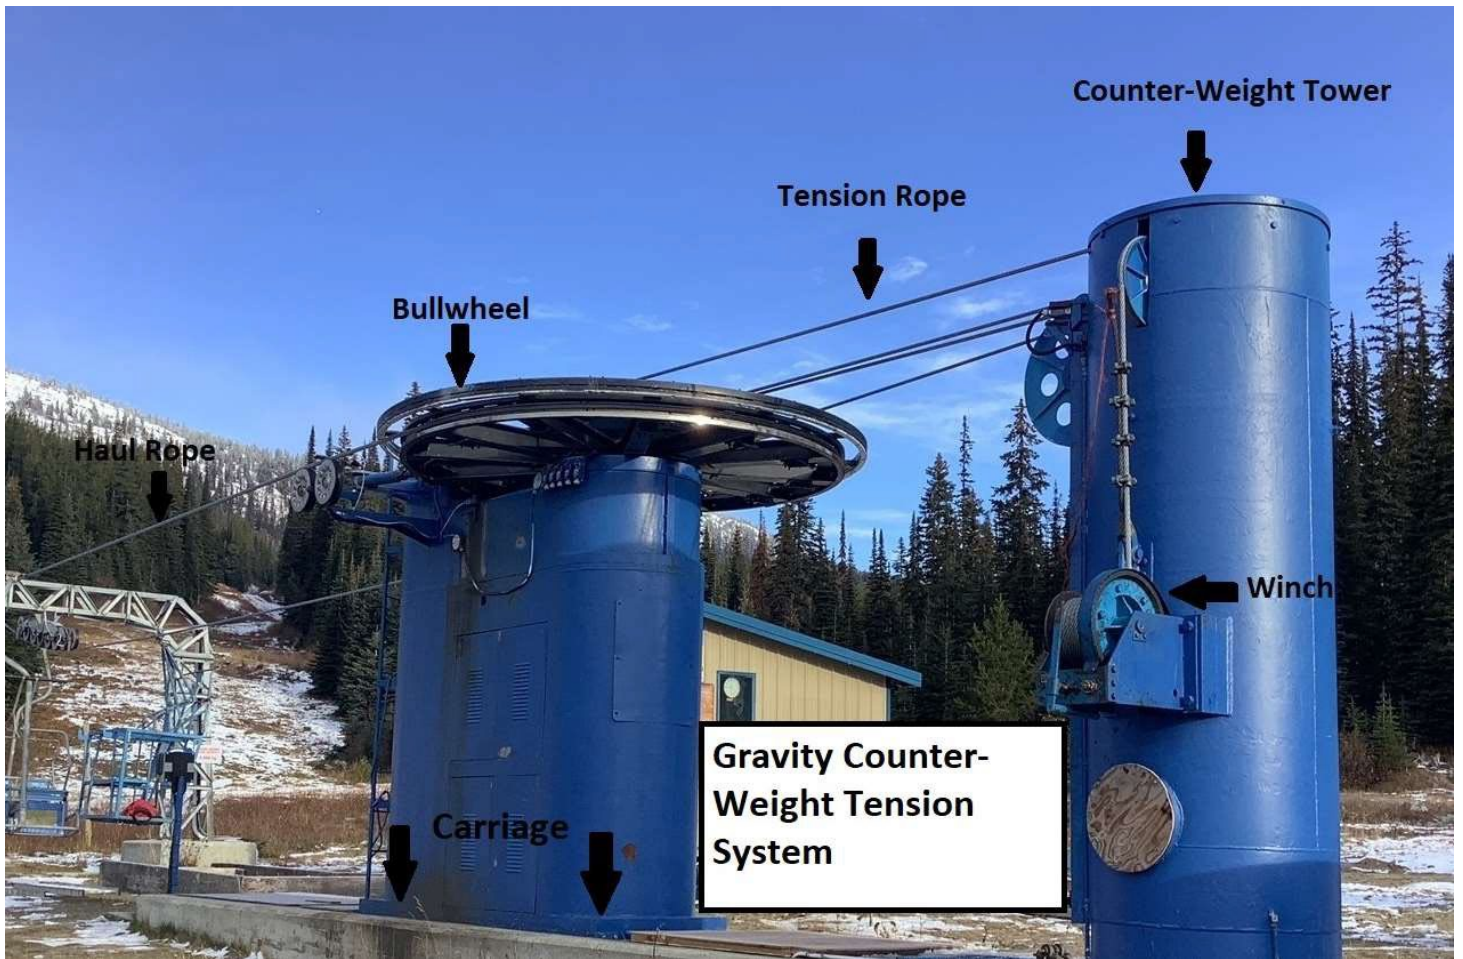
Failure scenario(s)	Equipment being utilized by workers for winch operation became disconnected, and the stop cogs on the winch ratchet disengaged allowing for the winch to unwind the tension system rope uncontrollably; until the counterweight bottomed out and the carriage was stopped by the rails front limits.	
		<p><u>Ropeway data:</u></p> <ul style="list-style-type: none"> <li>Originally built in the late 1970's.</li> <li>Re-located to its existing location in 1999.</li> <li>Tension system at bottom (load) station.</li> <li>Gravity Counter-weight tension system.</li> </ul> <p><u>Observed by Safety Officer:</u></p> <ul style="list-style-type: none"> <li>Protruding/broken wires in tension rope.</li> <li>Broken roller on tension carriage.</li> </ul>

<p>Causes and contributing factors</p>	<p>Maintenance personnel unsure of the tension system winch operation certainly caused the ropeway tension system, carriage, and counterweight, to move uncontrollably causing damage to the tension system rope, carriage roller and rail limit switch. A lack of maintenance experience and written procedure for maintenance personnel likely contributed the incident.</p>

Image – Tension System.

<p>Facts and evidence</p>	<ul style="list-style-type: none"> <li>• Carriage limit switch and bracket damaged.</li> <li>• Maintenance personnel have minimal ropeway experience and support.</li> <li>• Personnel unaware of tension winch Safety Bulletins issued by manufacturer.</li> </ul> <p><u>As reported by duty holder:</u></p> <ul style="list-style-type: none"> <li>• Personnel were uncertain of tension winch operation.</li> <li>• No procedure was available for personnel.</li> <li>• Ropeway Maintenance manual is limited.</li> <li>• The stop cog for winch ratchet was disengaged.</li> <li>• Maintenance personnel installed a gear mechanism, chain and power drill to operate the tension system winch.</li> <li>• Power equipment became disconnected when the chain fell off that was operating the winch.</li> <li>• The tension system rope began to unwind uncontrollably.</li> <li>• The counterweight released to the ground.</li> <li>• Carriage travelled uphill along rails, 2 meters, in an abandoned manner.</li> <li>• Carriage movement was halted by rail front mechanical stops.</li> </ul> <p><u>Manufacturer Winch Bulletin</u></p> <ul style="list-style-type: none"> <li>• Ensure all ratchet cogs are freely moving and properly retained.</li> <li>• Ensure all cog tension springs are intact and applying sufficient pressure to maintain contact with the ratchet wheel.</li> <li>• It is not acceptable to use power equipment to lower the counterweight any faster than it can be done by hand.</li> </ul> <p><u>CSA Z98 requirements:</u></p> <ul style="list-style-type: none"> <li>• Owner/representative shall be responsible for training maintenance personnel.</li> <li>• Maintenance manual, service and safety instruction bulletins shall be available to appropriate personnel.</li> <li>• Written safety procedures for safe rigging shall be prepared and available in place.</li> </ul>
