Incident Summary #II-1759094-2024 (#51649) (FINAL)

SUPPORTING INFORMATION	Incident Date	September 10, 2024	
	Location	Coquitlam	
	Regulated industry sector	Gas - Natural gas system - Propane gas system	
	Impact	Qty injuries	17+
		Injury description	Multiple adults and youths experienced carbon monoxide poisoning symptoms, some of which included light headedness, shortness of breath, exhaustion, dizziness, headaches, nausea, and vomiting.
		Injury rating	Moderate
	Damage	Damage description	N/A
		Damage rating	None
	Incident rating	Moderate	
Incident overview	Dangerous levels of carbon monoxide (CO) were released and contained within the indoor space of an ice rink facility containing employees and members of the public. Several people were unknowingly exposed to the CO over several hours and experienced a variety of CO poisoning symptoms with some seeking medical attention.		
INVESTIGATION CONCLUSIONS	Site, system and components	<p>The ice rink facility was built and opened in 1993 and houses four ice rinks. Two rinks are located on either side of a central lobby, restaurant and fitness facility. The building contains several natural gas burning appliances including heaters, boiler

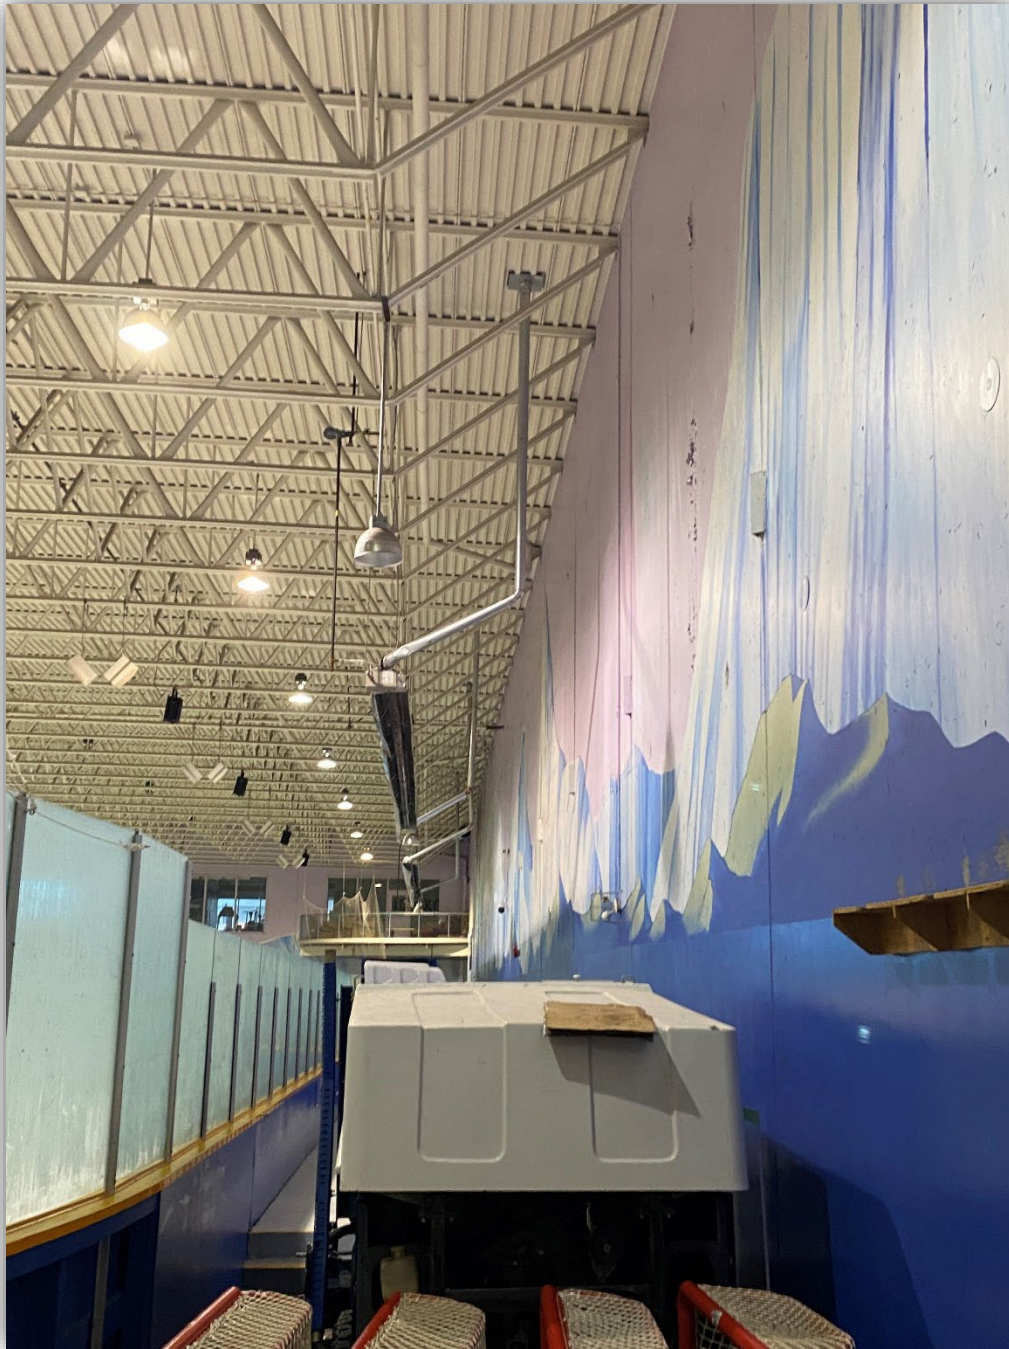
Image 2 – Two tube heaters above the spectator stands at rink 2.

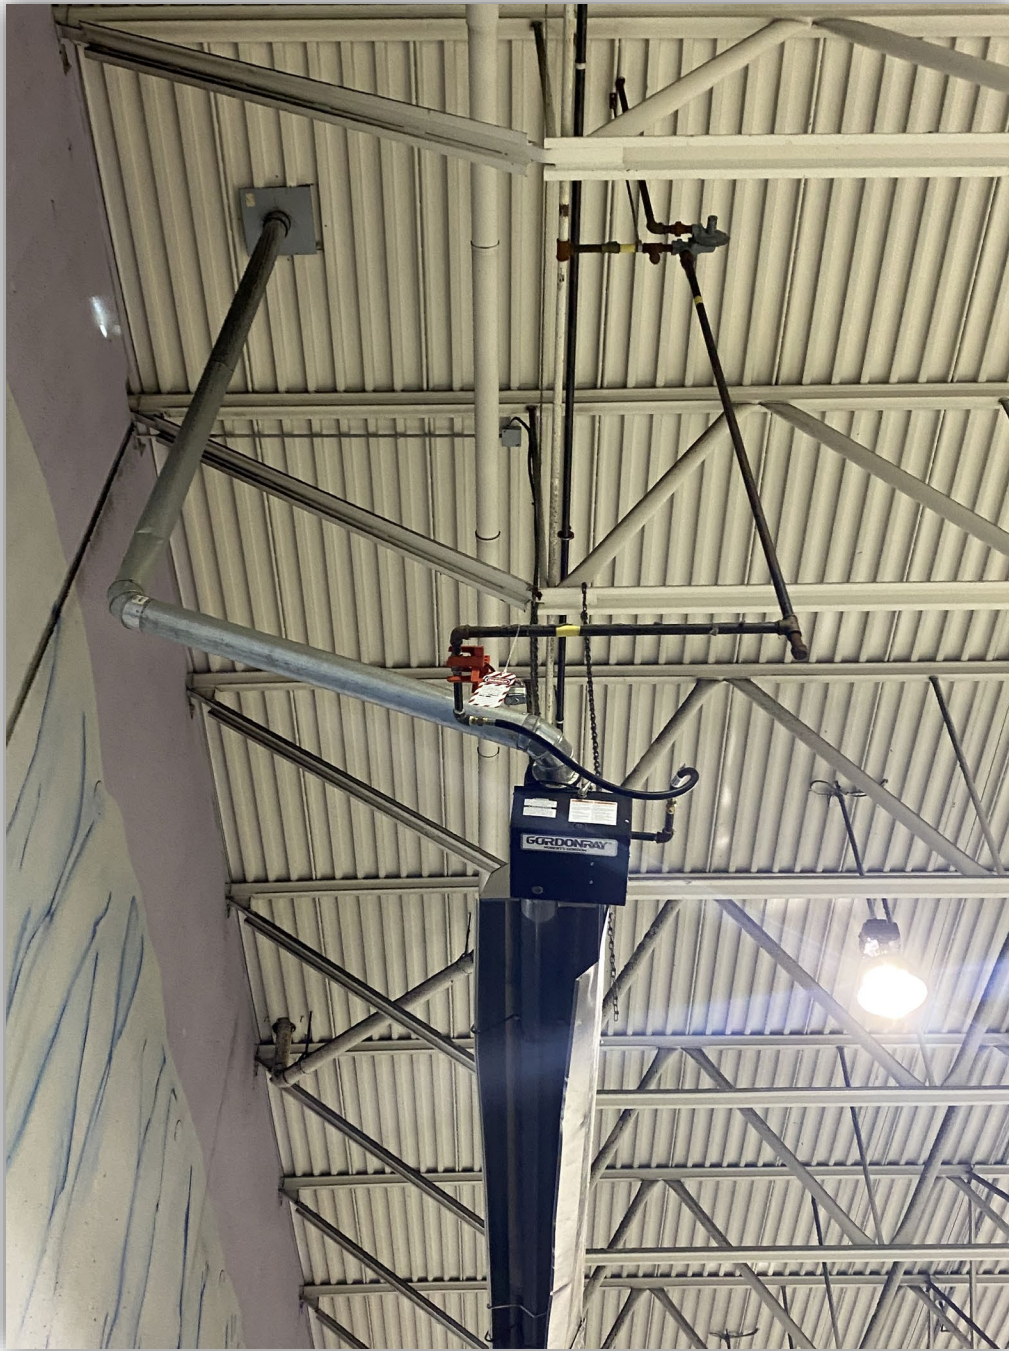
Image 3 – Air intake piping and burner unit for tube heater #1 on rink 2.

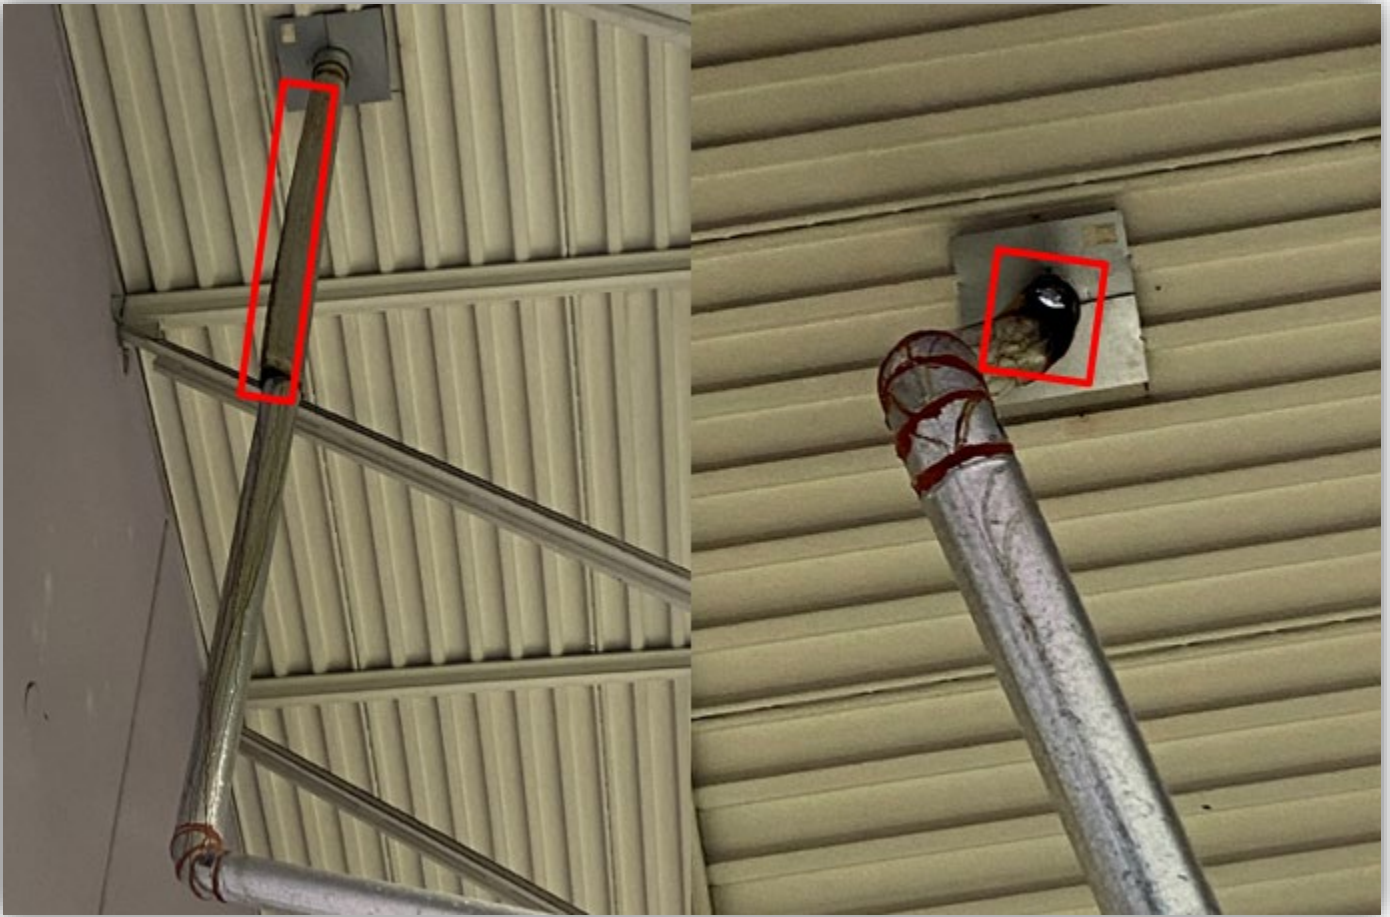
A gas technician was hired to examine the dehumidifier and when tested, found that it was operating correctly within acceptable parameters and was not the main source of CO in the building. Further examination identified one of the tube heaters for heating the spectator stands on rink #2 had a split open vent pipe indoors and had been spilling flue gasses including CO into the indoor space ([Image 4](#)). This became the next expected source of CO for the building as the heater had been operating continuously that evening. The heater is operated by an automatic timer switch accessible to the public but can also be set for continuous operation which it had been that evening from an undetermined time until 11pm the day of the incident. The heater was then turned off and disconnected for use.

Image 4 – Two angles showing the split and open vent pipe for Tube heater #1. Image on right showing light from the outdoors coming through the open piping.

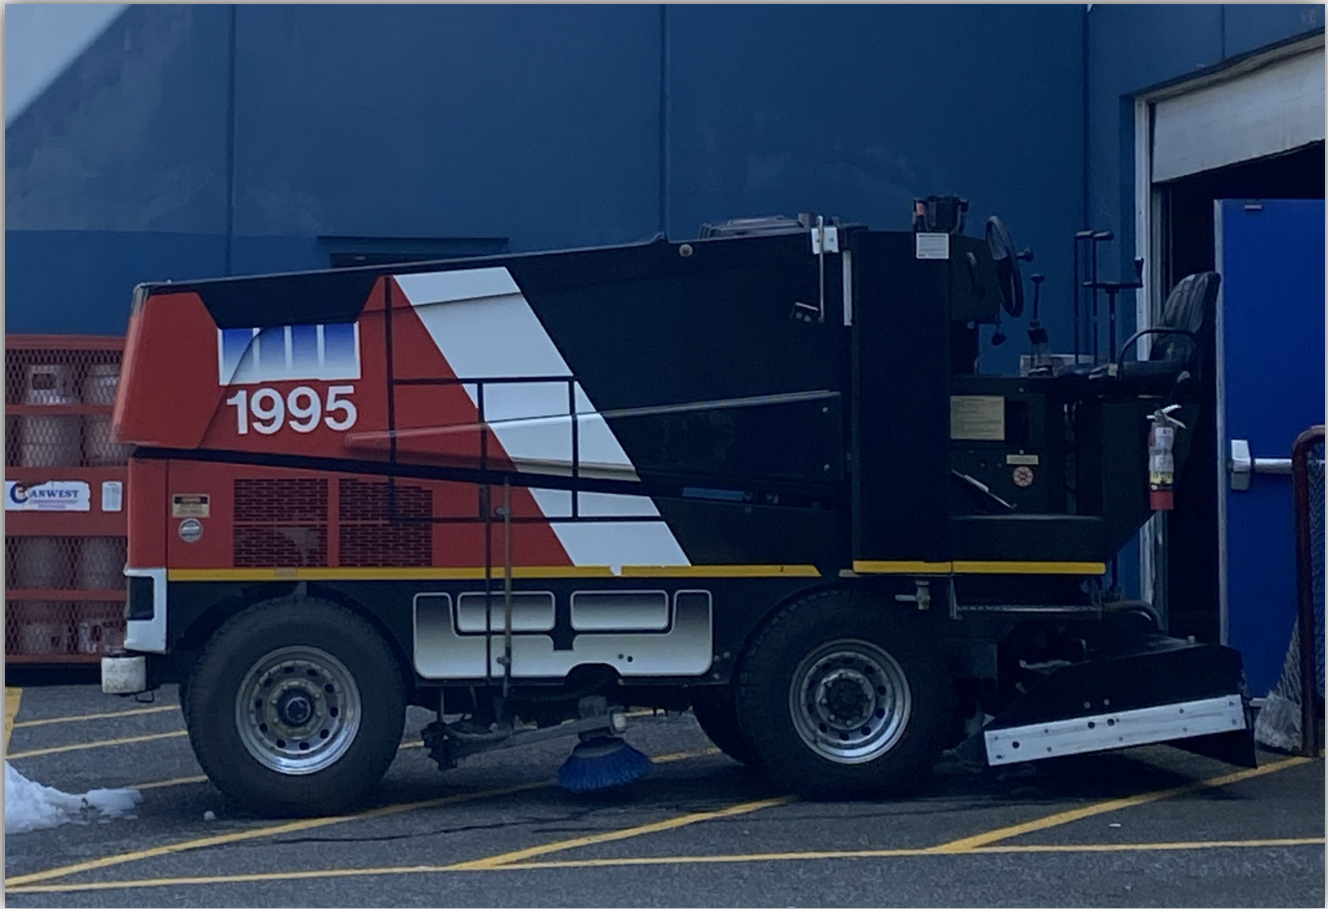
<p>6.88% (68,800ppm) CO under load and 7.25% (72,500ppm) CO with no load. After the repairs were completed to the electronic fuel pressure regulator. It was tested again, and the emissions measurements improved to 0.34% (3400ppm) CO under load and 0% (0ppm) with no load.</p> <ul style="list-style-type: none"> The Zamboni service manual states that rinks must be adequately ventilated during operation of the ice surfacer and that measuring and recording of the engine's emission levels should be completed every 300 operating hours. <p>Testing and measurements</p> <p>The natural gas fueled heating appliances had combustion analysis tests completed by qualified contractors after incident. No significant sources of CO were identified. The radiant tube heater with the damaged vent pipe and the direct fired dehumidifier both allowed flue gasses to enter the indoor space, and the documented tests identified the CO measurements of both appliances were 4-14 ppm.</p> <p>When CO was identified in the rink the next day, a test was conducted to analyze the Zamboni use as a CO source. The Zamboni was sent out to do an ice clean of rink 2 and after 10-12 minutes of operation, the measured CO reading in the ambient air around rink 2 increased by 80 ppm (from 60-140ppm).</p>

<p>Causes and contributing factors</p>	<p>Regulated gas heating/dehumidification equipment was found to have some deficiencies; however, it was unlikely that they were a major contributing factor to the incident. The use of a propane powered Zamboni with a faulty electronic fuel pressure regulator was the main source of high levels of CO in the indoor space of the public ice rink facility.</p> <p>Contributing factors to the carbon monoxide exposures and illnesses include:</p> <ol style="list-style-type: none"> <u>Carbon monoxide detection</u> - The facility not having carbon monoxide detection systems inside the ice rink sections of the building prevented the early warning of hazardous levels of CO in the area. <u>Mechanical ventilation operation</u> - The operation of the Zamboni without the use of the mechanical ventilation fans allowed the CO concentrations to increase without the dilution of incoming fresh air. <u>Management decisions</u> - The decisions to assume the boiler was the main source of CO without proper testing and the allowance of continued occupancy of the building by employees and the public after CO was detected indoors allowed for extended periods of exposure. <u>Gas equipment condition and operation</u> - The gas tube heater venting to the indoors through the damaged vent pipe and the direct fired dehumidifier drawing in combustion air containing high levels of carbon monoxide could have contributed to a slight increase in the CO levels indoors.

Image 5 – Faulty Zamboni parked outside of ice rinks 1-2.

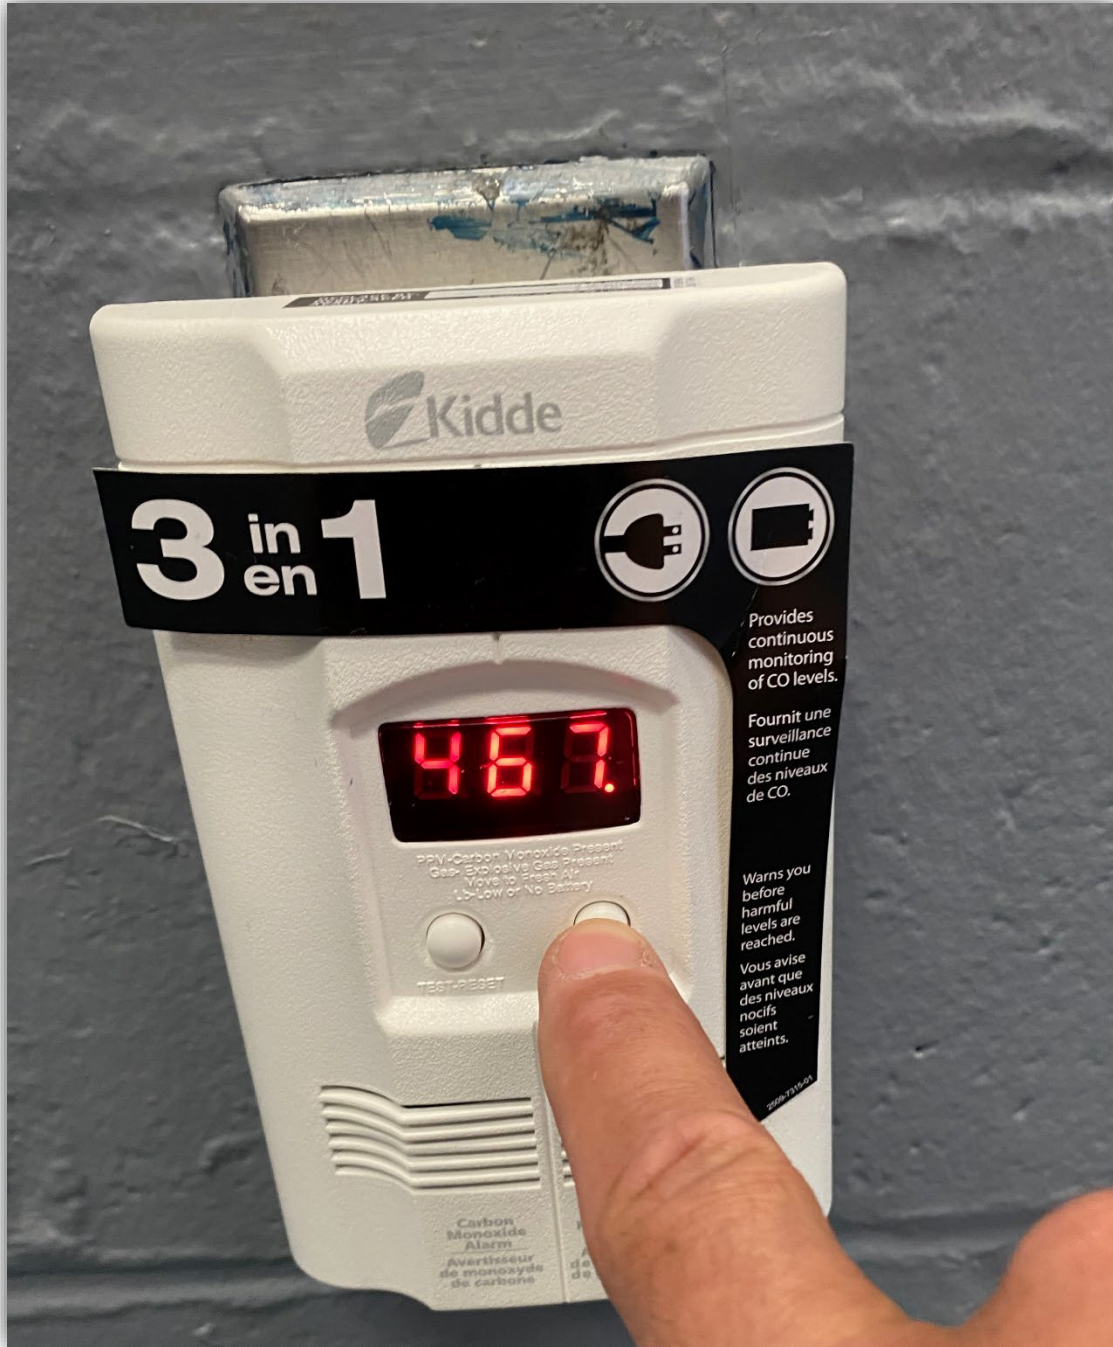
Image 6 – New CO detector installed in the building lobby showing a recall of a maximum reading of 467ppm.

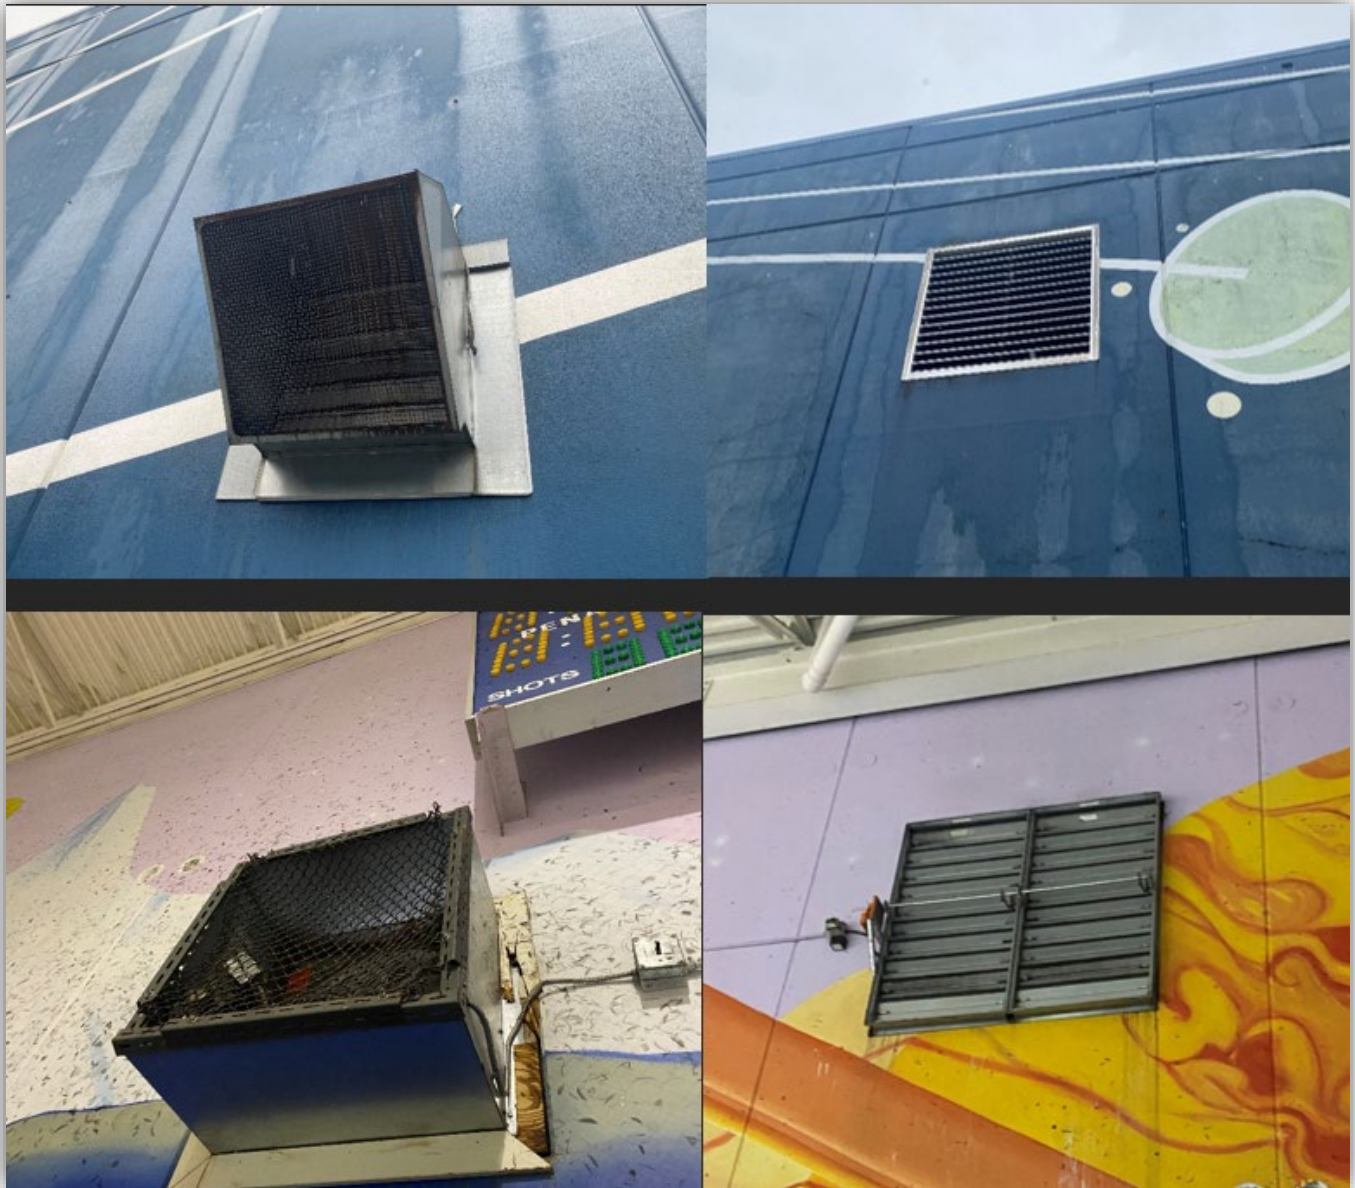
Image 7 – Left – The outdoor and indoor views of the rink 2 ventilation fan. Right – The outdoor and indoor view of the rink 2 louvered ventilation intake grate.
