Incident Summary #II-1110240-2020 (#19900) (FINAL)

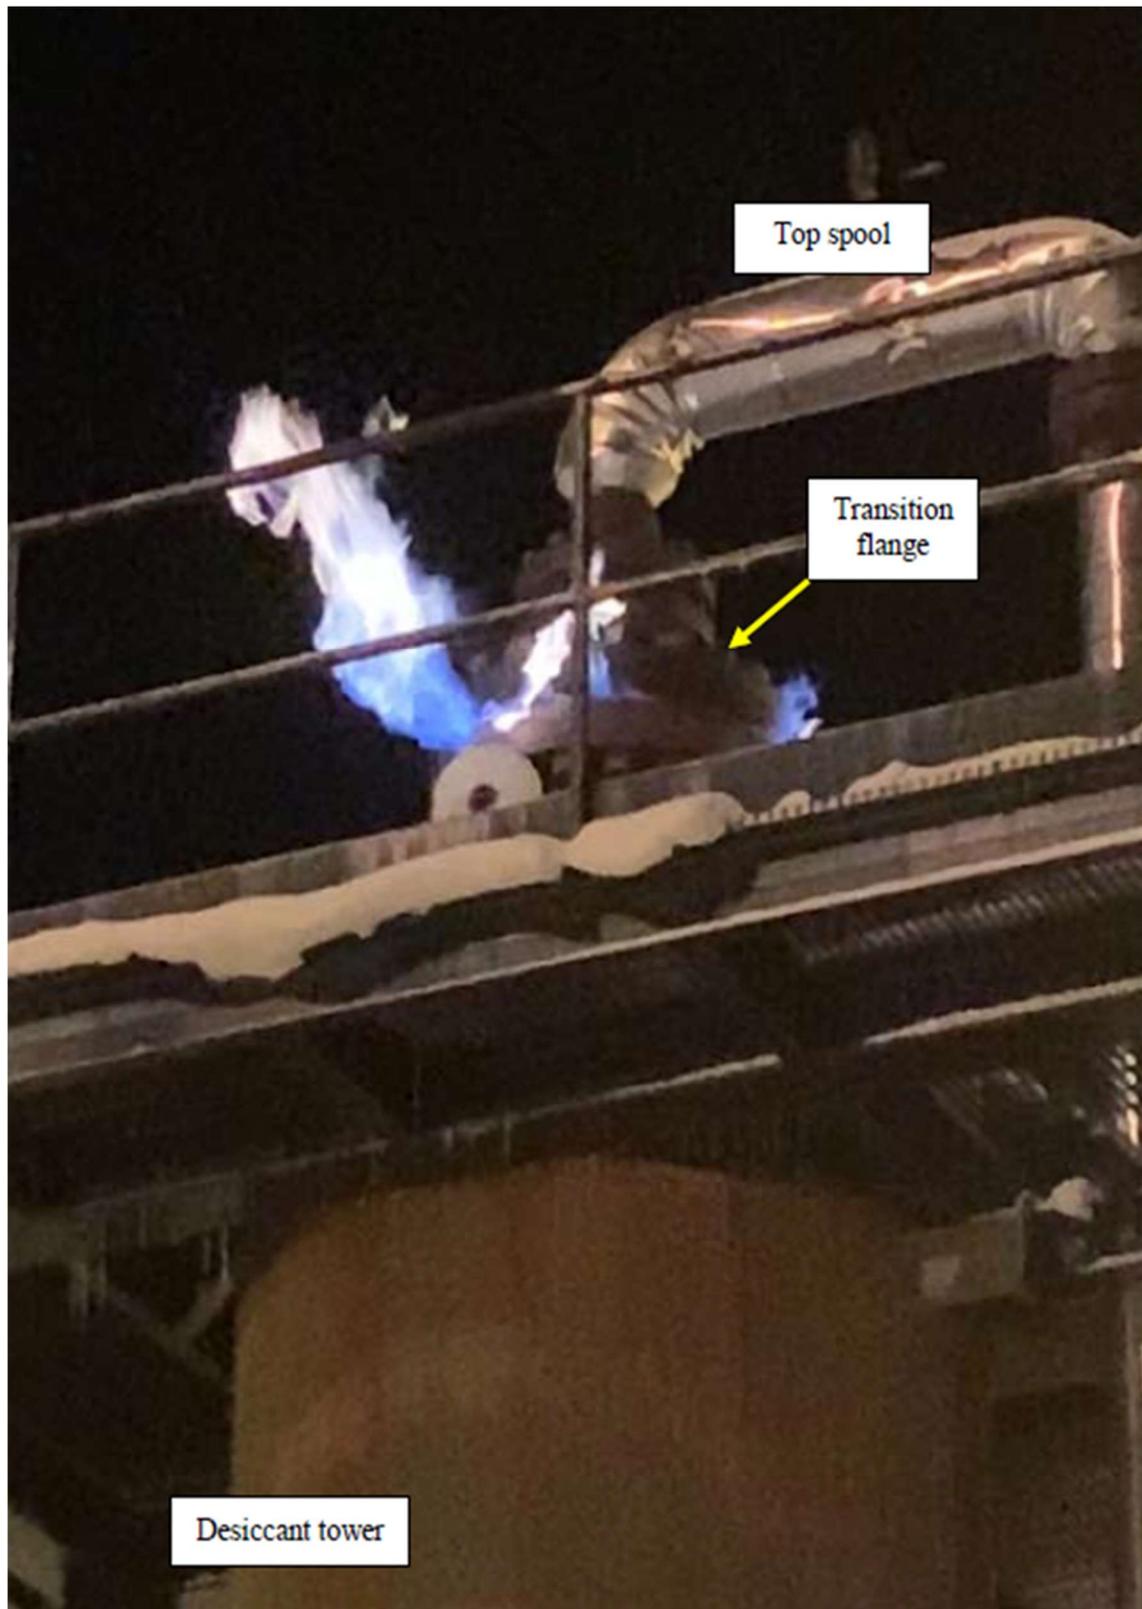
Causes and contributing factors	It is likely that no bolt re-torque after thermal cycling and incorrect gasket type led to the release of natural gas resulting in a fire from an unknown ignition source.

Image# 1 Top flange connection of the desiccant tower on fire.

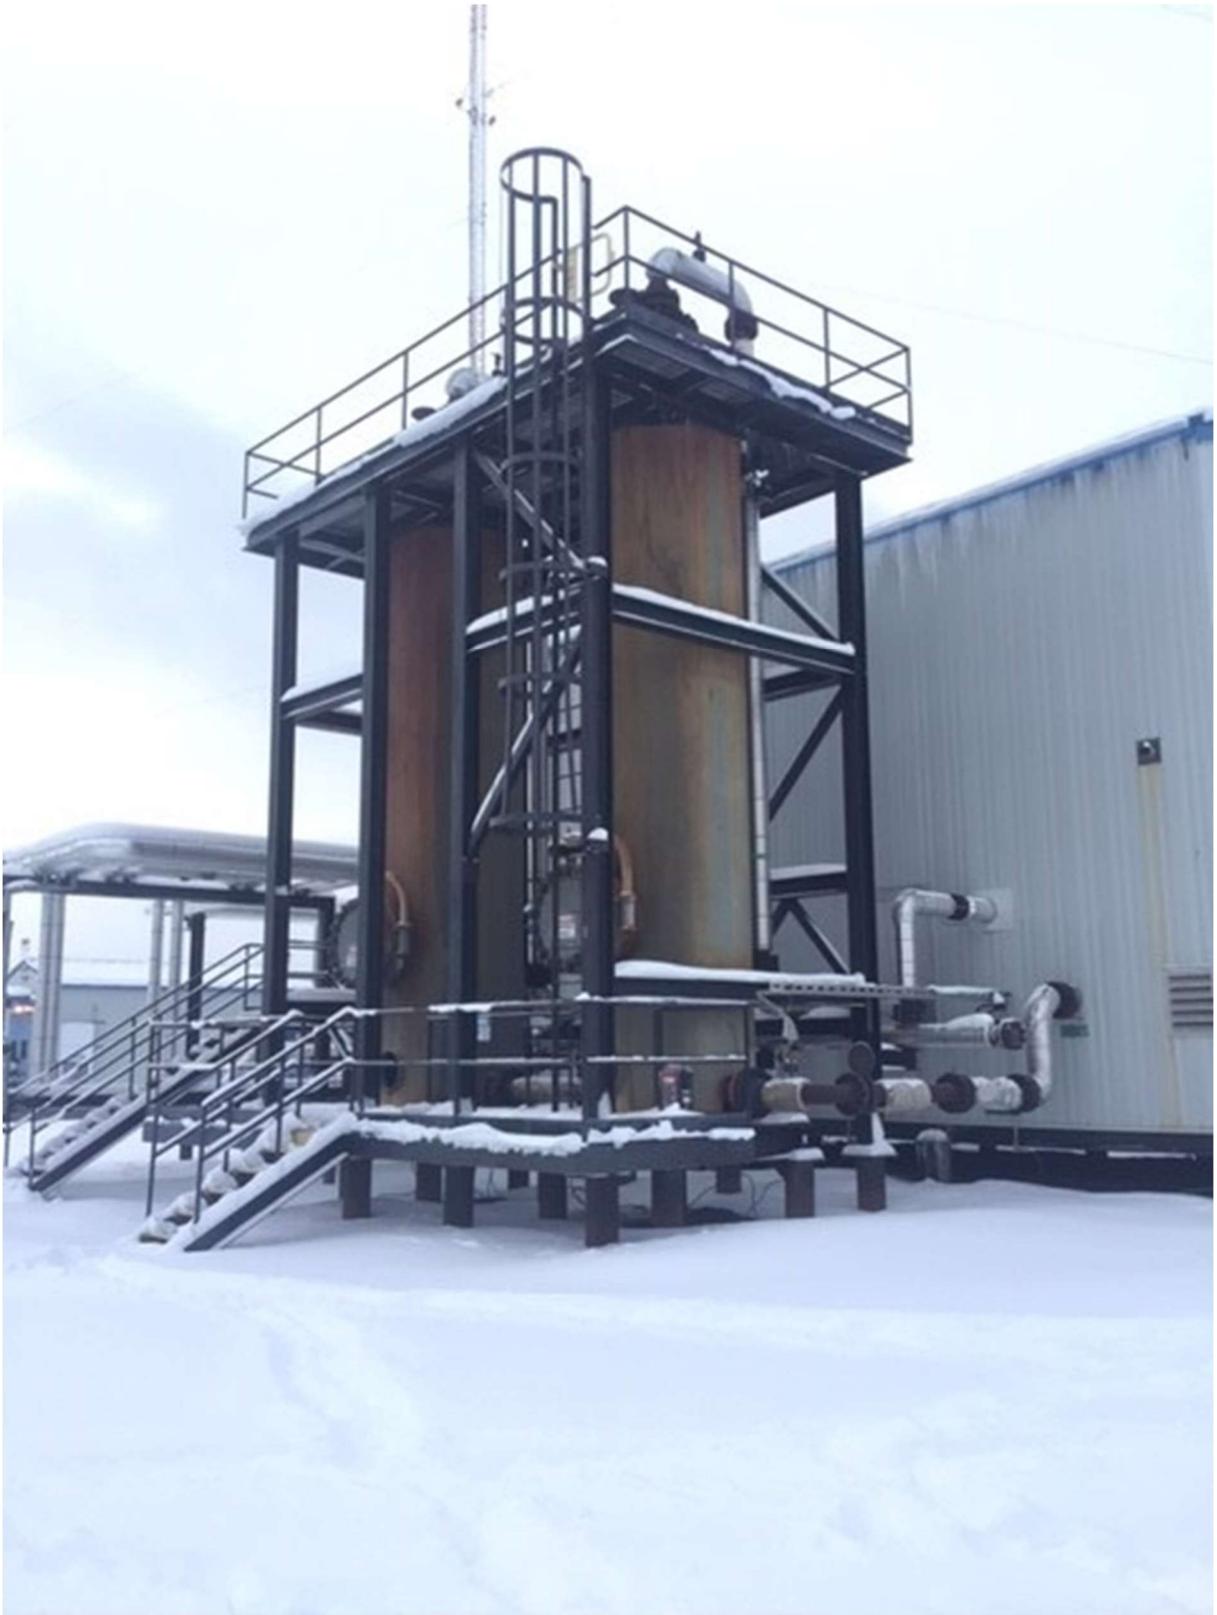
Image# 2 Desiccant Towers.

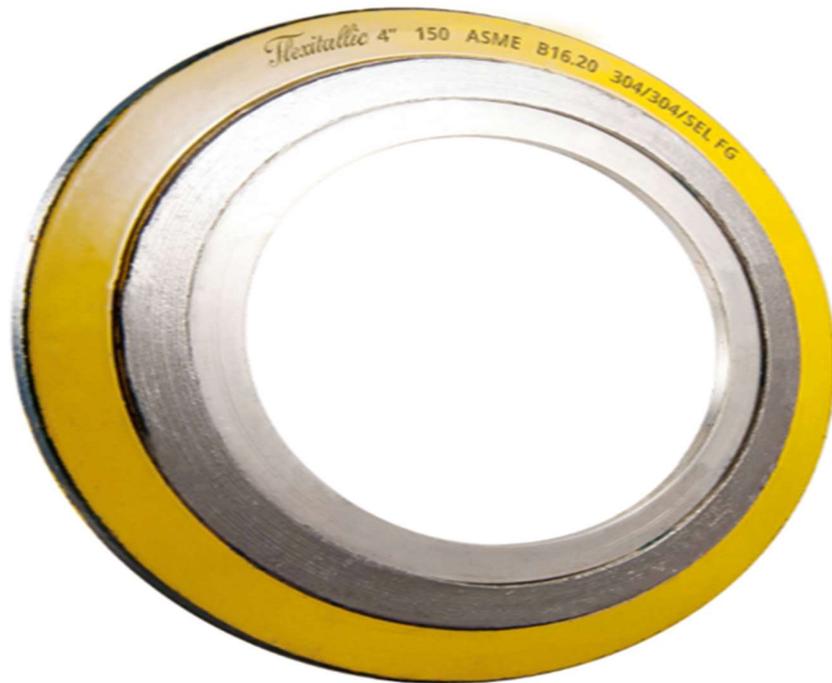
Image# 3 New spiral wound gasket with inner ring.

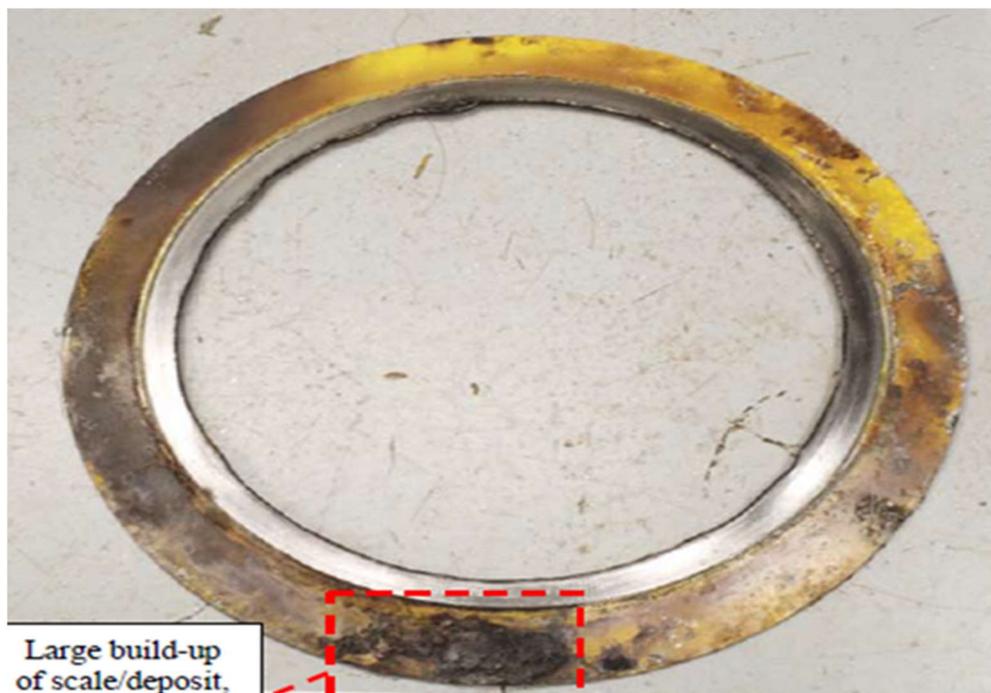
Failure scenario(s)	In 2019, at the failed flange connection, the deflector was replaced and new deflector that did not fit properly was installed. To accommodate the new deflector a spiral wound gasket without inner ring was used. The bolts at this flange connection were torqued however the bolts were not re-torqued after thermal cycling. Over a period of time fluctuations in temperature compressed the gasket, reducing the tension load on the bolts holding the flange faces tight against the gasket allowing natural gas to escape this flange connection.	
	Facts and evidence	<ul style="list-style-type: none"> Owner reported that a new deflector was installed at the flange location that did not fit properly. Owner reported that this flange connection was not re-torqued after thermal cycling. Owner reported that a spiral wound gasket without inner ring was used when a spiral wound gasket with inner ring should be used.

Image# 4 The damaged spiral wound gasket without inner ring.

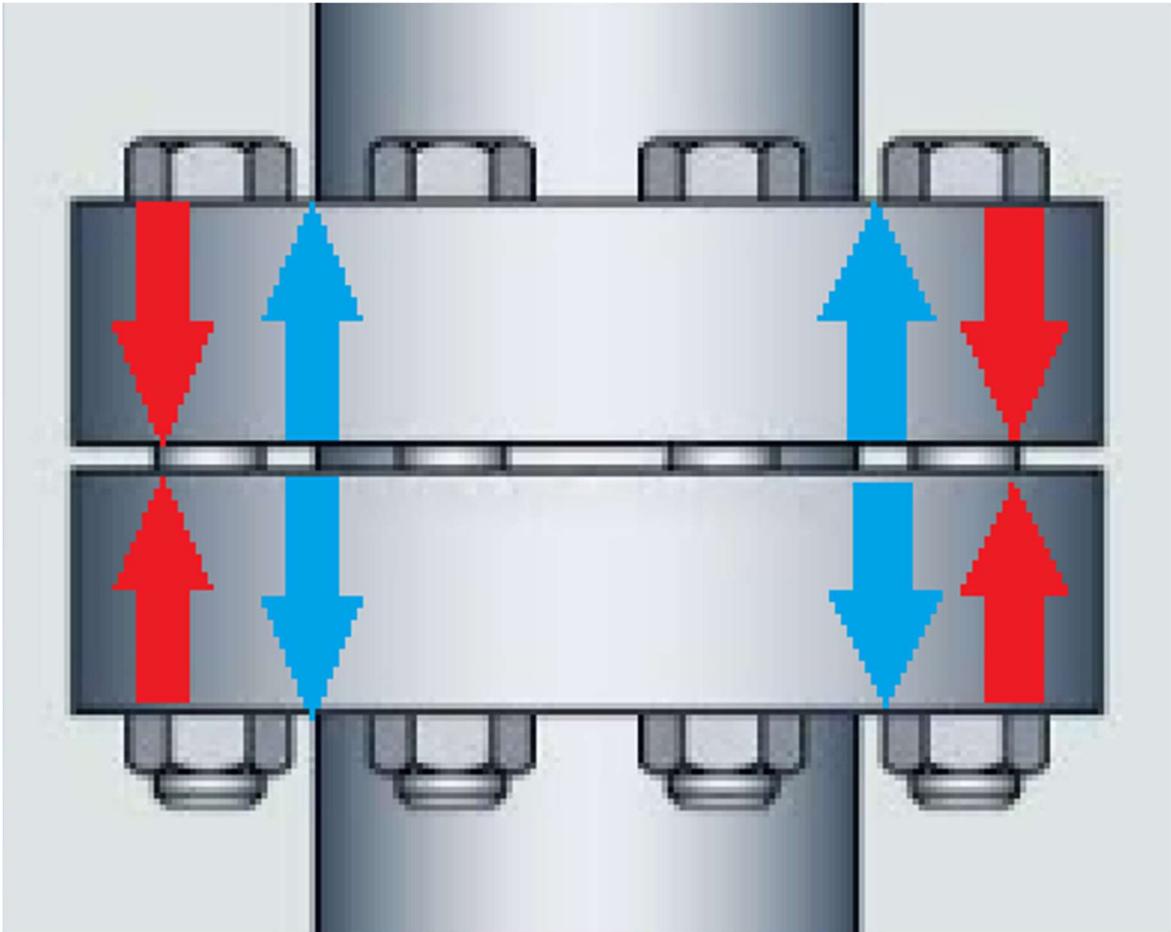
Image# 5 Thermal Cycling on a flange. Heat adds compression load and Cold reduces compression load.
