# Appendix H – Ammonia purge timeline

## Overview

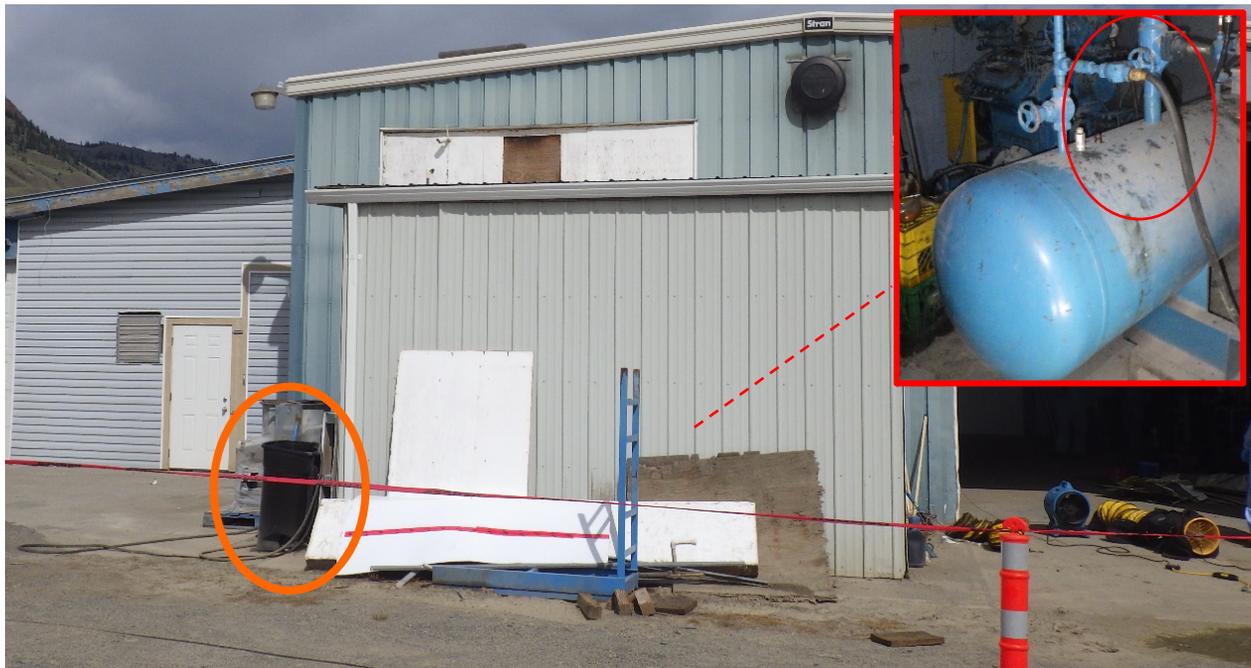
Image 1 (Purging equipment & setup) – Purge vessel and hoses that were in place prior to the incident. The purging barrel (orange oval) was fed by one hose connected to a water tap inside, while the other hose had ammonia flowing through it from a valved pipe (red oval) on the high-pressure ammonia receiver (in the red square) associated with two P24 ice making machines.

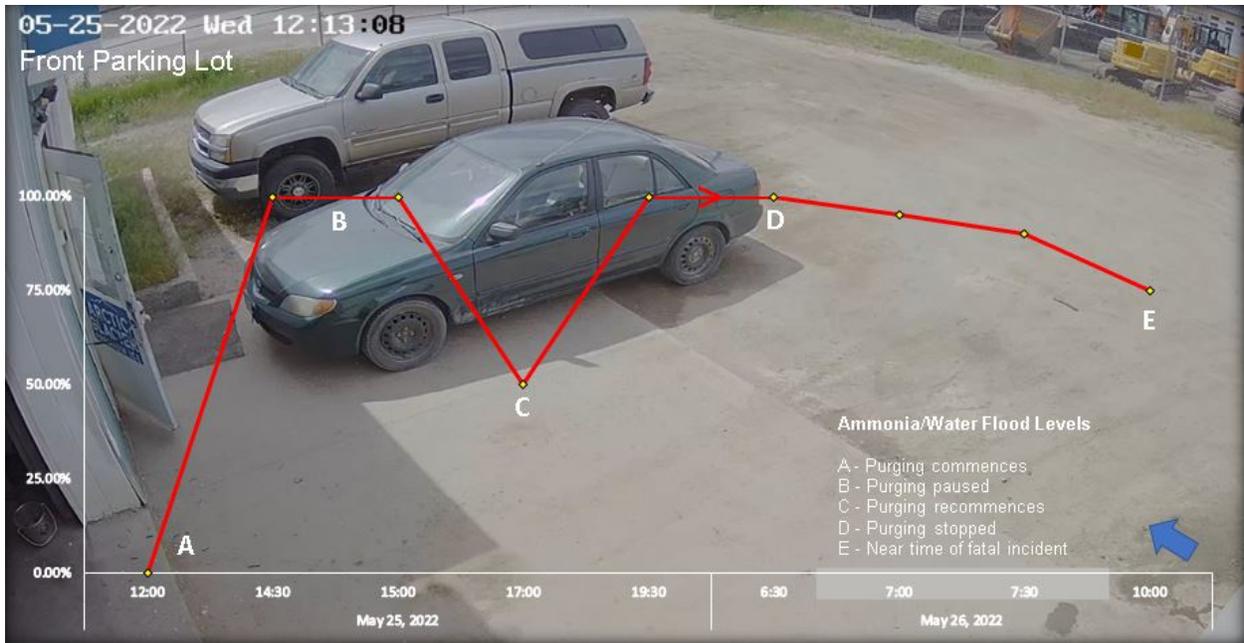
Image A – Purging commences in the front parking lot; blue arrow shows water/ ammonia mixture starting to form.

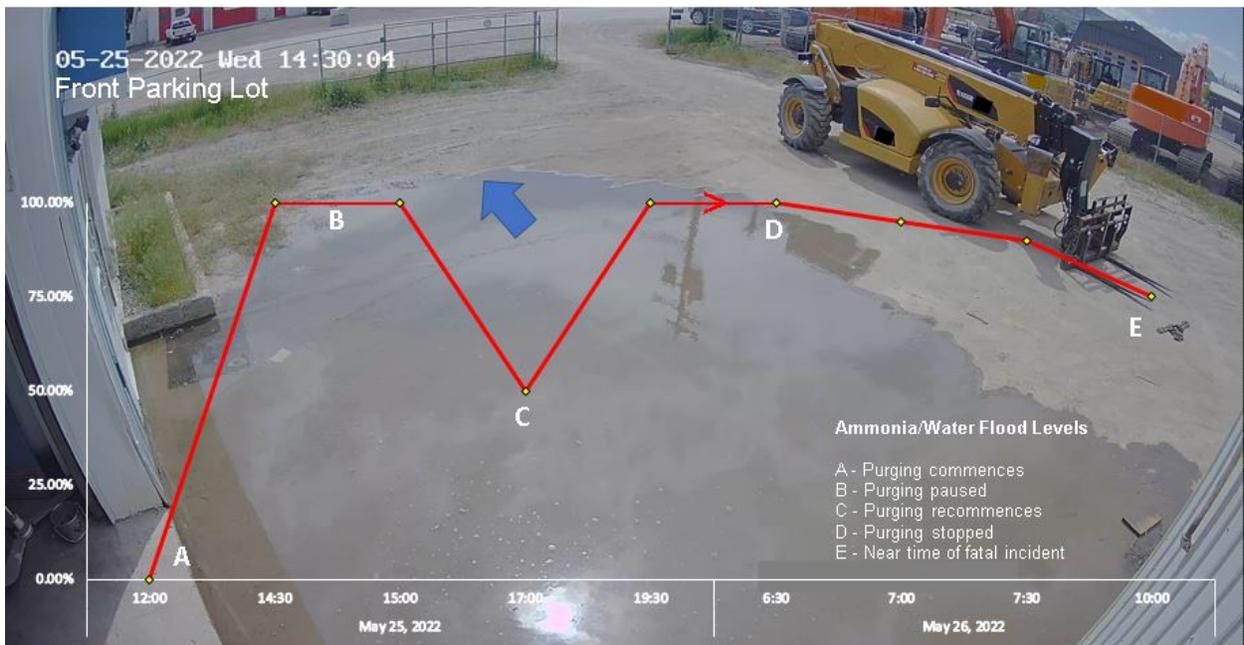
Image B – Purging is paused and the parking lot is at a high level of flooding.

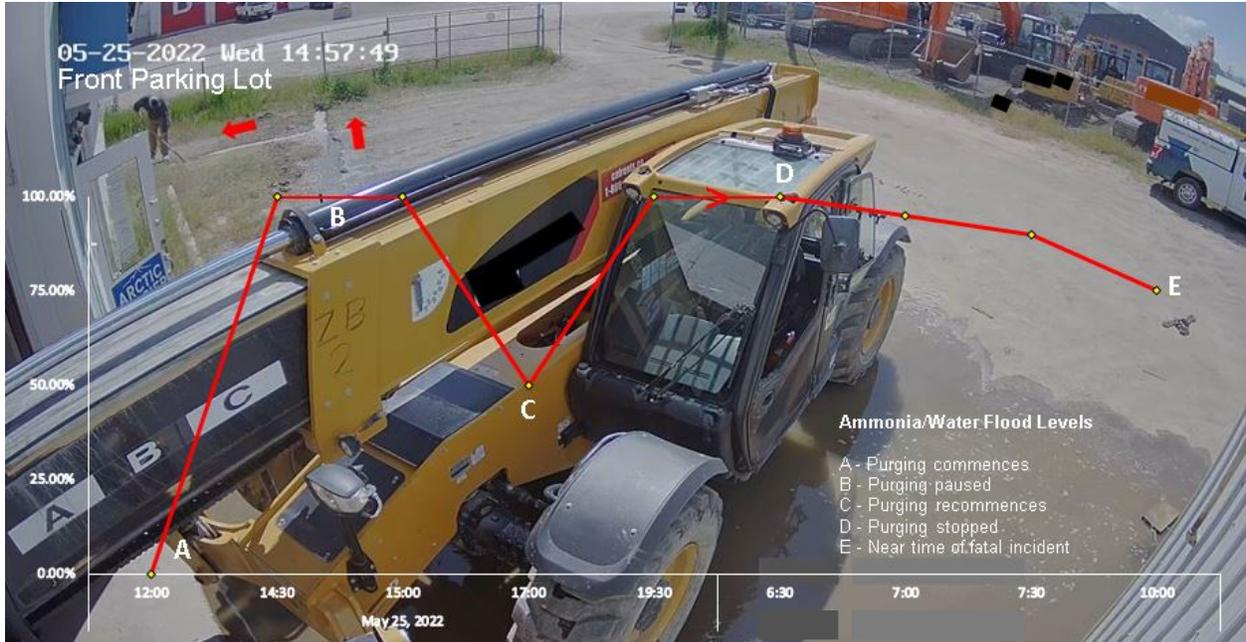
Image B-C – Southside trench is dug by Arctic Glacier employee using a shovel and the flooding begins to recede as the water ammonia mixture moves to the south.

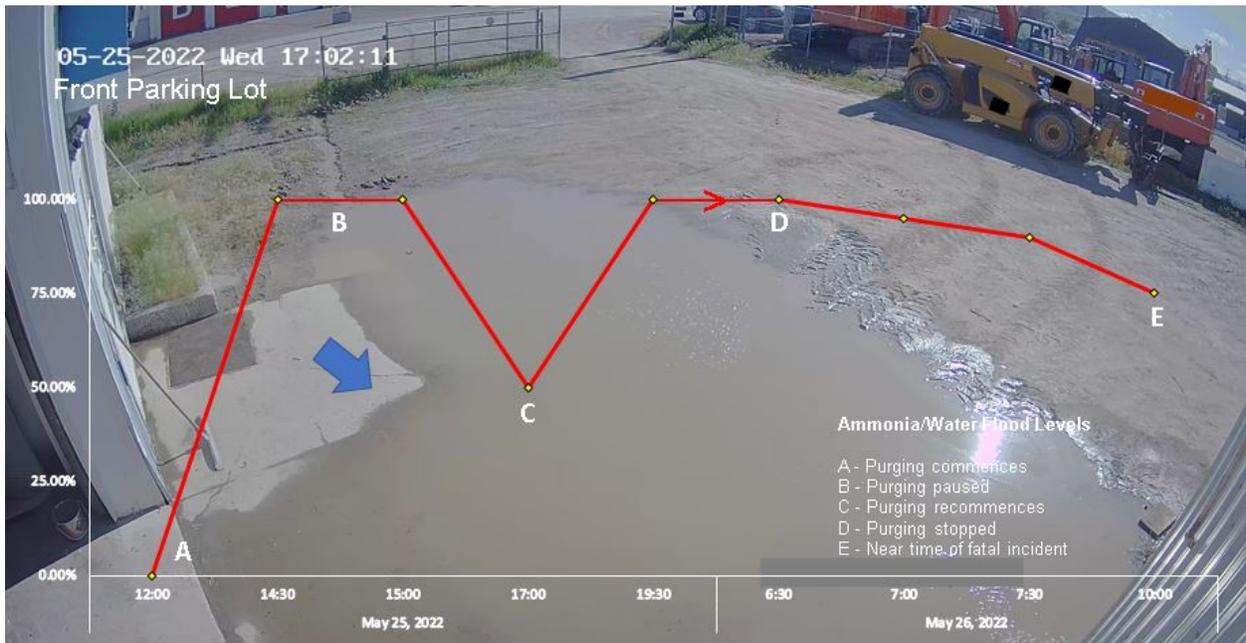
Image C – Amount of parking lot flooding has receded by 50% and the purging recommences.

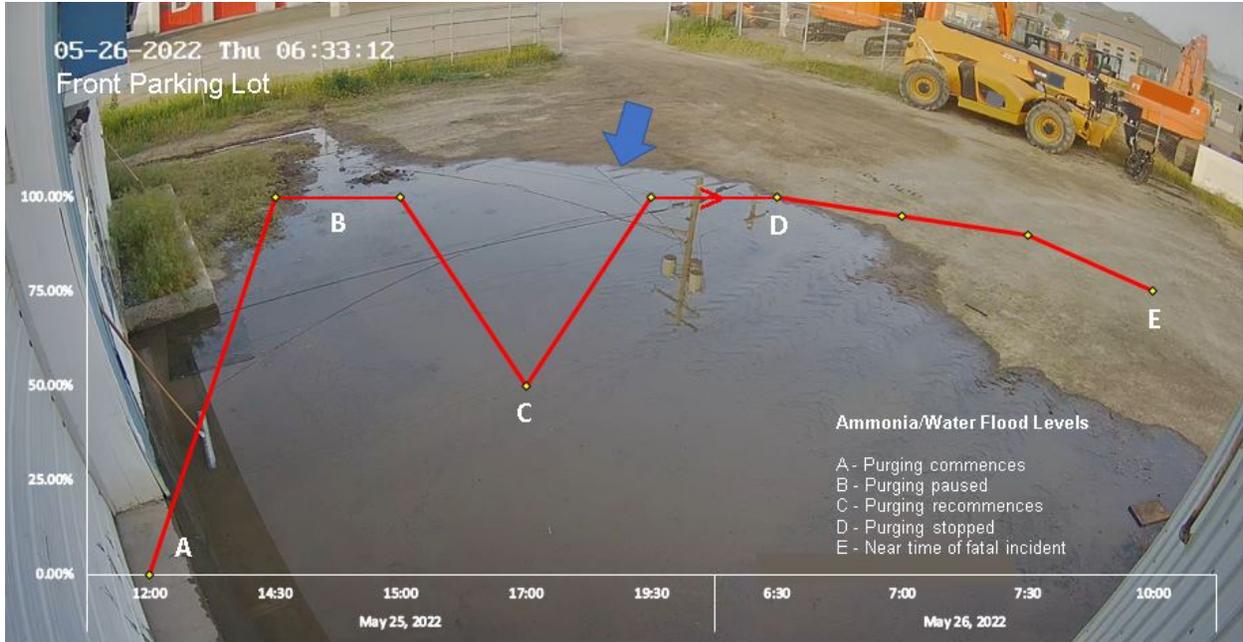
Image D – Purging is stopped and the water begins to recede.

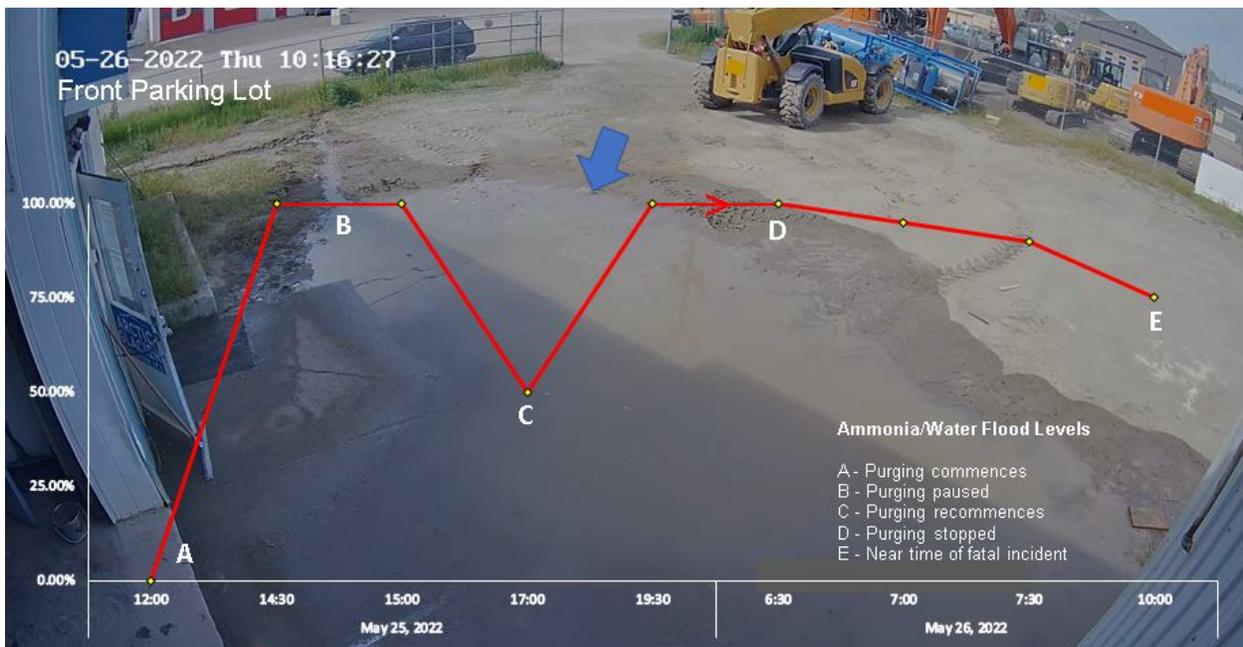
Image E – Parking lot flooding partially recedes near the time of the fatal incident.
