Incident Summary #II-1014286-2020 (#17612) (FINAL)

SUPPORTING INFORMATION	Incident Date	May 15, 2020
	Location	Abbotsford
	Regulated industry sector	Boilers, PV & refrigeration - Refrigeration system
	Qty injuries	0
	Injury description	No injury reported
	Injury rating	None
	Damage description	Threaded connection failed and released ammonia that was intended to be contained within the refrigeration system.
	Damage rating	Moderate
	Incident rating	Moderate
	Incident overview	The ammonia piping connection within a refrigeration system of an industrial food processing facility failed and released ammonia in a cold storage room.
INVESTIGATION CONCLUSIONS	Site, system and components	<p>Ammonia refrigeration systems are typically designed for maximum allowable working pressure of 250 psig on the high pressure side and 150 psig on the low pressure side. The refrigeration cycle contains four major components; compressor, condenser, evaporator and expansion devices. The refrigerant remains piped between these four components and is contained in the refrigerant loop. In cold storage facilities, food products are kept well below freezing for maintaining their texture and keeping them safe. T

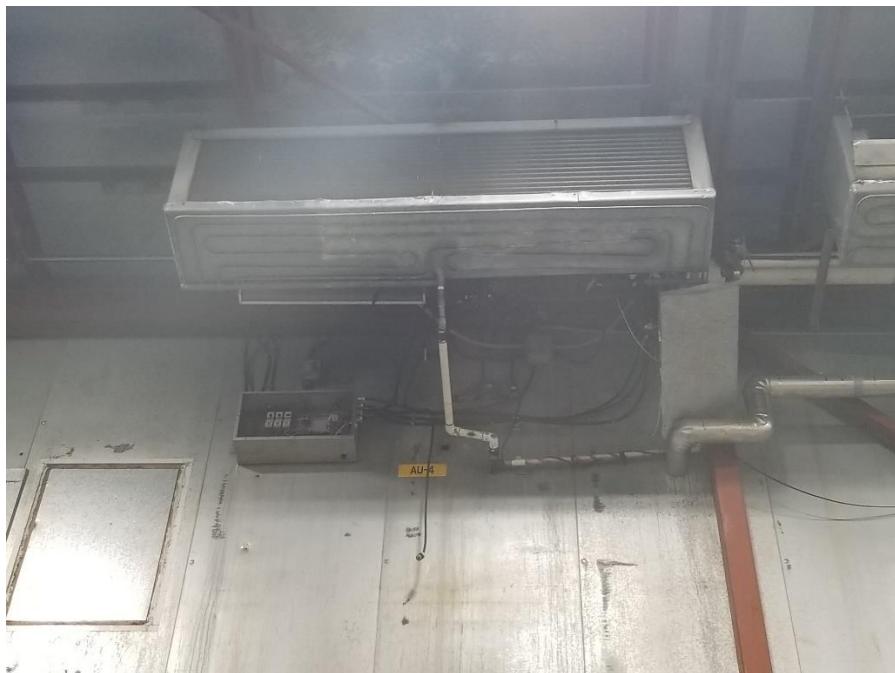
Fig. 1: Evaporator (Image provided by repairing contractor)

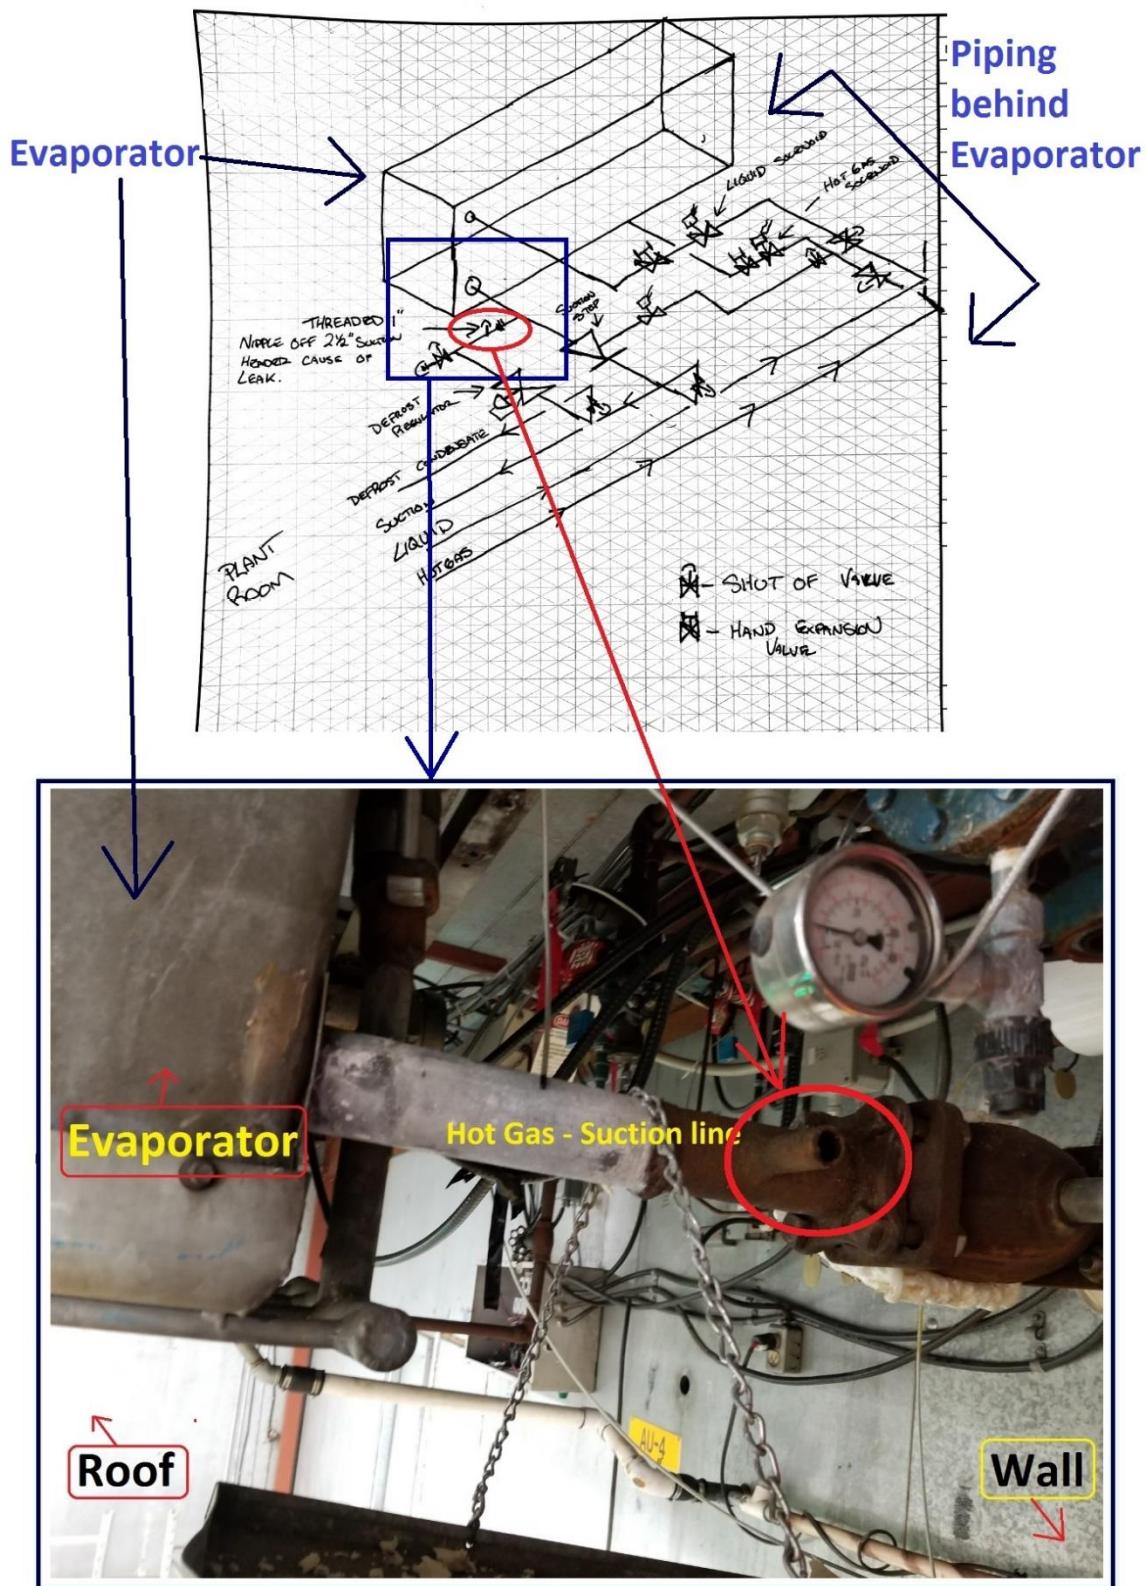
Causes and contributing factors	<p>It is very likely that the threaded joint failed because of the expansion and contraction of the piping joint due to the hot gas defrost cycle process for the evaporator. The corrosion under insulation may have also exaggerated the threaded joint failure and caused the ammonia leak.</p>

Fig. 2: Location of Leak (Image and diagram provided by repairing contractor)

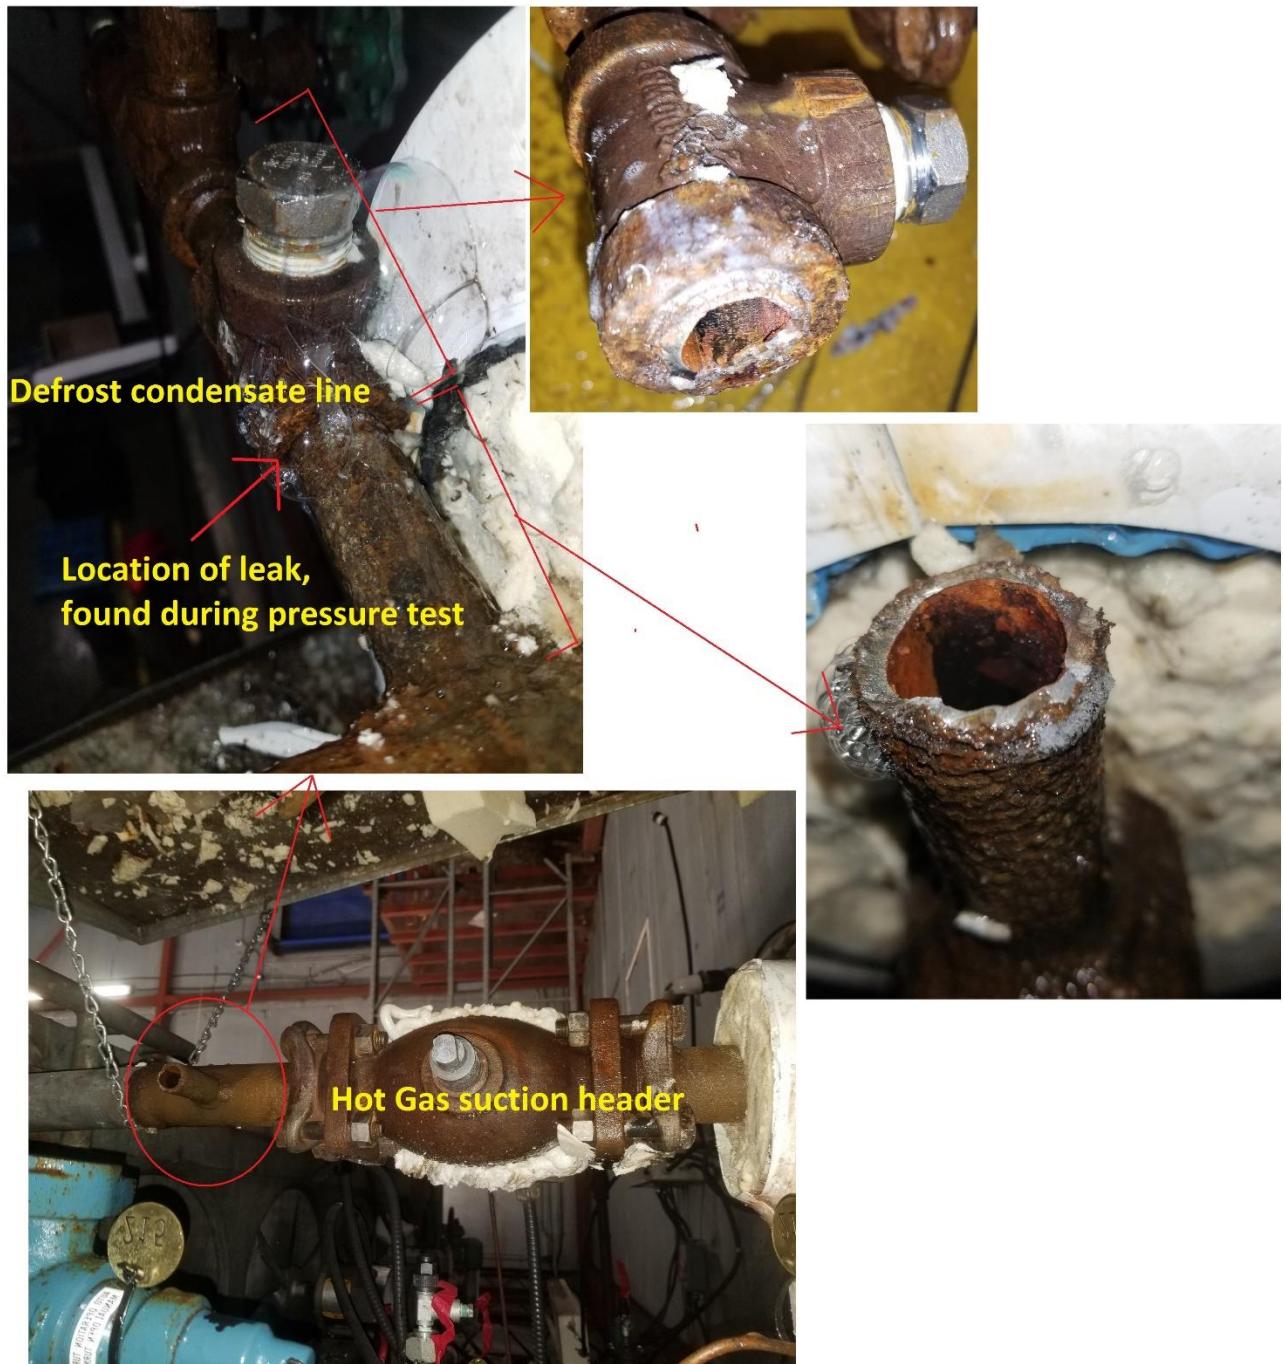
Fig. 3: Location of Leak (Image provided by repairing contractor)
