Incident Summary #II-1347693-2022 (#26712) (FINAL)

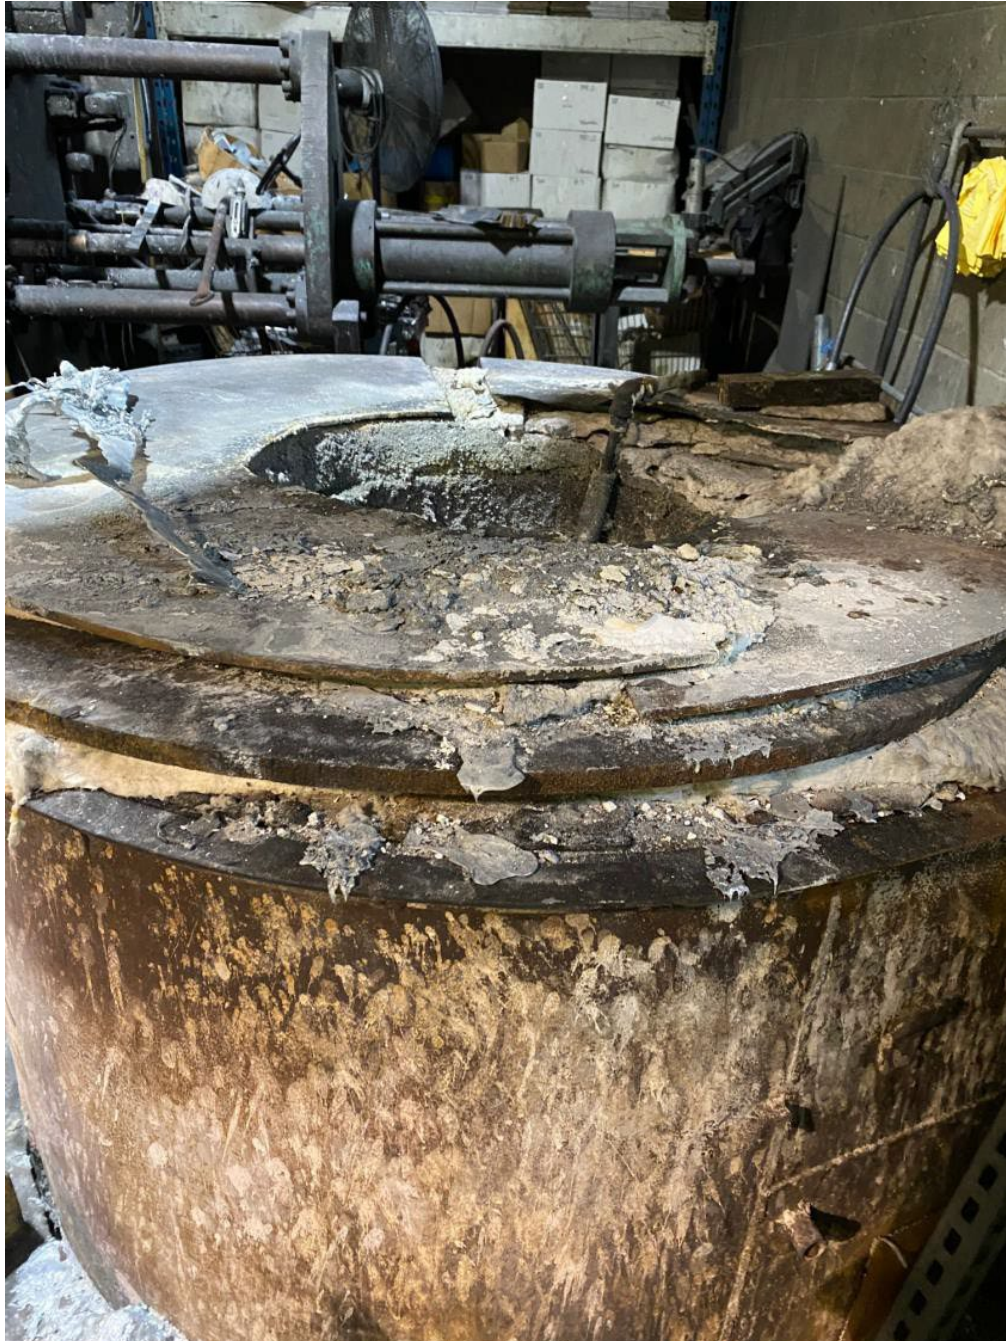
SUPPORTING INFORMATION	Incident Date	March 20, 2022	
	Location	Burnaby	
	Regulated industry sector	Gas - Natural gas system	
	Impact	Qty injuries	0
		Injury description	None
		Injury rating	None
	Damage	Damage description	Under-fired aluminum melting crucible, damaged. Burner and controls destroyed. Fire extinguishing foam damage to adjoining melting crucible and equipment. Minor structural damage and major smoke damage.
		Damage rating	Moderate
Incident rating	Moderate		
Incident overview	A crucible used for melting aluminum was suspected of overheating, causing the aluminum in the crucible to ignite creating smoke, heat, and small fire damage. The facility's alarm system detected the fire, and the fire department was notified. The fire department attended and used an extinguishing foam product to put out the fire.		
INVESTIGATION CONCLUSIONS	Site, system and components	The facility has two crucibles to melt aluminum to produce aluminum anodes. Each crucible is heated by a natural gas burner which heats the lower section of the crucible. Each burner is controlled by a temperature controller which uses a temperature sensing probe to sense the melted aluminum's temperature and increase or reduce the Btu input of the burner. The temperature controller's temperature sensing probe sits in the molten aluminum. The burner is left to operate continuously to ensure that the aluminum in the crucible remains in a liquid state.

Failure scenario(s)	The burner heating the crucible is controlled by a supervisory temperature controller and temperature probe. It is believed that the temperature controller failed to control the burner temperature which overheated the aluminum causing it to ignite.	
	Facts and evidence	The crucibles, burners, controls, and exhaust system had been in use for several decades and had not been updated. The facility was unoccupied when the fire occurred. The building security alarm detected the fire, and the fire department was notified. The fire department responded and used a fire extinguishing foam product to quench the aluminum and put out the fire. The burner and controls were damaged by the heat from the fire as well as from the extinguishing foam. A site made plywood cover to protect the burner from aluminum splash was burned and there was major smoke damage to the wood ceiling and wall. The old, overhead exhaust ducting was damaged from the heat and from being hit with the extinguishing foam. A FortisBC technician attended the site and shut off the gas supply at the meter location.

It is probable that the continual cycling of the temperature controller and the reliance on the single temperature probe contributed to the overheating of the aluminum and resultant fire.
