Incident Summary #II-1628835-2023 (#40977) (FINAL)

SUPPORTING INFORMATION	Incident Date	October 16, 2023	
	Location	Prince George	
	Regulated industry sector	Electrical - Low voltage electrical system (30V to 750V)	
	Impact	Qty injuries	0
		Injury description	None
		Injury rating	None
	Damage	Damage description	Fire damage to flooring, wall board, floor mounted custodial sink, lighting fixture and ceiling.
		Damage rating	Moderate
	Incident rating	Moderate	
Incident overview	<p>A fire was started in the custodial room of a portable school building when a thermoplastic lampholder, or “tombstone,” in a ceiling-mounted fluorescent lighting fixture overheated and caught fire. The lampholder material melted as it burned and dripped through holes in the fixture’s metal cover onto the plastic lens cover. This plastic lens cover then also caught fire and dripped burning plastic onto the floor, causing the floor to catch on fire as well.</p> <p>A school staff member noticed smoke coming from the portable, entered the adjacent school, and pulled the fire alarm. The fire department attended and extinguished the fire.</p>

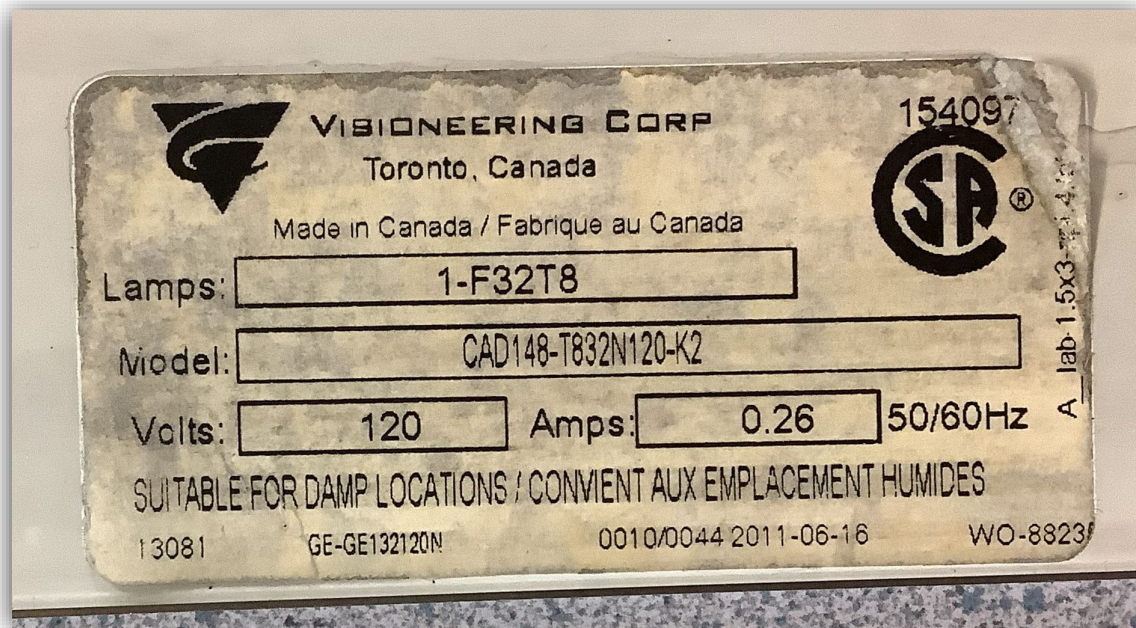
Image 1 - Label on the lighting fixture.

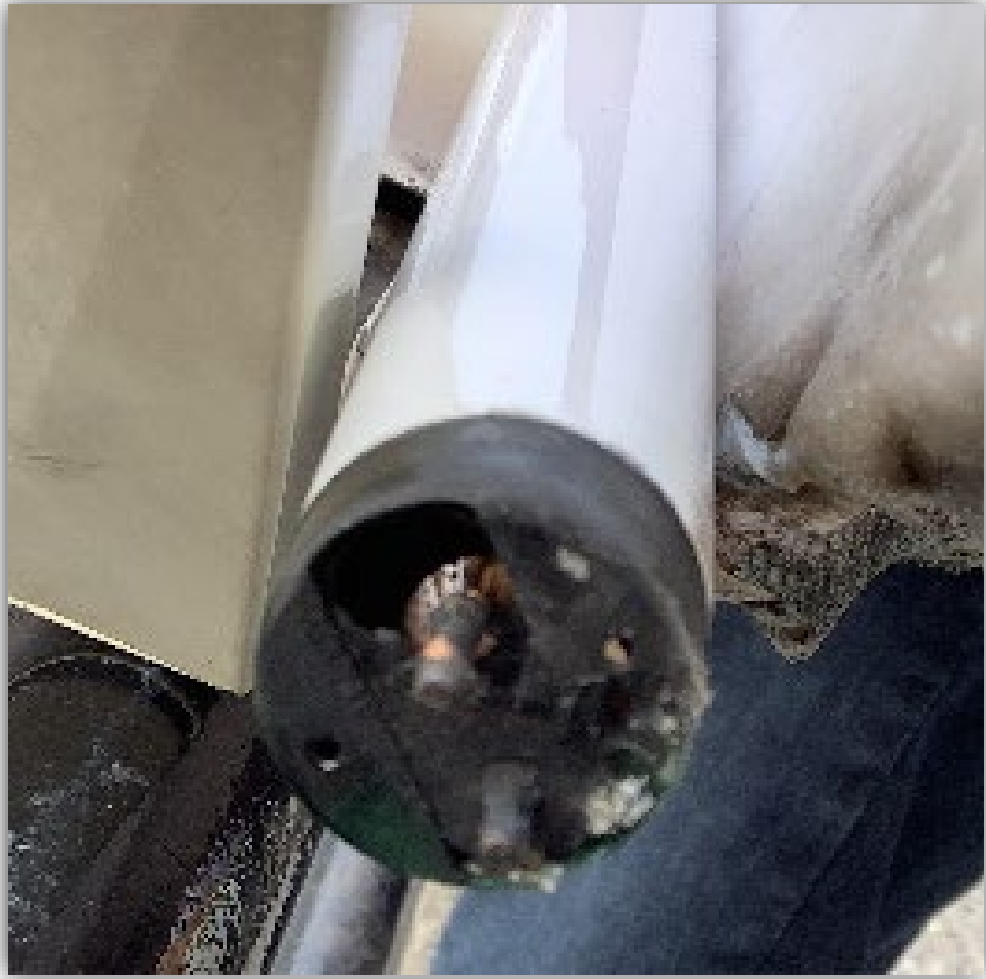
<p>Facts and evidence</p>	<ul style="list-style-type: none"> • The lighting fixture was burned at one end where the tube makes electrical contact with the socket of the lampholder. • The fixture was on site at the time of investigation. • The melted lampholder, charred metal cover, and burnt and melted lens cover were all damaged by the fire. <p>School district custodians are allowed to change fluorescent lighting tubes at the schools where they work.</p> <p>The electrical supervisor stated that he was not aware of any training for the custodians on how to change the fluorescent tubes of lighting fixtures.</p>
<p>Causes and contributing factors</p>	<p>This lighting fixture may have failed due to improper installation of the fluorescent lighting tube within the lampholder sockets.</p>

Image 2 - Burnt end of the fluorescent tube.

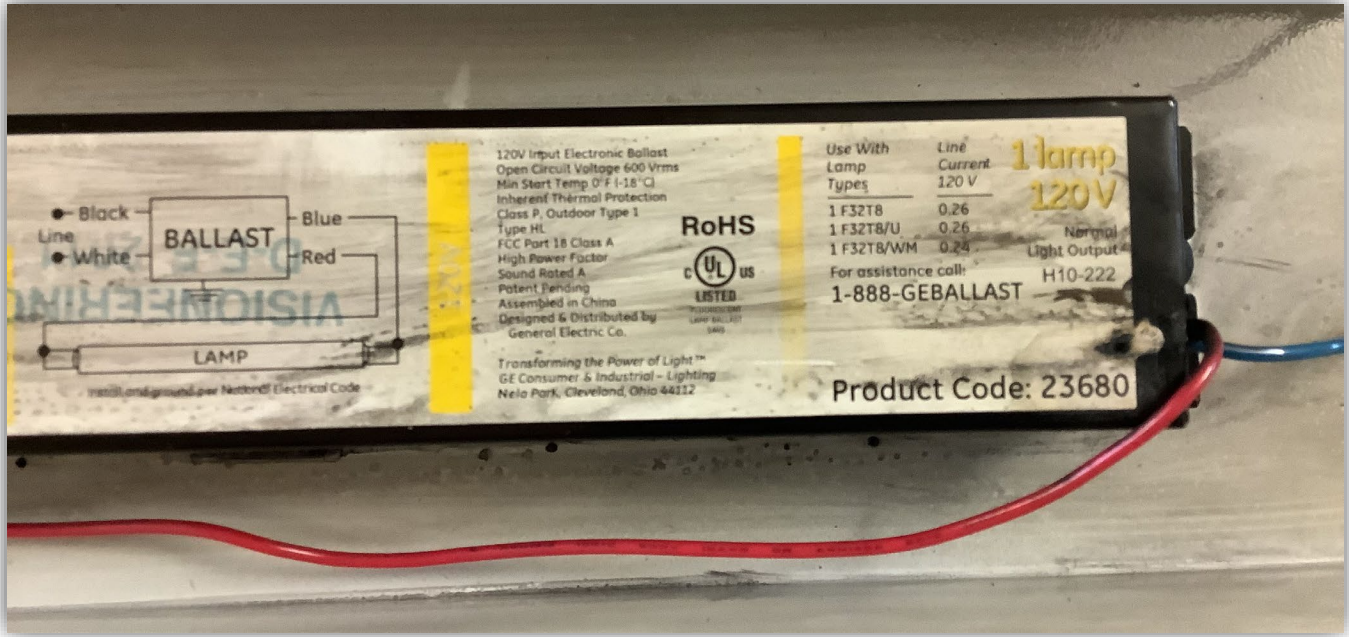
Image 3 - Electronic ballast inside the fixture.

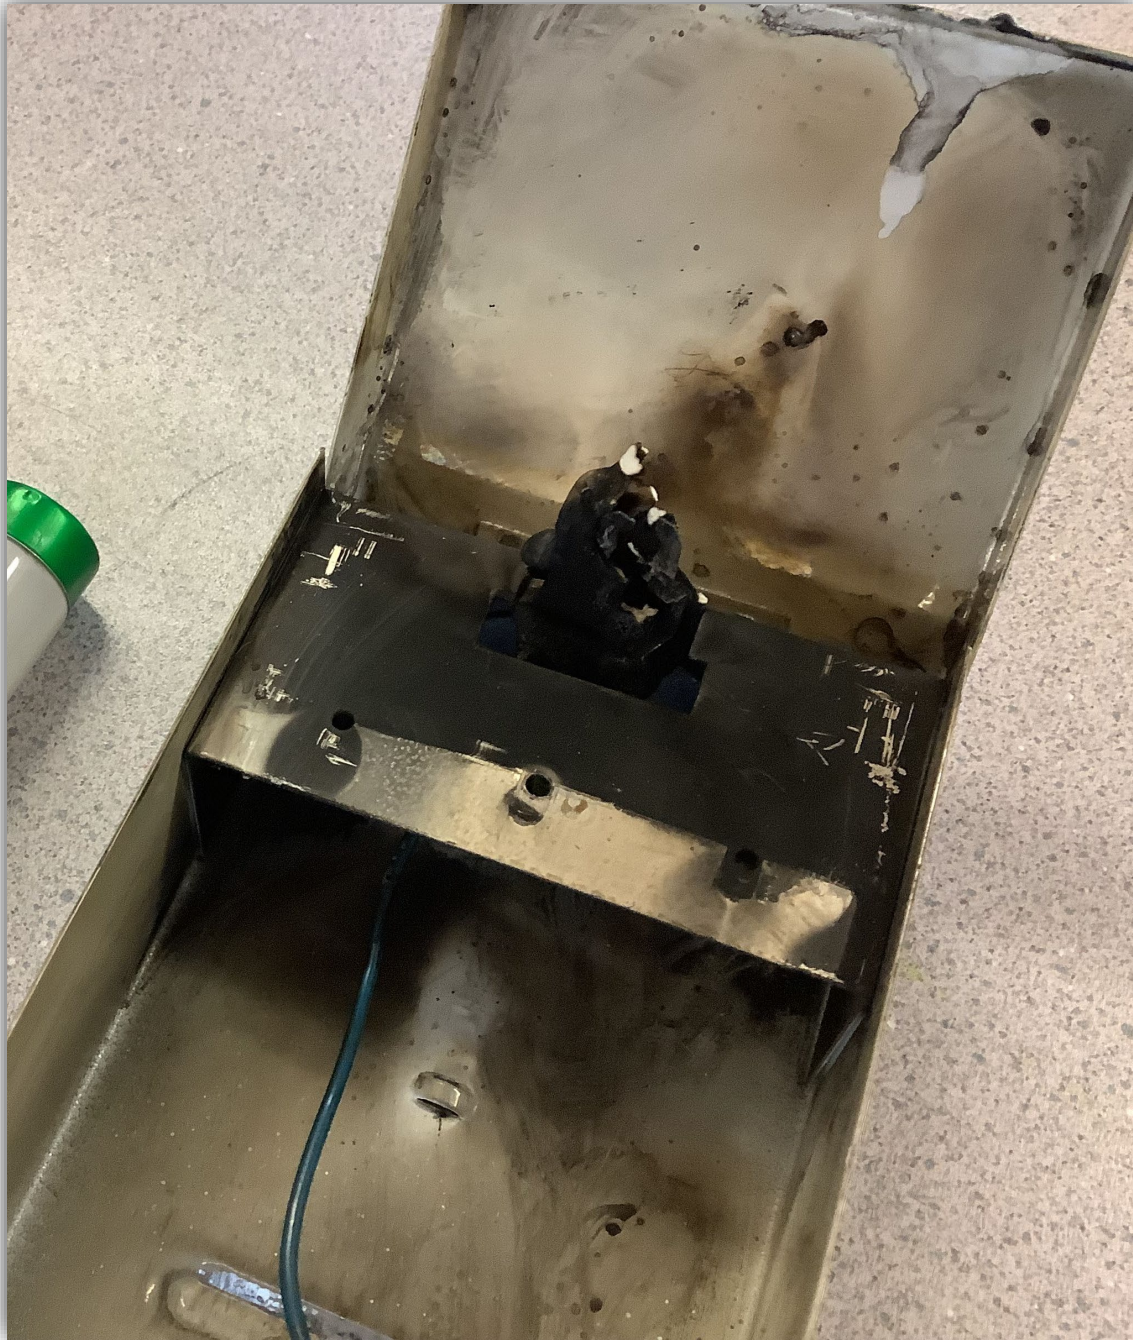
Image 4 - Burnt tombstone socket.

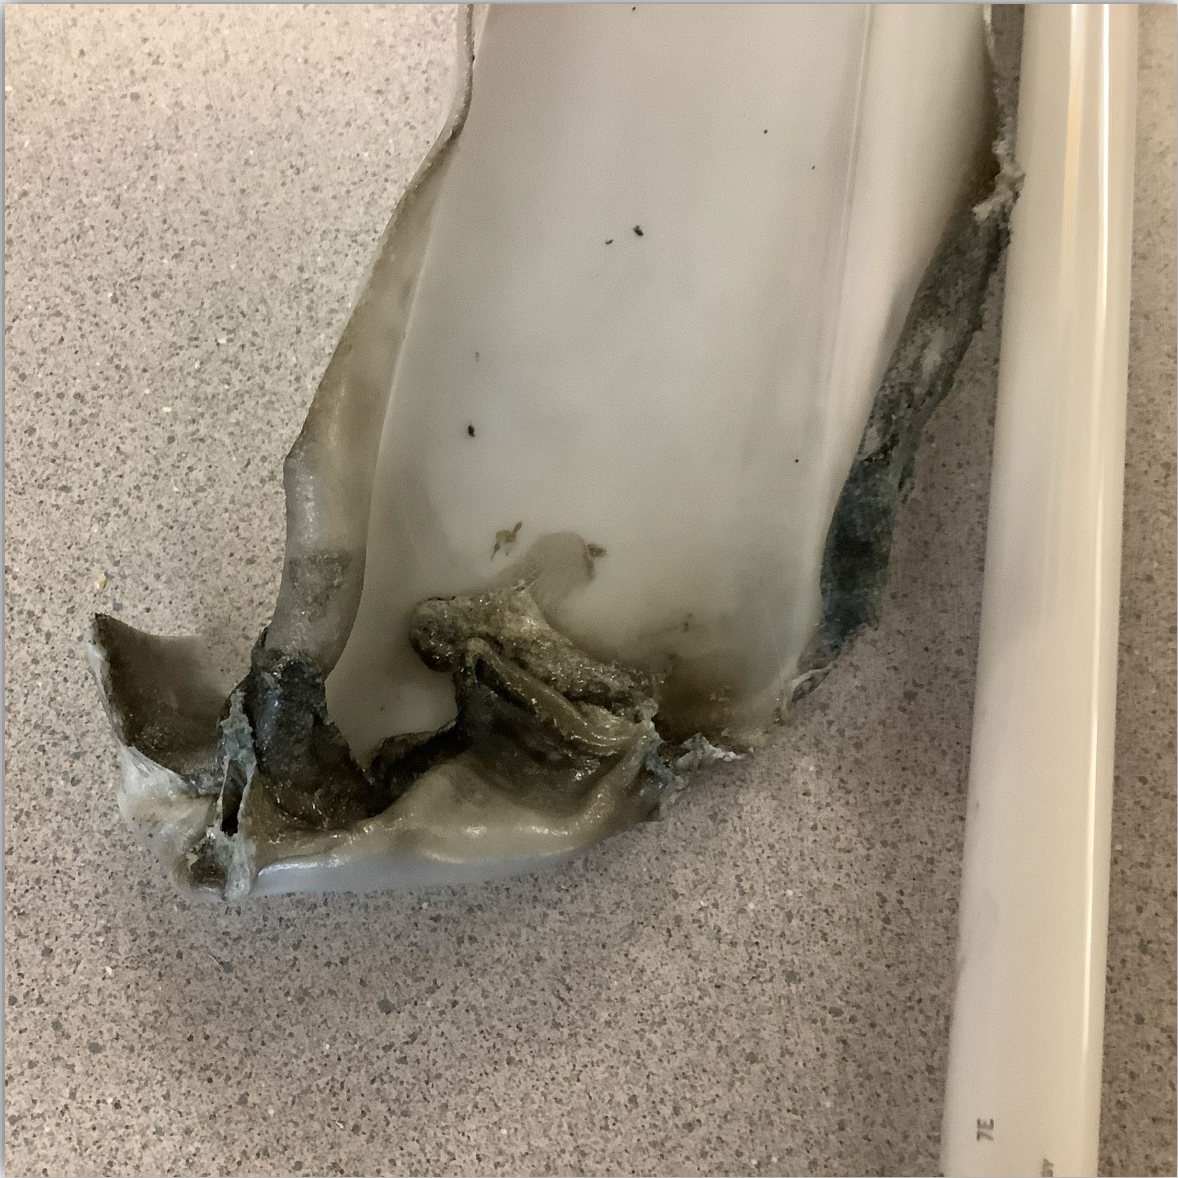
Image 5 - Burnt and melted lens cover.
