## Incident Summary (Reference #5604145) Final

SUPPORTING INFORMATION	Incident Date		<i>August 27, 2016</i>	
	Location		<i>Boston Bar</i>	
	Regulated industry sector		<i>Passenger Ropeway, Above Surface Ropeway</i>	
	Impact	Injury	Qty injuries	<i>2</i>
			Injury description	<i>Person 1 sustained an injury to their little finger. Person 2 sustain an injury to their elbow.</i>
			Injury rating	<i>Minor</i>
	Damage	Damage	Damage description	<i>Surface damage to the bottom exterior of the one of the cabins, hinged platform at the docking area was bent by impact with the cabin. An end of carrier travel the spring buffer became over-compressed and jammed in the compressed position.</i>
			Damage rating	<i>Minor</i>
	Incident rating		<i>Minor</i>	
	Incident overview		<p>Carriers entered the upper and lower stations without reducing speed, the carriage sheave assembly of the carrier made contact with the end of travel spring buffer with a significant amount of force. The resulting excessively abrupt stop caused the cabin of the carrier to swing forward and becoming lodged with a hinged flip down platform that is attached to the loading dock. 2 occupants in the cabin sustained minor injuri

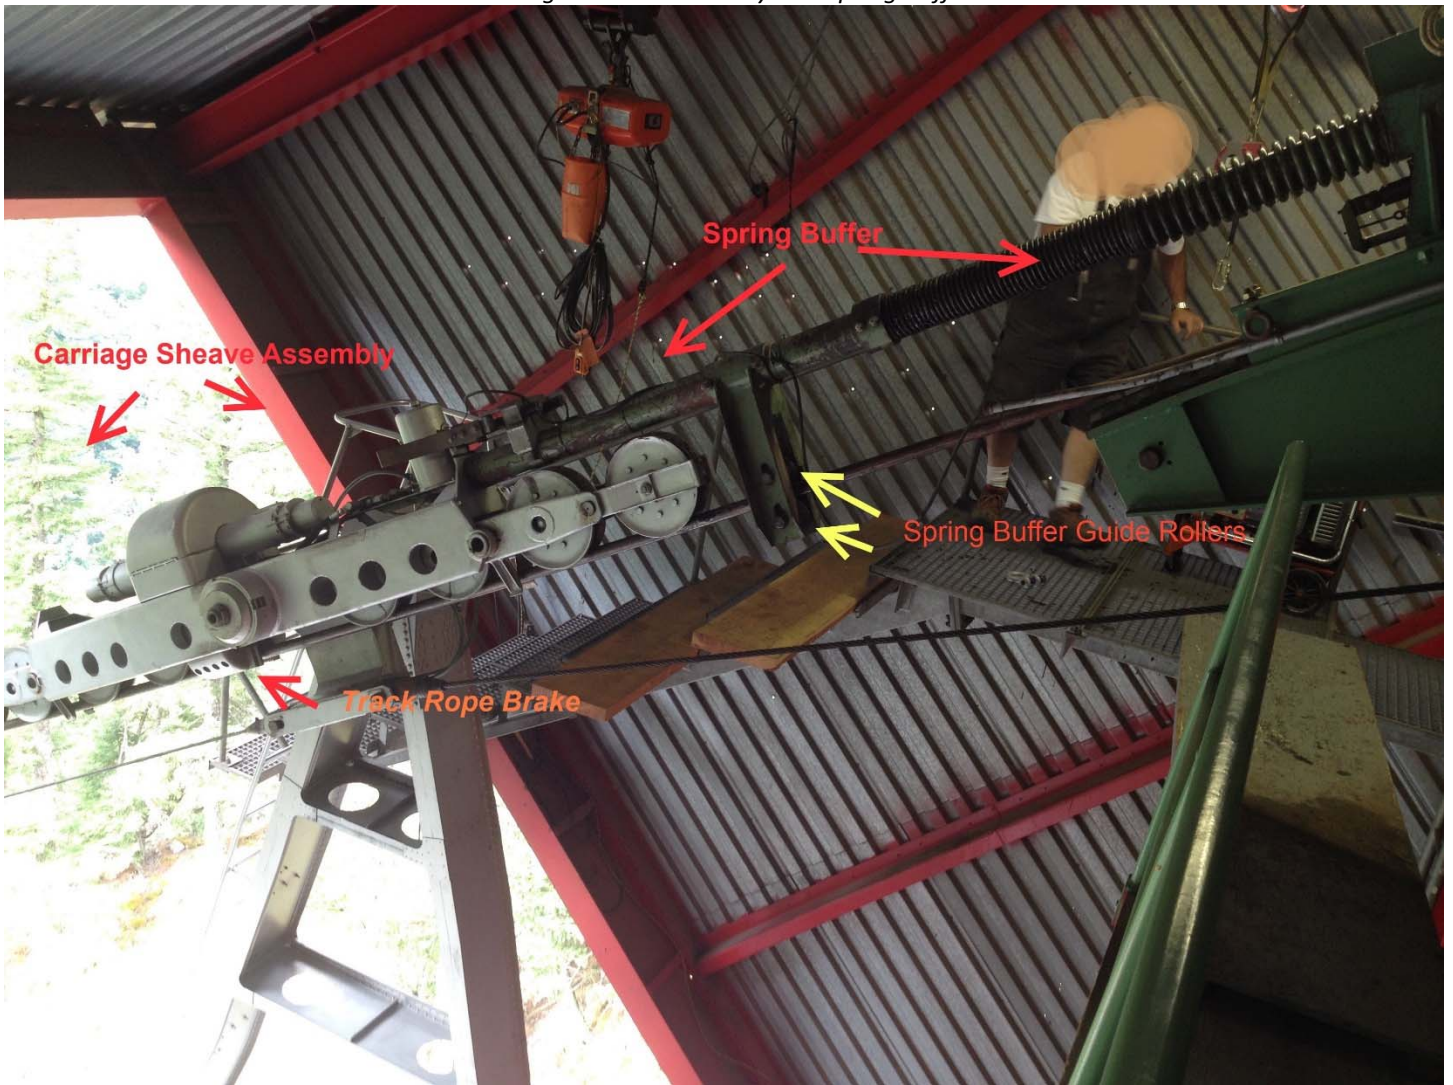
Carriage Sheave Assembly and Spring Buffer

- *A very likely cause of the carriage sheave assembly lifting up and out of configuration with the track rope was the excessive speed and the subsequent hard impact with the spring buffer. A contributing factor is that the excessive clearance of the spring buffer guide rollers could have caused the spring buffer to lift upward with the impact of the carriage sheave assembly. This in turn causing the uphill end of the carriage sheave assembly to lift upward and off of the track rope.*

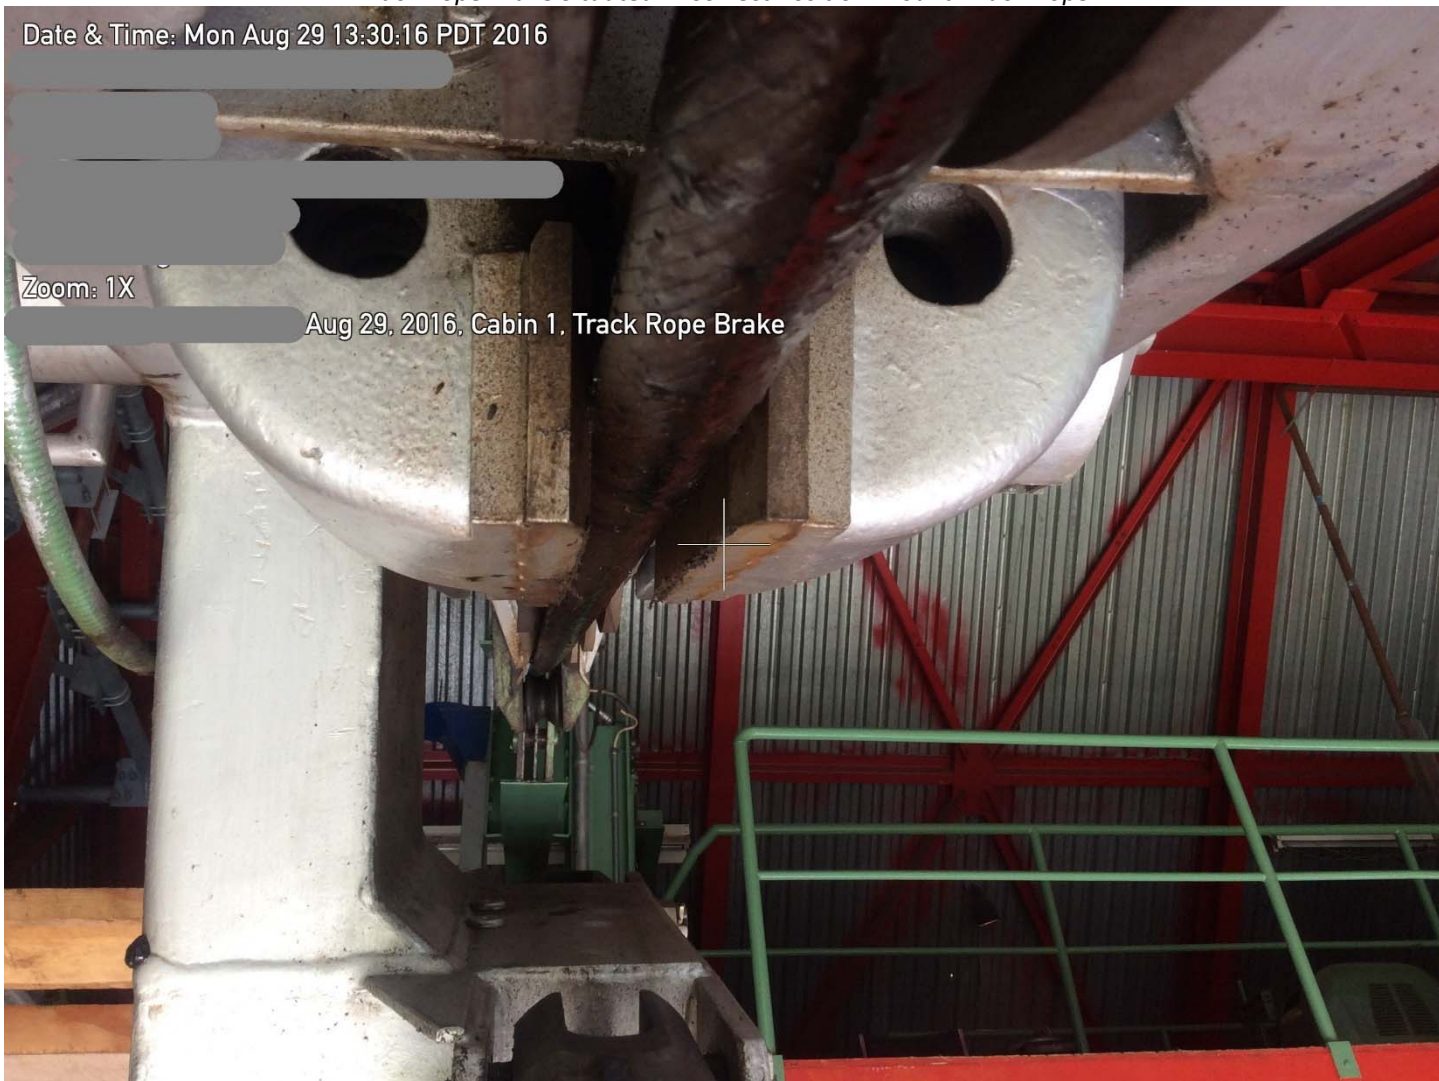
Aug 29, 2016, Cabin 1, Track Rope Brake

- *The track rope brake position switch being out of adjustment or failure of the circuit to detect that the track rope brake was closed was a very likely cause in it being possible to operate the ropeway with the track rope brake closed.*

*Track Rope Brake Situated in Correct Position Around Track Rope*
