Incident Summary (Reference #5617901) (Final)

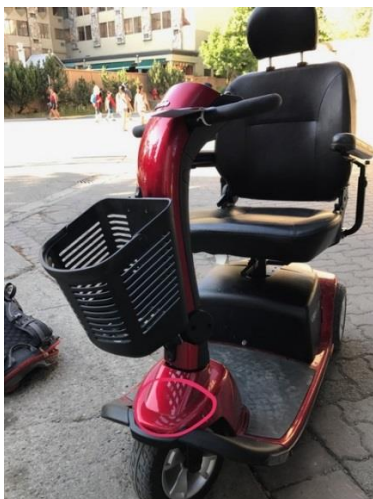
Motorized Mobility Scooter

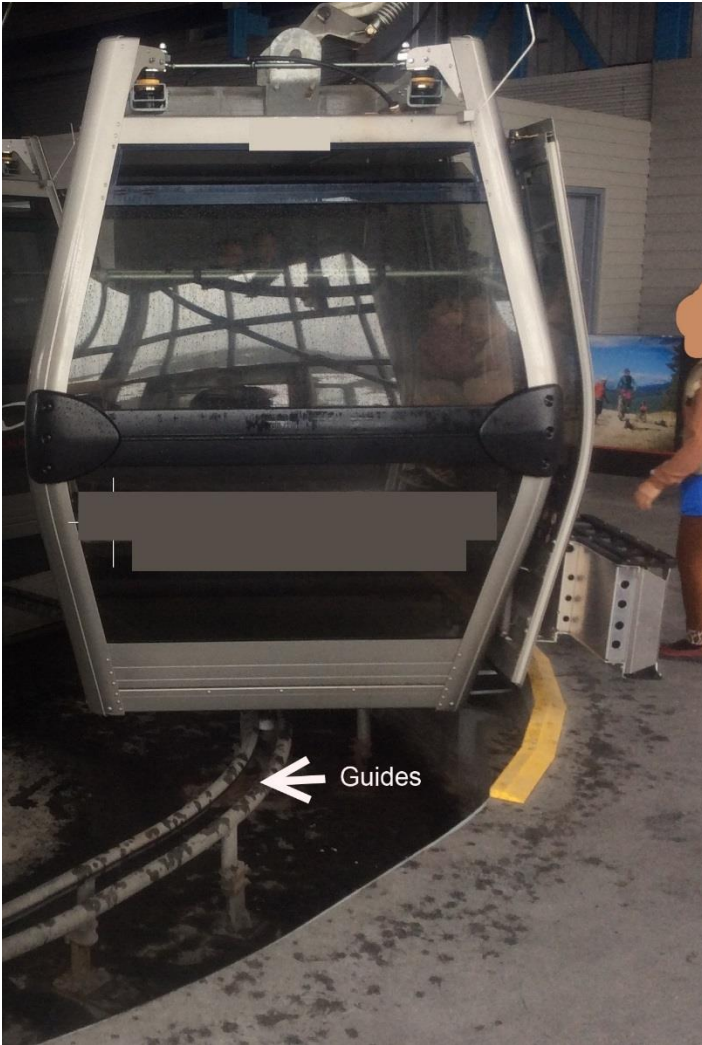
Example of a Cabin in the Station

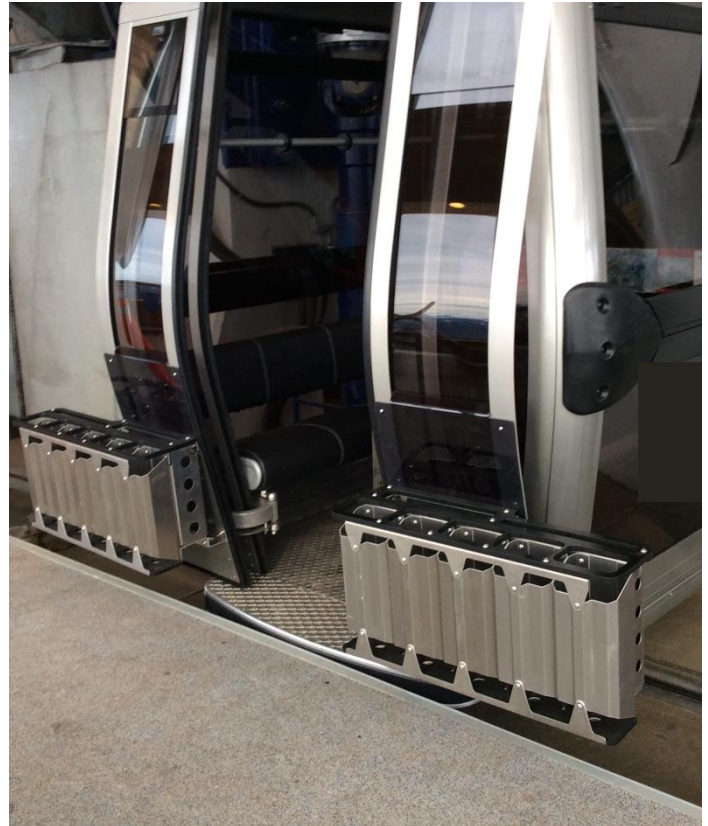
Example of Cabin Entrance
