Incident Summary #II-1420747-2022 (#29291) (FINAL)

SUPPORTING INFORMATION	Incident Date	August 13, 2022		
	Location	Vancouver		
	Regulated industry sector	Elevating devices - Lifts for the physically disabled		
	Impact	Qty injuries	1	
		Injury	Injury description	The passenger sustained a sprained ankle as per incident report
			Injury rating	Minor
	Damage	Damage description	The lift sustained significant amount of damage.	
		Damage rating	Major	
Incident rating	Major			
Incident overview	As the lift and passenger descended in the lift, the lift stopped approximately 6" from the floor level (second landing). A loud banging noise was heard, and then the lift dropped approximately 6' to the pit floor.			
INVESTIGATION CONCLUSIONS	Site, system and components	Chained hydraulic lifts use a combination of a hydraulic jack and chains to lift and lower the platform. The hydraulic jack resides in the hoistway between the rails. Two pulleys are attached to the top of the jack. Two chains tie together the system. One end is attached to the platform. The other end is tied to a fixed point at the base of the rails. The controller and hydraulic pump reside in a machine room next to the hoistway.

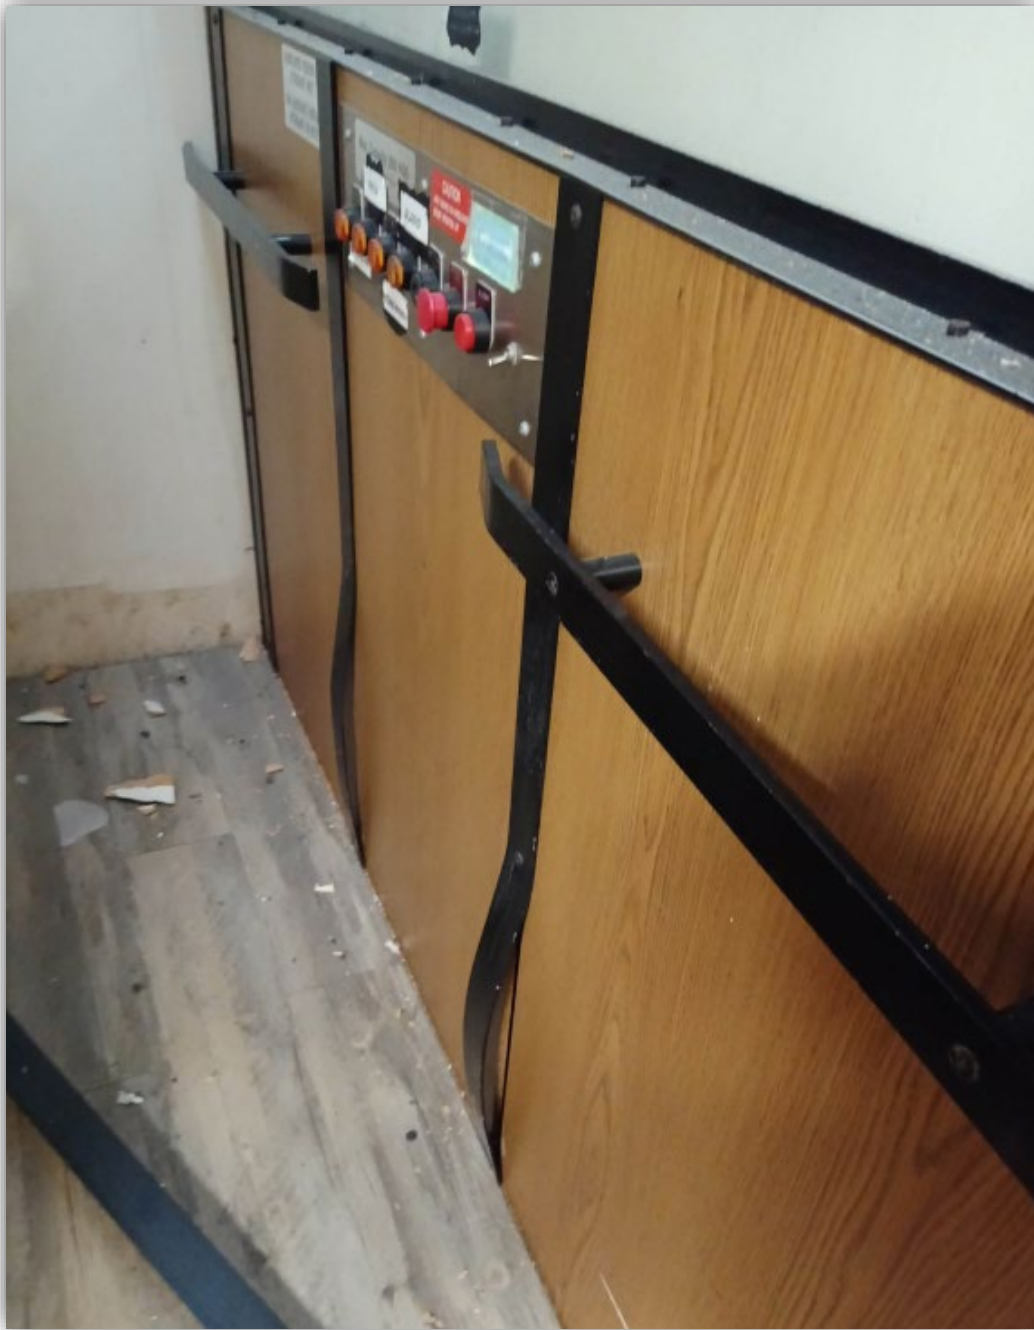
Photo 1 – Lift showing damage from drop into pit.

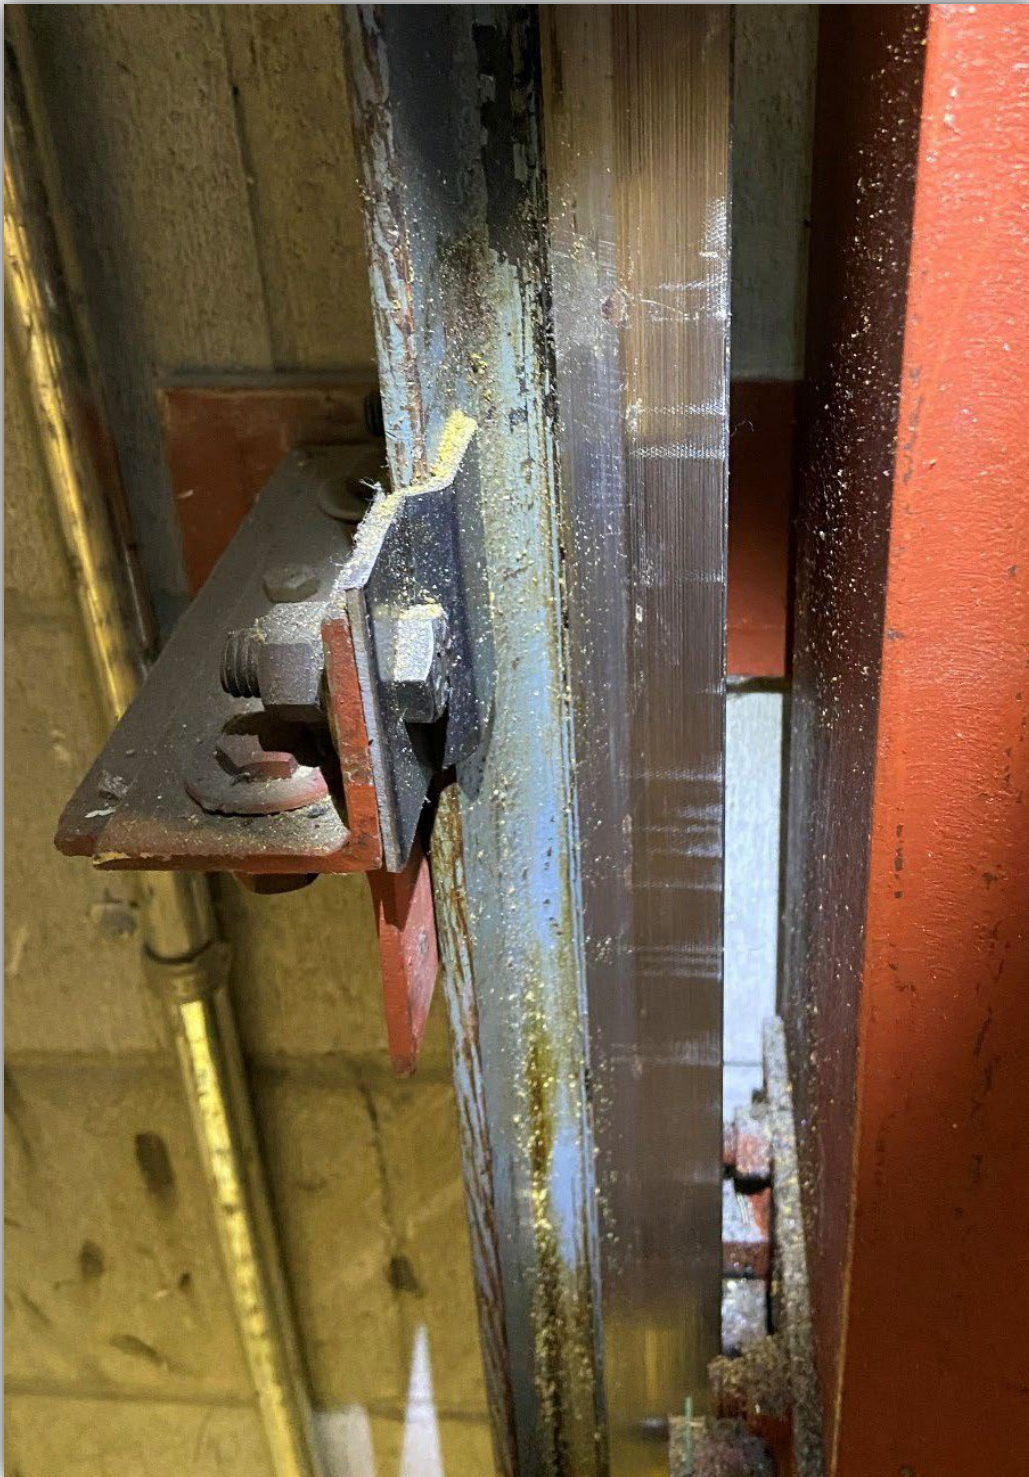
<p>Facts and evidence</p>	<p>The unit was registered in 1980s.</p> <p>Upon inspecting the guiderail, it was noticed that there are sections of the guiderail that showed the slack chain safeties intermittently engaged during normal operation that did not cause the platform to stop (Photo 2 & Photo 3).</p> <p>Upon examining the safety rollers, it was noticed that one of the rollers was covered in paint (Photo 5). Both rollers appeared to have severely worn knurling.</p> <p>The elevating maintenance contractor stated that regular maintenance had been performed.</p> <p>Hydraulic down valve was not closed (the normal function of the slack chain safety switch would trip the valve to close), and hydraulic piston had fully retracted into the cylinder. Worn packing gland at the piston head was observed.</p>
<p>Causes and contributing factors</p>	<p>Debris in the hydraulic system may have caused particles to inhibit the down valve to close thus allowing the hydraulic piston to fully retract into the cylinder. Due to the additional weight of the passenger weight/movement, one of the safety rollers failed to hold the platform in position, resulting in the platform plunging down to the pit floor. One of the safety rollers had dislodged from its installed position and the other roller due to paint on it, was unable to support the platform in the stopped position when the safety rollers engaged.</p>

Photo 2 – Multiple contacts on guide rails by safety roller(s)

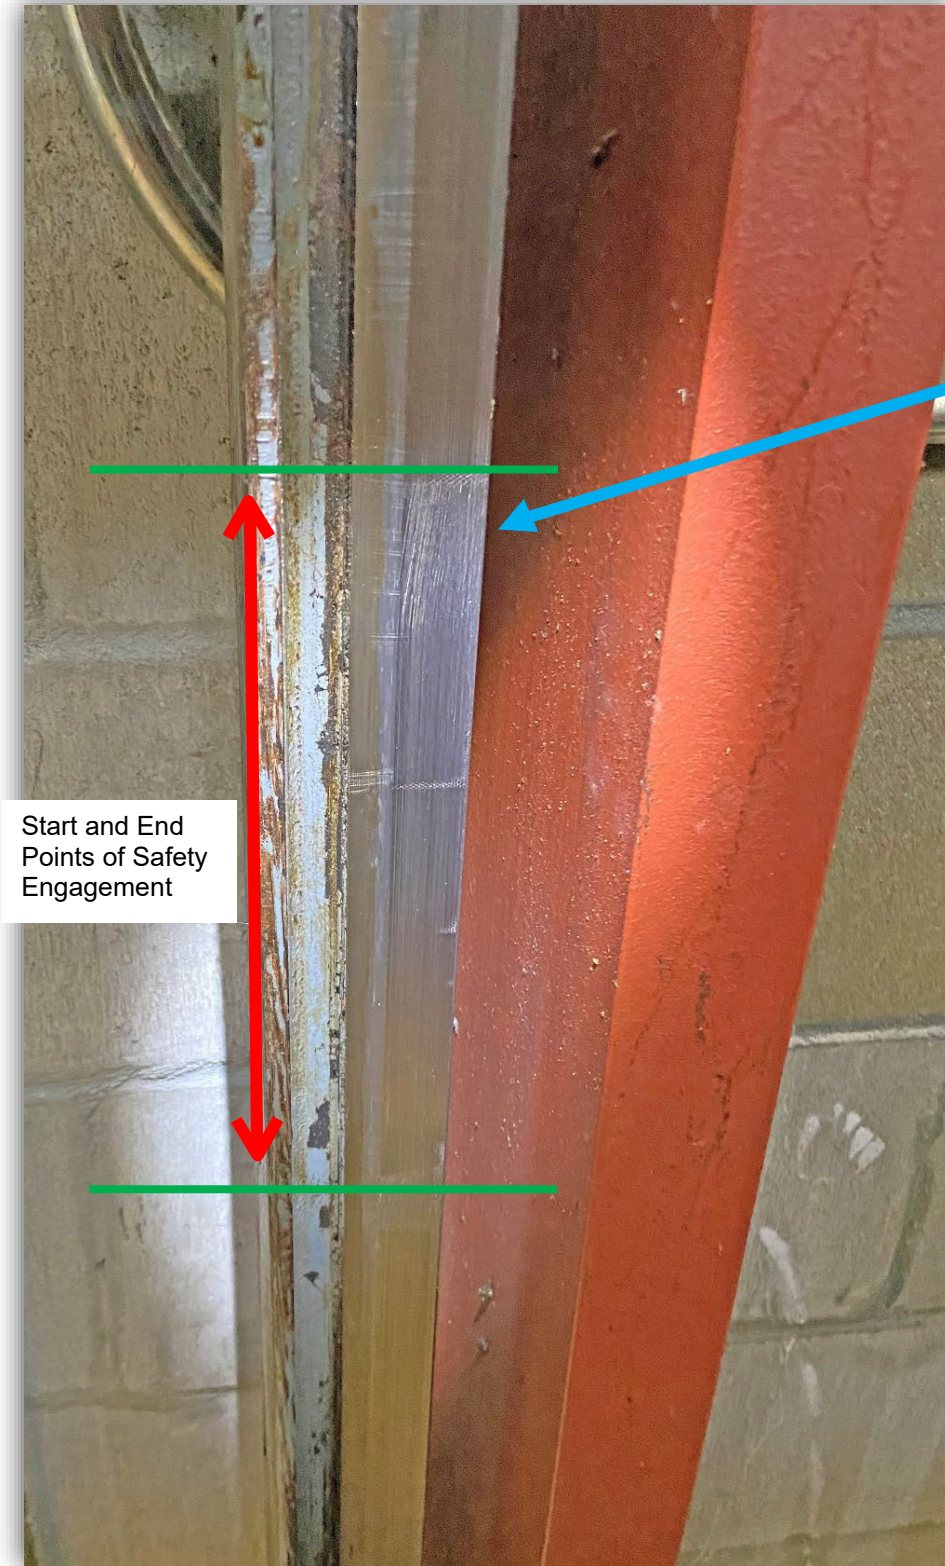
Location of Safety Engagement

Start and End Points of Safety Engagement

Photo 3 - Safety slide

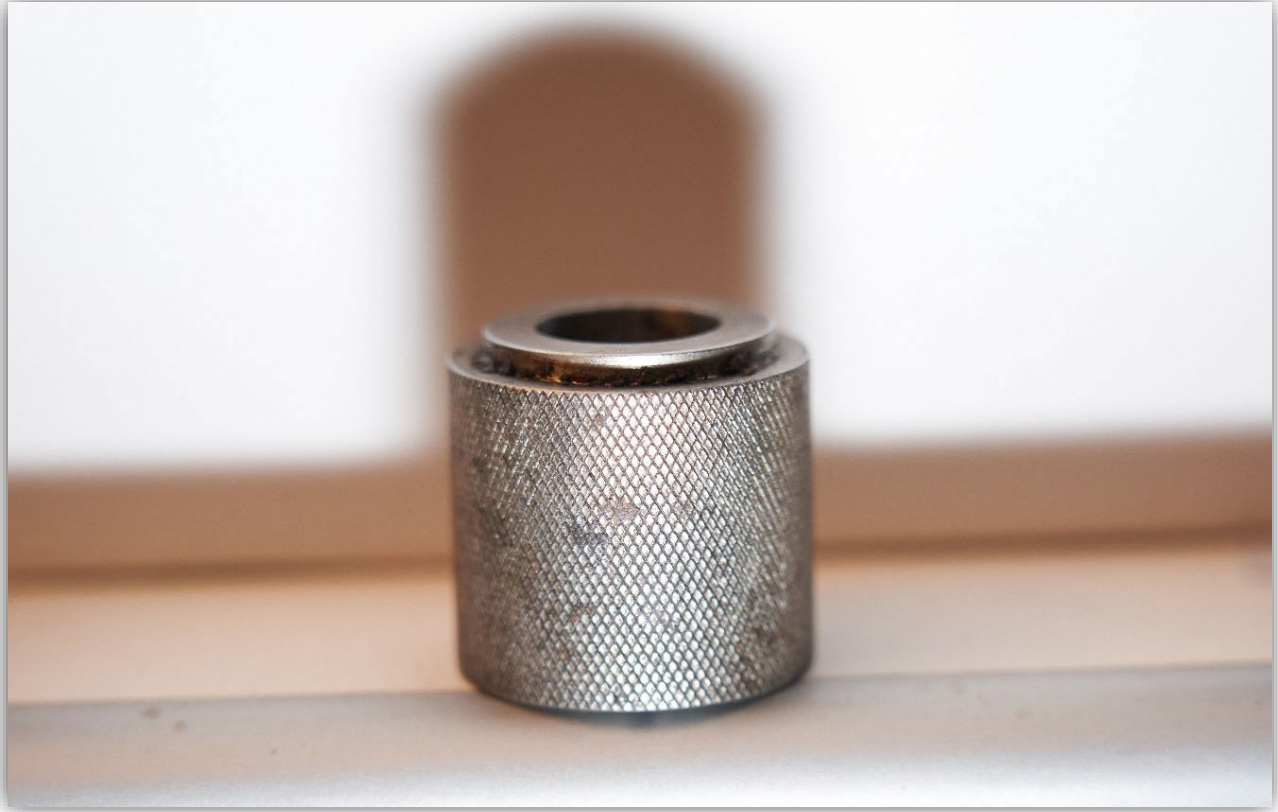
Failure scenario(s)	<p>One of the safety rollers on the lift was covered in paint and both rollers had severely worn knurling. Due to the intermittent contact with the guide rail, the knurling had worn down. As the unit traveled to the second landing, it is highly probable that one of the rollers was dragging on the guide rail. When the unit was near the second landing, the unit stopped. This would be an indication that one or both safety rollers engaged causing the unit to stop. At this time the slack chain safety switch would have tripped, causing the controls to close the down valve.</p> <p>As the platform traveled down to the second landing it was noticed by the passenger that the platform was travelling slower than normal. When the platform came just short of the second landing, the platform safety device engaged, resulting in the platform stopping. The hydraulic piston continued to retract, causing the suspension chain to become slack. The slack chain safety rollers failed which caused the platform to fall to the pit.</p>

Photo 4 – Safety roller

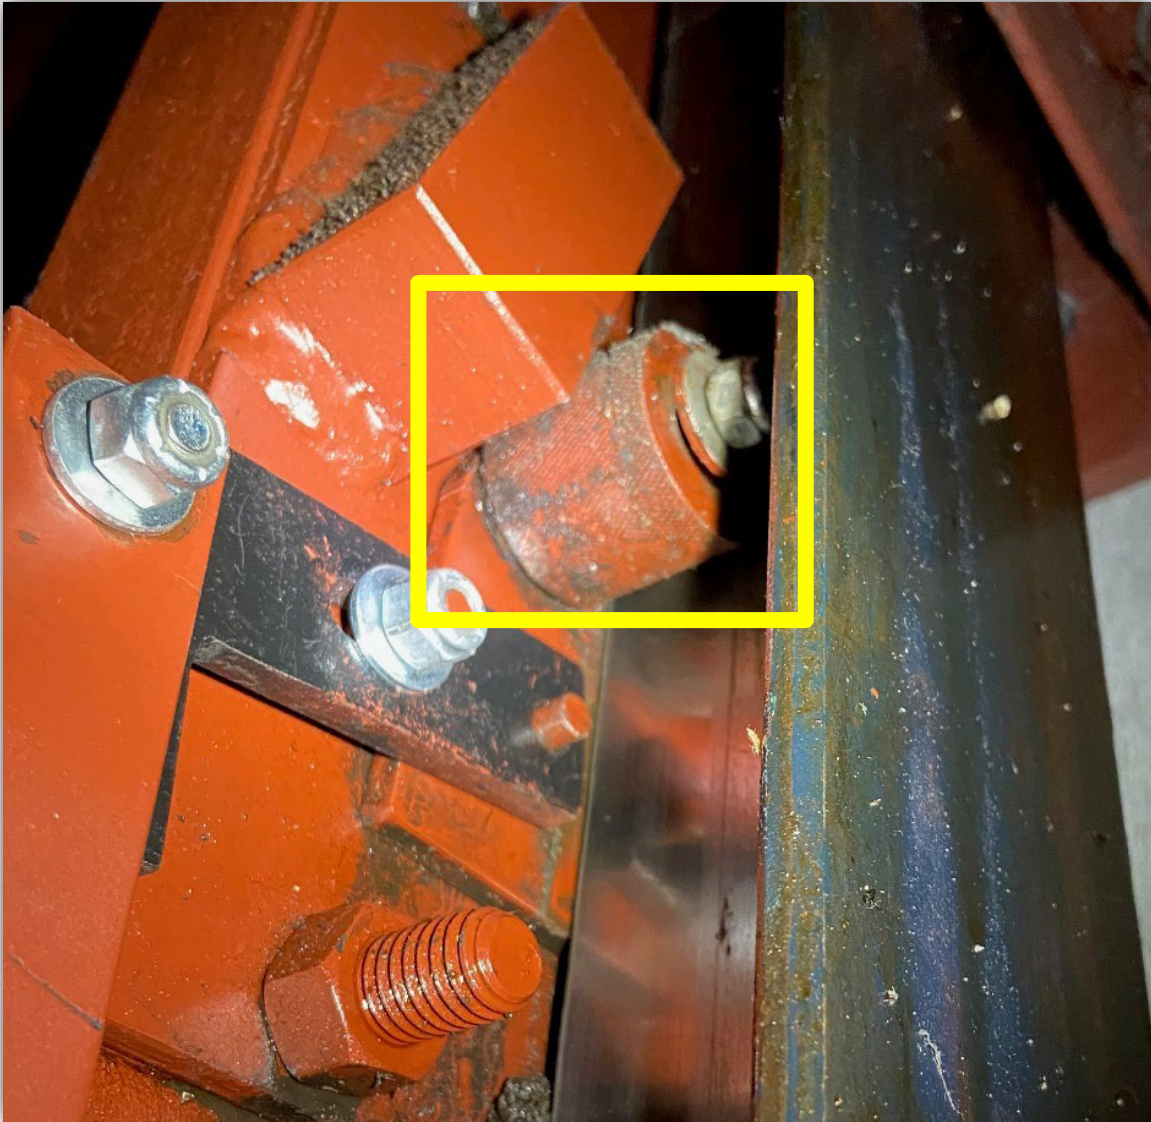
Photo 5 – Safety roller with paint
