Incident Summary #II-1405542-2022 (#28732) (FINAL)

SUPPORTING INFORMATION	Incident Date	July 11, 2022	
	Location	Burnaby	
	Regulated industry sector	Boilers, PV & refrigeration - Boiler and pressure vessel system	
	Impact	Qty injuries	0
		Injury description	N/A
		Injury rating	None
	Damage	Damage description	Damage was limited to the gasket seals, with no damage to the heat exchanger.
		Damage rating	Insignificant
Incident rating	Insignificant		
Incident overview	A gasket seal leak occurred in the Splitter Unit on the exchanger at the channel head gaskets during a maintenance cleaning process. The unit was shut down and was being prepared for maintenance. In this transient condition, steam was used as one medium for pre-maintenance cleaning steps at the time of the failure. The tube side was isolated from service but still had gas oil slop material.		
INVESTIGATION CONCLUSIONS	Site, system and components	<p>Refinery, Splitter Unit (Splitter unit could be any conventional device for the separation), Crude Feed Heat Exchanger (in refineries heat exchangers are used for the crude oil distillation and subsequent refining stages) splitter bottoms (tube side/hot side) to crude feed (she

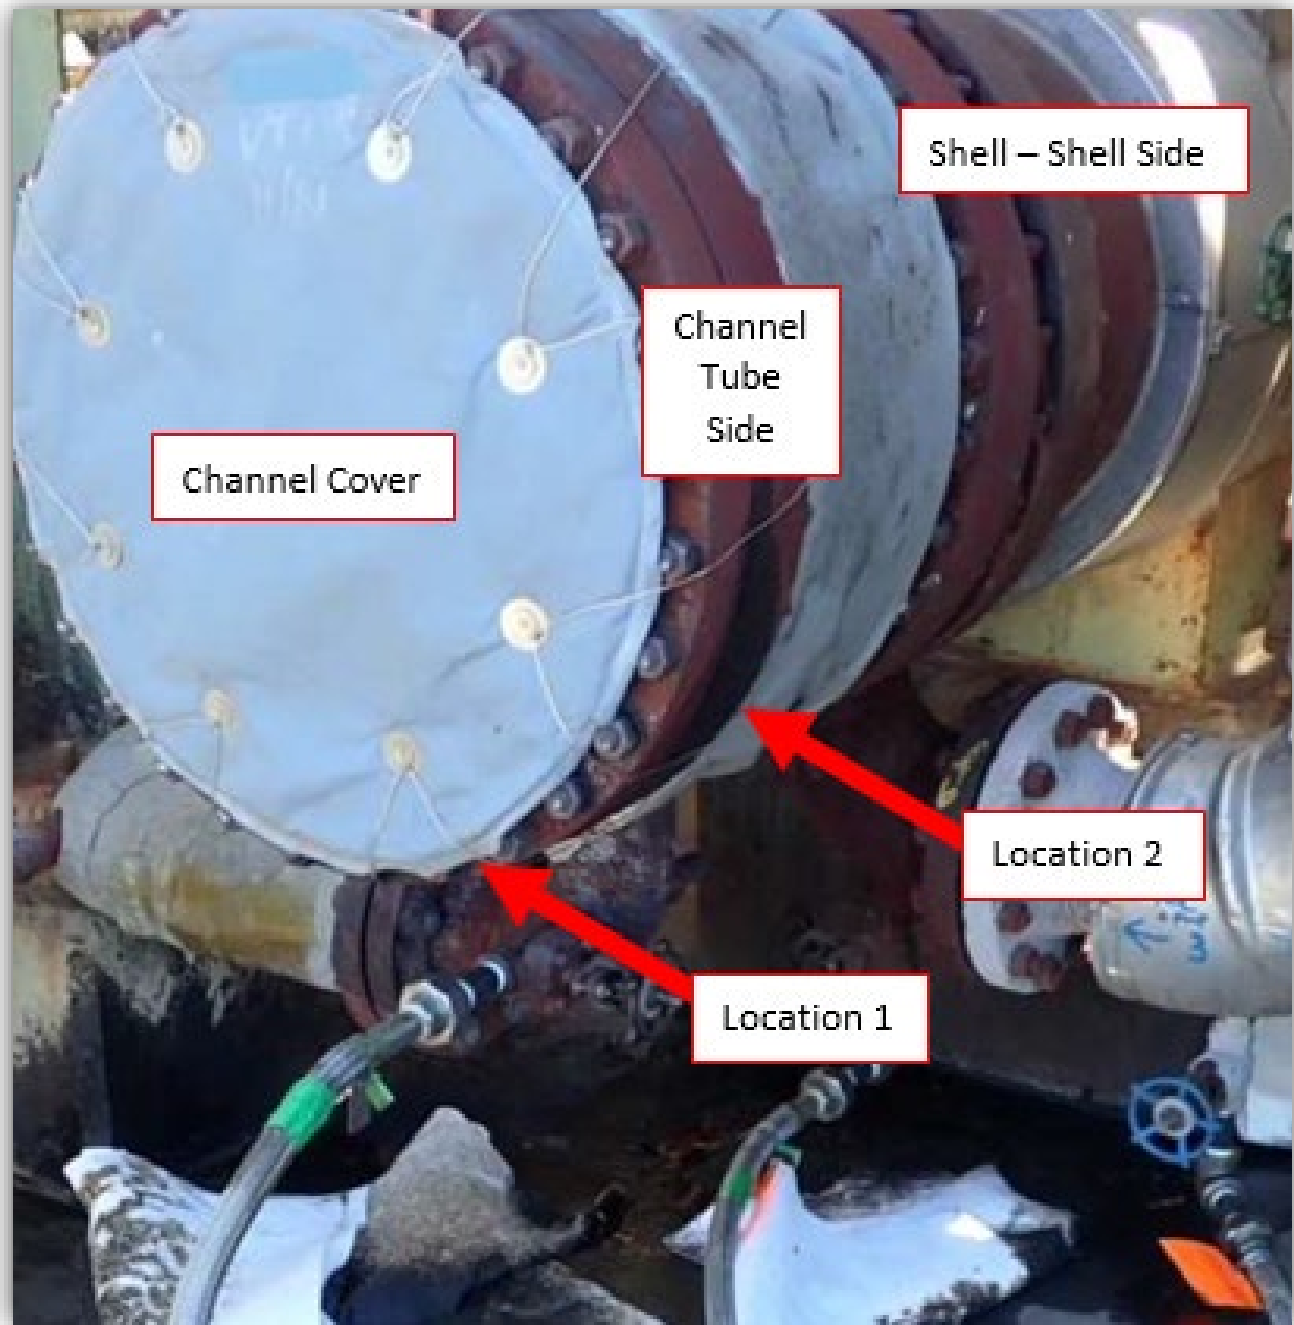
Failure scenario(s)	<p>An overpressure scenario due to thermal/hydraulic expansion from the steam on the shell side of the E-5304 exchanger. The failure happened during a scheduled operational shutdown when blocking in the Splitter bottoms circuit around heat exchanger from the pump to facilitate Column cleaning.</p> <p>Heat exchangers are used to transfer heat from one medium to another. The mediums in normal service are both hydrocarbons. During this transient condition, the heat exchanger worked in reverse, with the steam thermally heating the blocked-in gas oil material. Hydraulic pressure was created as the gas oil liquid thermally expanded resulting in an abnormal overpressure scenario at the gasket sealing connection. Once the pressure was relieved, there was no further leaking.</p>

<p>Causes and contributing factors</p>	<p>Plant manager and investigation team have found that there was no documented protocol for draining blocked in the equipment (specifically one side of an exchanger) when applying a source of energy to the other side, certainly during abnormal operations (steam / chemical cleaning in this case).</p>

Image 1 – Flange leak locations 1 and location 2.
