Incident Summary #II-828248-2019 (#11504) (FINAL)

SUPPORTING INFORMATION	Incident Date	March 20, 2019	
	Location	Prince George, BC	
	Regulated industry sector	Electrical - Low voltage electrical system (30V to 750V)	
	Impact	Qty injuries	1
		Injury description	An electrician sustained burns and strained back muscles.
		Injury rating	Minor
	Damage	Damage description	No Damage
		Damage rating	None
Incident rating	Minor		
Incident overview	An electrician was shocked by an energized non-metallic sheathed cable (NMD90) that was partially damaged. The cable was part of the emergency lighting system that was being removed and relocated due to a renovation.		
INVESTIGATION CONCLUSIONS	Site, system and components	<p>An emergency lighting system was undergoing some minor renovations when an electric shock incident occurred. The emergency lighting system consists of an emergency lighting pack and extra low voltage (12 volts DC) emergency lights located through the commercial building.</p> <p>The emergency lighting pack is supplied by a separate circuit breaker powered through a multi-tap transformer that allows this style of emergency pack to be connected to a variety of input voltages. At t

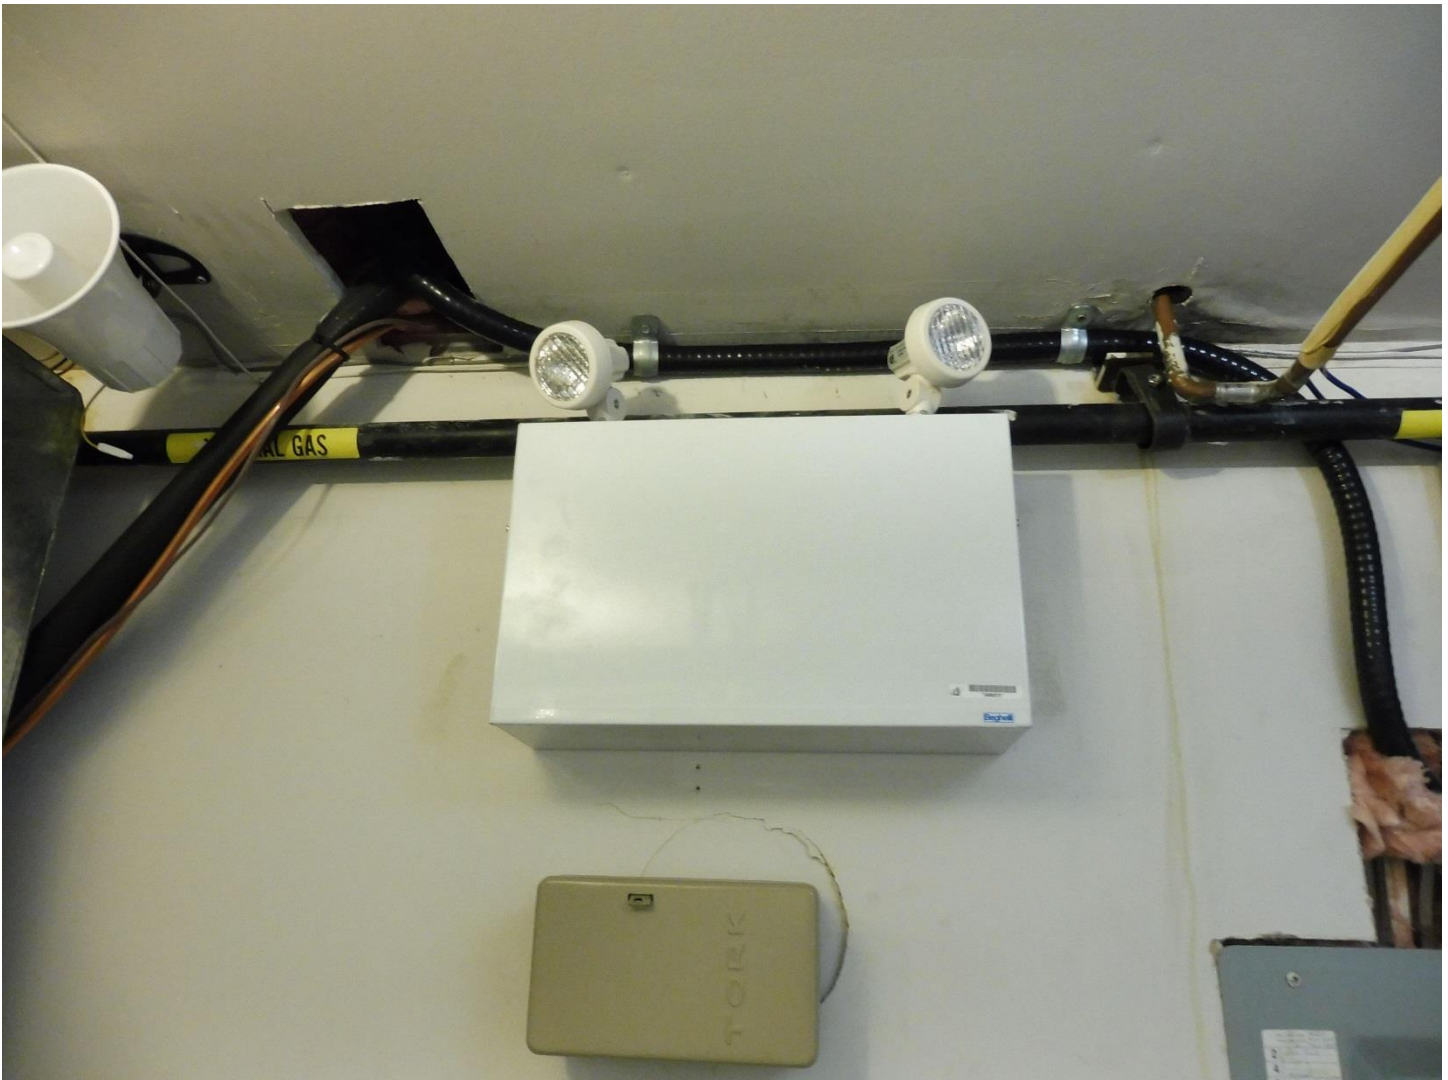
Photo 1: The emergency lighting pack is situated just to the right and above the electrical distribution panel that supplies it.

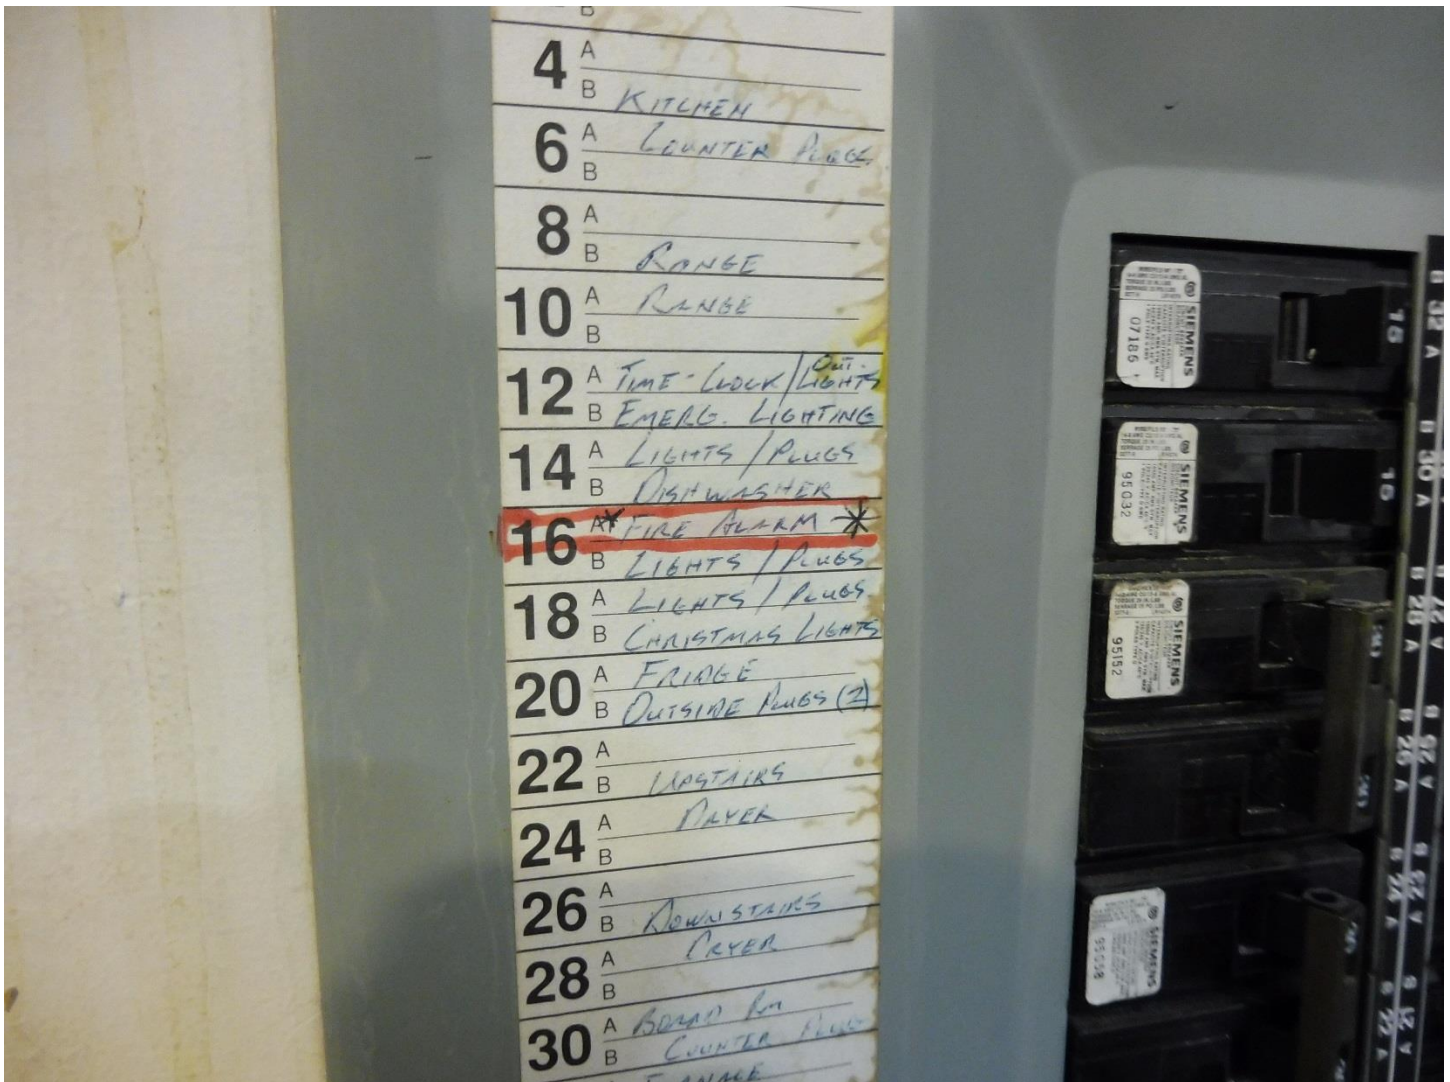
Photo 2: As noted on the panel directory circuit 12B supplies the emergency lighting pack.

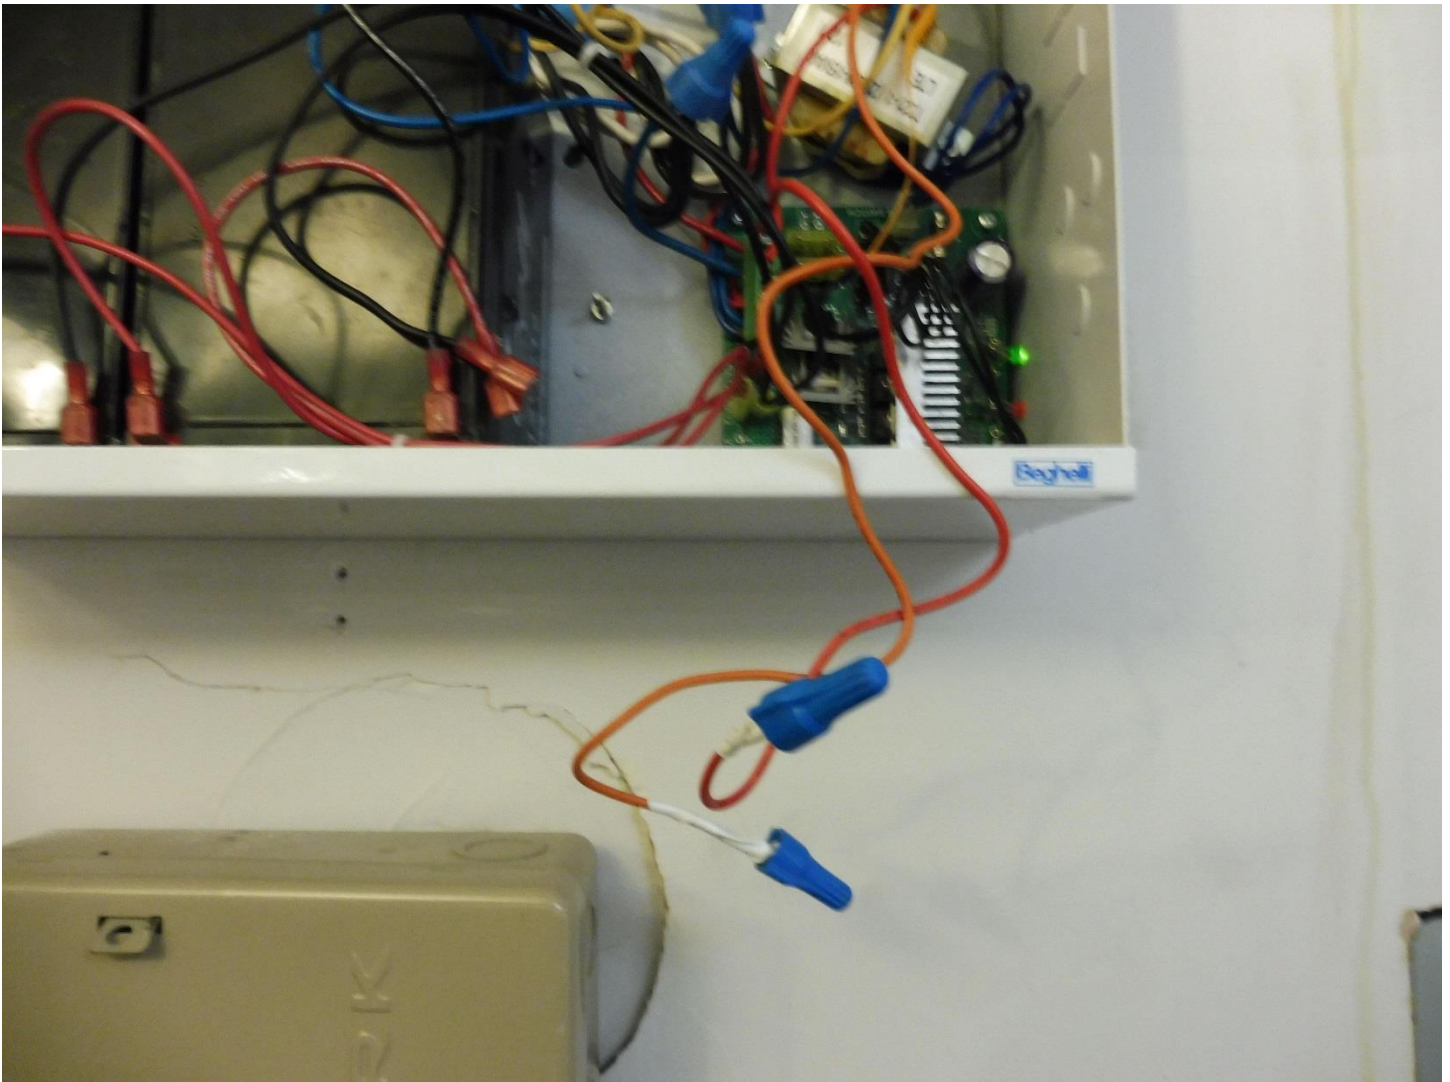
Failure scenario(s)	The primary winding taps of the emergency lighting pack input transformer were not properly capped off. The 347 volt tap wire was pushed into the area of the extra low voltage terminal board. Only the batteries were disconnected and not the incoming 120 volt circuit breaker supplying the emergency lighting pack. With the vibrations during construction the 347 volt uninsulated wire end made contact with the extra low voltage circuit board terminal energizing the emergency lighting wiring.	
	Facts and evidence	The emergency lighting pack was not properly locked out. Proper lock out procedures as per Rule 2-304 of the BC electrical code were not followed. Only the DC batteries were isolated while the AC input circuit was left energized. Due to the 347 volt tap on the input transformer primary winding not being properly isolated 347 volts was energized and exposed. At some point during the renovation it was possible that the 347 volt wire moved (e.g. due to vibration) and contacted the extra low voltage lighting terminal that had the wiring under renovation connected to it. During renovation the extra low voltage wiring had been damaged. The onsite electrician grabbed the wiring (NMD 90) to get it out of the way and to tape up the exposed end. While holding the damaged cable in one hand his other hand came in contact with the bare bond wire. This completed the circuit between the damage expose live conductor in one hand and the bond (ground) wire in the other.

The incorrect termination of a 347 volt conductor wire likely created an unsafe condition and potential for electric shock. By not following proper lock out procedures for an emergency lighting pack an exposed energized conductor was left unsecured inside the emergency lighting pack. This energized expose conductor then came into contact with the extra low voltage wiring running into the area of the building being renovated. This extra low voltage wiring was damaged during the renovation. The onsite electrician grabbed the wiring to secure it out of the way and tape up the end. This was when the electrician was shocked with 347 volts.

Photo 3: The 277 volt (orange) and 347 volt (red) transformer tap wiring have now been properly isolated with tape and wire nuts. During the renovation the electrician pulled the wiring from the batteries to prevent the 12 volt lighting power from energizing the emergency light wiring.

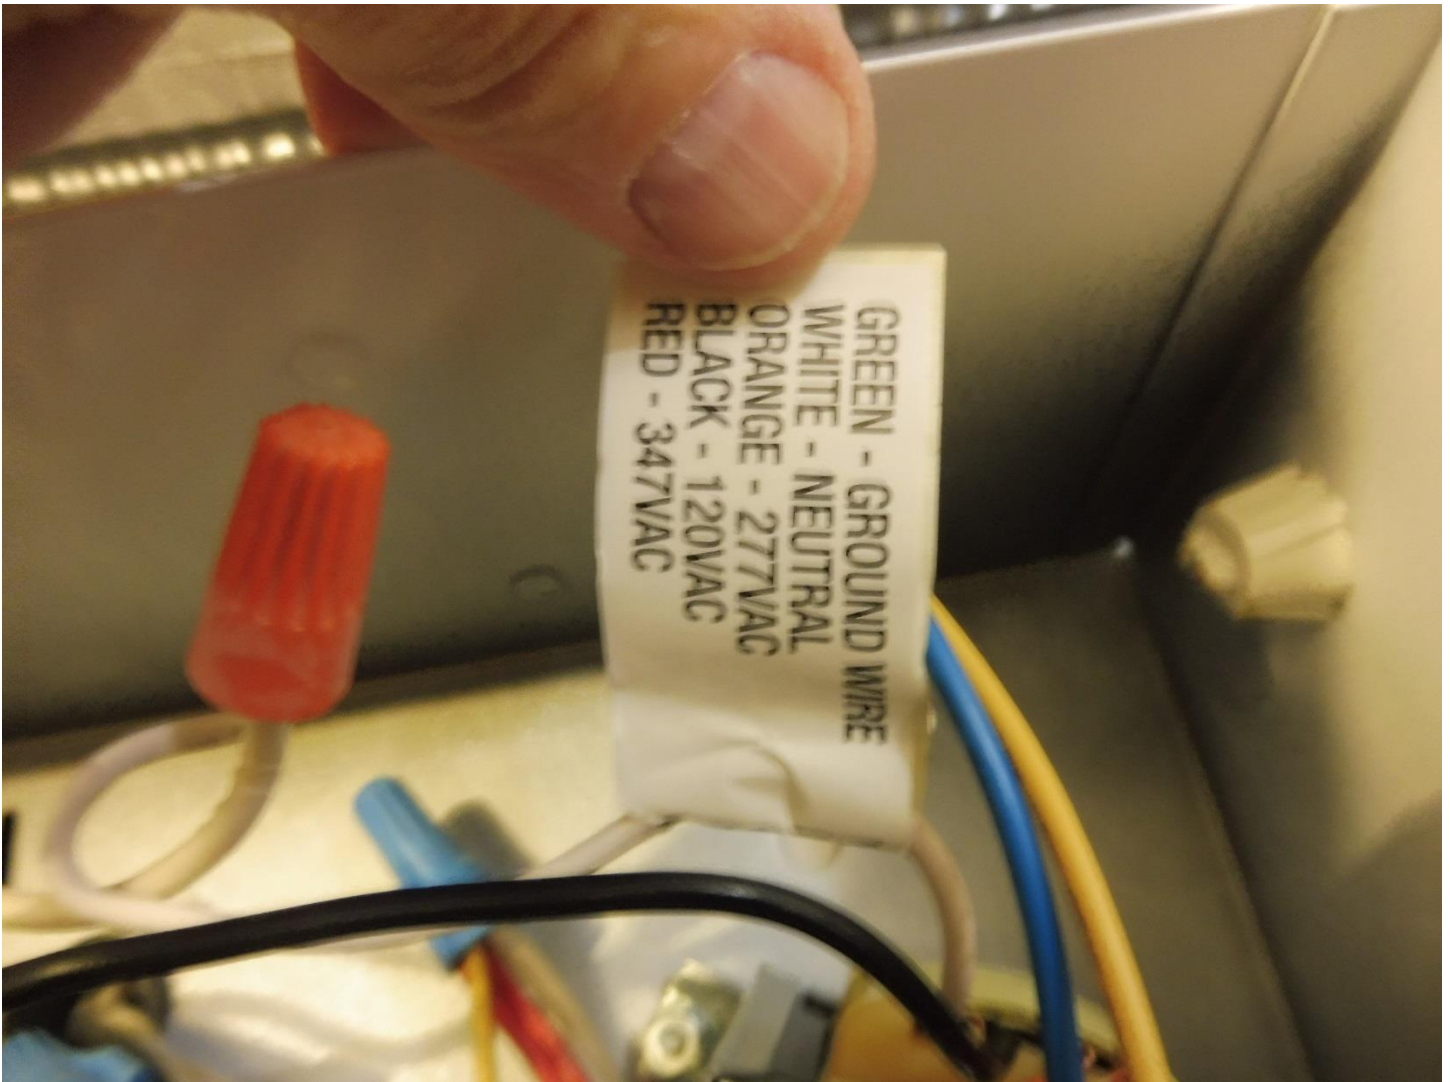
Photo 4: Tag on the input transformer showing the different input wiring.
