## Incident Summary #II-888381-2019 (#14685) (FINAL)

SUPPORTING INFORMATION	Incident Date	August 5, 2019	
	Location	Vancouver, BC	
	Regulated industry sector	Amusement Devices - Amusement ride	
	Impact	Qty injuries	0
		Injury description	None
		Injury rating	None
	Damage	Damage description	Damage to the wooden track, approximately 30 metres in length, and abrasions on the passengers right pilot car wheel.
		Damage rating	Moderate
	Incident rating	Moderate	
Incident overview	On August 5, 2019, while in motion, the pilot car of a wooden roller coaster came out of its pre-determined path of travel and derailed, skidding to a stop by abrasion against the wooden coaster track. The coaster was evacuated safely, with no injury.		
INVESTIGATION CONCLUSIONS	Site, system and components	<p>Wooden coaster travels along a wooden track, the wooden track is topped with a steel plate upon which the coaster cars ride with steel wheels. The coaster is conveyed to the top of the track using a driven chain, and from that point on is gravity powered.</p> <p>Wooden track consists of a lattice work of wooden beams and planks, interconnected using steel fasteners and concrete foundations. Elevated sectio

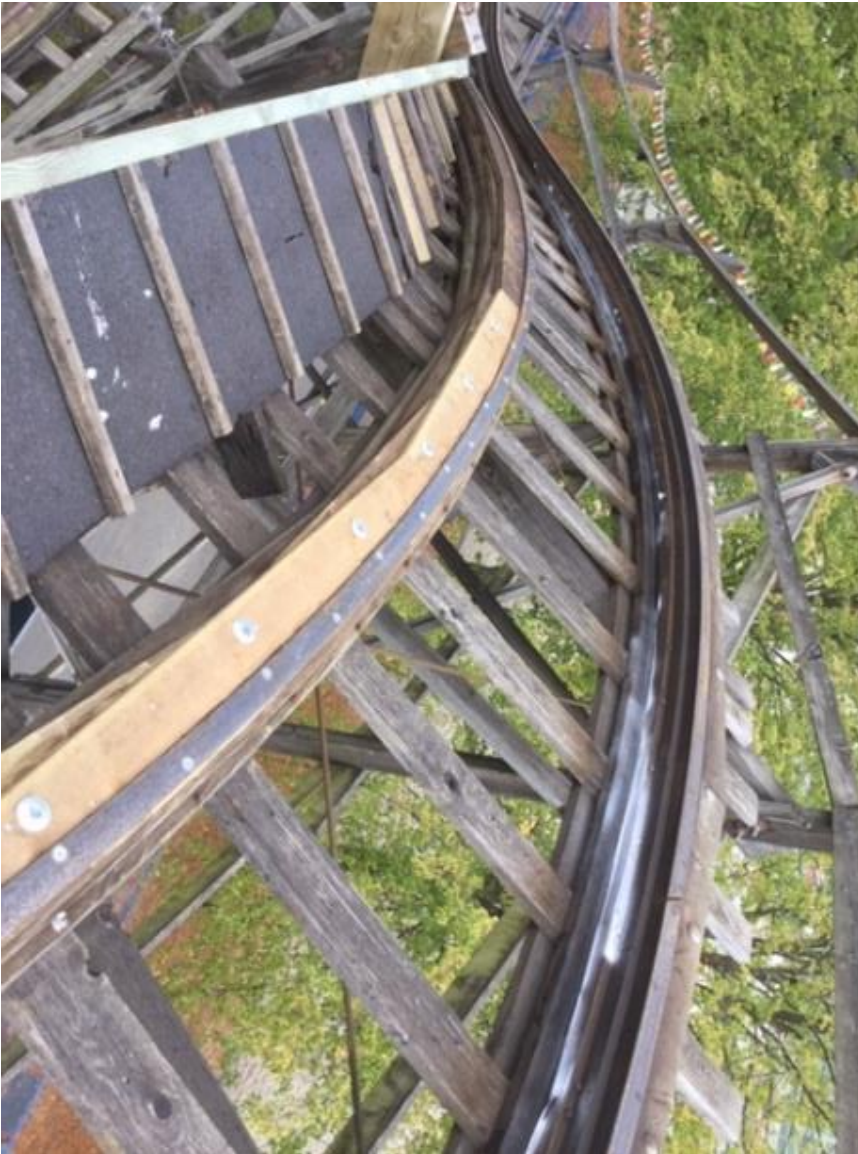
Failure scenario(s)	<p>On August 5, 2019, while in operation for the public, a track misalignment caused the pilot car (1<sup>st</sup> car) of the purple train, to disengage from the steel track as it travelled through the upper south horseshoe of the coaster track.</p> <p>The right wheel (North) of the pilot car came off the steel rail and dropped 1.5 inches on to the wooden layer of the track causing the left wheel flange (South) to ride up on to the south steel rail plate and eventually skidding to a stop with the steel wheel flange resting on the steel plate.</p> <p>When the pilot car derailed it caused the steel brake fin (upstop) of the left (North) side of the pilot car to dig into the north face of the wooden uplift (upstop) opening causing the purple train to come to a stop in approximately 30 metres.</p>

<p>Causes and contributing factors</p>	<p>The pilot car disengaged from its pre-determined path of travel due to track misalignment at the upper southern horseshoe.</p> <p>It is highly likely that a combination of factors contributed to this incident including: lack of track inspection/maintenance, lack of guy line inspection/maintenance, and drying and shrinking of wooden track due to an inoperable sprinkler system.</p>

Photo 1: Post incident, area where pilot car disengaged. This entire area should be regularly watered, weather depending, to inhibit drying and shrinking of wood

Note: bright wood indicates repaired area.

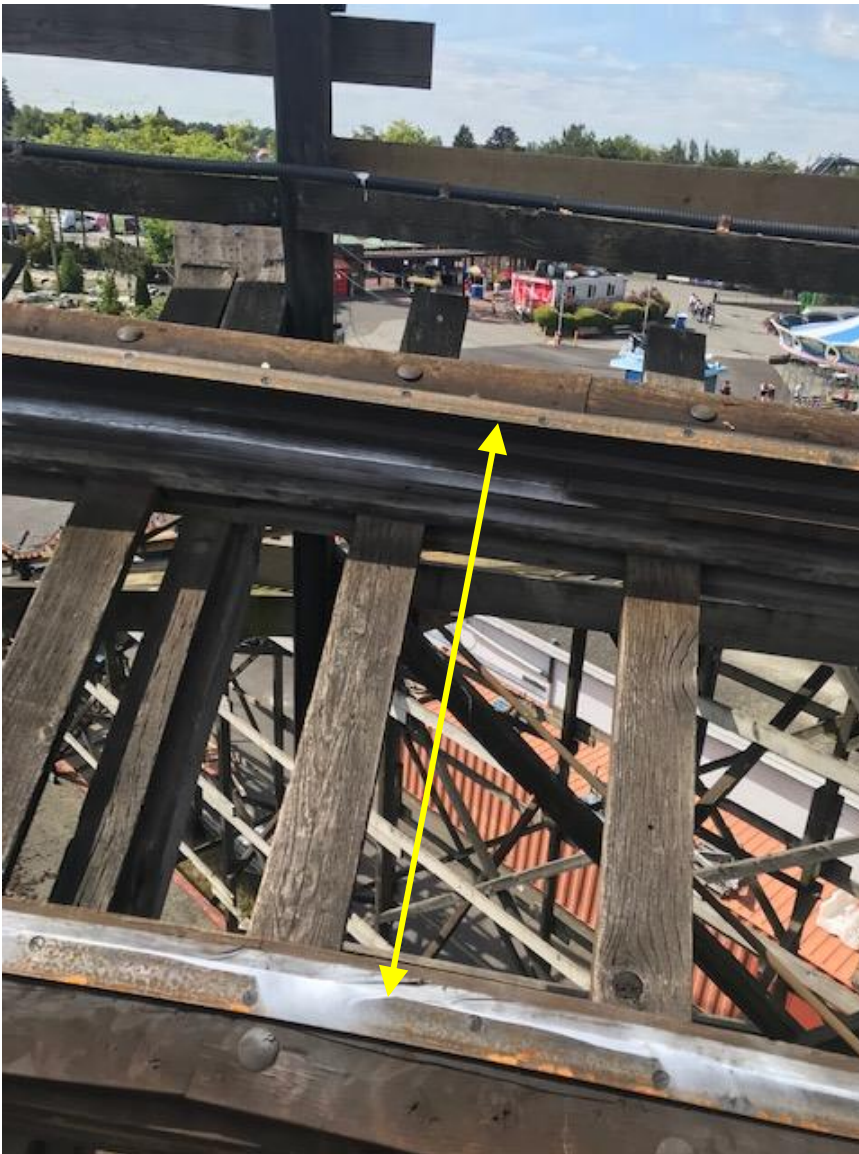
<p>Facts and evidence</p>	<ul style="list-style-type: none"> <li>• The spacing between the tracks steel rails (gauge width) was measured after the incident and found to be over tolerance in the area where the train had derailed.</li> <li>• Pre-season track width measurements, were confirmed during interview with maintenance staff, as having not been conducted prior to the incident.</li> <li>• Guy lines from ground level to the upper south horseshoe, were confirmed during interview of maintenance staff, as having been loose and requiring significant tightening, immediately following the incident.</li> <li>• A water sprinkler system is used to maintain moisture content of the wooden roller coaster structure to control shrinkage. Excessive shrinkage can cause the spacing between the track rails to increase.</li> <li>• An interview with the maintenance staff confirmed that the sprinkler system for the upper south horseshoe was inoperable prior to the incident for an unknown period of time.</li> <li>• The weather was very hot and dry prior to and during the time of the incident.</li> </ul>

Photo 2: Track gauge width is the distance between the track steel rail plates, as shown above.

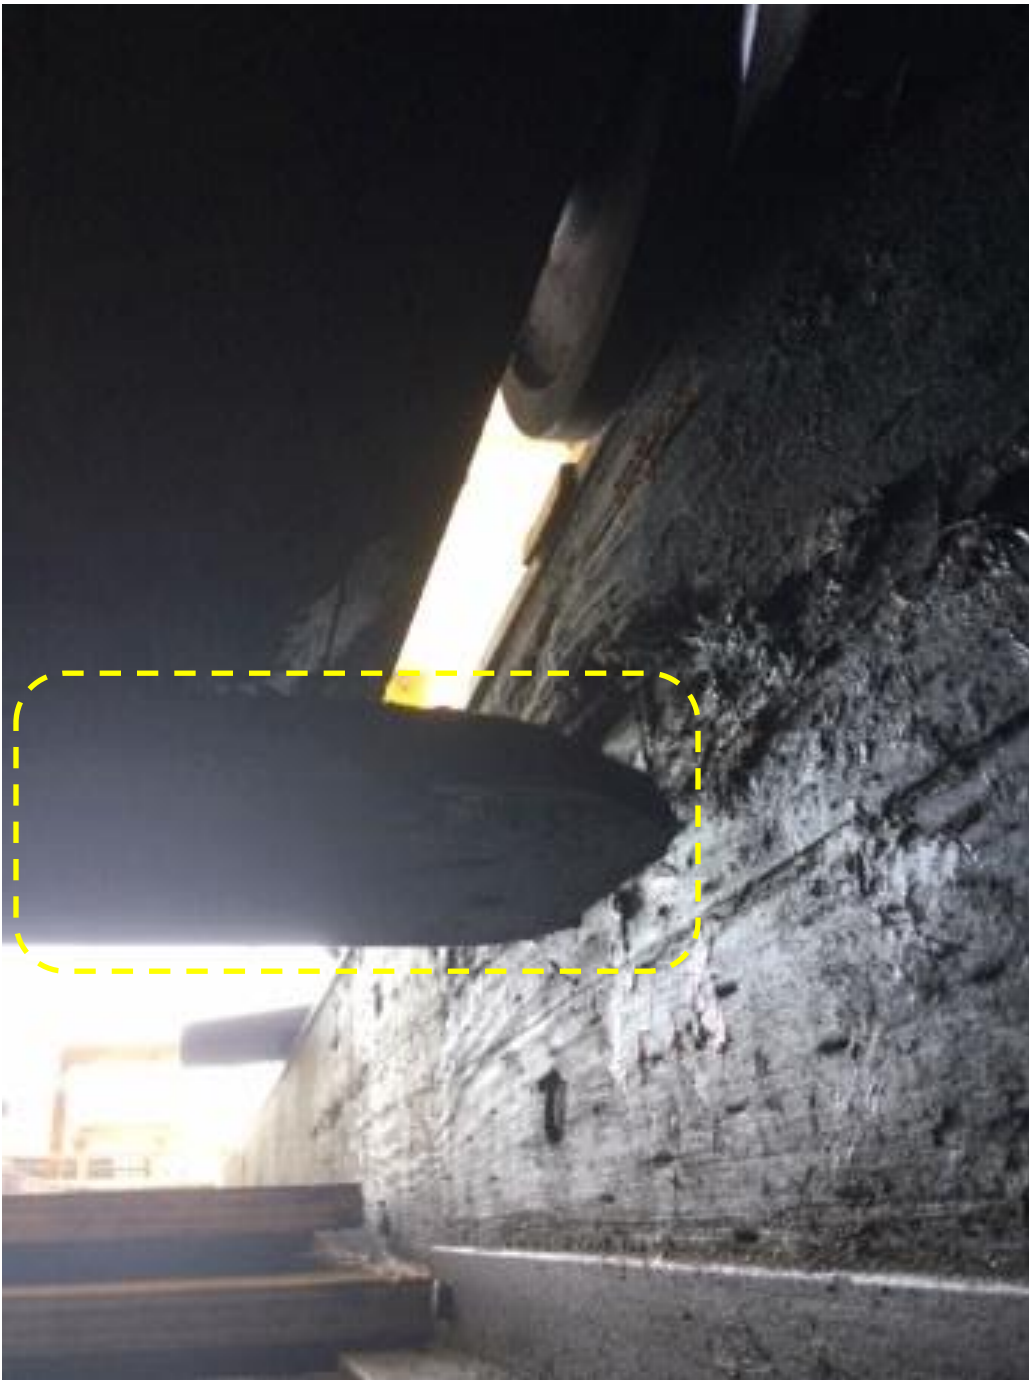
Photo 3: Pilot car brake fin (upstop). Taken from underneath car.

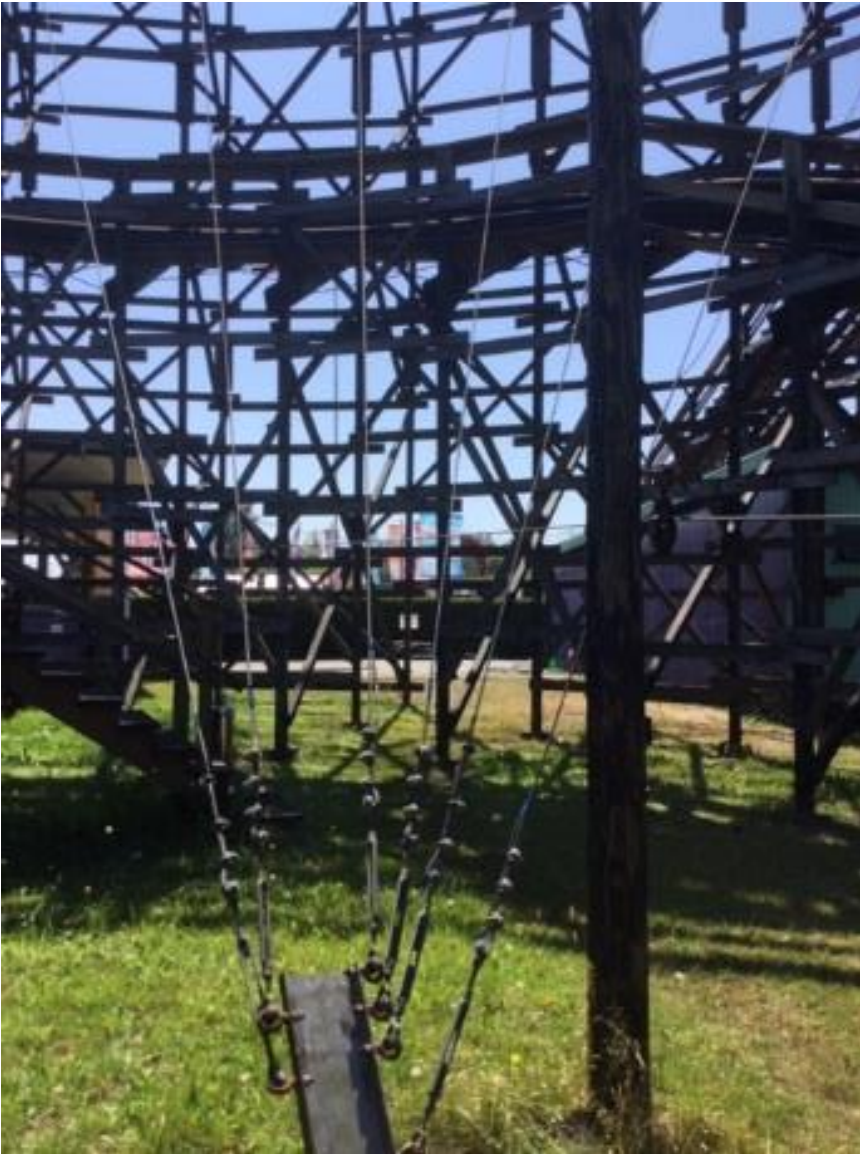
Photo 4: East guy lines connected to southern upper horseshoe.

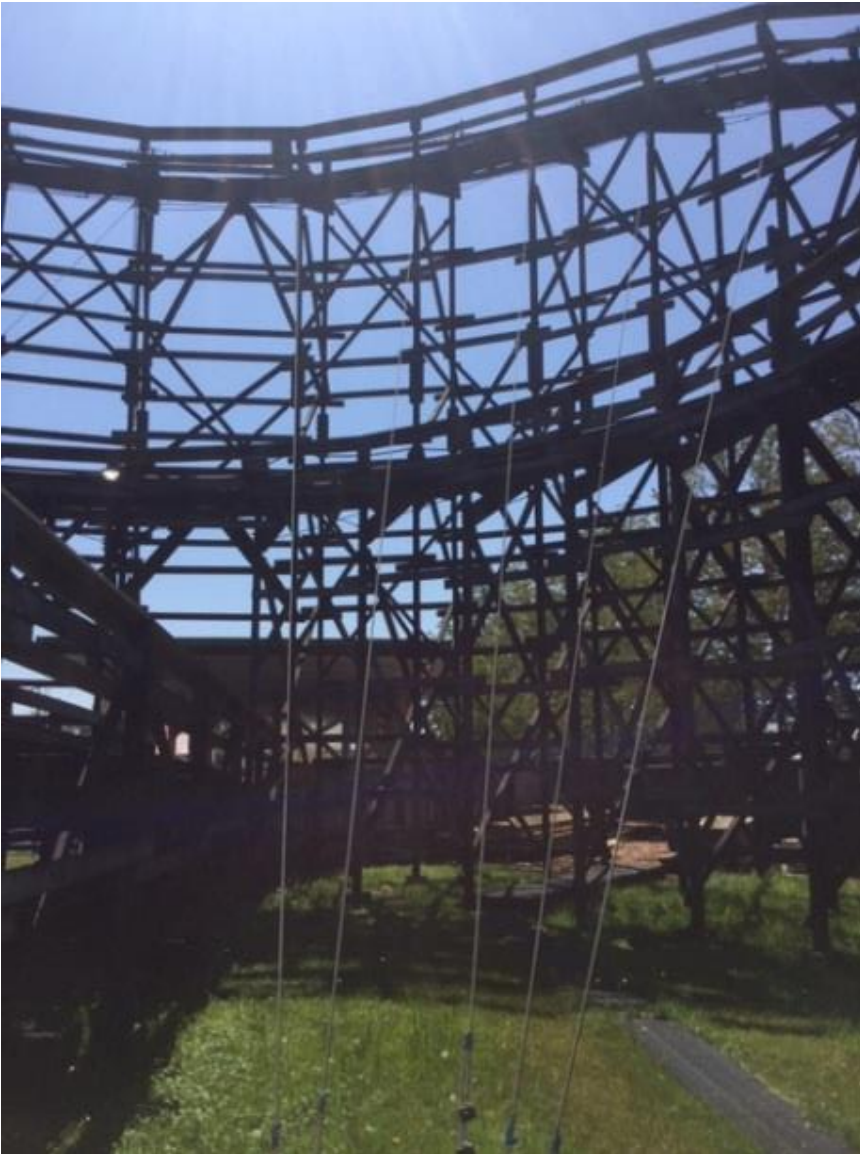
Photo 5: West guy lines connected to southern upper horseshoe.
