## Incident Summary #II-1023571-2020 (#18192) (FINAL)

SUPPORTING INFORMATION	Incident Date	June 3, 2020	
	Location	North Vancouver,	
	Regulated industry sector	Boilers, PV & refrigeration - Refrigeration system	
	Impact	Qty injuries	0
		Injury description	N/A
		Injury rating	None
	Damage	Damage description	Cracked 90 elbow(5/8") on the discharge line of Low Temp(subcritical) Compressor # 3
		Damage rating	Moderate
Incident rating	Moderate		
Incident overview	A CO2 refrigeration rack fitting failed and filled the machinery room with 750 lbs of CO2. Fire department evacuated the building.		
INVESTIGATION CONCLUSIONS	Site, system and components	Site: Grocery Store System: CO2 refrigeration direct system for display cases and cold room in the store. Total charge is 2200 lbs CO2. Component: The compressor discharge piping is made out of copper K at 5/8" OD. It sends the refrigerant to the receiver at a pressure of 470 psig.	
	Failure scenario(s)	The compressor rack was installed without vibration pads at the center supports. The compressors VFD(variable frequency drives) were not calibrated properly and produced very high vibration on certain ranges of frequency. The 90 degrees elbow(5

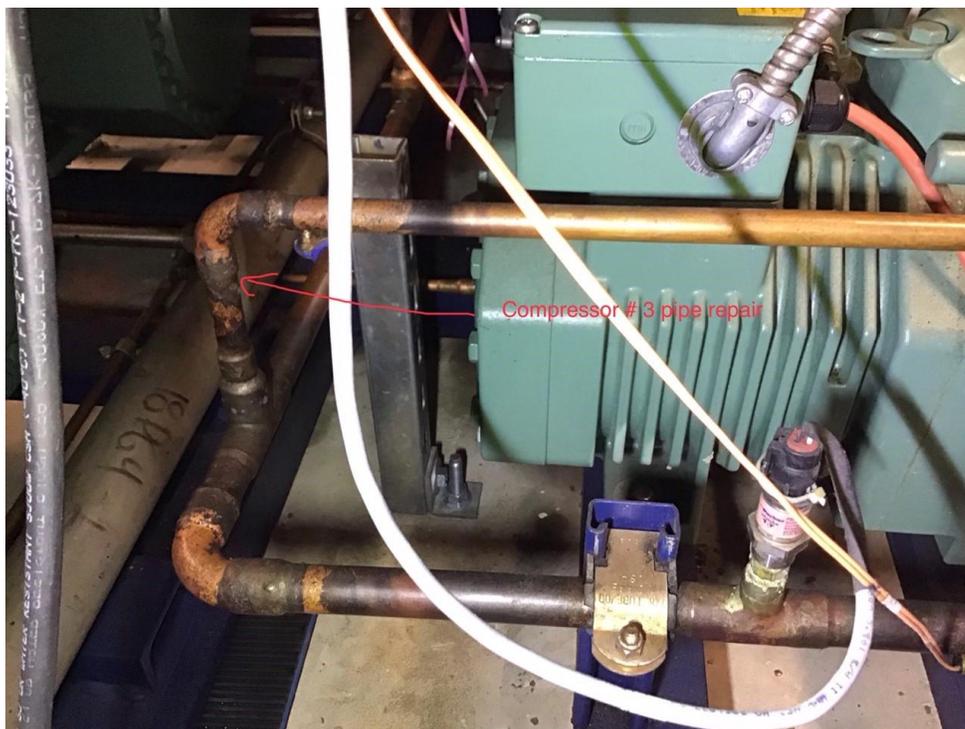
Compressor # 3 fitting repair

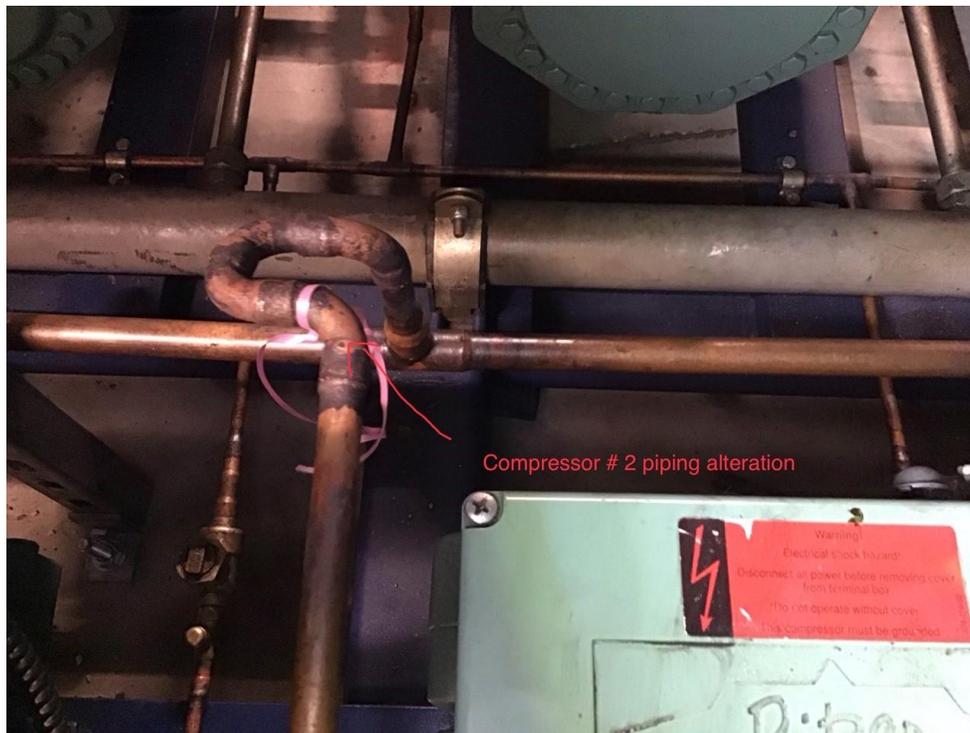
Compressor # 2 piping alteration

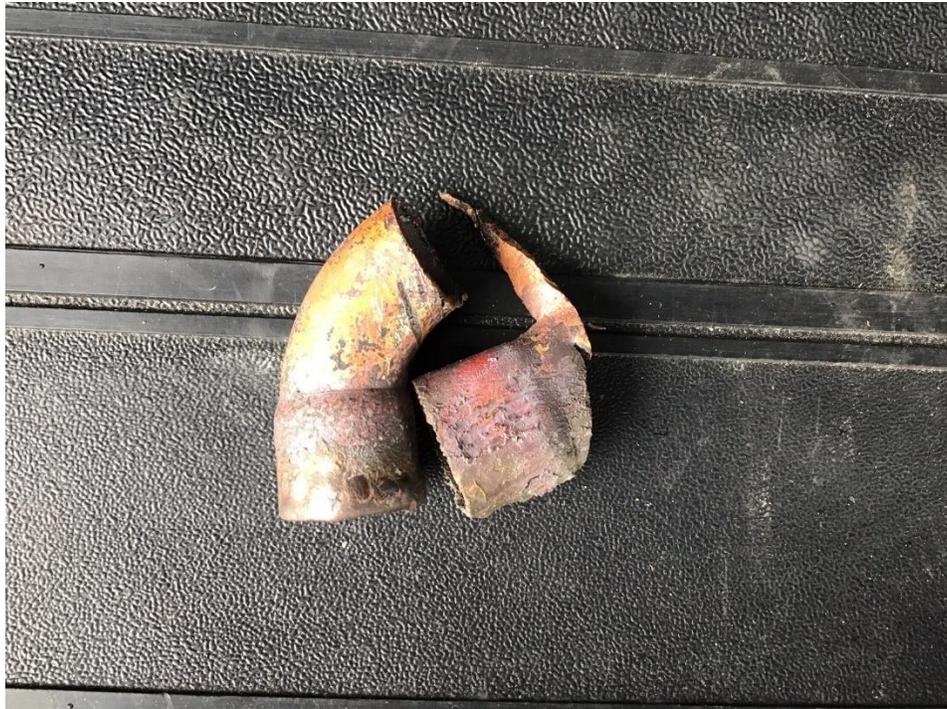
Causes and contributing factors	Very likely due to high vibration of the CO2 rack.

Copper fitting and section of pipe Compressor # 2
