## Incident Summary #II-1664306-2024 (#43678) (FINAL)

SUPPORTING INFORMATION	Incident Date	January 14, 2024	
	Location	Chilliwack	
	Regulated industry sector	Electrical - Low voltage electrical system (30V to 1000V)	
	Impact	Qty injuries	0
		Injury description	N/A
		Injury rating	None
	Damage	Damage description	The main residential combination panel and connected branch circuit wiring within approximately 1m of the panel were damaged by heat and fire beyond repair.
		Damage rating	Major
	Incident rating	Major	
	Incident overview	In the main residential combination panel, the main point of mechanical interconnection between the load side of the main circuit breaker and the panel bussing failed. This point of failure created electrical arcing, which caused heat and ignition of the surrounding combustible components of the electrical panel into a fire.	
INVESTIGATION CONCLUSIONS	Site, system and components	<p>A typical electrical combination panel found in most residential dwellings consists of a single metal enclosure consisting of two sections separated by a metal divider. The smaller section contains a main circuit breaker whose function is to disconnect or interrupt the flow of e

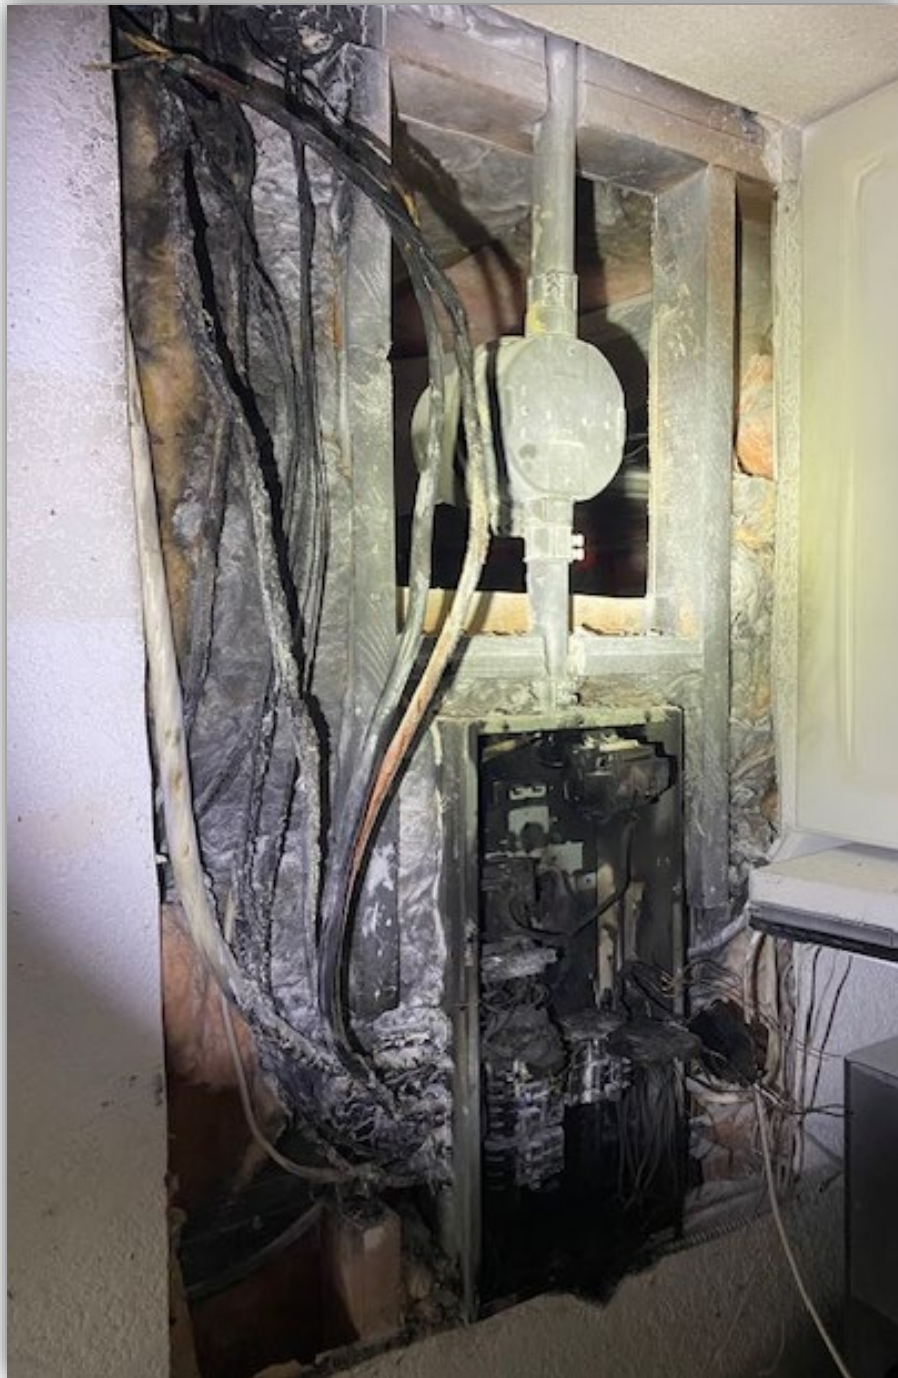
Image 1 – Main electrical panel within dwelling showing damage to panel and connected electrical equipment.

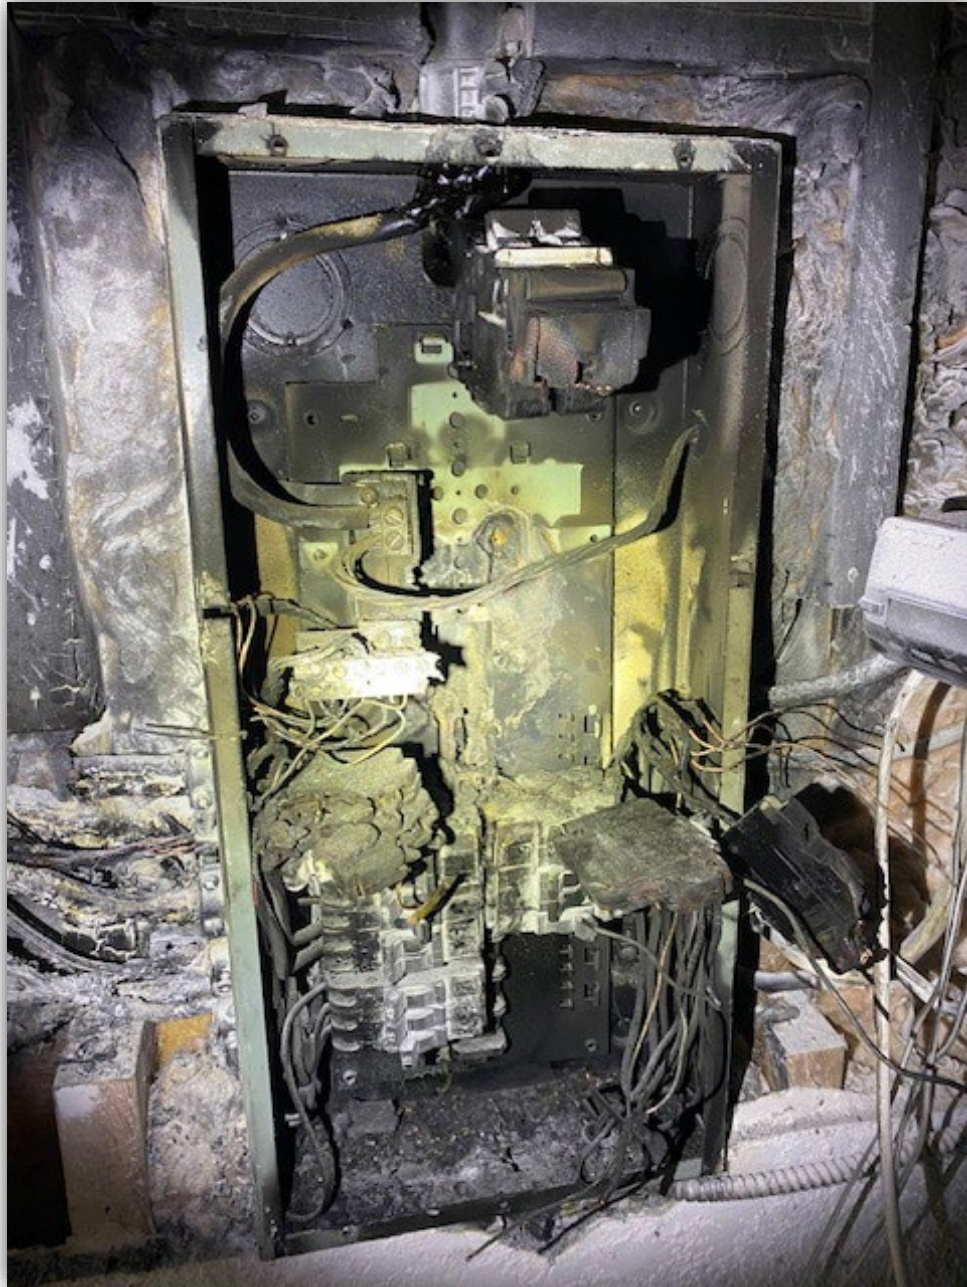
Image 2 - Close up image of Federal Pacific Electric (FPE) main combination panel.

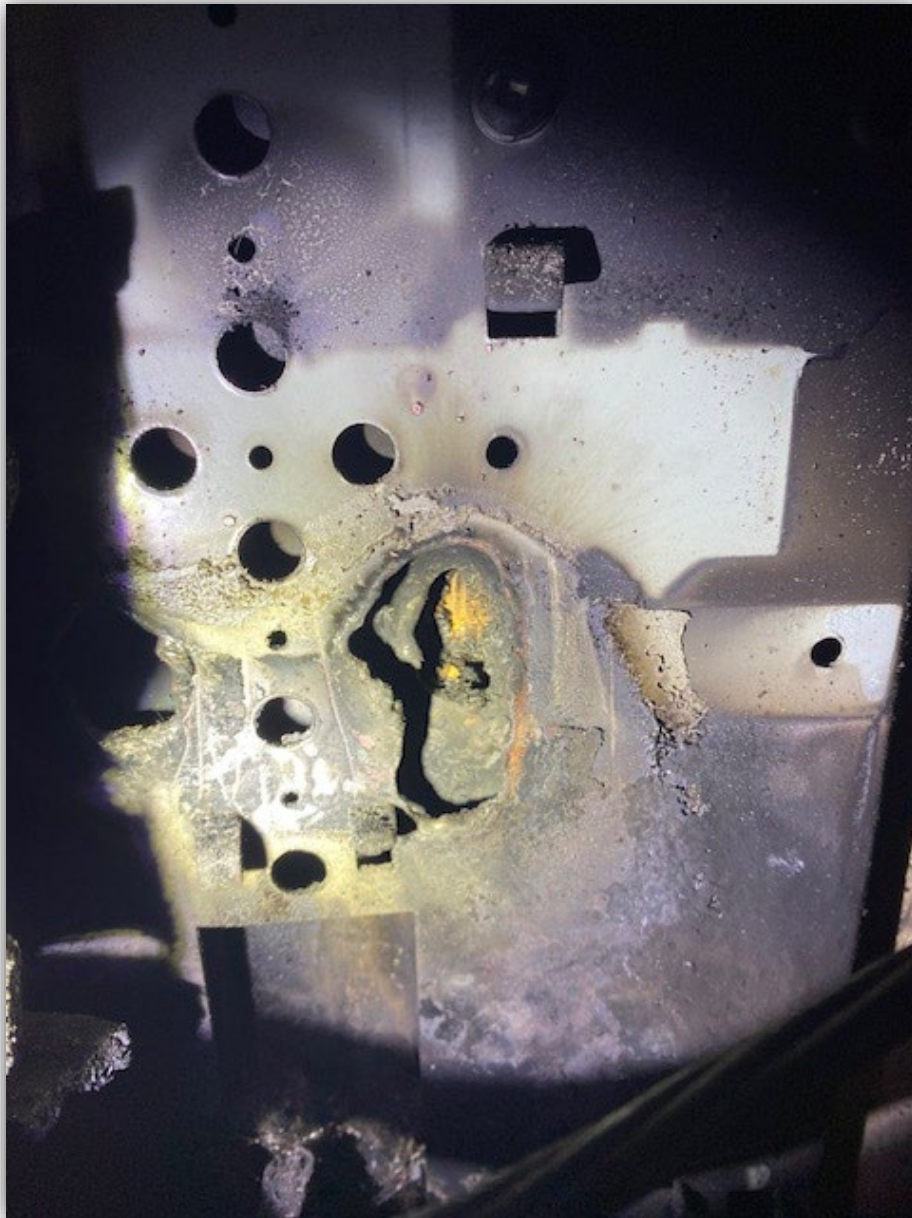
Image 3 - Close up image of electrical main combination panel metal enclosure located directly behind where main circuit breaker and metal bussing mechanically interconnect.

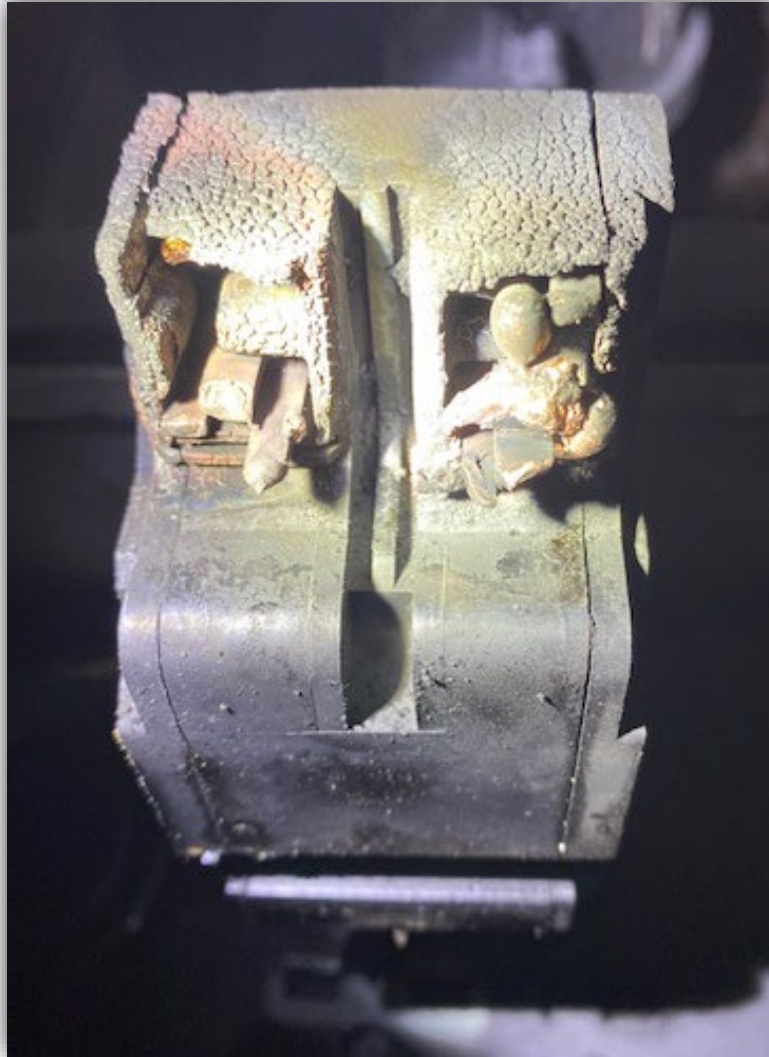
Failure scenario(s)	<p>The electrical combination panel that was installed at the time of the incident was manufactured by Federal Pacific Electric (FPE). Examination of the panel after the incident identified that the origin of the fire was located at the mechanical point of interconnection between the load side of the main circuit breaker and the metal bussing by observing the discoloration of the metal enclosure directly behind the interconnection and the subsequent damage of the internal component expanding outward from that location. As the interconnection is static with no moving components, two possible failure scenarios are possible leading to the same outcome.</p> <p>Either the main circuit breaker was not secured to the metal bussing as per manufacturers specifications causing the failure or that the location experienced long-term degradation of the point of interconnection creating air gaps which created electrical arcing between components generating heat which eventually led to its failure.</p>

Image 4 - Close up image of load side of main circuit breaker showing tab design of connection and damage to the tabs. Condition of circuit breaker plastic enclosure also shown.
