Incident Summary #II-774658-2018 (#9731) (FINAL)

SUPPORTING INFORMATION	Incident Date	November 11, 2018	
	Location	Delta, BC	
	Regulated industry sector	Gas - Natural gas system	
	Impact	Qty injuries	0
		Injury description	N/A
		Injury rating	None
	Damage	Damage description	Damaged unit heater and venting system, both are a total loss.
		Damage rating	Moderate
	Incident rating	Moderate	
Incident overview	A unit heater which was used to heat a garage bay, had a very hard light off (When the appliance attempted to ignite, rather than lighting off smoothly as designed, factors caused a small explosion in the combustion chamber), this blew off the bottom access cover and damaged the appliance.		
INVESTIGATION CONCLUSIONS	Site, system and components	<p>Direct vented appliances have their combustion air ducted directly into the burner chamber from the outdoors. Often a concentric venting kit, where a pipe installed within a second pipe, is used. The outer pipe draws the combustion air into the appliance, while the inner pipe conducts the products of combustion outdoors. This venting system is made out of materials which should resist corrosion from the elements which they are subjected

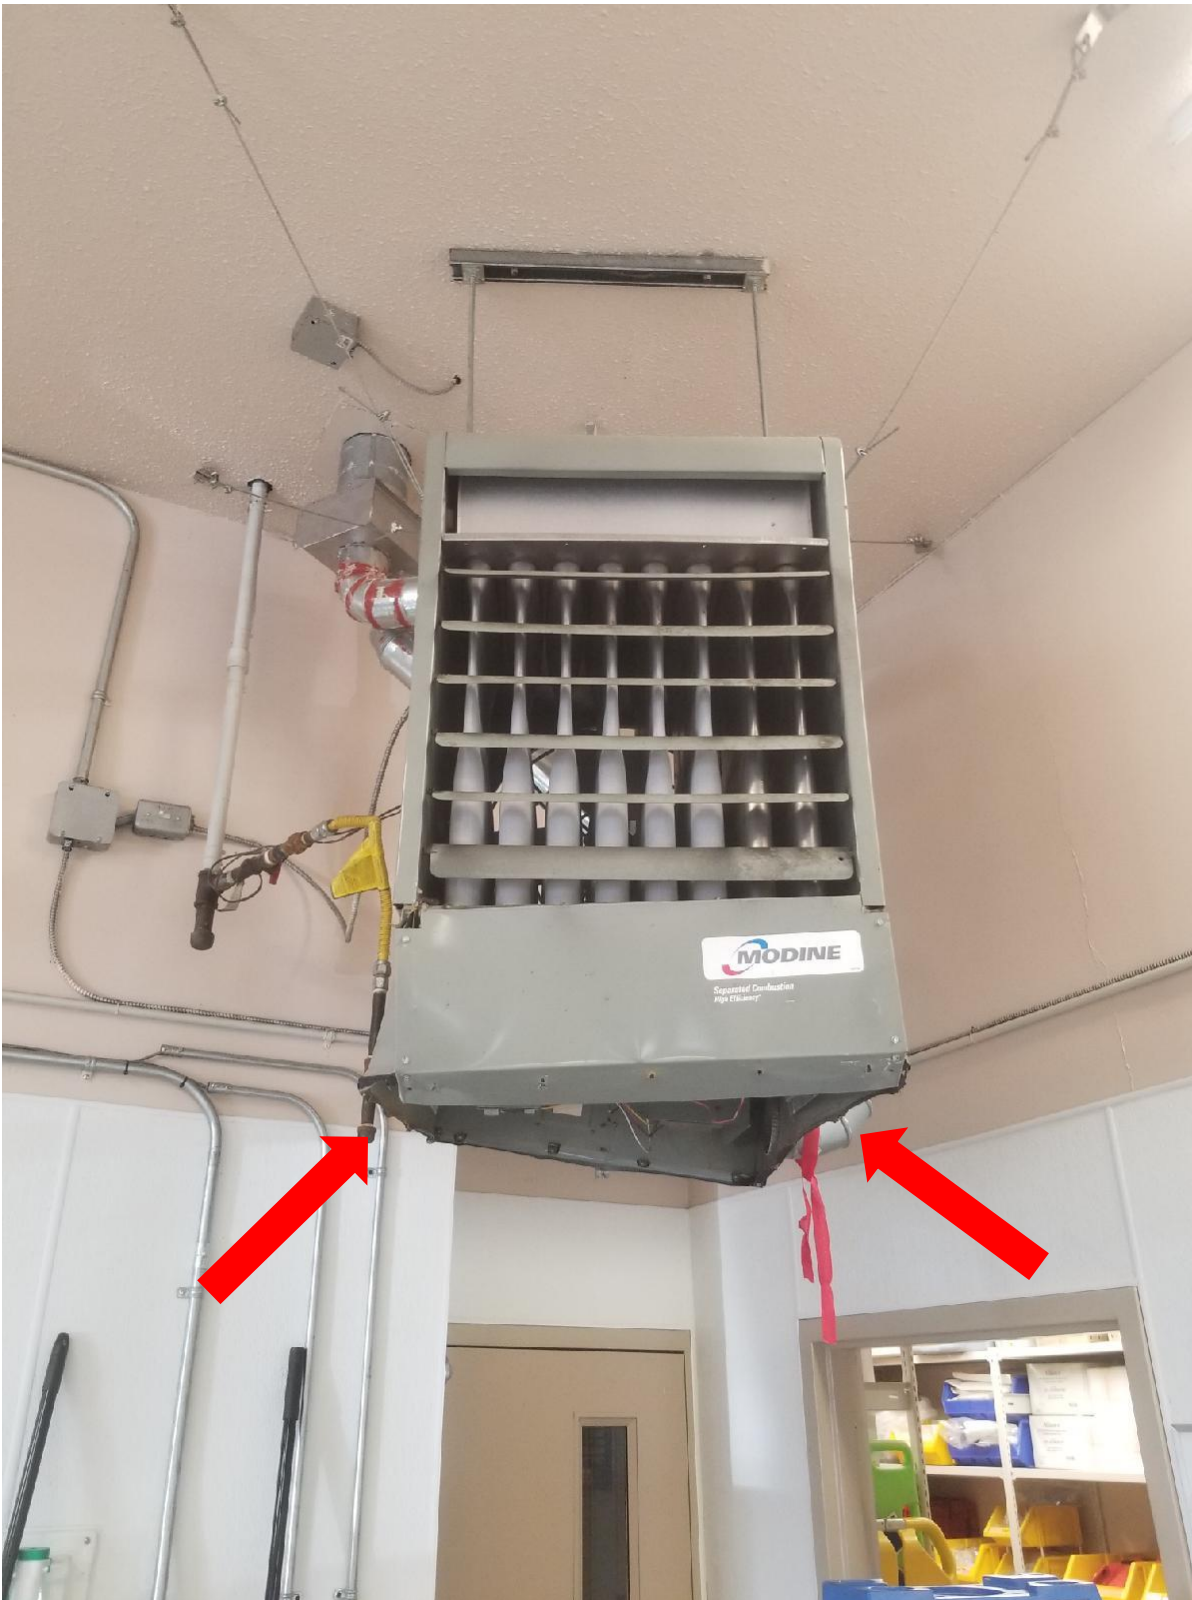
Figure 1. Picture of appliance showing damage

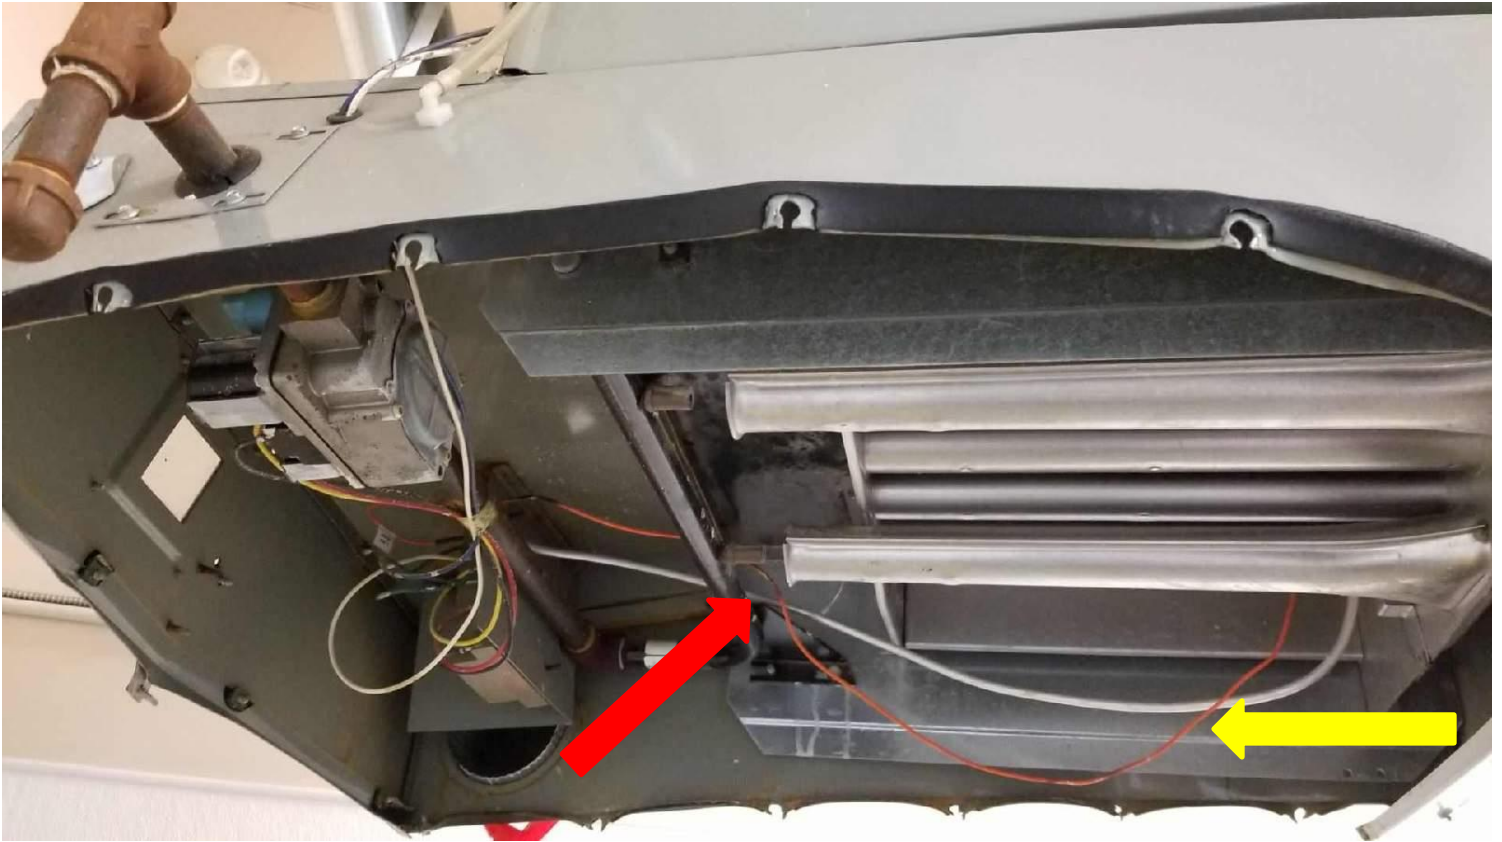
<p>Facts and evidence</p>	<ul style="list-style-type: none"> -Assessment of the vent pipe within the concentric venting kit found the vent pipe was extremely corroded. Although a hard light off may have perpetuated the damage to the venting system. - Signs of charring were found on the ignition wire at the point where it passes very close to one of the appliance burners. -The ignition module for this appliance was a “continuous retry” type, so every time the pilot flame failed to ignite, the appliance purged the chamber, and attempted its “trial for ignition” again.
<p>Causes and contributing factors</p>	<ul style="list-style-type: none"> -It is very likely that the cold air being drawn in for combustion caused the warm flue products to condense in the vent pipe, corroding the inner piping of the vent kit -It is very likely that the burnt ignition wire caused the appliance to spark somewhere other than the ignition electrode. Since the appliance was recycling back into itself, the gas would have been able to build up until it found the spark elsewhere in the appliance, igniting the explosive mixture. -It is very likely that during pre-purge cycle the appliance was cycling gas back into the combustion chamber, when the appliance attempted to operate the explosive mixture ignited damaging the unit. -It is possible that a lack of inspection of the venting system during routine maintenance of this appliance may have contributed to this failure. This highlights the importance of not only servicing and inspecting the appliance, burner, and ignition system, but also the venting system which serves the appliance.

Figure 2. Picture of appliance underside showing ignition wire (yellow arrow), and burnt section of wiring (red arrow). Ignition wires are almost always solid red, and generally wouldn't have any black markings on them.

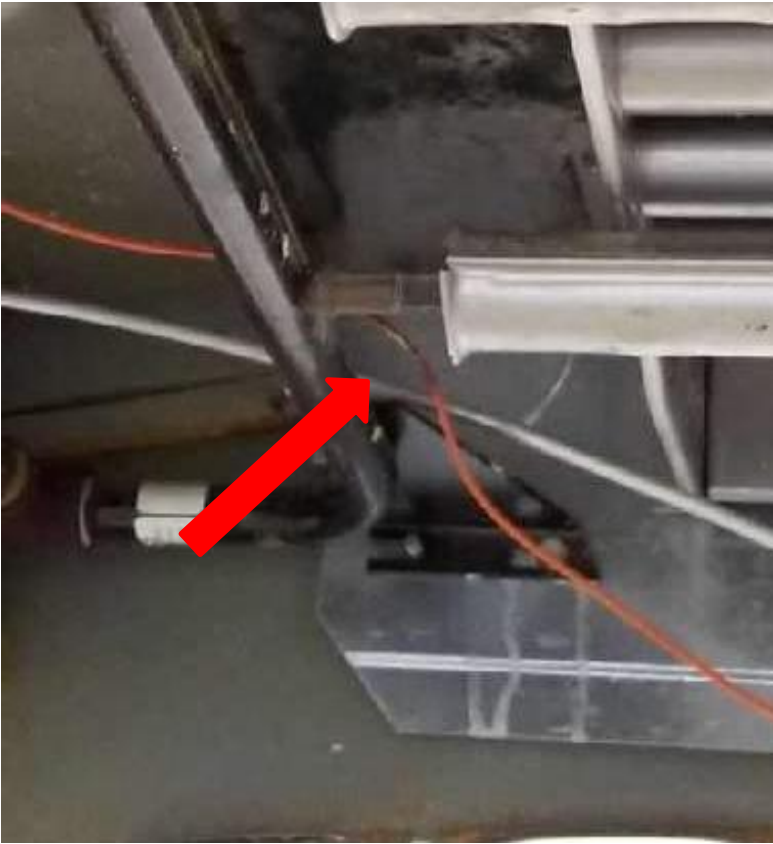
Figure 3. Close-up picture of burnt ignition wire.

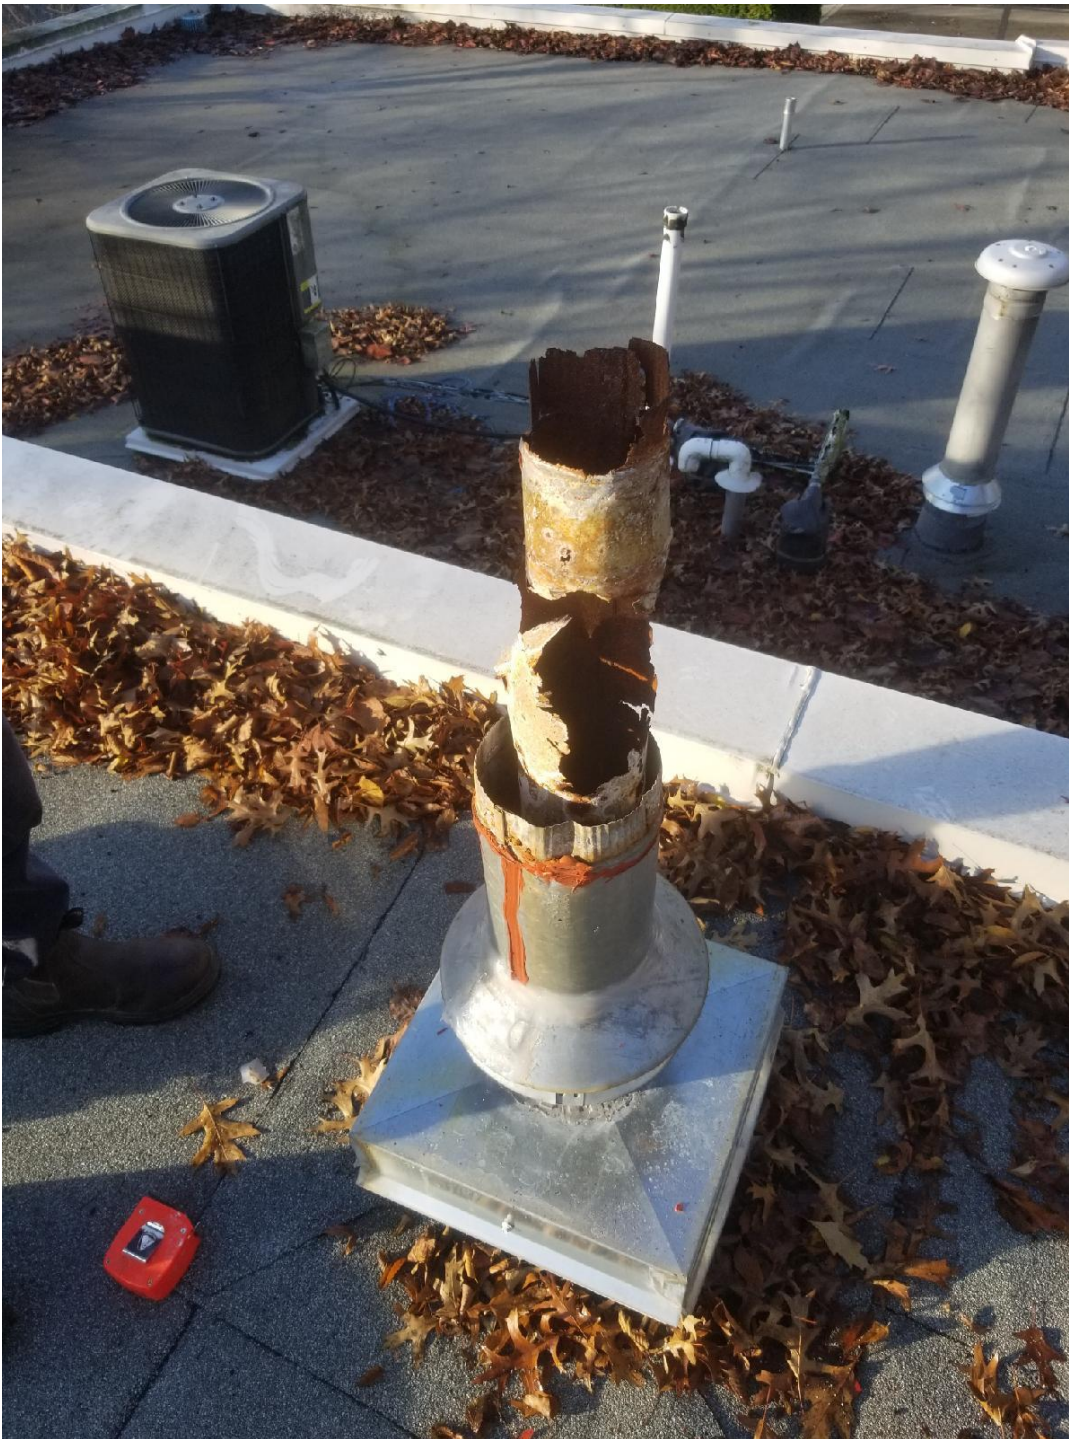
Figure 6. Picture of disassembled concentric termination showing corrosion damage

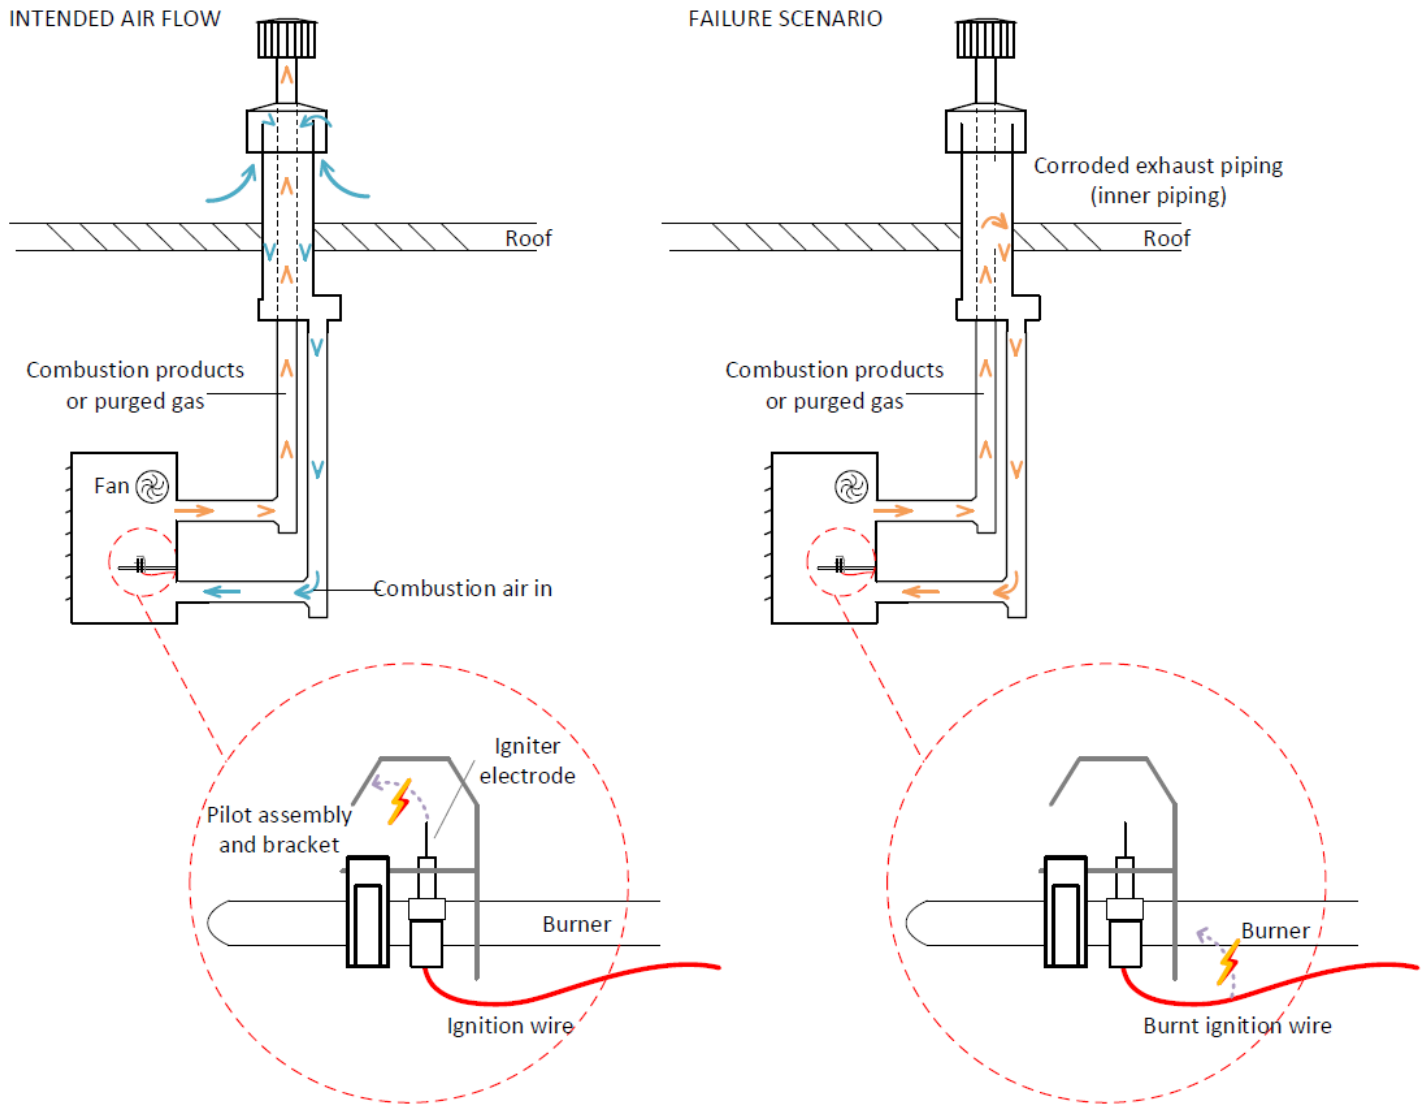
<p>Should an appliance with an intermittent ignition fail to establish a pilot after 15 seconds it will stop trying to ignite the pilot, go into pre-purge mode, and depending on the type of ignition control it may try to light the pilot again. The ignition module for this appliance was a “continuous retry” module, meaning that it will continue to ignite the pilot burner, instead of locking out after one or several failed attempts.</p> <p>In this situation the appliance installation appeared to be compliant and installed correctly, and no technical non-compliances were identified.</p>
<p>Failure scenario(s)</p>	<p>Due to its placement within the combustion chamber, the wire running from the ignition module to the pilot ignition electrode was damaged by heat (see Figures 2 & 3 below). This caused the appliance to spark between the burner piping and the wire rather than at the ignition electrode. Every time the appliance attempted to light gas was released from the pilot burner.</p> <p>The inner pipe of the concentric vent kit serving the appliance had corroded to the point where holes formed between the vent outlet pipe and the combustion air intake pipe. This allowed any gas that was being purged during the pre-purge, to recirculate back into the burner chamber. Eventually an explosive mixture of natural gas built up within the burner chamber.</p> <p>Finally this gas found the spark between the charred ignition wire and the burner piping and ignited causing an explosion within the unit, ejecting the bottom access panel from the unit, and warping the bottom of the appliance.</p>

Figure 7. Illustration detailing failure scenario.
