Incident Summary #II-969209-2020 (#16379) (FINAL)

SUPPORTING INFORMATION	Incident Date	January 18, 2020	
	Location	Peace River Region	
	Regulated industry sector	Boilers, PV & refrigeration - Boiler and pressure vessel system	
	Impact	Qty injuries	0
		Injury description	None
		Injury rating	None
	Damage	Damage description	Fire damage to firetube, gas burners, building exterior and structural walkway.
		Damage rating	Major
	Incident rating	Major	
	Incident overview	It was reported that the emulsion treater had caught on fire.	
INVESTIGATION CONCLUSIONS	Site, system and components	During process operations, oil with other fluids from the geological well formation combine and develop what is known as emulsion. This emulsion must be separated in order to recover the oil and to process the other recoverable fluids. As part of the separation process to break down the emulsion, the emulsion is heated in a treater which is a horizontal separator containing a fire tube in it where natural gas is burned to provide heat. The fire tube is in contact with the emulsion and once heated, gravity then separates the emulsion into useable products.

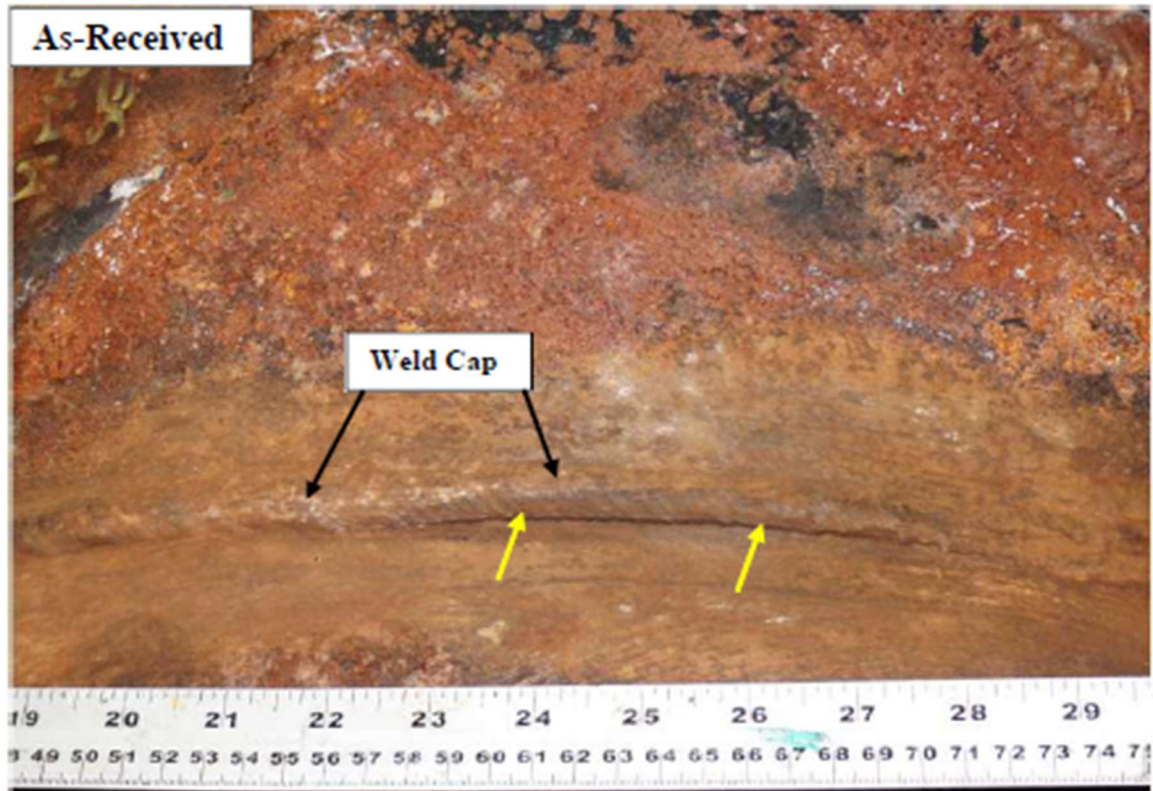
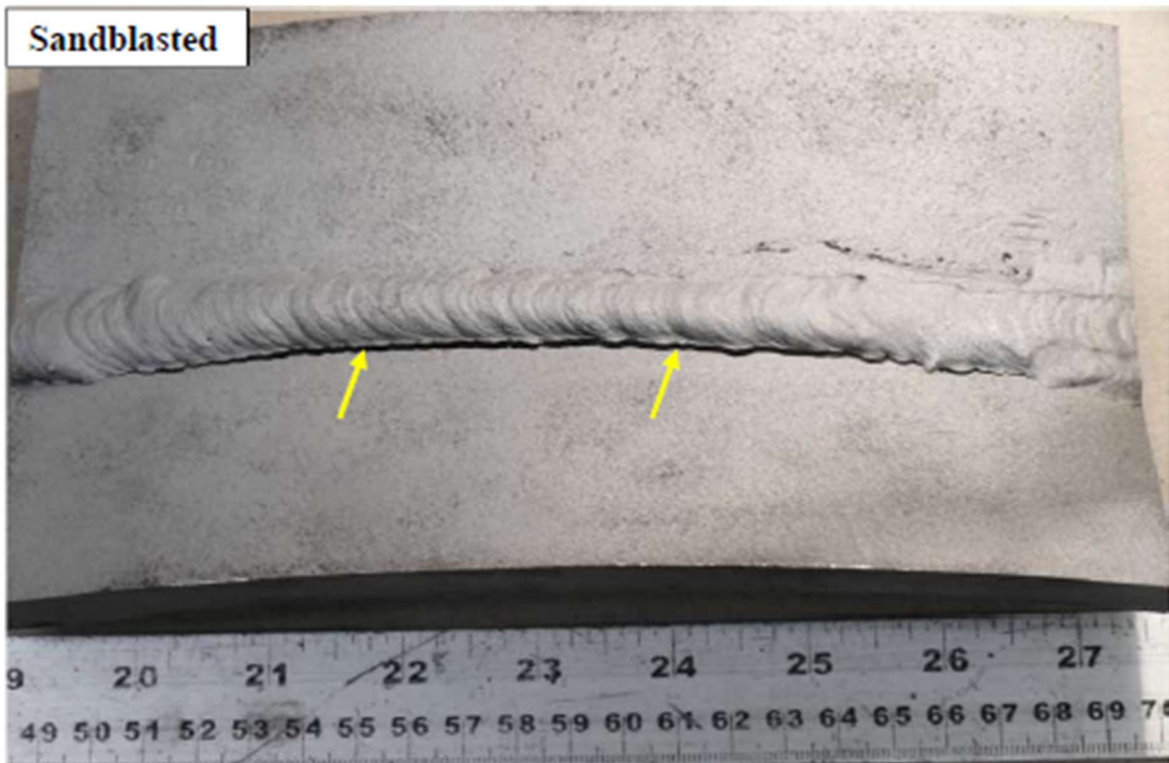
- Metallurgical analysis reported that fatigue cracking had propagated from the top of a weld, joining sections of firetube, throughout 25 percent of the firetube wall thickness.
- The Metallurgical Engineer reported that from the point of the fatigue crack, there appeared to have been brittle overload fracture through-out the remaining wall thickness of the firetube.
- The Metallurgical Engineer explained that fatigue cracking is caused by the application of cyclic tensile (pulling) stress, of which, may have been related to the expansion and contraction associated with fluctuating temperatures within the firetube during heating cycles.

FIGURE 2 CRACK ON EXTERNAL SURFACE

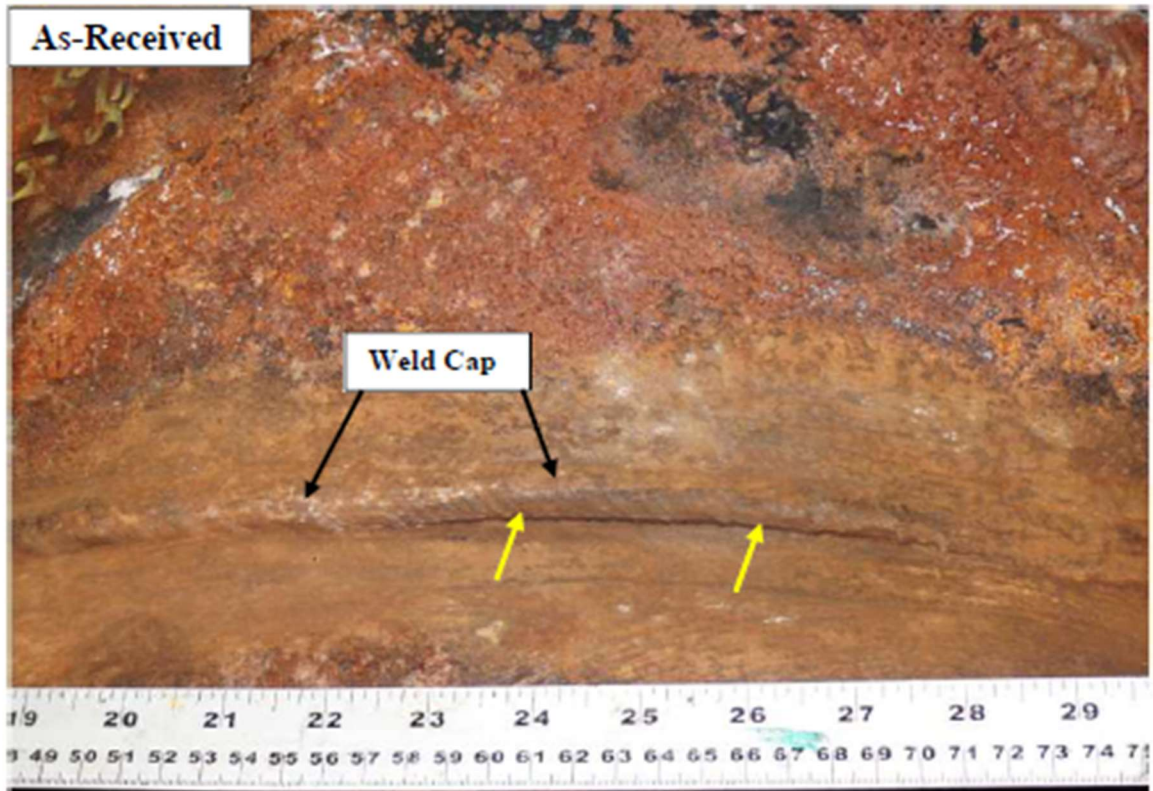
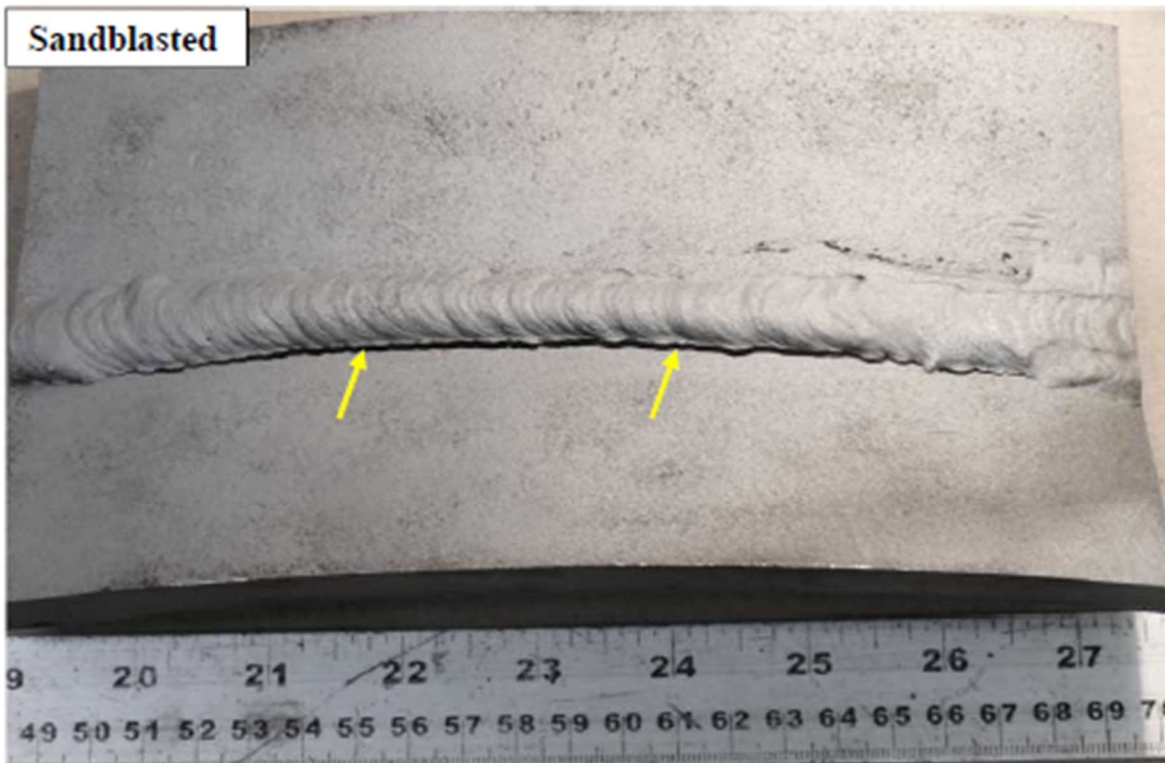
FIGURE 2 CRACK ON EXTERNAL SURFACE

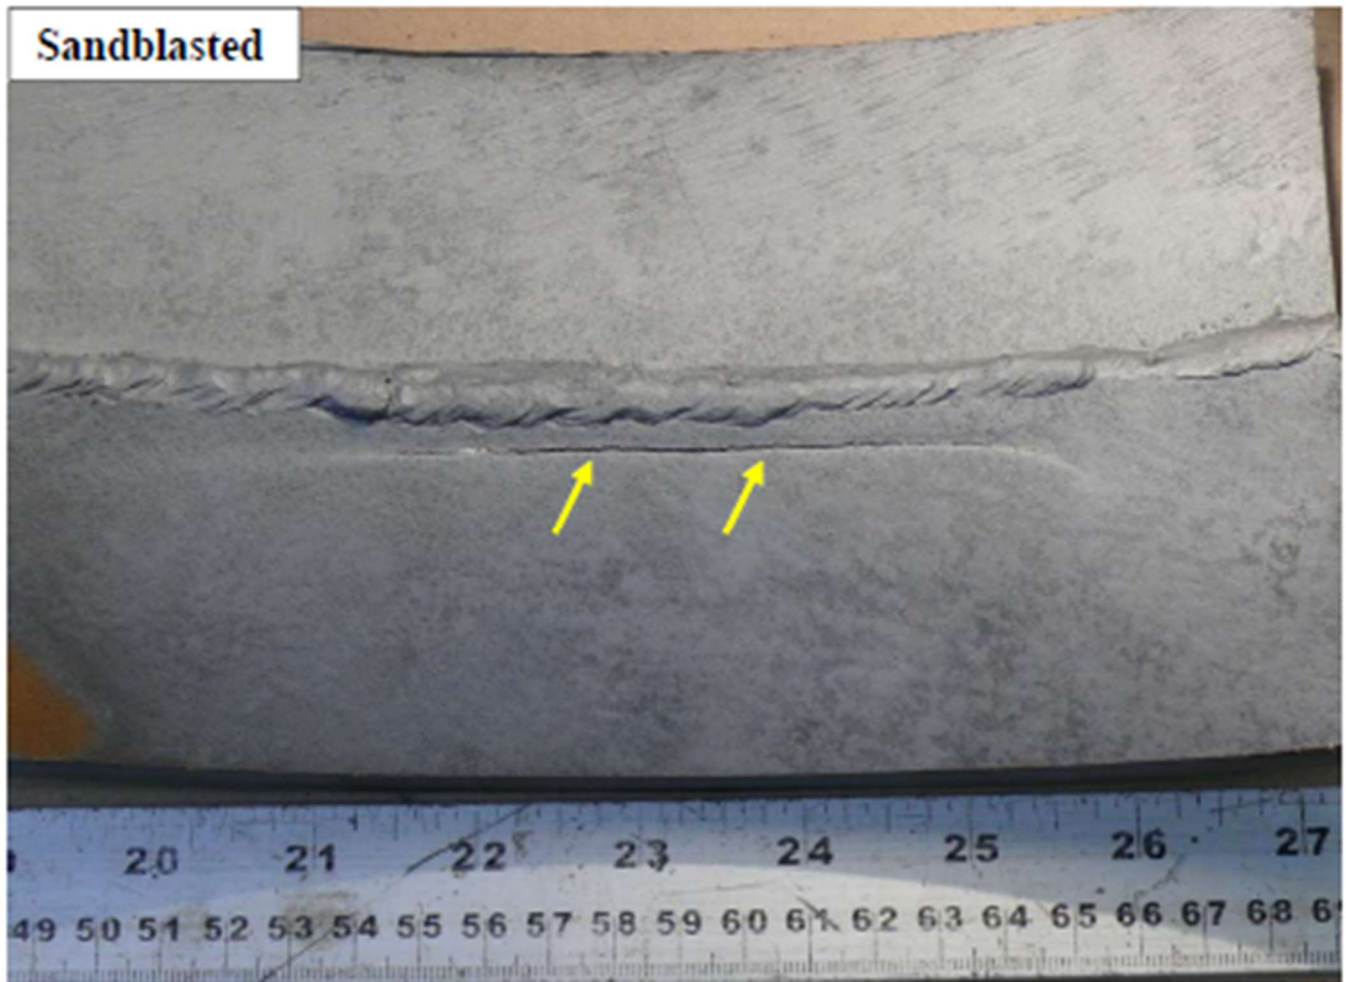
FIGURE 3 **CRACK ON INTERNAL SURFACE**

Internal side of crack (through wall) of firetube.
