Incident Summary #II-1244167-2021 (#23713) (FINAL)

SUPPORTING INFORMATION	Incident Date	August 24, 2021		
	Location	New Westminster, BC		
	Regulated industry sector	Elevating Devices - Elevator		
	Impact	Qty injuries	0	
		Injury	Injury description	N/A
			Injury rating	None
	Damage	Damage description	Damage to variable frequency drive unit, regenerative resistors, and wiring.	
		Damage rating	Moderate	
	Incident rating	Moderate		
Incident overview	During a fault with the variable frequency drive, the regenerative resistors overheated. Maintenance records and manuals that were sitting on top of the controller cabinet directly over the resistors, caught on fire. Fire Department was called, and the fire was extinguished.			
INVESTIGATION CONCLUSIONS	Site, system and components	The variable frequency drive receives commands from the controller that will provide power to accelerate and decelerate the elevator during operation. The regenerative resistors dissipate energy in the form of heat when the elevator is slowing down or accelerating when stopping or leaving floors.

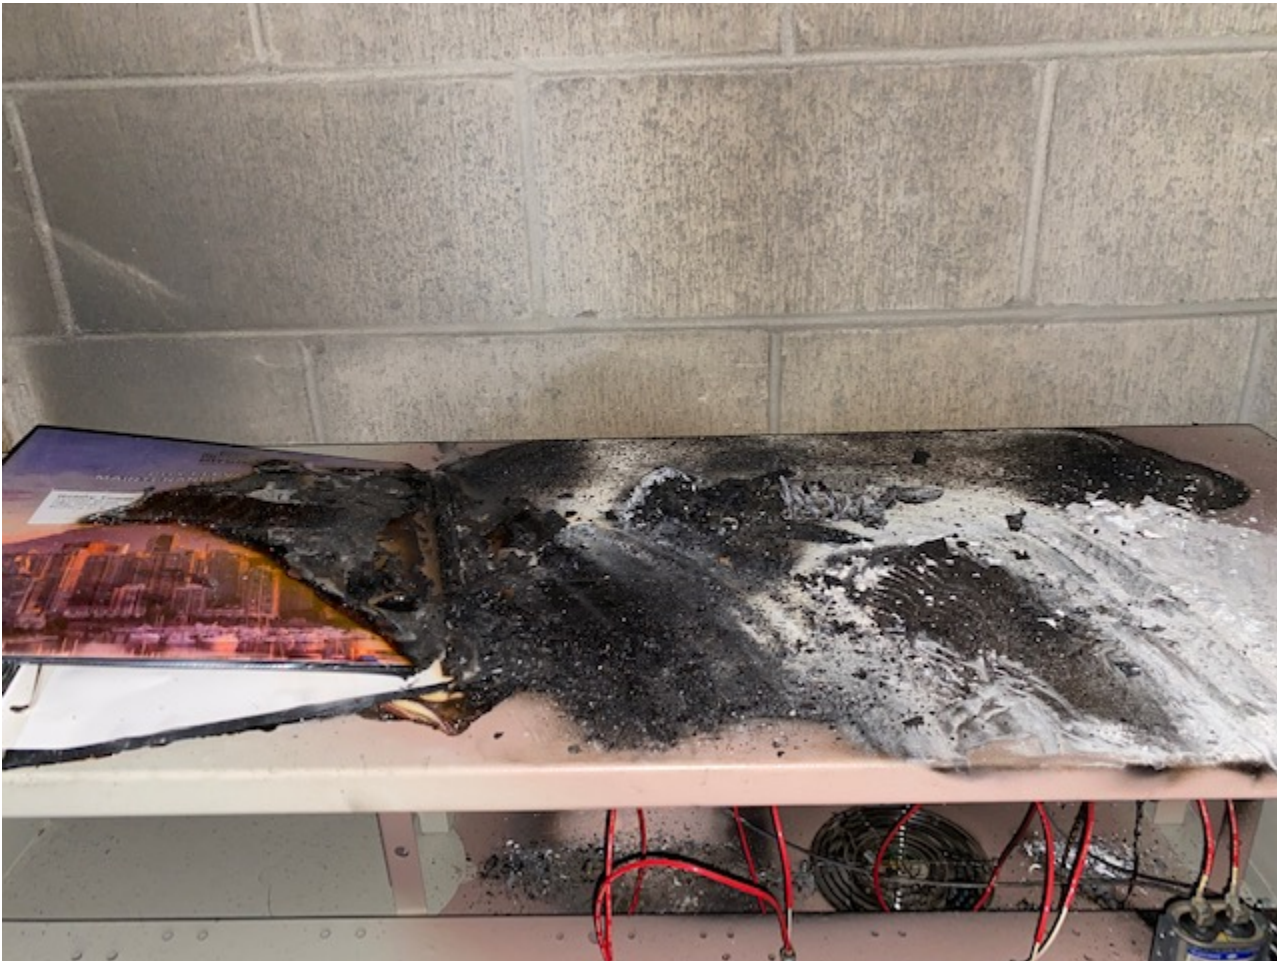
Failure scenario(s)	A fault in the drive (overheat) caused the drive to fail and the resistors to dissipate excess heat. A fire started where maintenance manuals and documents were placed on top of the controller cabinet directly above the regenerative resistors (Image 1 and 2).		
	Facts and evidence	<ul style="list-style-type: none"> The fire was contained to the top of the cabinet based on amount of ash where the maintenance records and documents were placed (Image 1). There was no evidence of fire inside the controller cabinet, other than ashes from the documents on top of the cabinet dropping down through ventilation openings onto equipment inside of the controller (Image 3 and 6). Damage caused by heat was found inside of the controller cabinet at the drive and wiring connected to the drive. Damage caused by heat was also found at the top of the controller or near the regenerative resistors and surrounding wiring (Image 4, 5 and 6). The variable frequency drive did shut down, but the mechanic was unable to determine when.

It is almost certain that heat was created by the regenerative resistors overheating, due to a fault caused by the variable frequency drive. It is probable that the maintenance manuals and documents caught on fire due to being placed on top of the controller cabinet directly over the regenerative resistors. The investigation was unable to determine the cause of the variable frequency drive overheating.

Image 1: Log Book, MCP Manual, schematics and documents were directly above the regenerative resistors

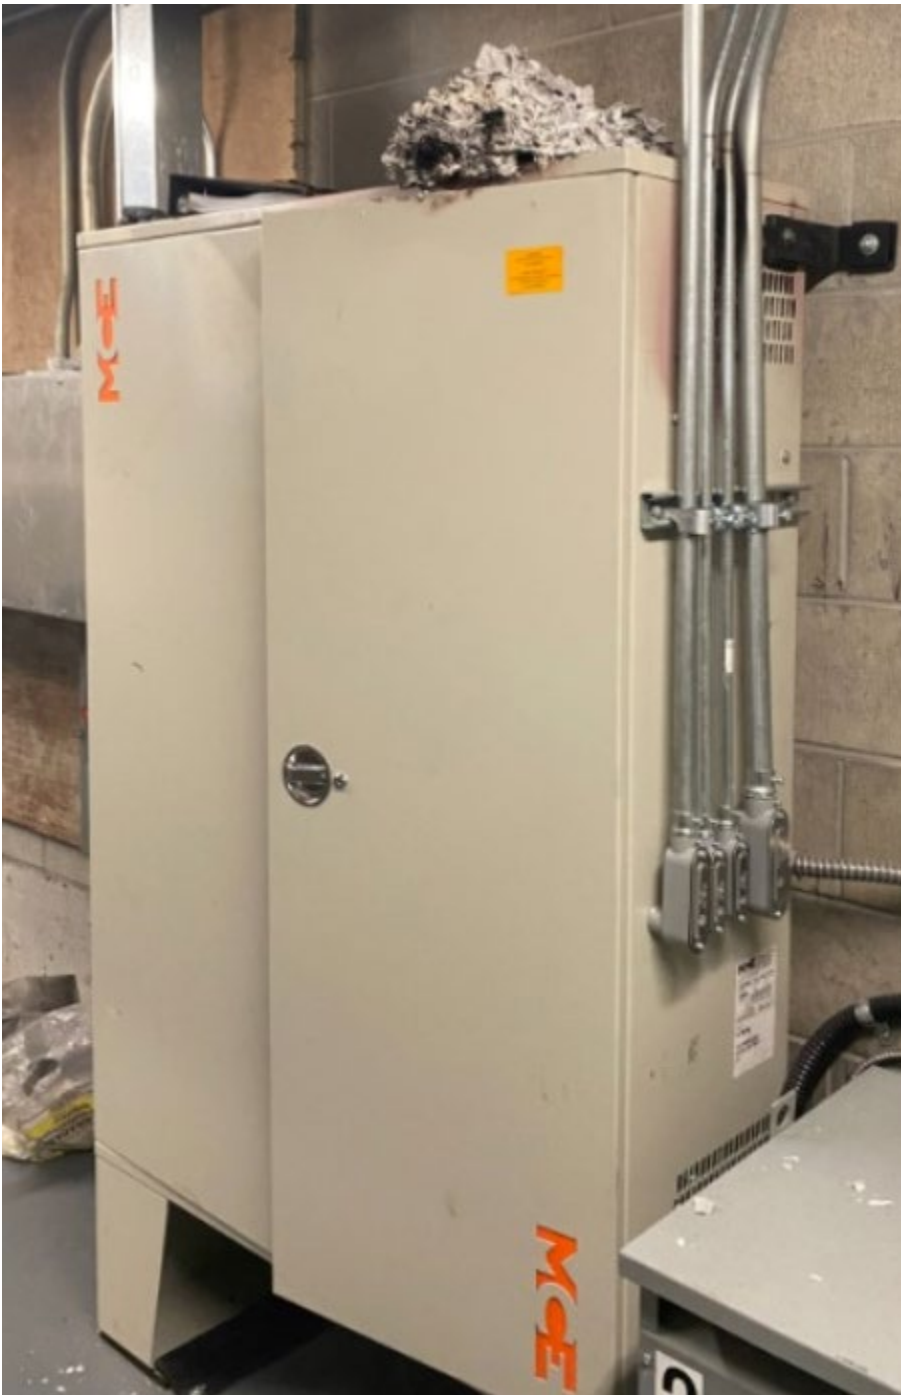
Image 2: The fire was contained to the top of the cabinet

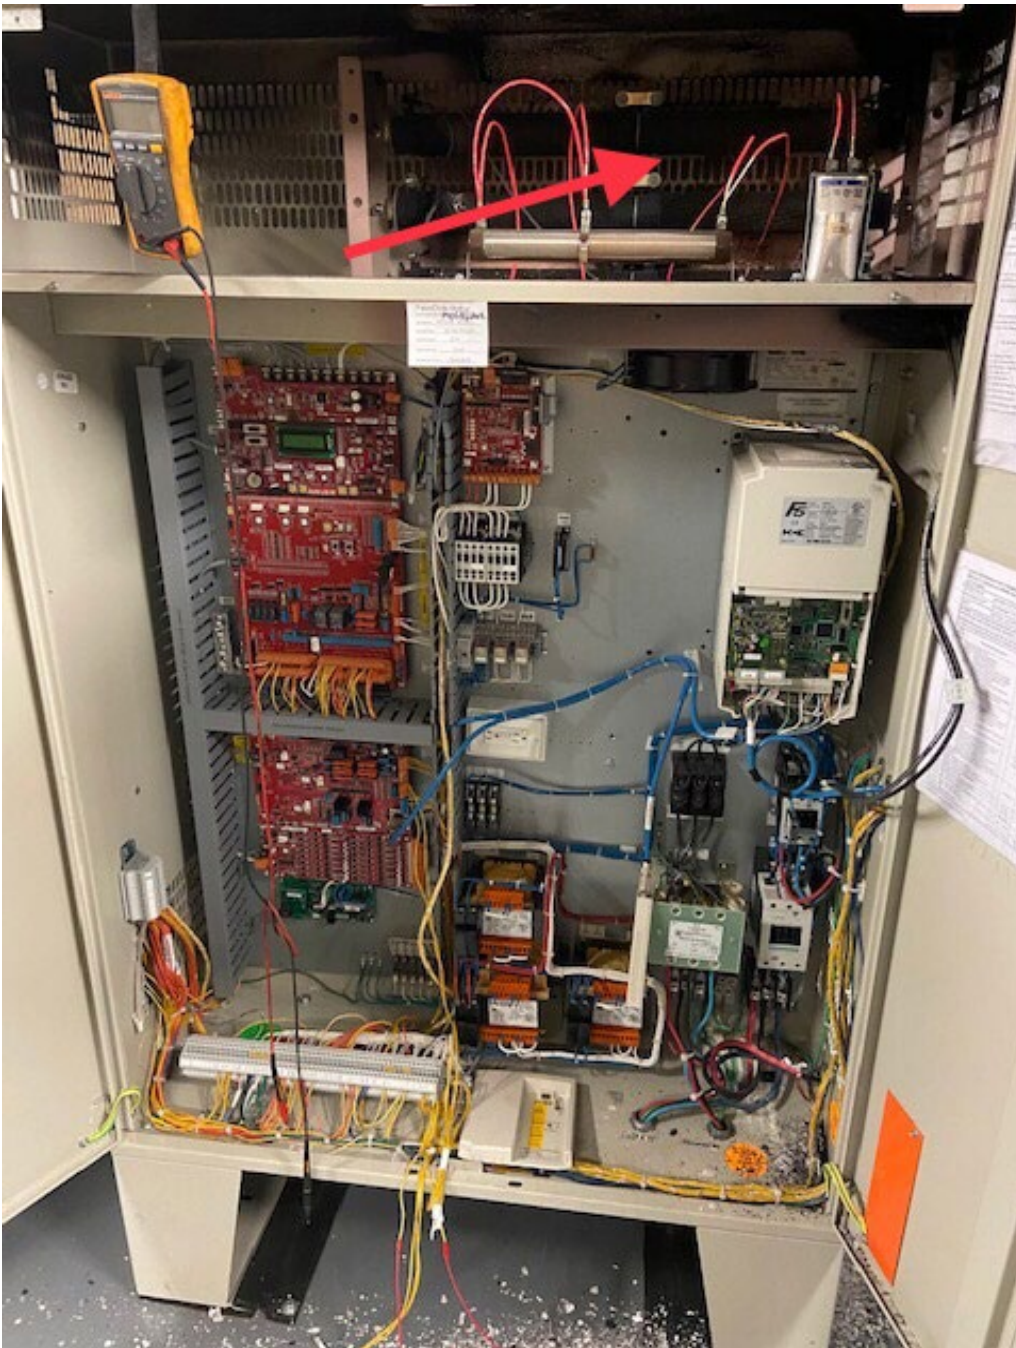
Image 4: Damage caused by heat

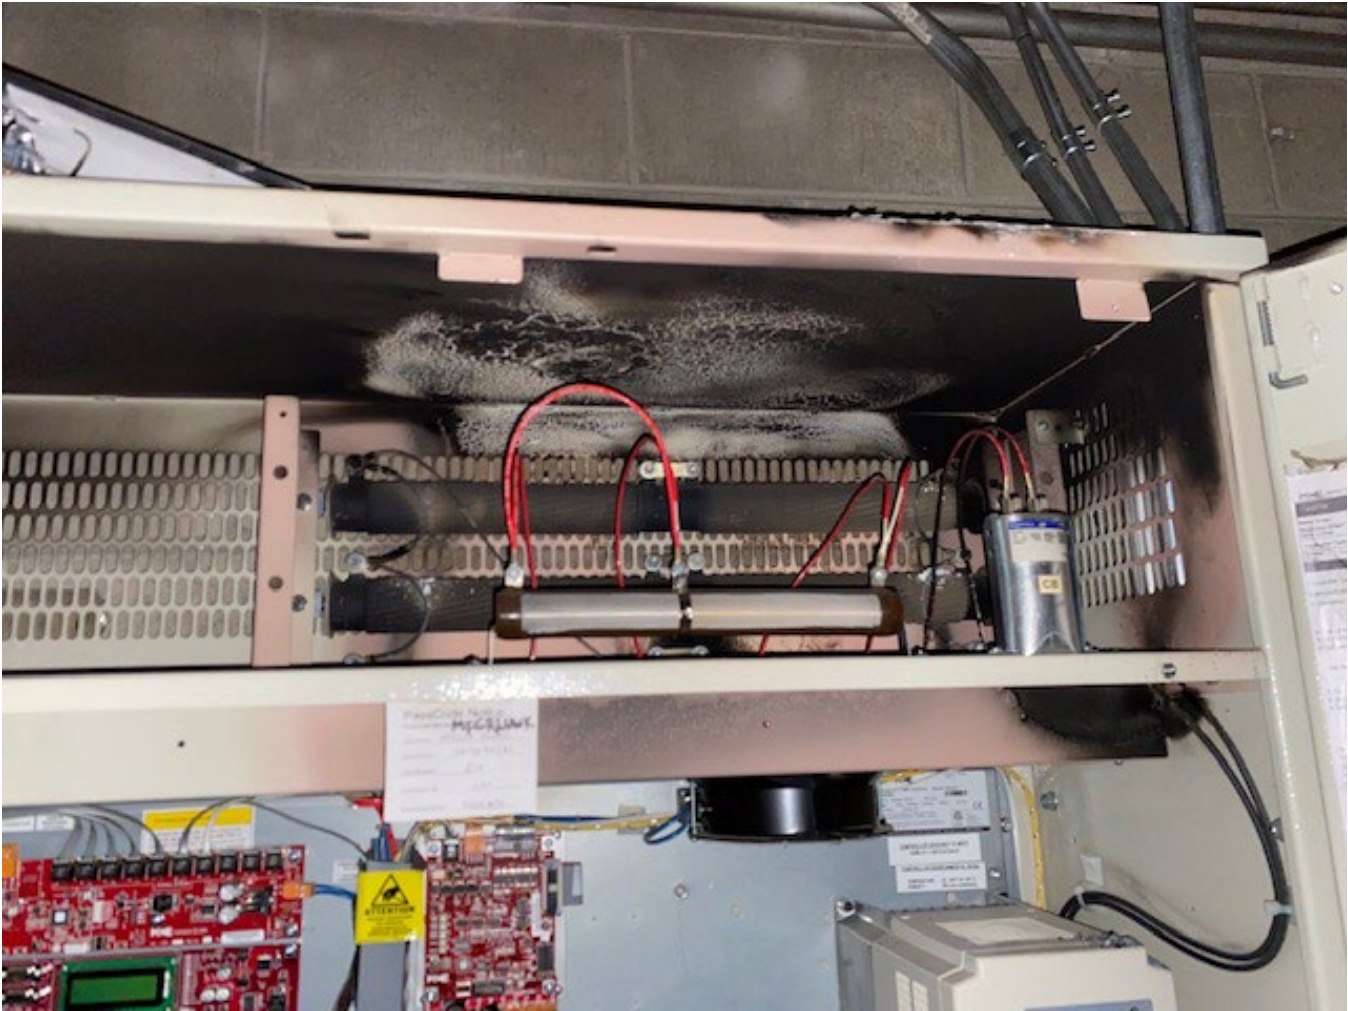
Image 5: Damage caused by heat

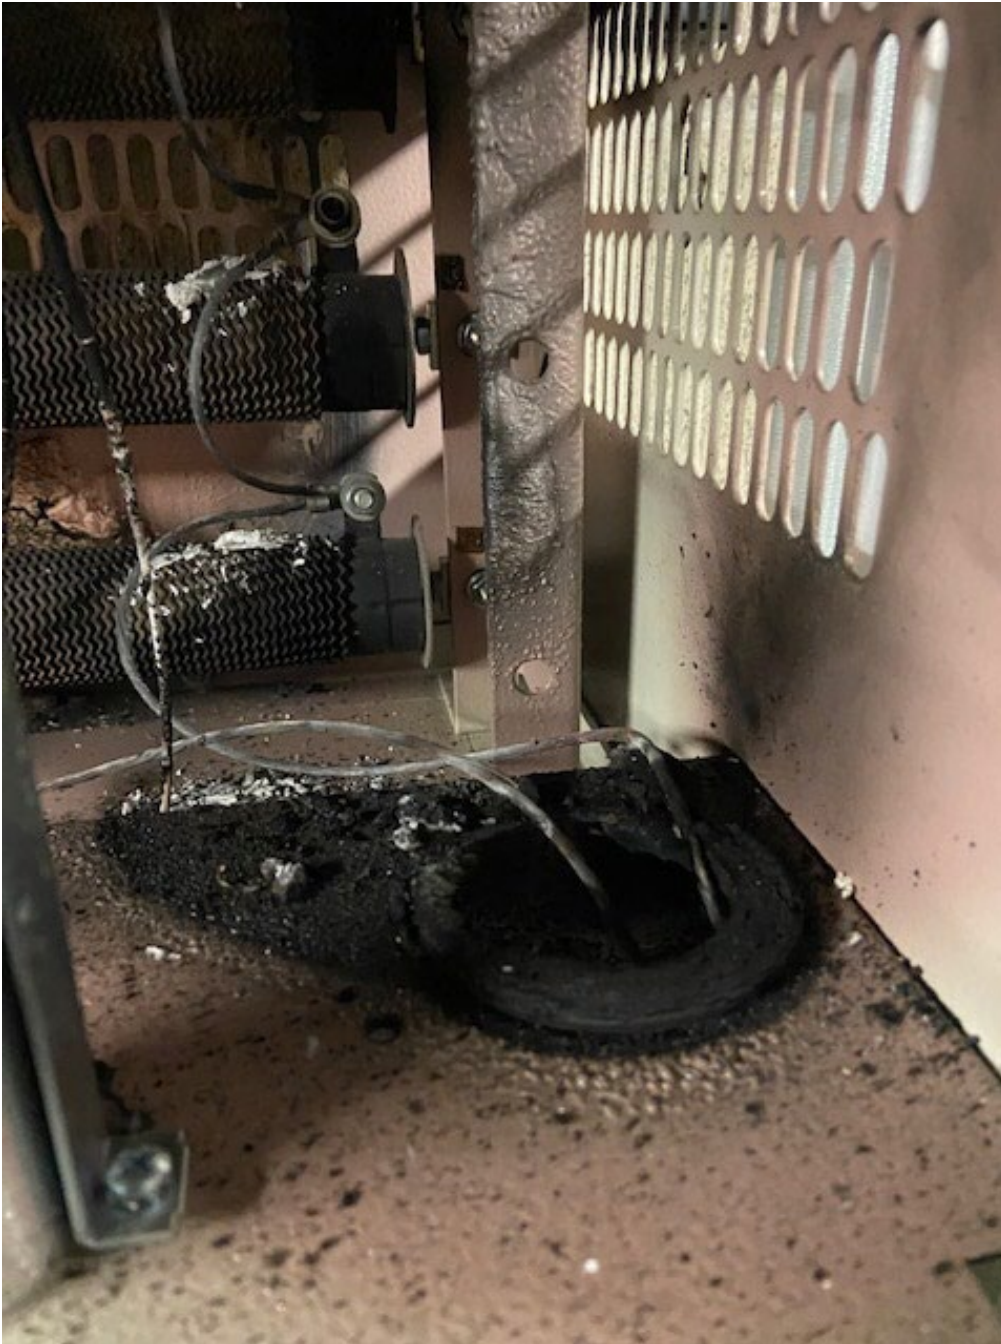
Image 6: Damage caused by heat
