Incident Summary – POSSE #5616585

SUPPORTING INFORMATION	Incident Date			May 02, 2017			
	Location			Trail, BC			
	Regulated industry sector			Electrical – low voltage electrical system (30 to 750 volt)			
	Impact	Injury	Qty injuries	0			
			Injury description	N/A			
			Injury rating	None			
		Damage	Damage description	A 600 volt, 800 amp phase fused equipment disconnect suffered extensive internal damage from a component failure and arcing flashover to the disconnect enclosure. The flashover resulted in an electrical fire inside the disconnect of the conductor insulations and plastic components. The heat from the electrical fire damaged adjacent plastic raceways and conductors installed within a one meter radius of the incident.			
			Damage rating	Moderate			
Incident rating			Moderate				
Incident overview			One of the three blade type moving contacts of a 3 phase, 600 volt, 800 amp fused disconnect had not been making an effective contact when closed. Over time, the faulty connection created a high impedance arcing fault resulting in an overheating condition at the contact point, an eventual breakdown of the contact insulating properties and a short circuit fault to the discon

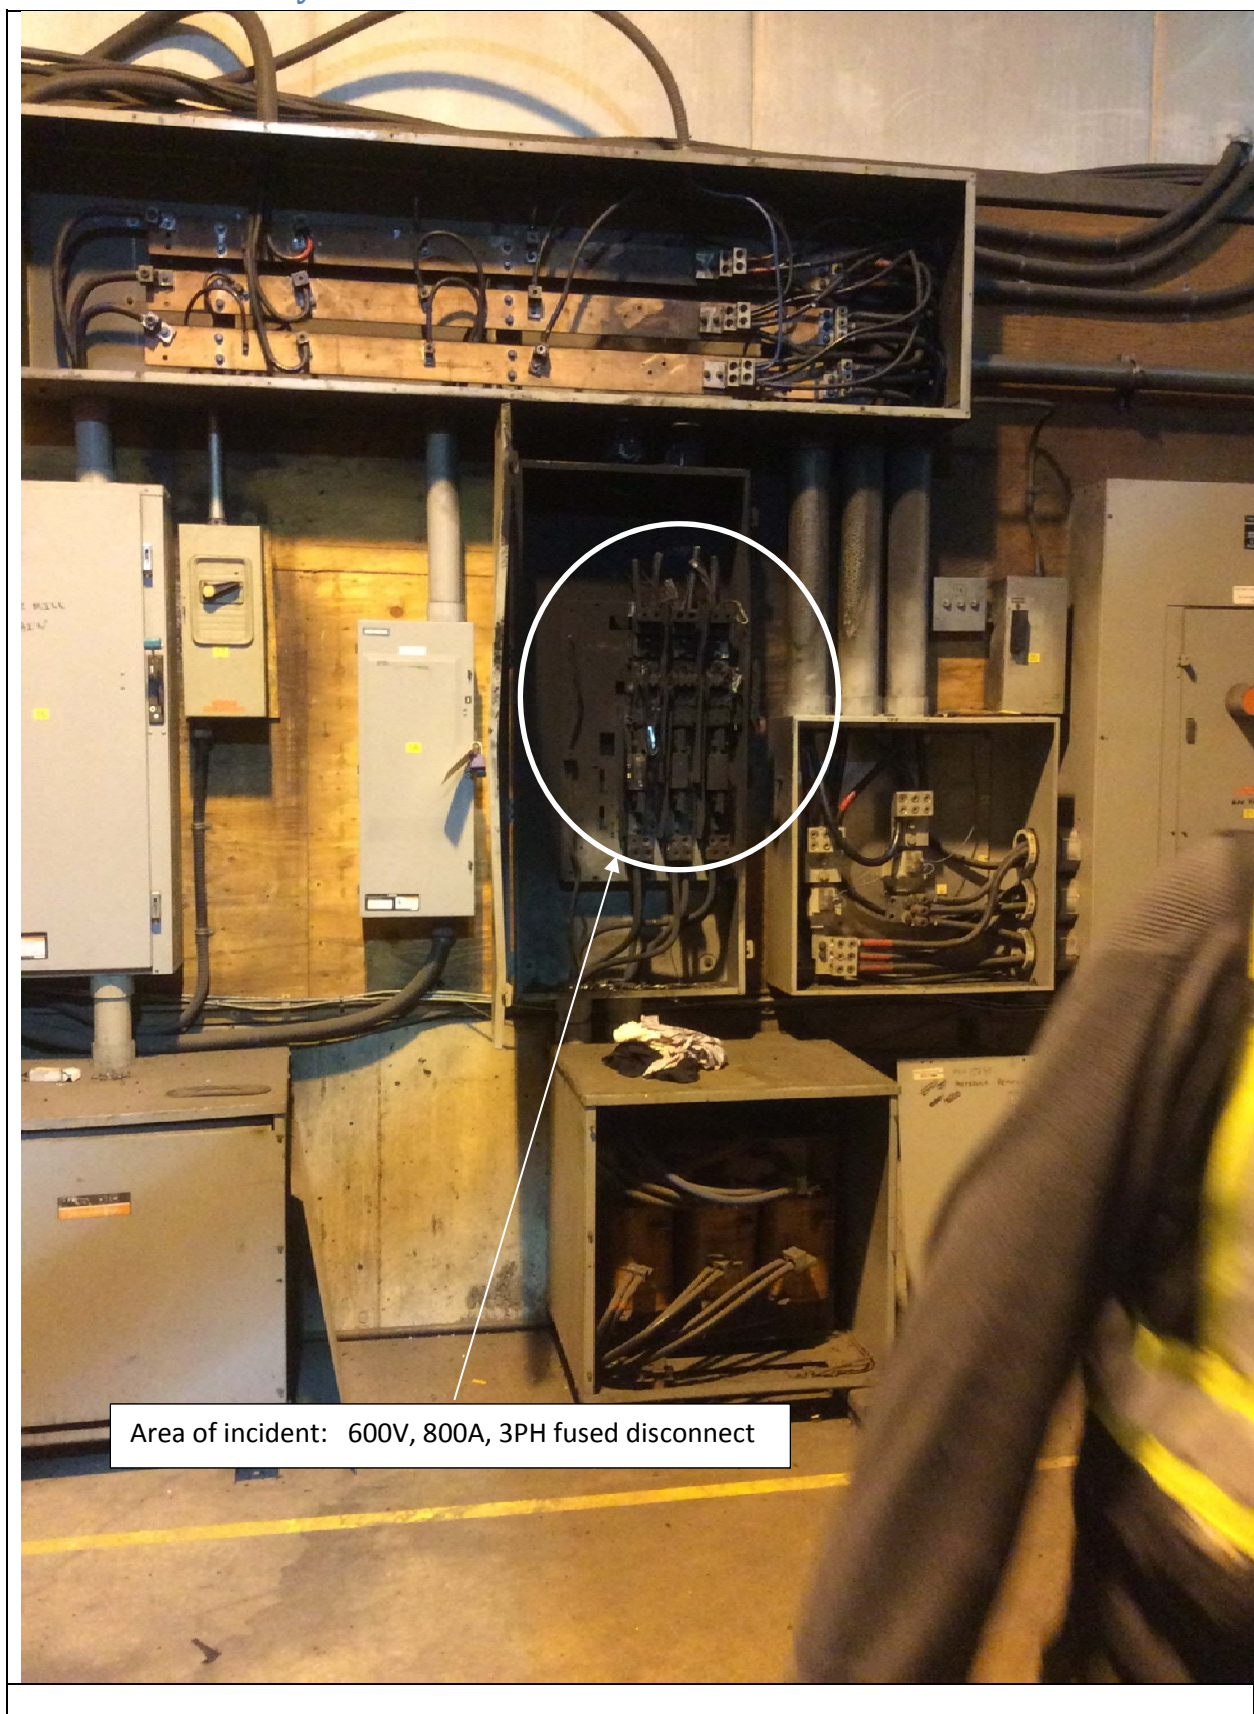
Area of incident: 600V, 800A, 3PH fused disconnect

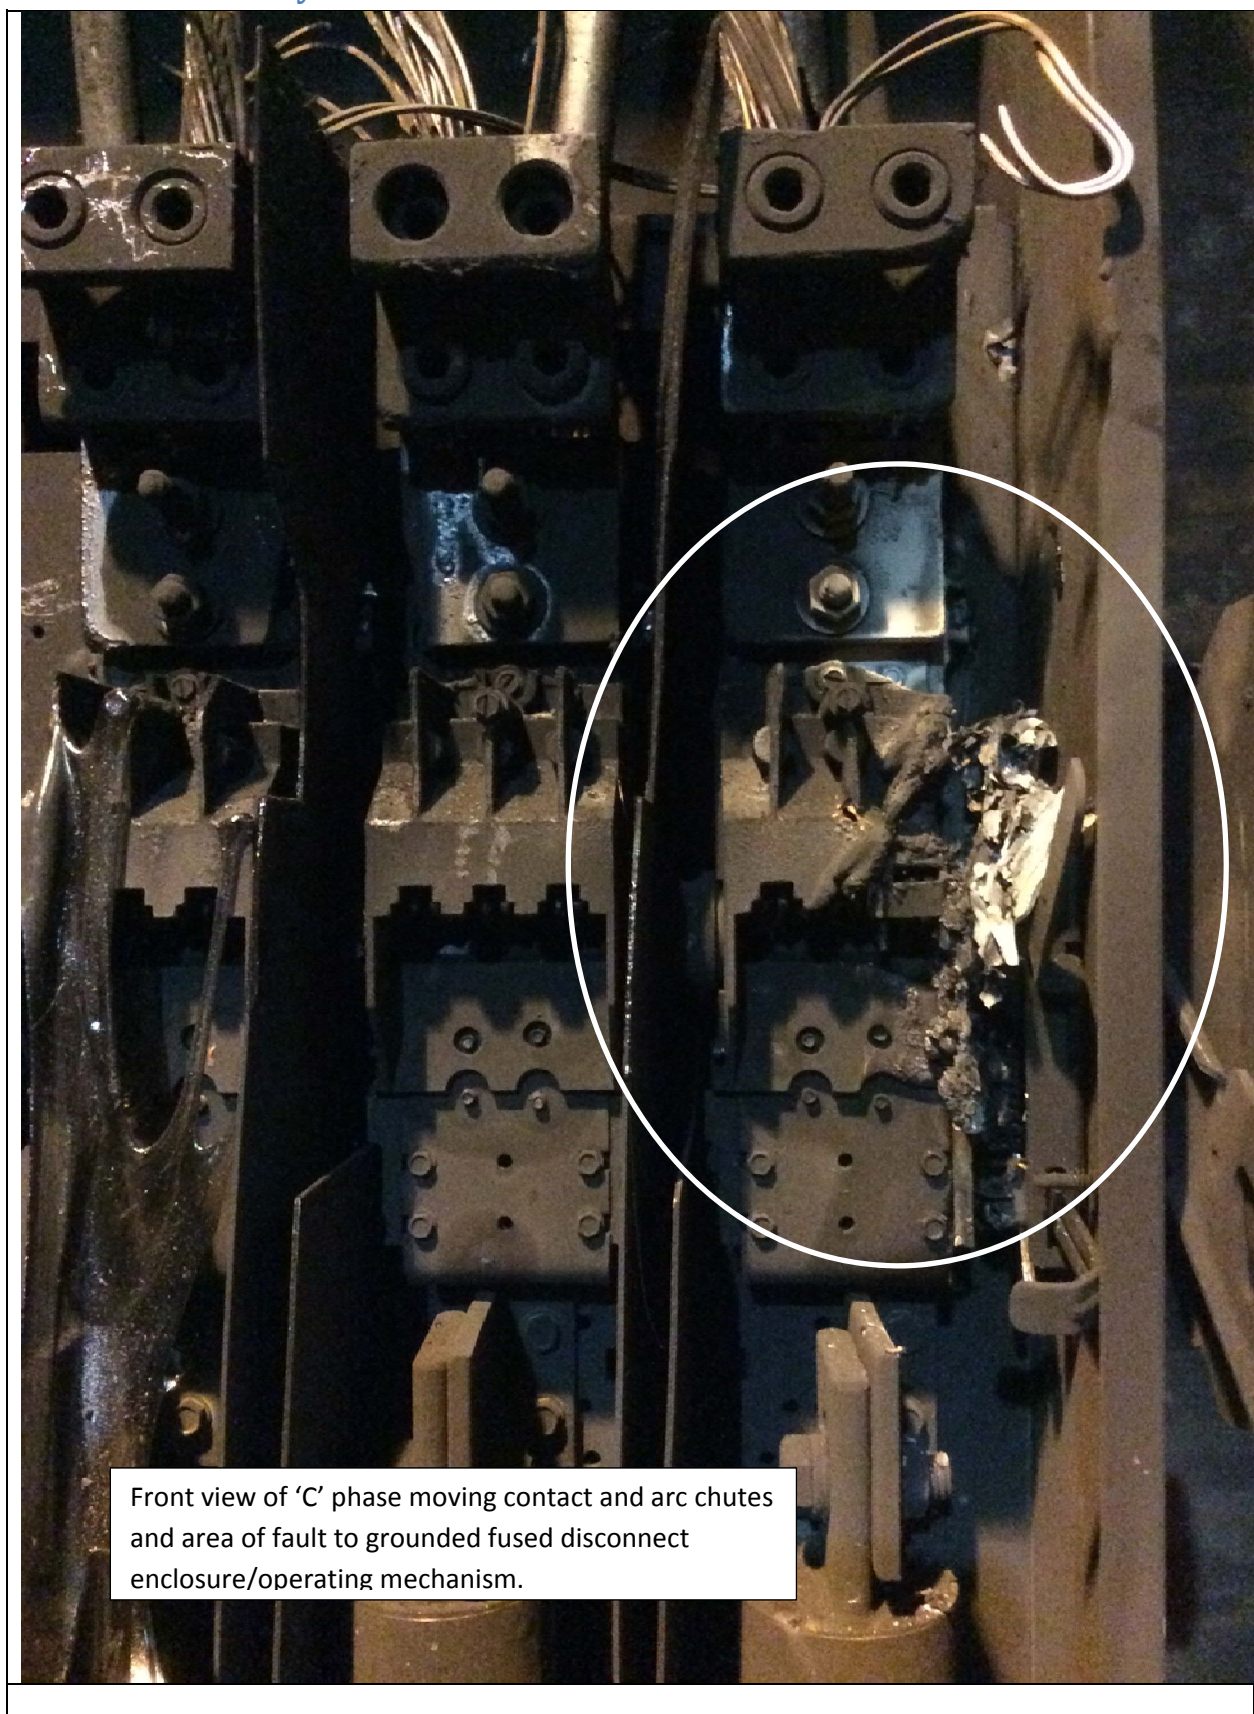
Failure scenario(s)			During the last ‘closed’ operation of the fused disconnect, the ‘C’ phase moving contacts did not engage or mate as designed. The fused disconnect controls and protects equipment that processes and recycles plastics. The connected load is approximately 620 amperes and the process is in operation 24 hours per day on a five day on, two day off cycle. Essentially, the fused disconnect is near the maximum safe operating ampacity during process operation and as such, it is vital that all contacts mate effectively and all conductor terminations are torqued to specifications. The poor contact mating of ‘C’ phase (third phase) created a high impedance condition at the contact point, a dangerous over-temperature condition at the contact which resulted in a breakdown of insulating properties and fault to ground at the ‘C’ phase area. Of note is that the operating handle mechanism, closing/opening springs and

enclosure door hardware are concentrated near the 'C' phase contact area providing several conductive paths for the ground fault once the breakdown occurred.
	Facts and evidence	The plastic recycling process had been in operation for approximately 36 hours since resuming operation after a weekend shutdown. Mid-morning one of the operations employees noted a distinct crackling sound emanating from the power distribution equipment area. He walked over and noted smoke and sparks in and around the fused disconnect. He immediately requested assistance from another employee and notified his supervisors who contacted local fire/rescue via 911. During the arcing and fire incident, the disconnect fuses opened under fault current conditions and upstream overcurrent circuit breaker protection operated as coordinated. The fire continued until fire/rescue personnel arrived and extinguished the fire.
	Causes and contributing factors	<p>Post fire investigation revealed that all conductor terminations in the switch were tight to specifications, all conductors are correctly sized, overcurrent protection fuses are correctly sized.</p> <p>Observations and discussion with staff and maintenance personnel did not identify any lack of attention or lack of maintenance: during the past twelve month period all equipment was thermal scanned for 'hot spots', equipment was surveyed and operated, conductor terminations were checked, nothing untoward was noted. Examination of adjacent equipment confirms a satisfactory level of maintenance; equipment is kept in good working order and in good condition.</p> <p>All indications point toward an internal equipment failure in and about the 'C' phase contact point of the fused disconnect resulting in an electrical fire incident.</p>

Front view of 'C' phase moving contact and arc chutes and area of fault to grounded fused disconnect enclosure/operating mechanism.

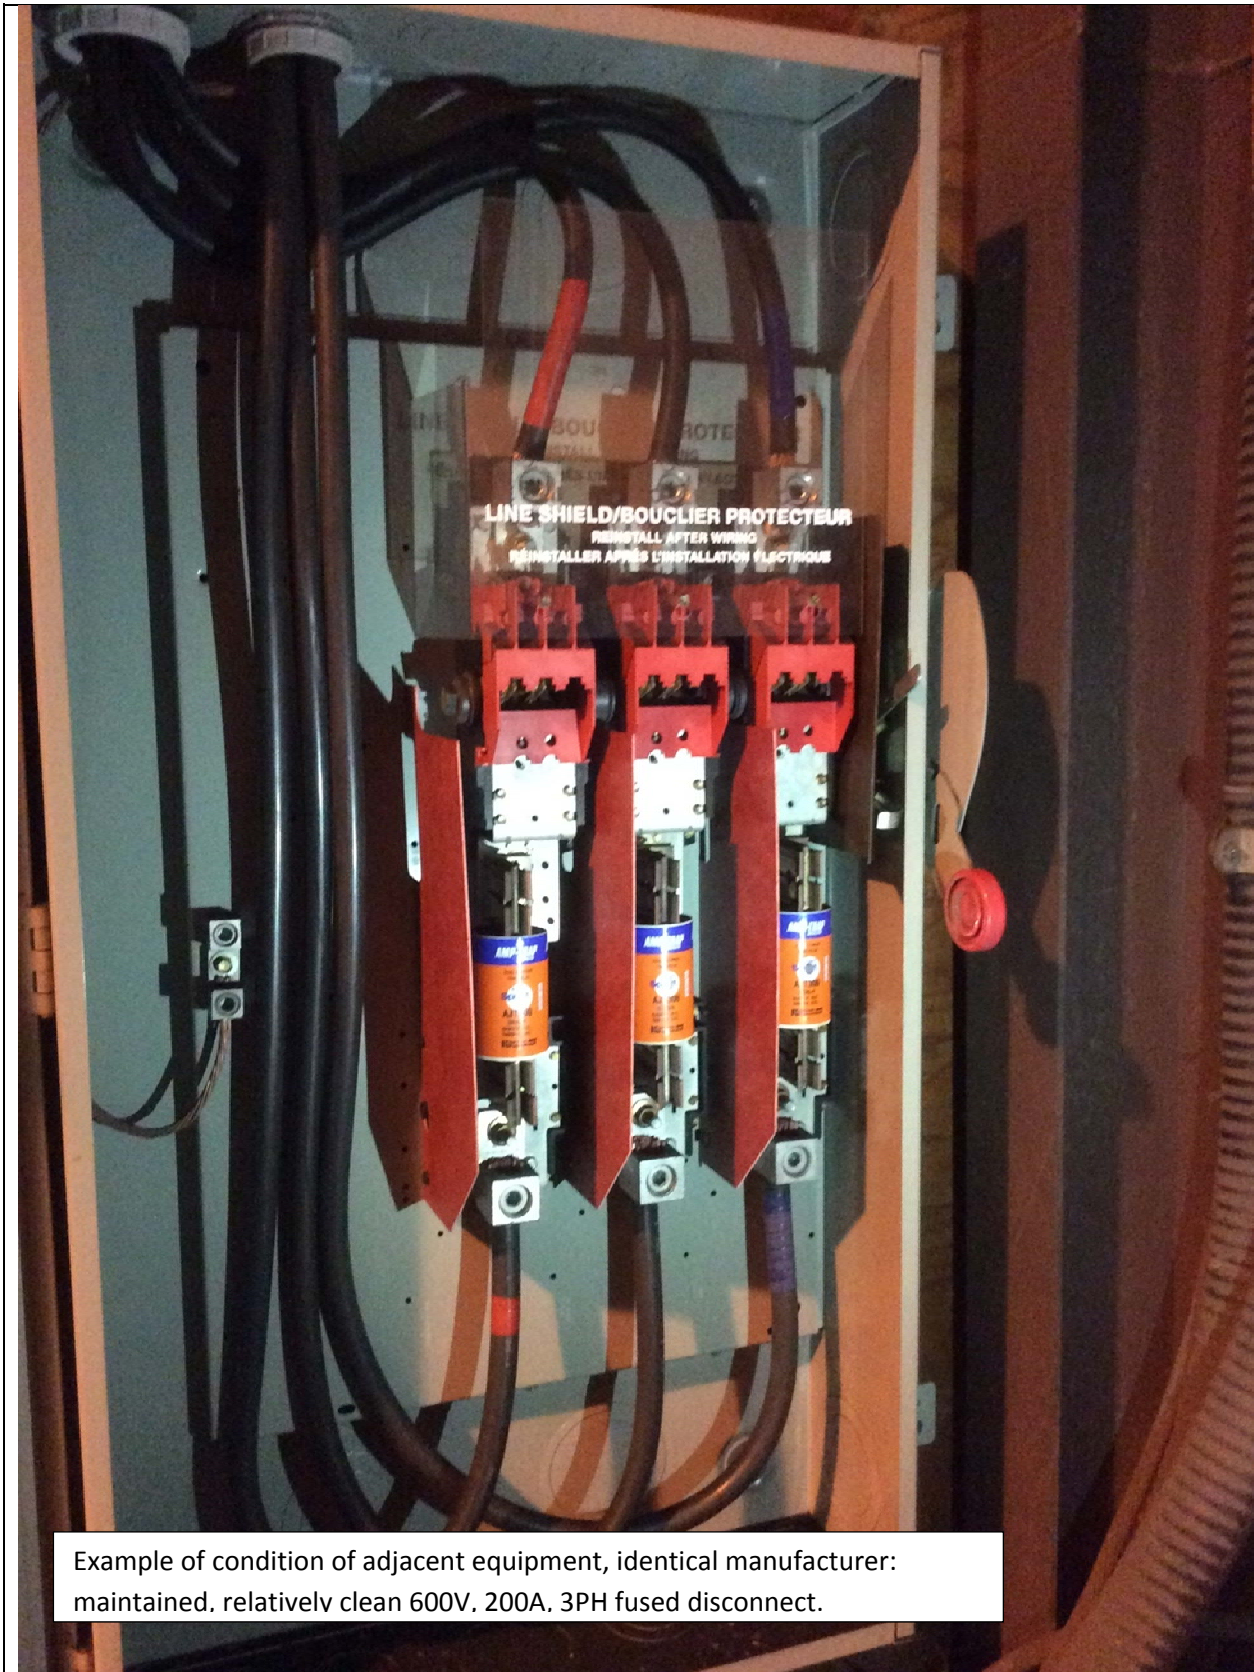
Example of condition of adjacent equipment, identical manufacturer: maintained, relatively clean 600V, 200A, 3PH fused disconnect.

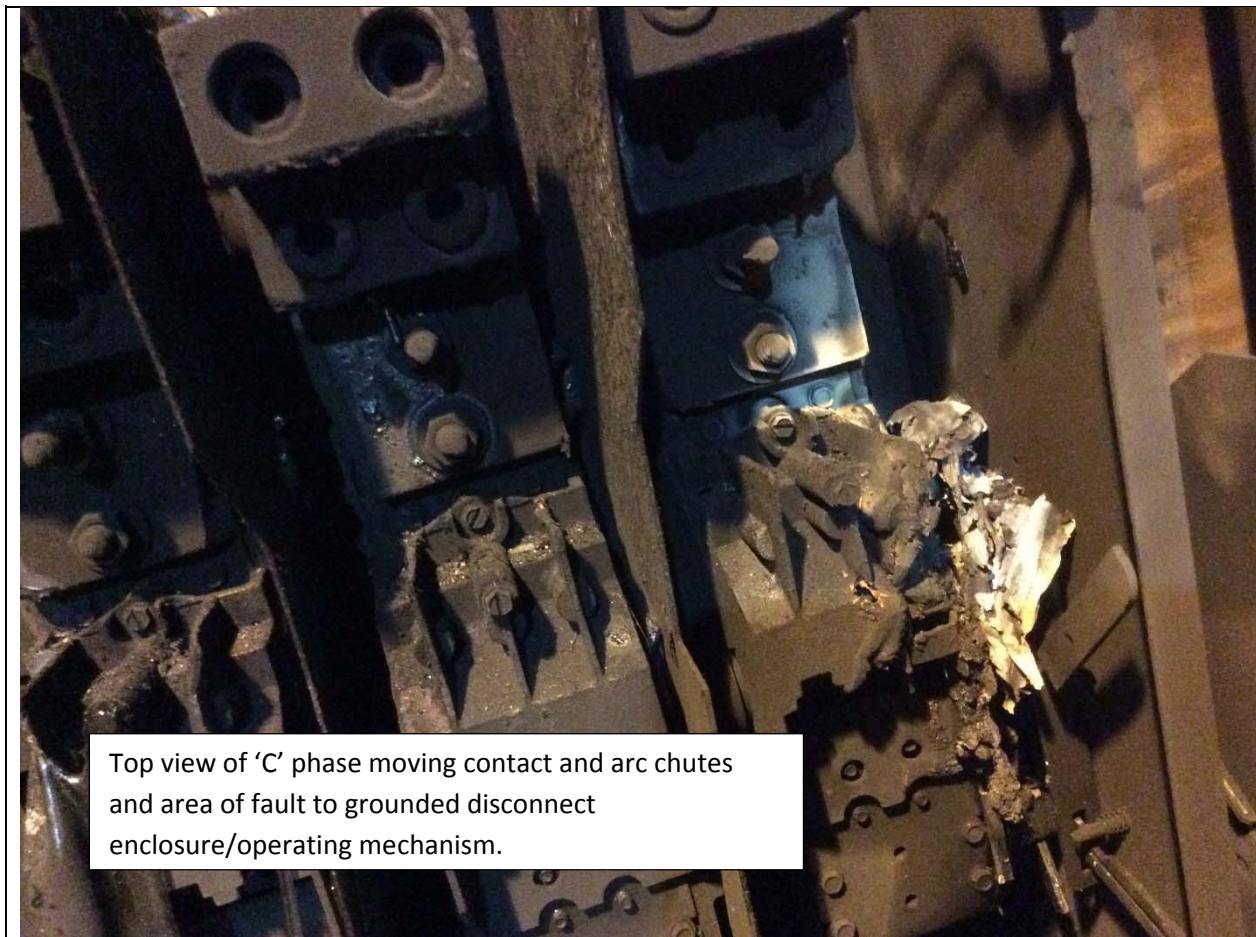
Top view of 'C' phase moving contact and arc chutes and area of fault to grounded disconnect enclosure/operating mechanism.
