## Incident Summary #II-947637-2019 (#16026) (FINAL)

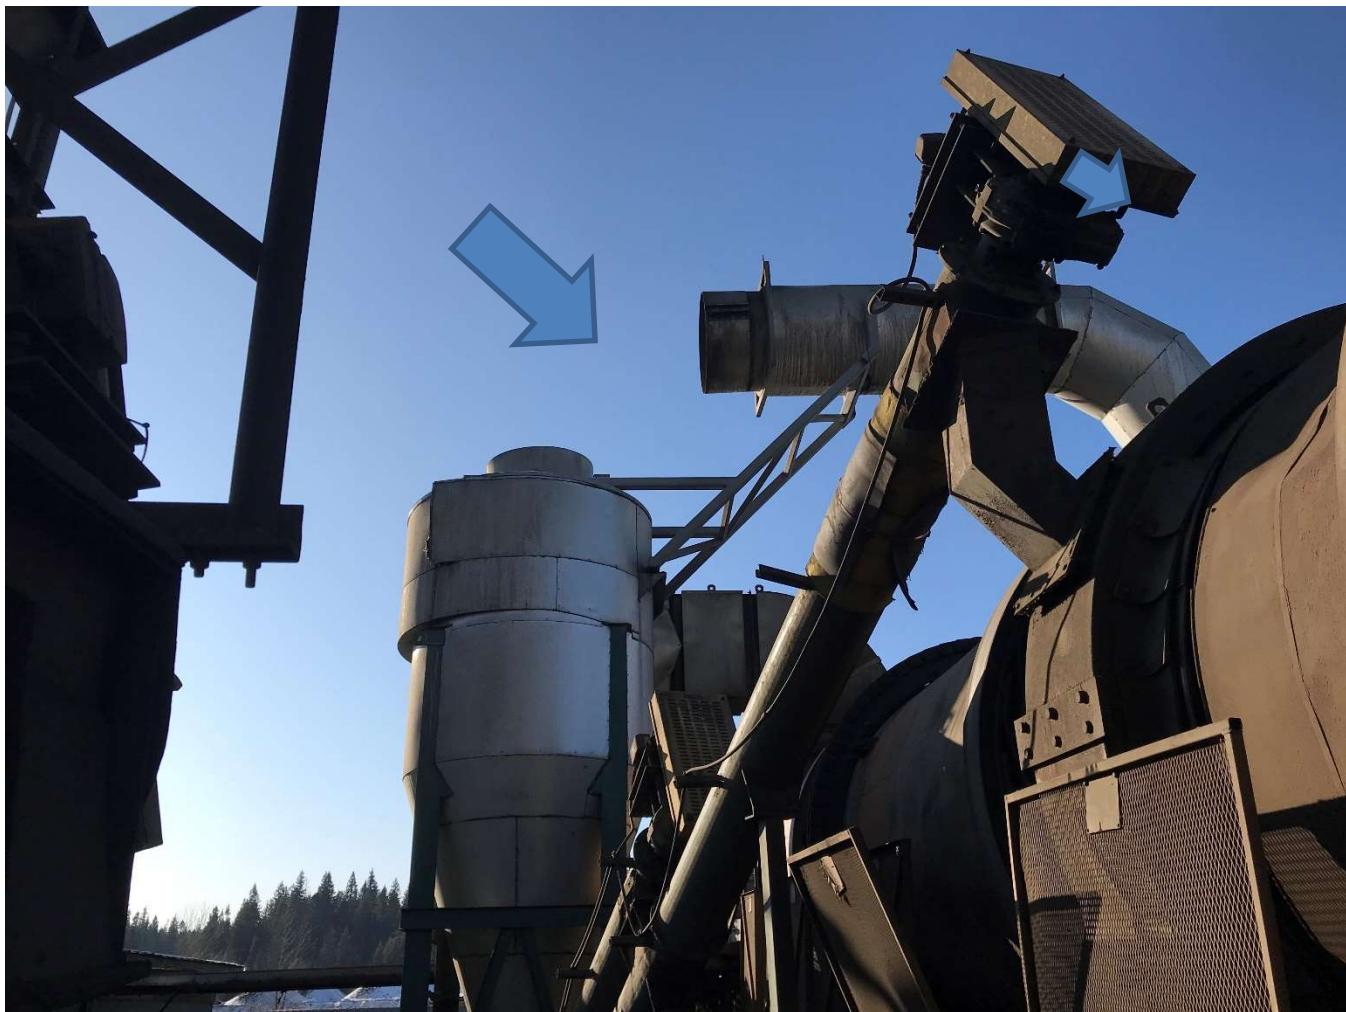
Image 1 – Showing missing 48" ducting exhaust elbow that blew off from the explosion

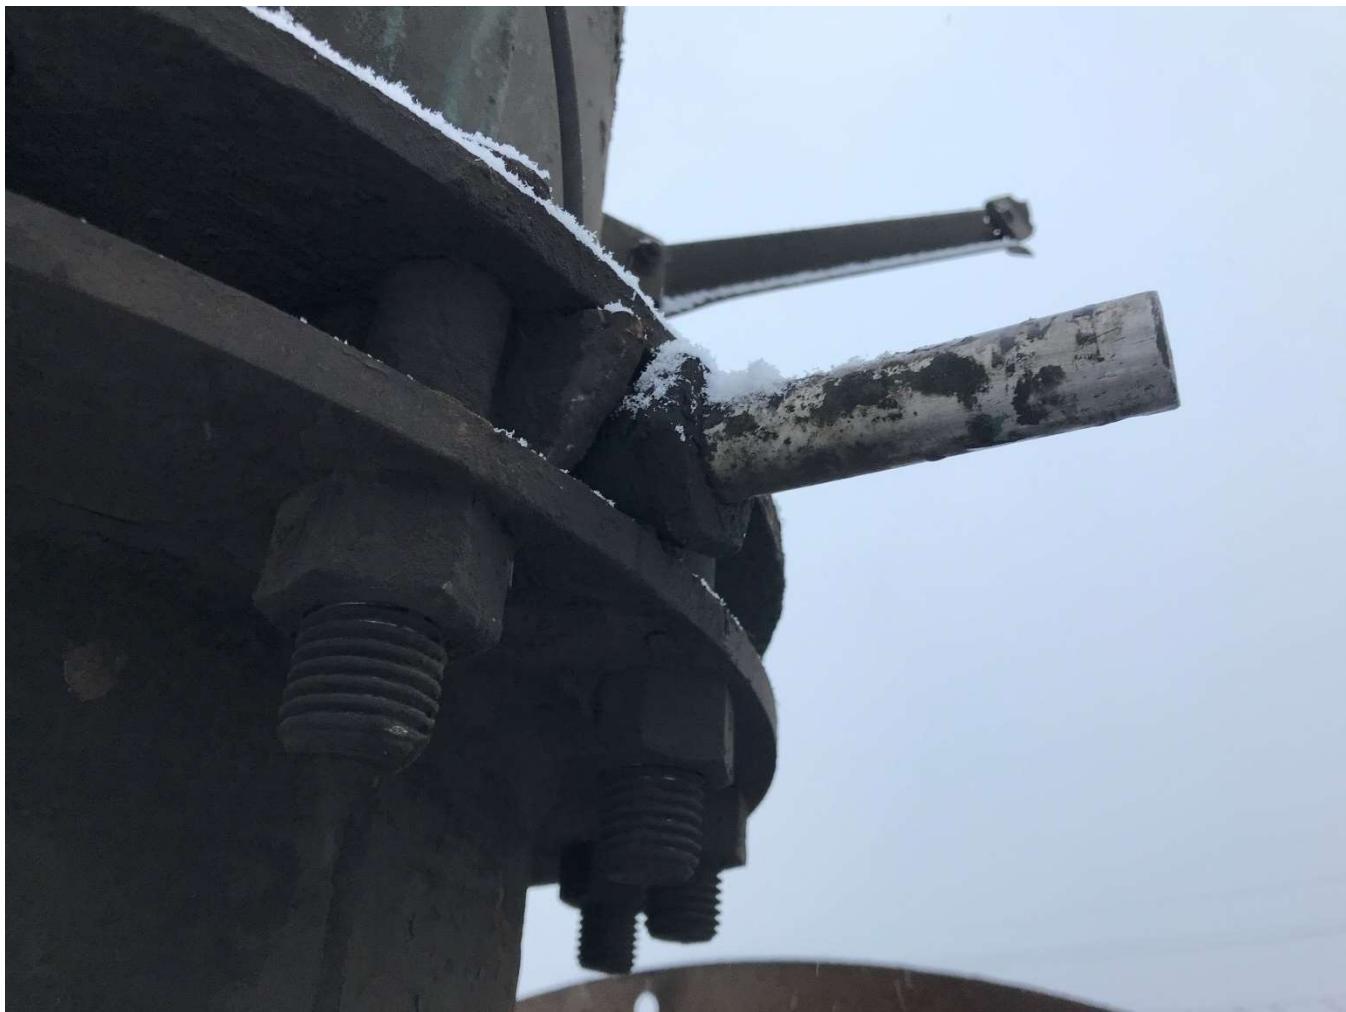
<b>Causes and contributing factors</b>	<p>It is highly likely that continued operation of the plant without proper repair of the combustion air damper operation allowed for failed ignition attempts and inadequate purging of the system. This allowed gas to accumulate inside the dryer drum causing an explosion.</p> <p>The damaged burner ring, leaking gas train shut off valves, failure to upgrade the non-functioning combustion air switches and inadequate purge time of two minutes likely were contributing factors to the explosion.</p>

Image 2 – Combustion air damper shaft showing missing actuator arm and markings indicating arm slippage

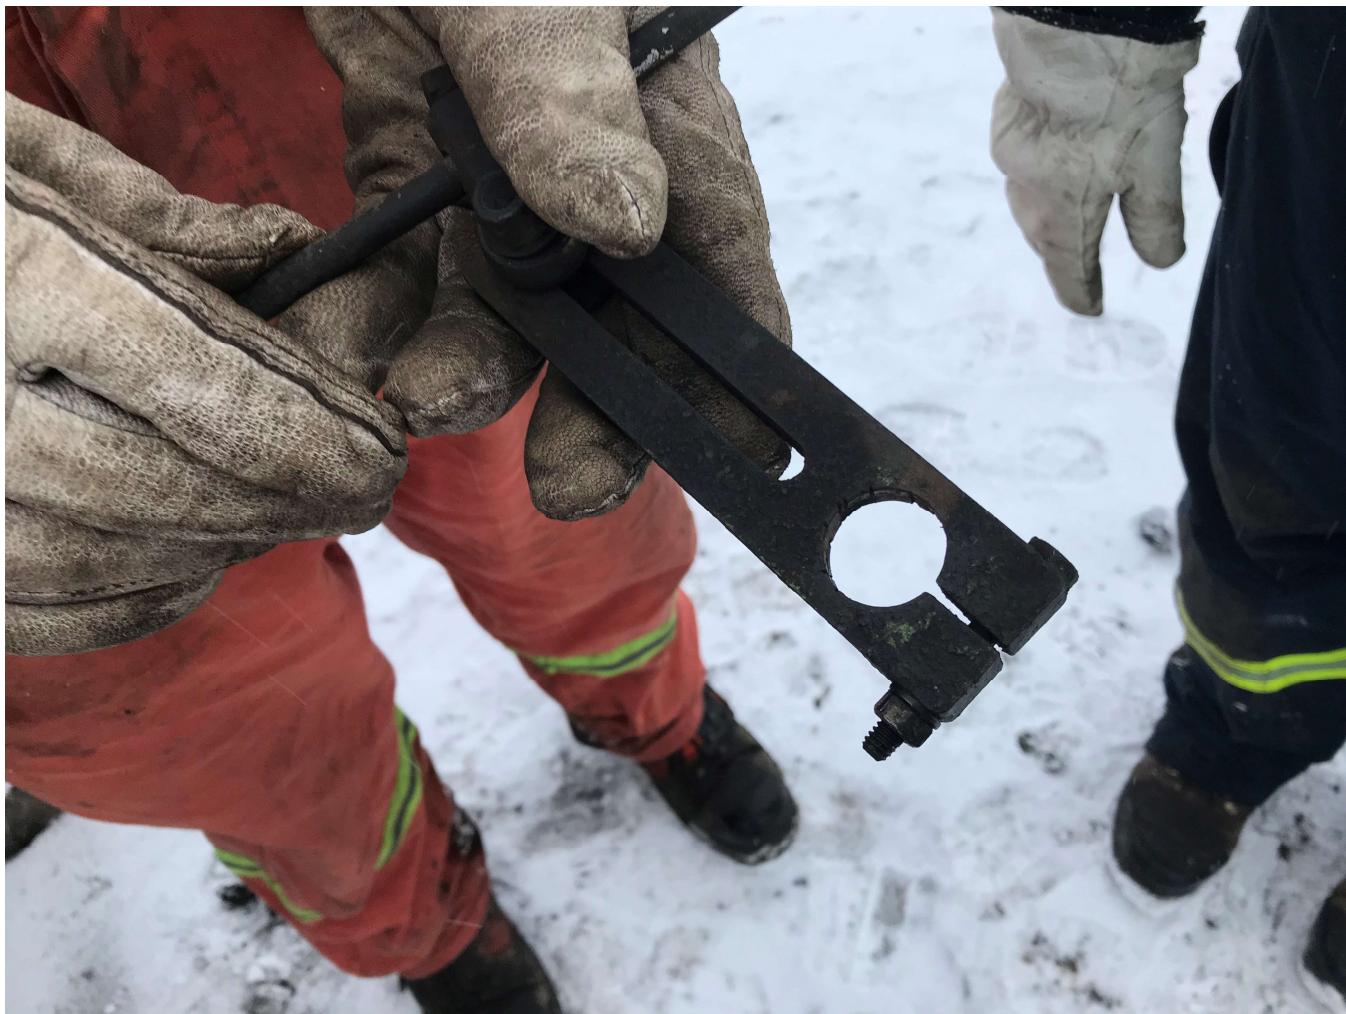
Image 3 – Detached combustion air damper actuator arm

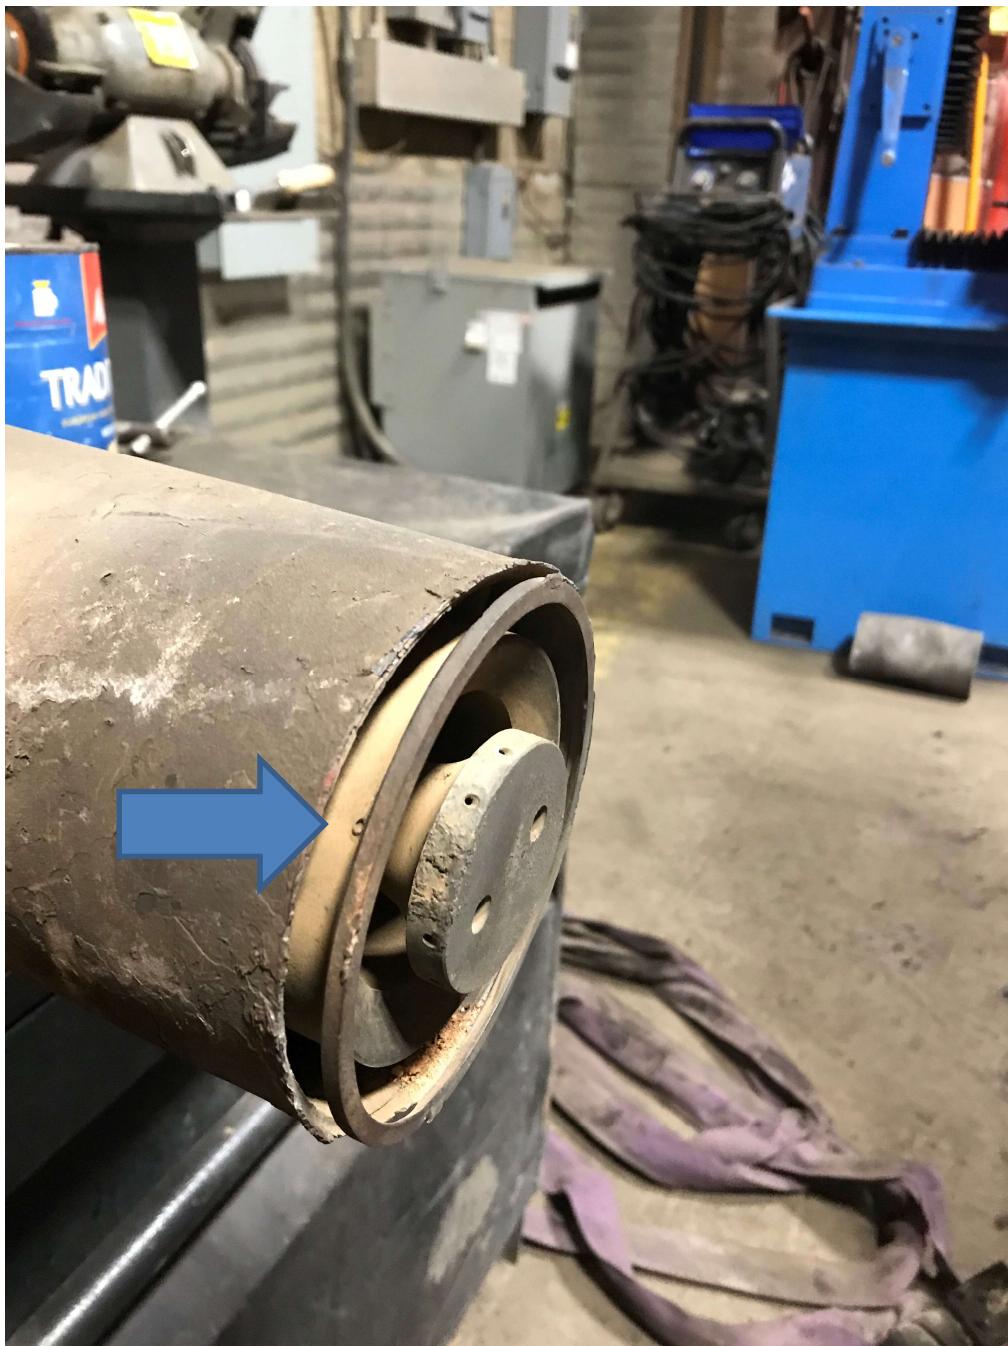
Image 4 – Burner after removal showing breakage and gap between the outer shell and the rim of the air diffuser (Blue arrow). This can disrupt the combustion air flow and allow air to leak out the side. This can contribute to an unstable air fuel ratio at the point of ignition from the pilot light causing intermittent burner ignition and unstable operation.
