Incident Summary II-680863-2018 (7047)

SUPPORTING INFORMATION	Incident Date	<i>May 3rd, 2018</i>	
	Location	<i>Prince George, BC</i>	
	Regulated industry sector	<i>Low Voltage Electrical System (30V to 750V)</i>	
	Impact	Qty injuries	<i>No injuries</i>
		Injury description	<i>N/A</i>
		Injury rating	<i>N/A</i>
	Damage	Damage description	<i>An appliance used within the car wash facility ignited nearby combustible materials. The ignited material damaged the adjacent equipment, affecting the operation of the car wash.</i>
		Damage rating	<i>Minor</i>
Incident rating	<i>Minor</i>		
Incident overview	<i>An electric water heater for the car wash was installed on a piece of plywood. After a year or so of operation the plywood the water heater was mounted to started on fire. The fire was discovered immediately and extinguished by an employee with a fire extinguisher. The water heater was damaged during the incident.</i>		
INVESTIGATION CONCLUSIONS	Site, system and components	<i>The electric water heater was one component in the functioning carwash. The electric water heater would heat up water as it flowed through the heater. The water heater had an outside metal case covering the insulat

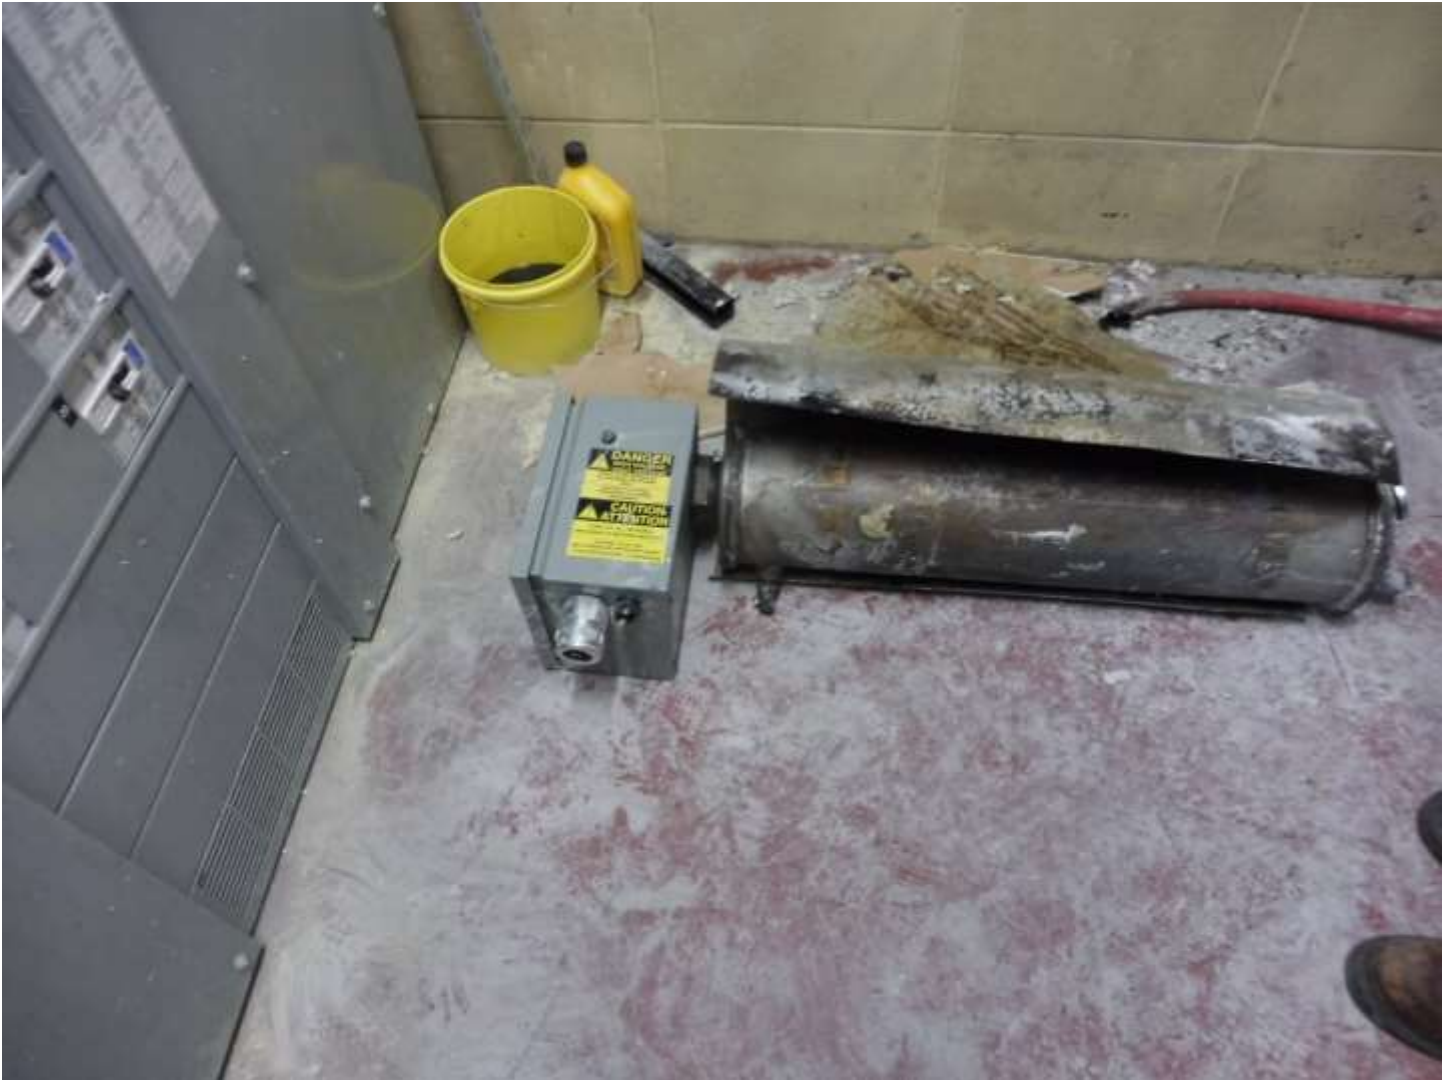
Failure scenario(s)	<p>The electric water heater was found on the floor of the car wash equipment room. The heat shield around the outside of the water heater was separated from the water heater with most of the insulation missing. At the location where it had been mounted, the existing plywood was scorched and burnt. The plywood appeared to have the most damage right behind where the electric heater had been installed.</p> <p>In the manufactures instructions it was noted that there were no warnings or instructions on what type of surface this electric water heater should be installed onto. In discussions with the onsite electrician it was determined that at another car wash site the water heater was mounted directly on a non-combustible cinder block wall. The electrician was clear that these water heater get very hot on their outside surface.</p> <p>The regulated product was working normally. The failure was in how the product was originally installed.</p>

A picture of the electric water heater
after the fire.

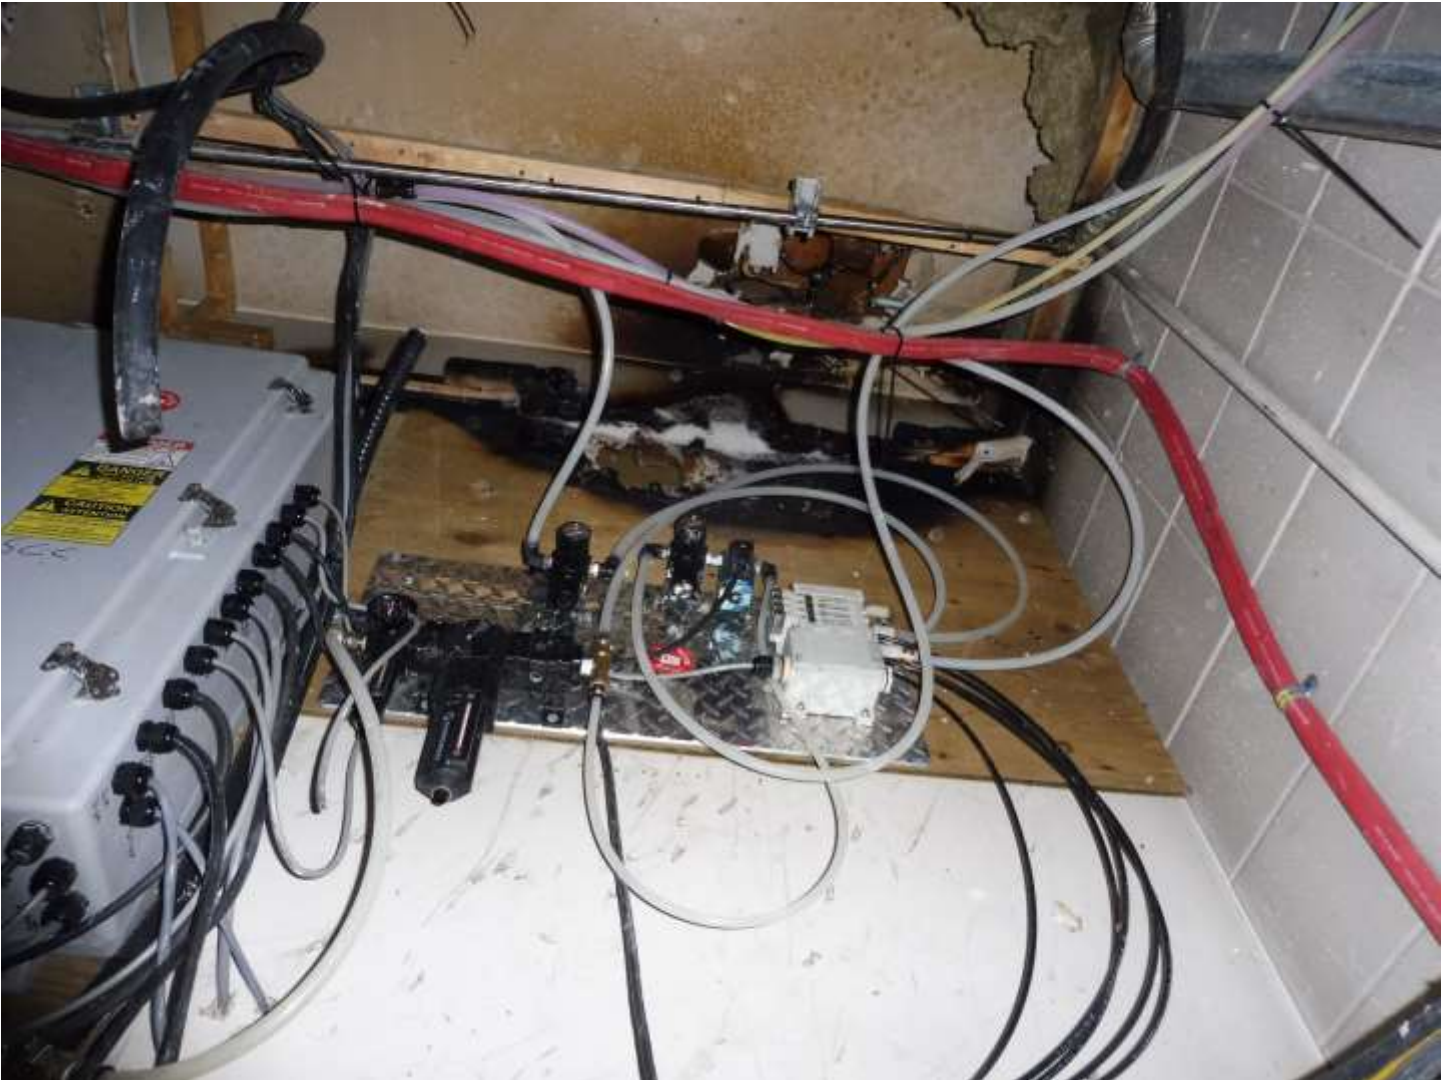
Facts and evidence	<i>The failure was not with the product itself but with the products accompanying installation instructions. There is no mention of what type of material the product should be mounted onto. For example (mount only on a non-combustible surface).</i>	
	Causes and contributing factors	<i>The amount of heat produced on the outside surface of the electric water heaters heat shield may have been sufficient to ignite the combustible plywood it was mounted to. The manufactures instruction manual for this water heater has no warnings or specific instruction detailing what type of surface the water heater should be mounted to.</i>

The location of the electric water heater at the time of the fire. The plywood it was mounted to started on fire.

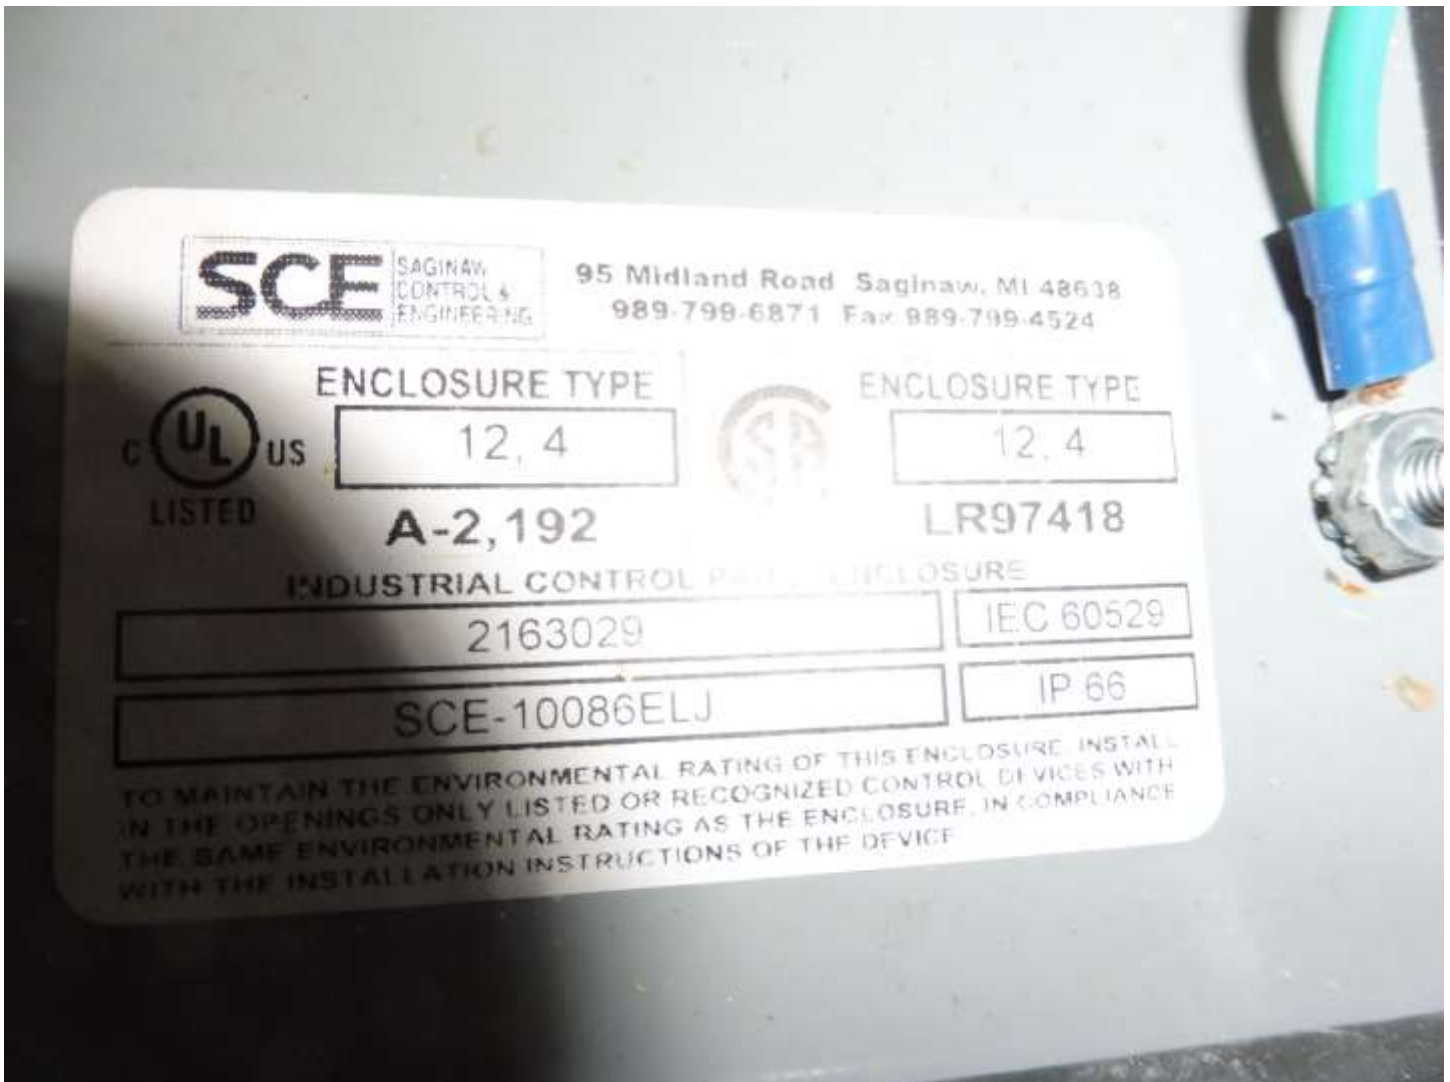
The certification label for the enclosure and industrial control panel.
