Incident Summary #II-840786-2019 (#11824) (FINAL)

SUPPORTING INFORMATION	Incident Date	March 29, 2019	
	Location	Kamloops	
	Regulated industry sector	Amusement Devices - Waterslide	
	Impact	Qty injuries	1
		Injury description	Bruising and swelling on top of head
		Injury rating	Minor
	Damage	Damage description	None
		Damage rating	None
	Incident rating	Minor	
Incident overview	Rider hit head on top of fully enclosed waterslide.		
INVESTIGATION CONCLUSIONS	Site, system and components	A waterslide consists of a flume with water being pumped onto flume. The waterslide discharges the flowing water into a run out lane, a horizontal flume with a maintained level of water. The flume is fully enclosed (tunnel) until the run out lane. The flume sections are bolted together. The CSA Z267-00 standard requires the flume shall be continuous and smooth and contact with riders will likely not cause injury. Waterslide manufacturer operating guidelines define the correct rider position is lying on back feet first arms and legs crossed. This position must be maintained until rider comes to complete stop in run out lane. Signage is in place to instruct riders of proper position and conduct. Prior to

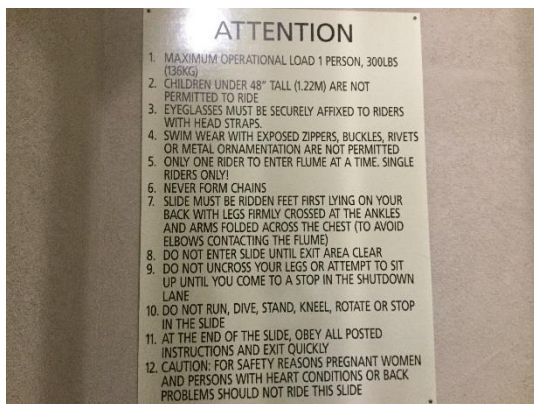
Photo 1: Waterslide Rules

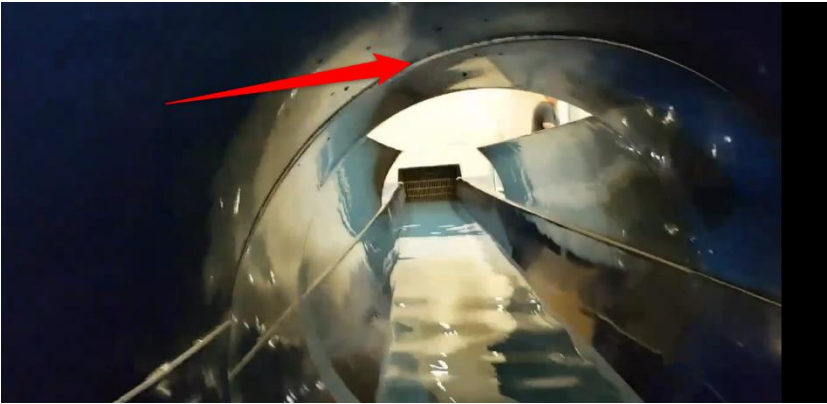
Failure scenario(s)	Pre-operational inspection not being completely satisfied, a part of the flume was not smooth and continuous. Attendant supervising the use of the waterslide is at a remote location performing other duties while discontinuously watching on a video monitor. The rider was in an upright position while sliding.	
	Facts and evidence	<p><u>Reported by the injured:</u></p> <ul style="list-style-type: none"> - Hit head on a protruding upper edge of tunnel flume sections - Golf ball size bruising and swelling on head for a week - Understood rules indicate to be in laying down position <p><u>Reported by Operator:</u></p> <ul style="list-style-type: none"> - Waterslide had maintenance performed by a third party within the last month - Rider complained to operator about hitting head

Photo 2: Misaligned flume connection prior to run out lane

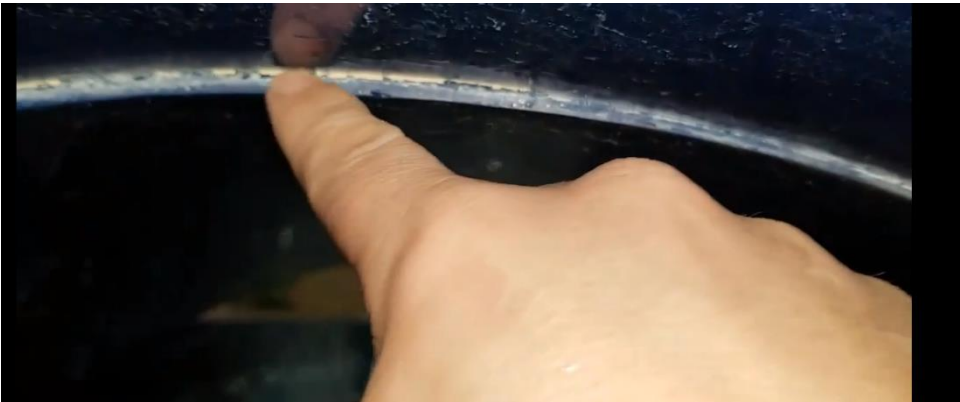
Photo 3: 1/4" protruding edge at flume connection
