Incident Summary #II-1349384-2022 (#26792) (FINAL)

SUPPORTING INFORMATION	Incident Date	March 27, 2022	
	Location	Invermere BC	
	Regulated industry sector	Electrical - Low voltage electrical system (30V to 750V)	
	Impact	Qty injuries	0
		Injury description	N/A
		Injury rating	None
	Damage	Damage description	Commercial hot water tank was damaged beyond repair due to an electrical fire contained within the electrical components of hot water tank unit.
		Damage rating	Moderate
	Incident rating	Moderate	
	Incident overview	A commercial hot water tank located in mechanical room of lodge had a fire that was contained within the electronic control module of unit. A Fire alarm triggered, and an overcurrent device tripped. The fire had extinguished itself by the time maintenance personnel attended area. Damage had left the unit beyond repair. No damage occurred beyond unit.	
INVESTIGATION CONCLUSIONS	Site, system and components	<p>A commercial hot water tank (HWT) has an electronic control module. This module contains all the electrical connections and internal wiring in the hot water tank unit. The internal wiring of the hot water tank unit is designed with a thermostat that controls the

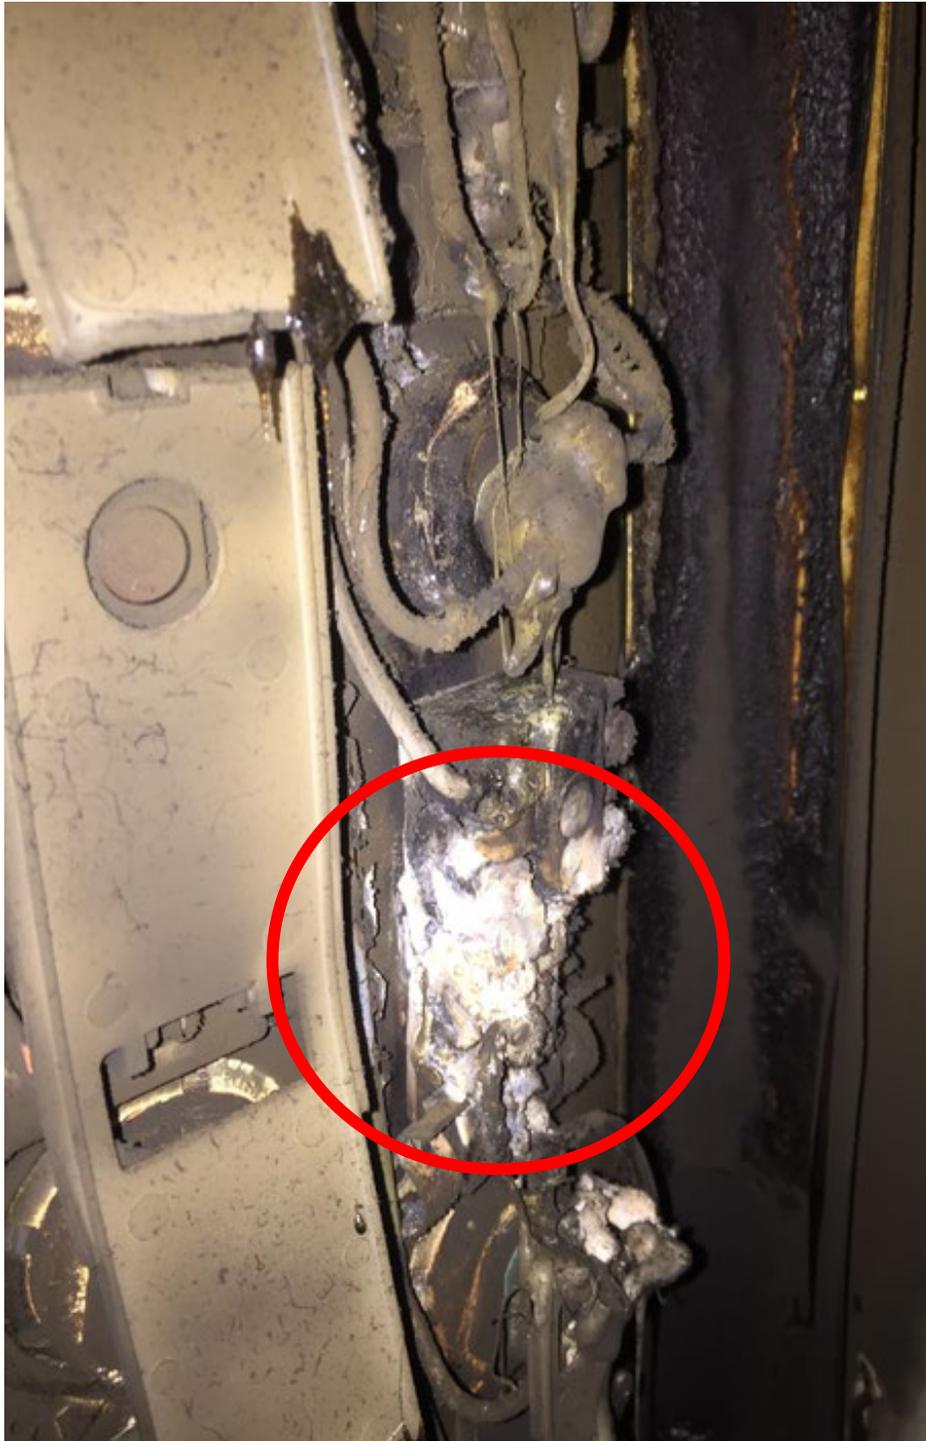
<p>heating element #2. The bulk of the damage, melting and component disfiguration is in this area. A white ash like substance remains around the termination points on this element indicating where the fire was burning the hottest.</p> <p>Smoke and fire debris damage observed throughout the entirety of the electrical control module of hot water tank unit.</p> <p>Upstream from the hot water tank is a heavy-duty safety switch located within site of the hot water tank unit. The safety switch was found locked in the open/off position.</p> <p>In an adjacent room is the main distribution equipment/ panel board for the building. This panel board houses the breaker overcurrent device for the hot water tank. The overcurrent device was in the tripped/open position.</p> <p>The field wired electrical cable was installed from the load side of the hot water tank unit overcurrent device in the main distribution panel, to the local safety switch disconnect, and then from the safety switch disconnect to the hot water tank unit. All terminations where complete.</p> <p>All components of this electrical circuit were found to be correctly sized.</p>

Causes and contributing factors	<p>It is very likely that overtime due to the thermal effects of the hot water tank unit that the heating element #2 termination point(s) where the conductors electrically connect to the heating element became loose. This very likely created an arcing condition which weakened the affected materials and in time created an electrical fire and a short circuit condition.</p>

Photo 1 - Heating Element #2 point of origin damage

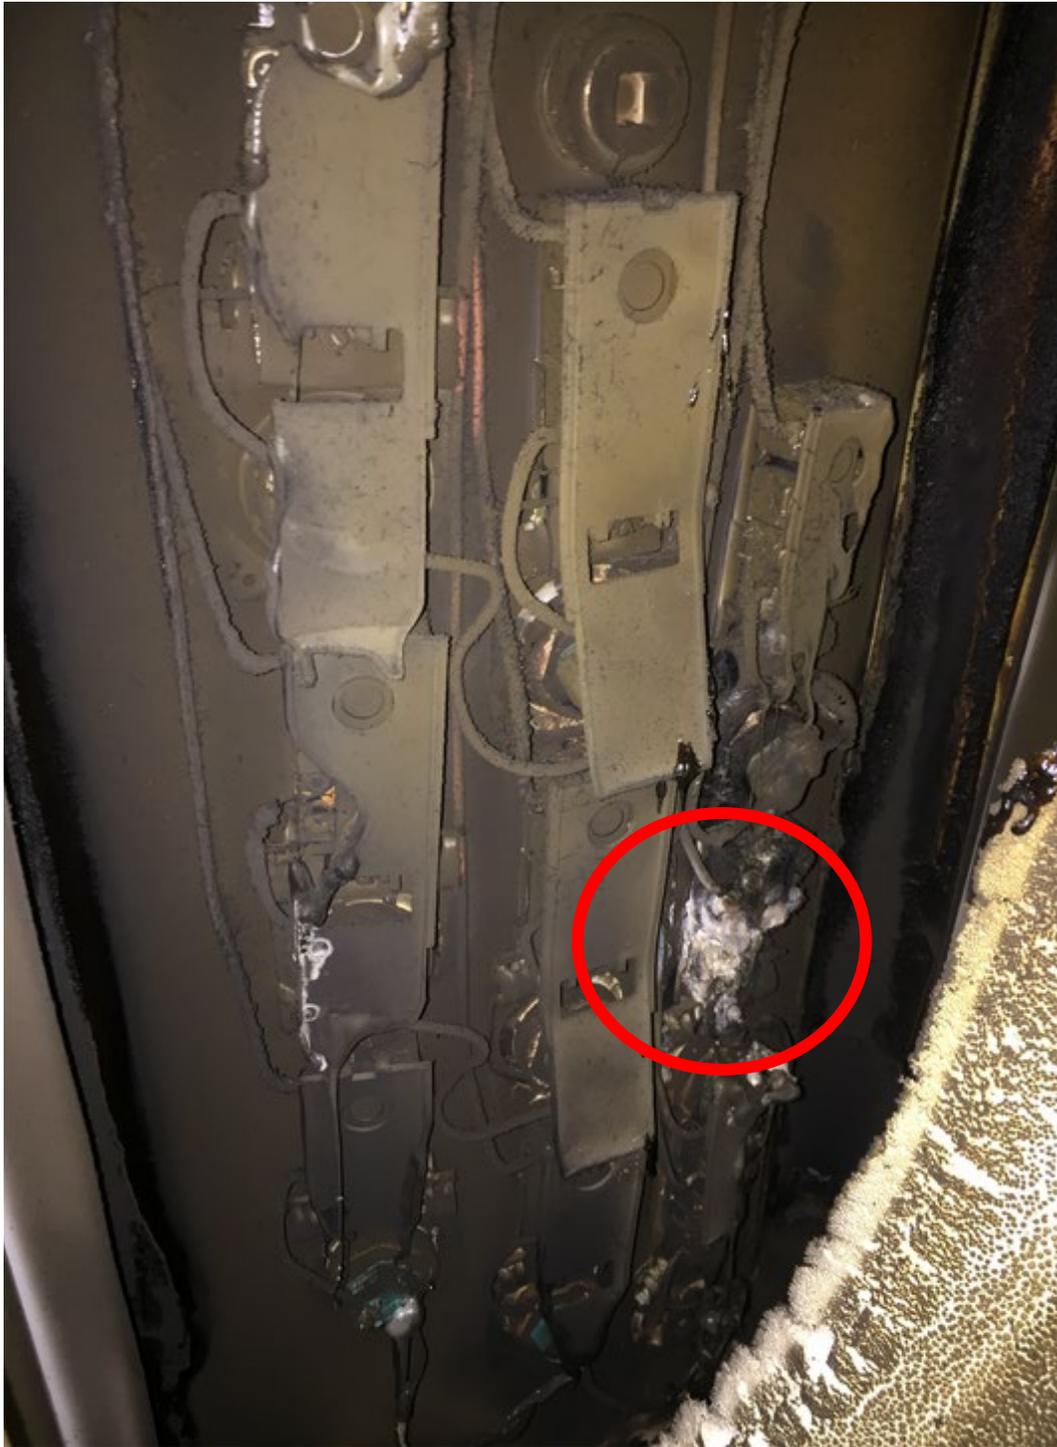
Photo 2 - Factor wired portion of HWT with majority of damage to middle heating element #2.

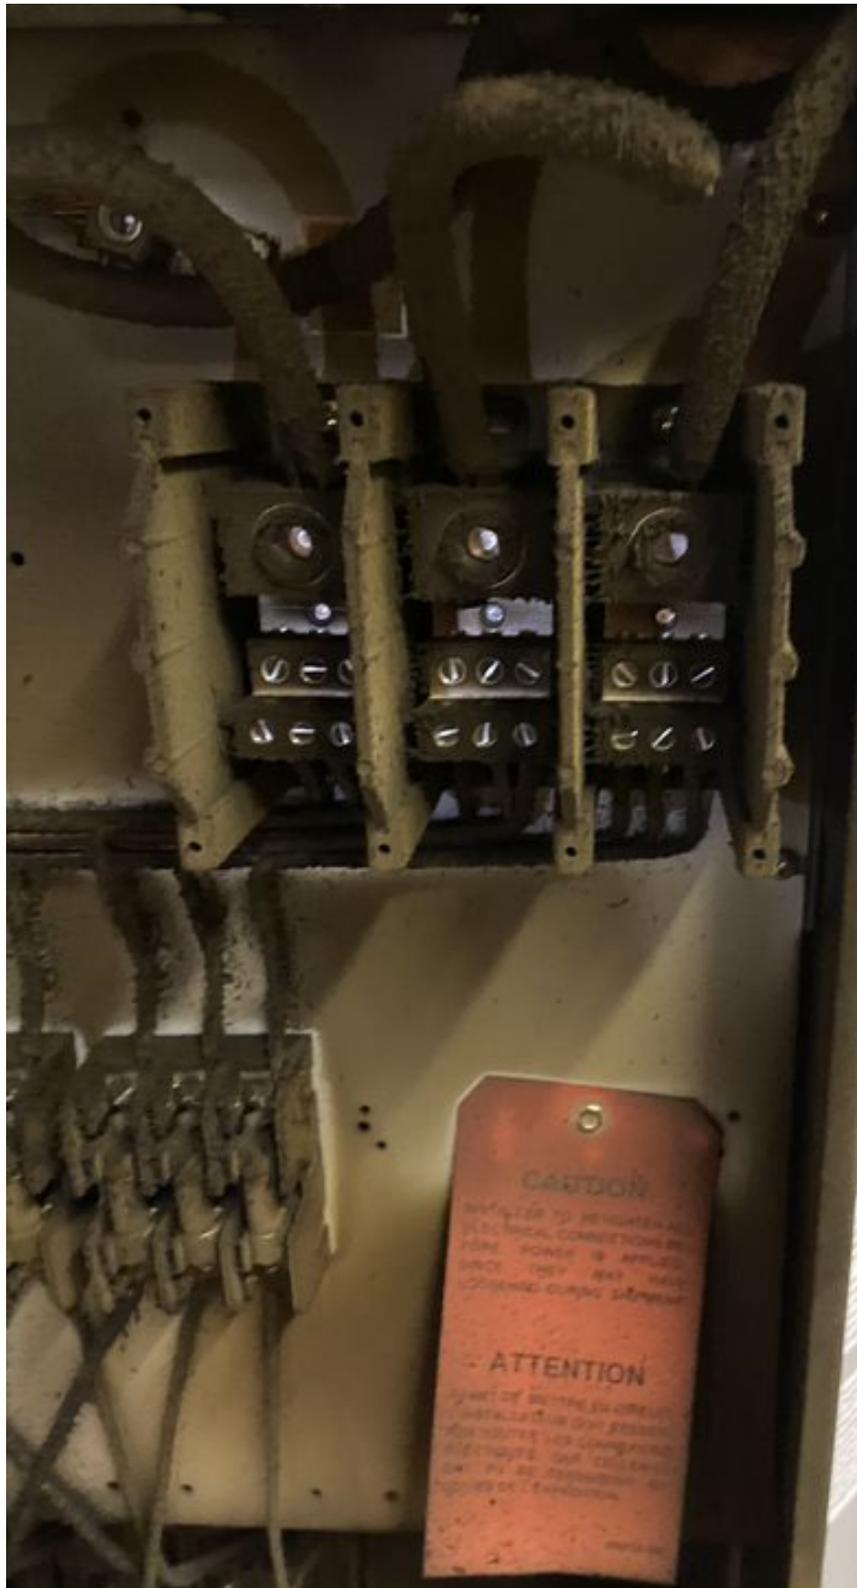
Photo 4 - Control block where incoming power terminates, located at the top of control module. Smoke and minor heat damage otherwise unaffected.

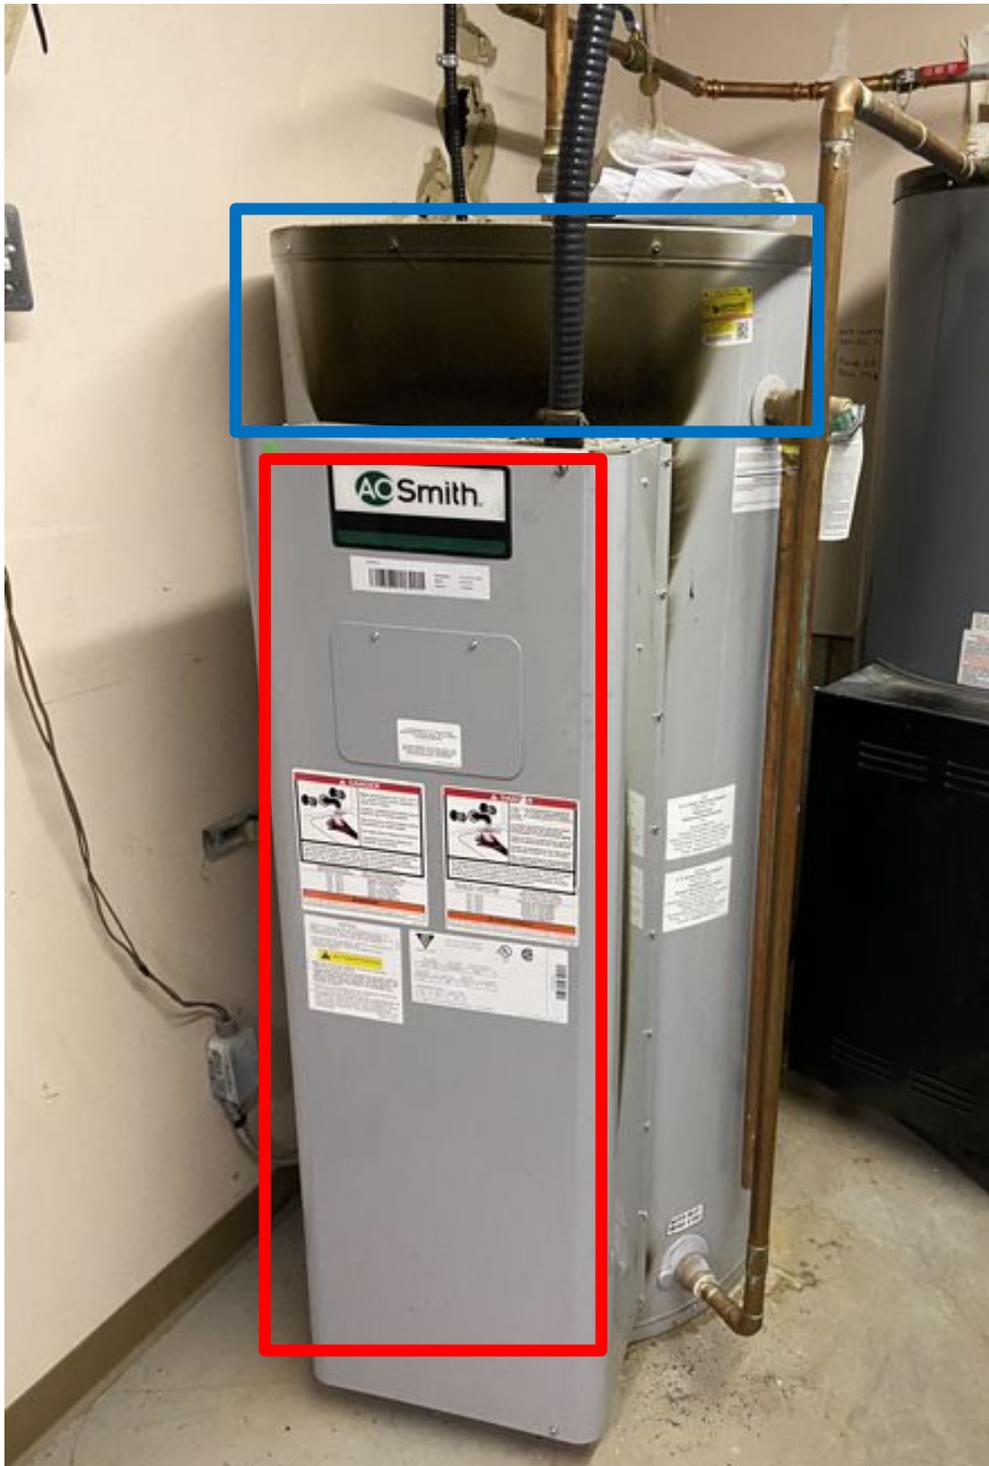
Photo 5 - HWT as found after fire. No clean up done. (**BLUE**) Smoke damage on the hot water tank above the control panel (**RED**).
