Investigation Report

Babine Forest Products – Explosion and Fire – January 20, 2012

BC Safety Authority – Incident Investigation – Jurisdiction and Role

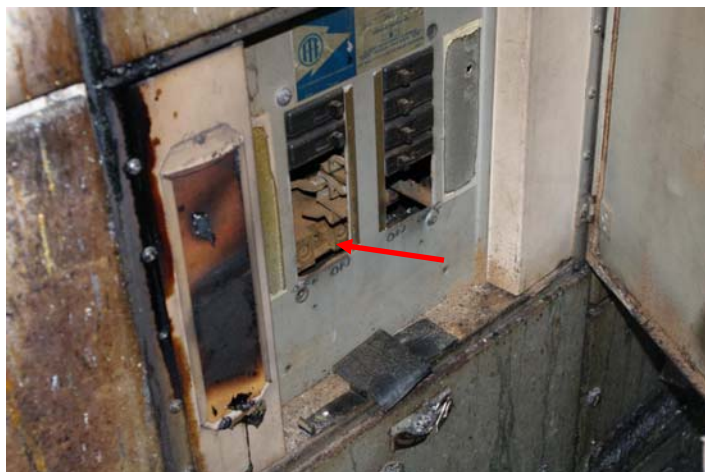
Photograph 3: Example of wood dust accumulation in MCC #9

Clean pressurization air was not being supplied to MCC #9 and wood dust was found within the cabinets. Normal operation or failure of electrical equipment within MCC #9 are potential sources of ignition for a wood dust cloud or layer. MCC #9 was not identified as being a likely ignition source, however, wood dust found within MCC #9 presented a fire hazard.

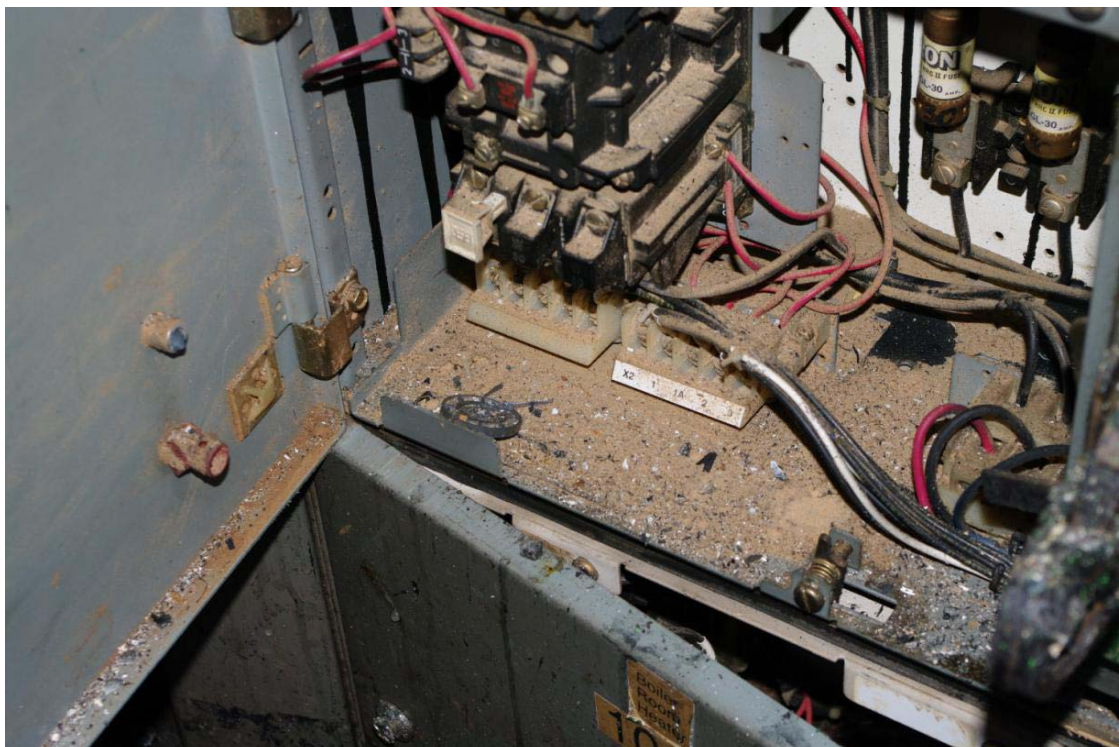
Photograph 4: Example of wood dust accumulation in MCC #10

Clean pressurization air was not being supplied to MCC #10 and wood dust was found within the cabinets. Unsecured cabinet doors may have exposed electrical equipment to a combustible atmosphere outside of MCC #10. It is also possible that the cabinet doors were opened as a result of an explosion from within MCC #10. On the evidence currently available to the BC Safety Authority, the operation of or a failure of the electrical equipment within MCC #10 could have ignited a combustible cloud of wood dust that came into contact with it.

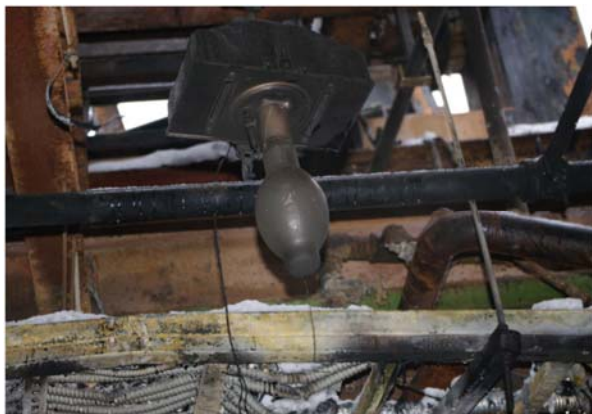
Photograph 6: Light assembly and metal halide bulb in front and above MCC #10

The light assembly shown in photographs 6 and 7 comprised of a ballast, 400 Watt metal halide bulb and a reflector. The reflector was found on the floor in front of MCC #10 and appeared to be an 'open' design, and no evidence of a shield was found in the area. The ballast and metal halide bulb were found in their installed locations above and in front of MCC #10, as shown in Figure 2 and Photographs 6 and 7. The bulb was intact and there was no evidence of electrical failure of the ballast or the bulb.

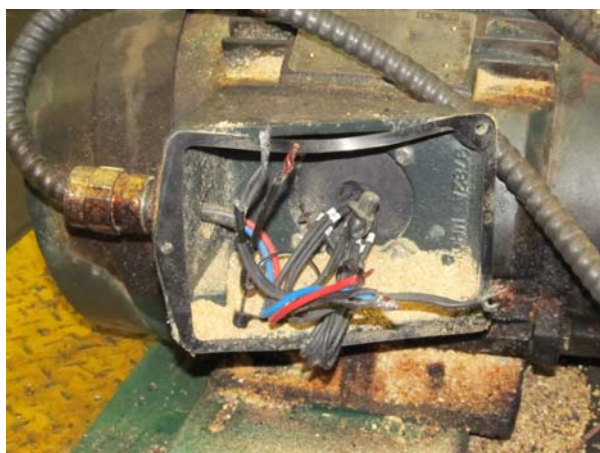
Photograph 8: Wood dust deposits within conveyor motor junction box labeled 8R-26.

Electrical equipment found within the areas of origin consisted of disconnects, push buttons, hydraulic oil tank heaters, switches, motors and lights. There were no indications that any of the electrical equipment found was certified for use in a hazardous environment containing combustible dusts. It is possible that electrical equipment located within either identified area of the basement provided an ignition source for wood dust.

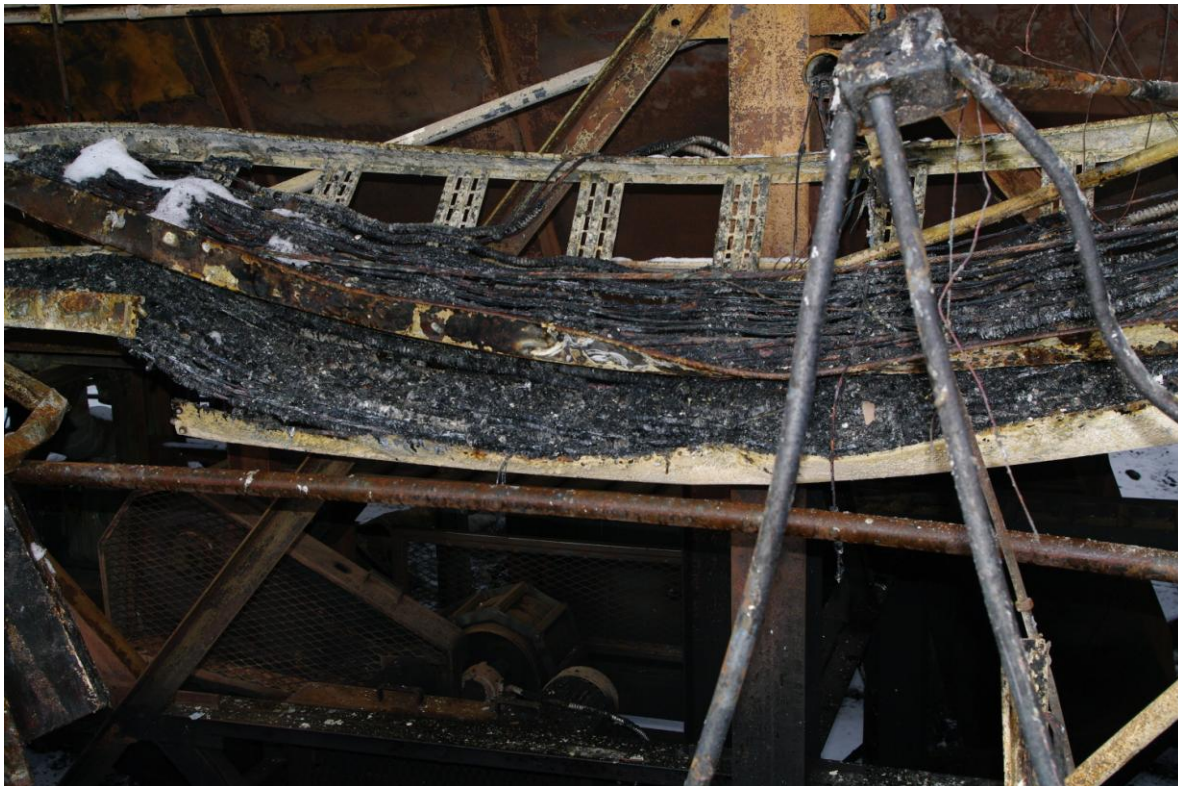
Photograph 8

Looking at an example of charred sawdust on wire cable trays. This is typical of the condition of cable trays in the basement of the mill.

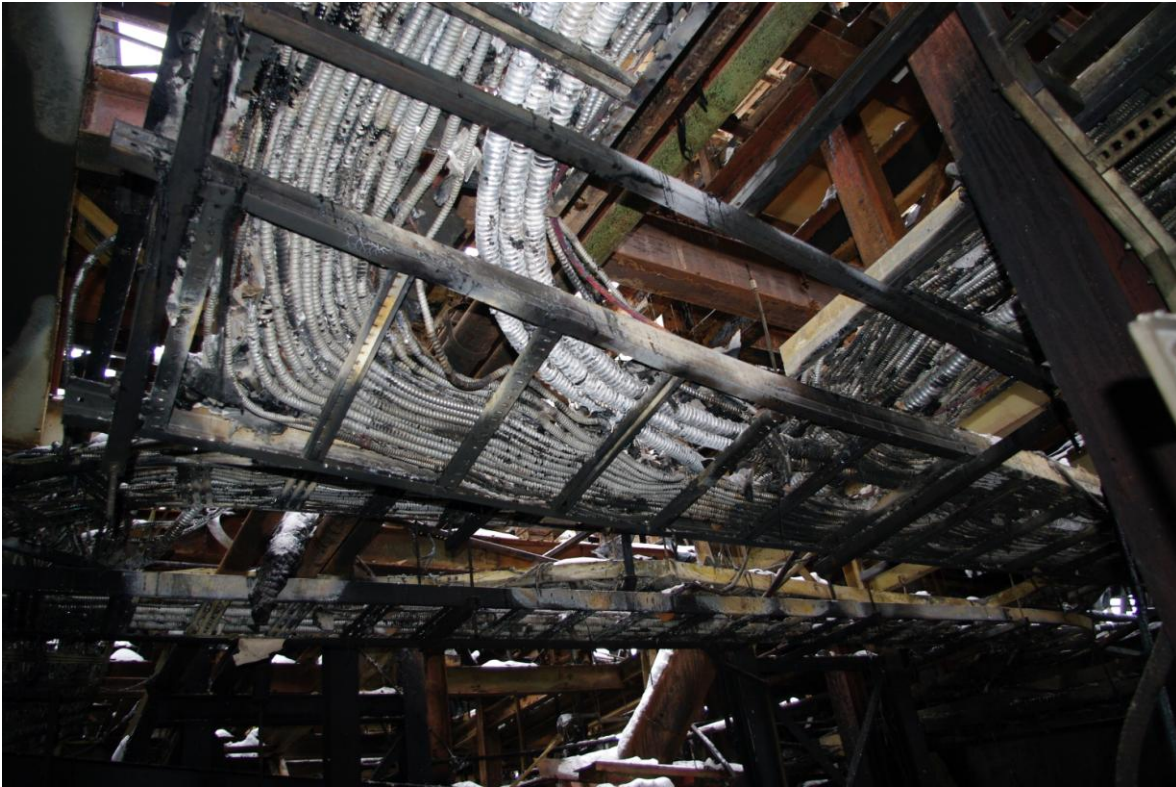
Photograph 9

Looking at the cable trays above MCC-10.

Note: the absence of charred sawdust.

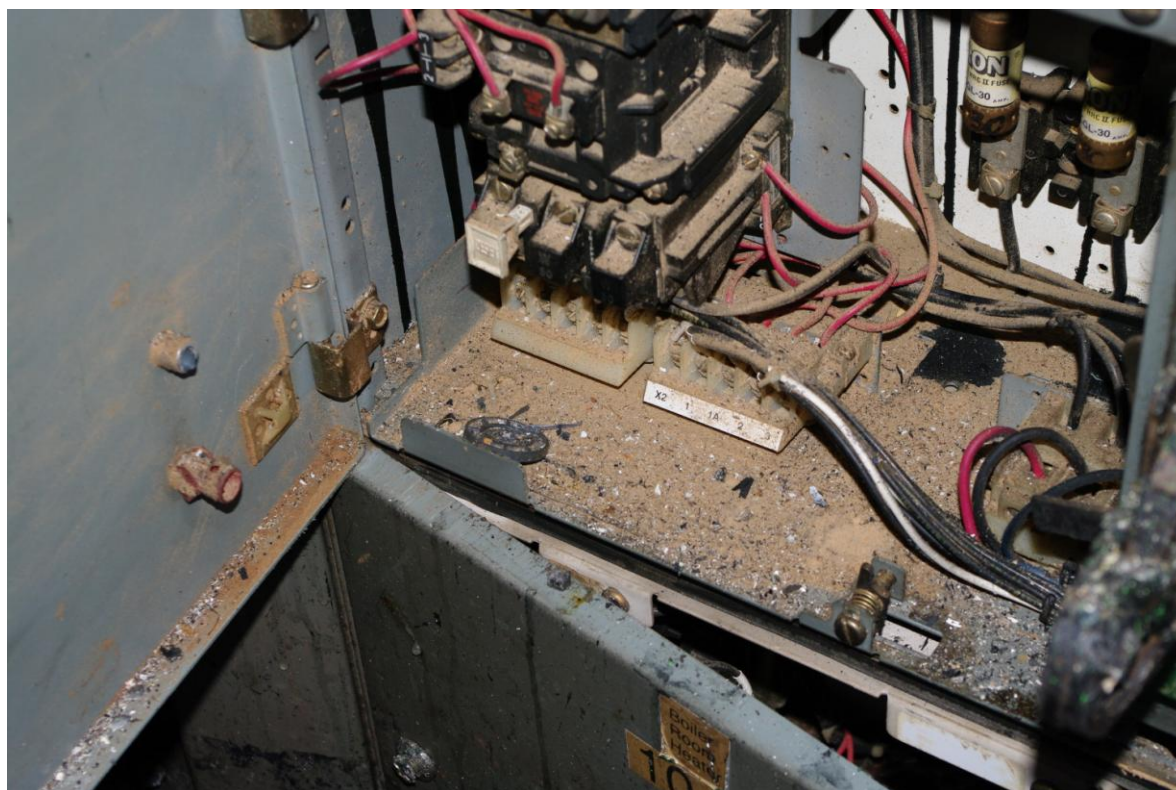
Photograph 11

Looking at the accumulation of sawdust inside MCC-10, sub panel 10-13.

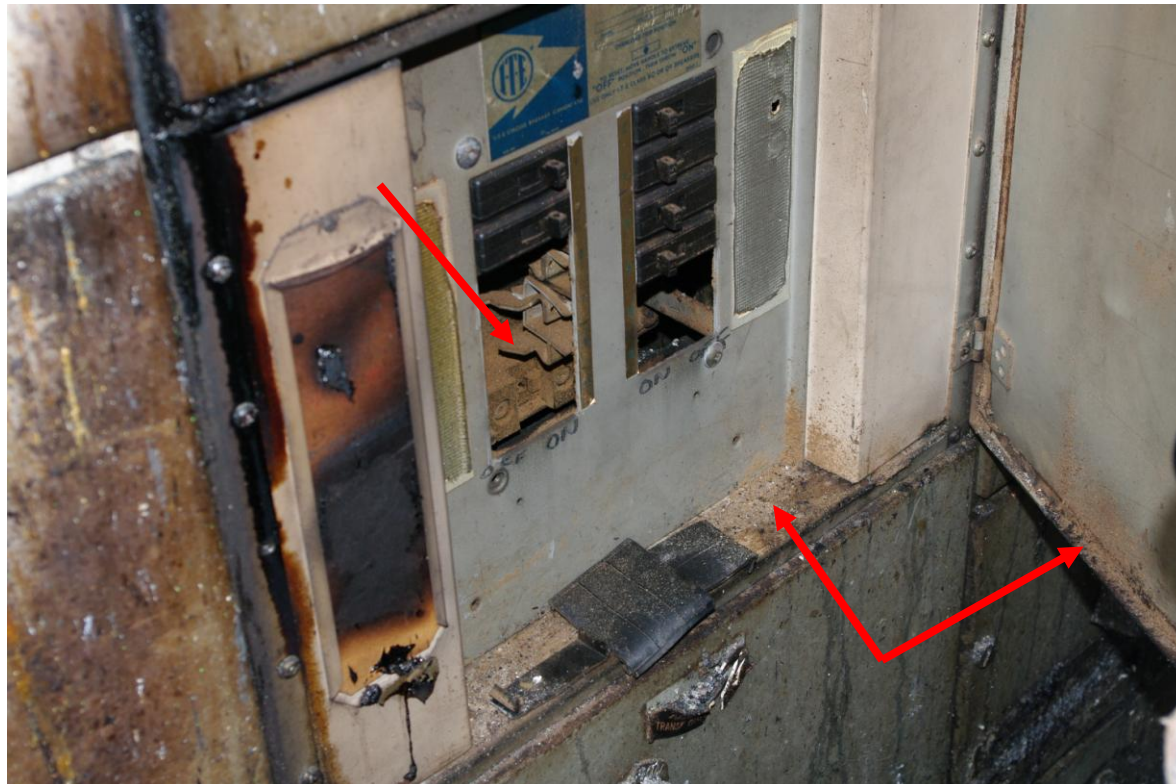
Photograph 12

Looking at the accumulation of sawdust inside MCC-9 (arrows).

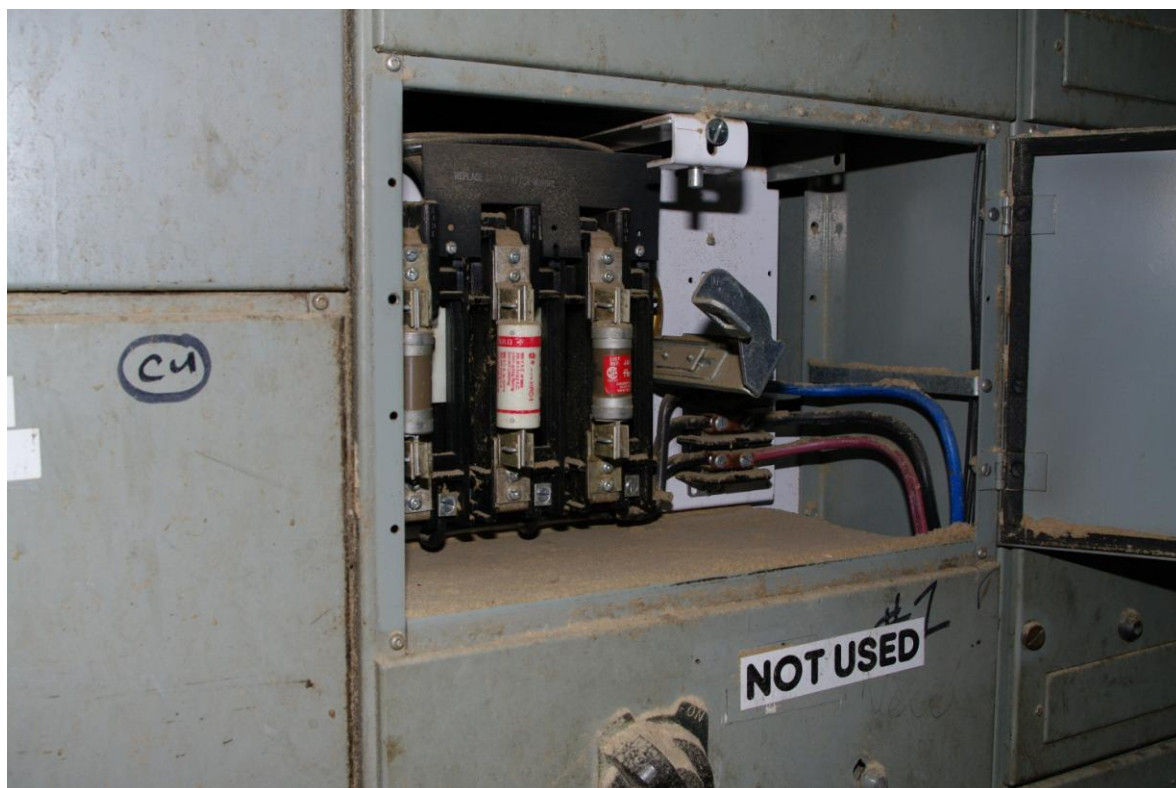
Photograph 13

Looking at the accumulation of sawdust inside MCC-12.

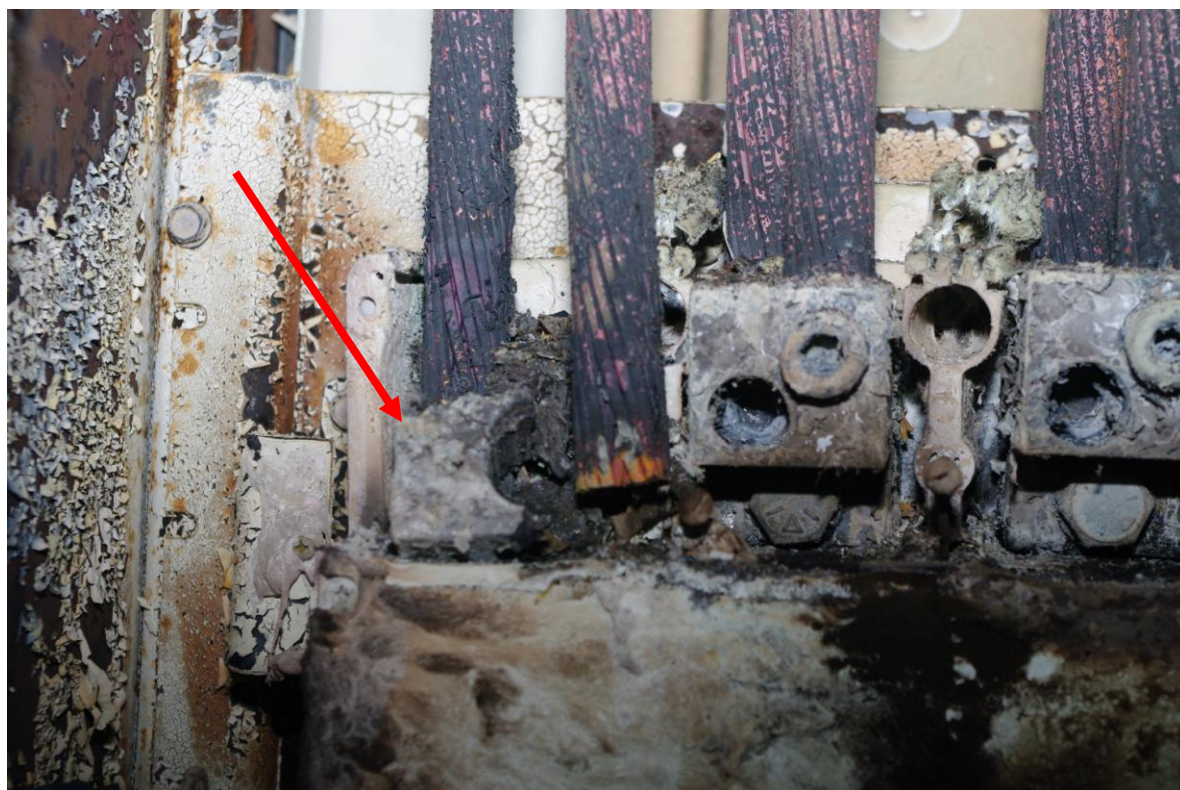
Photograph 15

Looking at a closer view of the three lugs in subpanel 10-31.

Note: two lugs are intact but the third (arrow) is broken up.

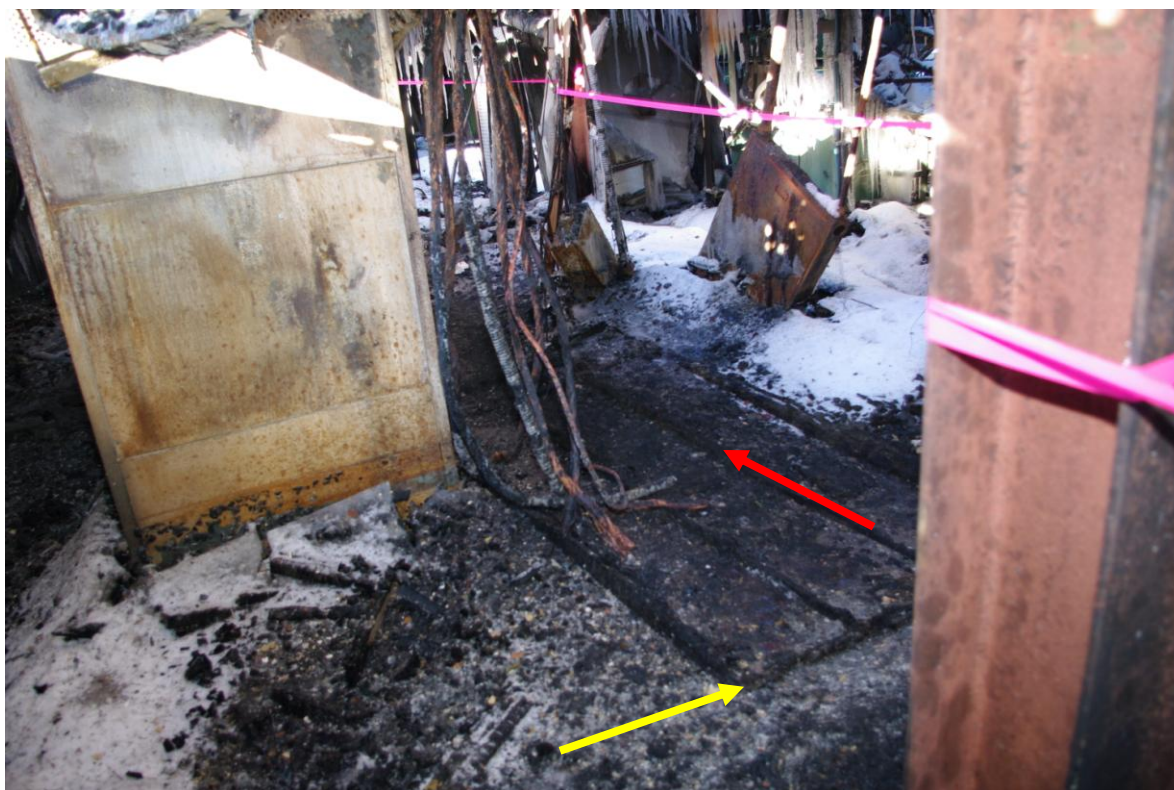
Photograph V7

Looking at the framing of the east wall of the PDC room (green arrow).

Note: the base of the framing (yellow arrow) is in its normal location however, the top has been pushed over to the west.

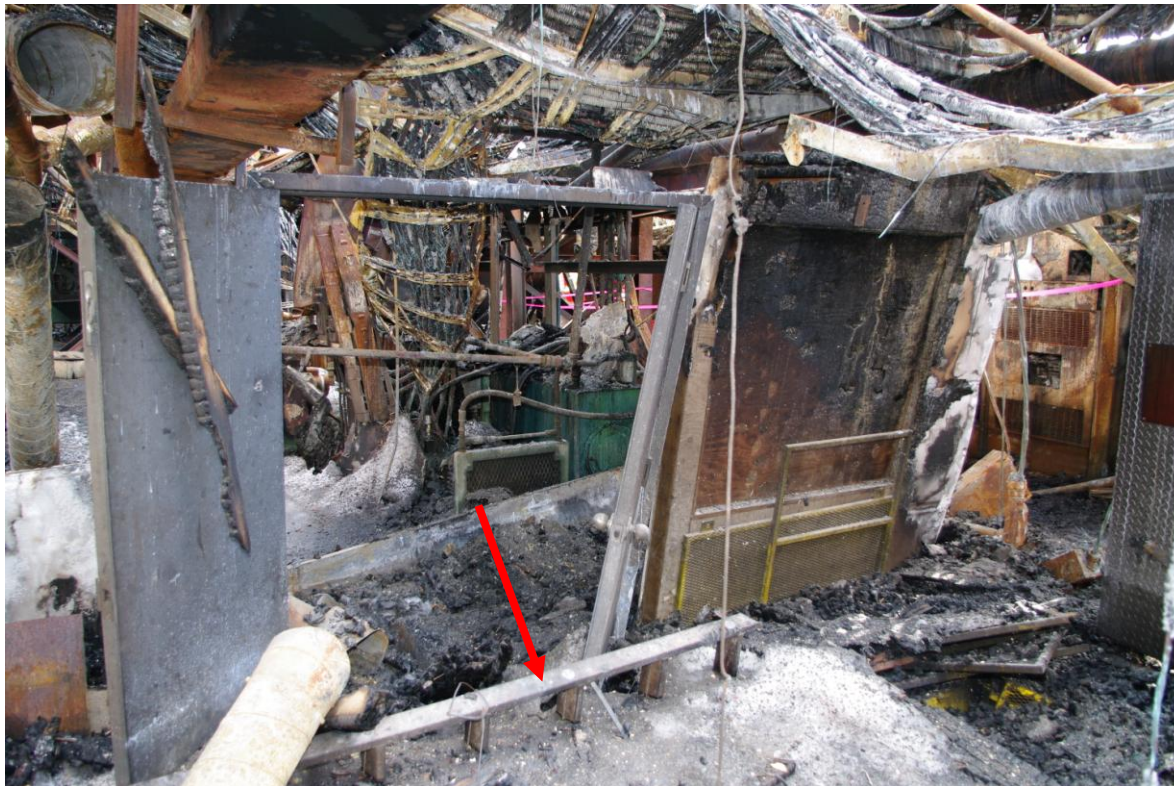
Photograph V8

Looking at the doors to the hydraulic room by the PDC room blown open to the west.

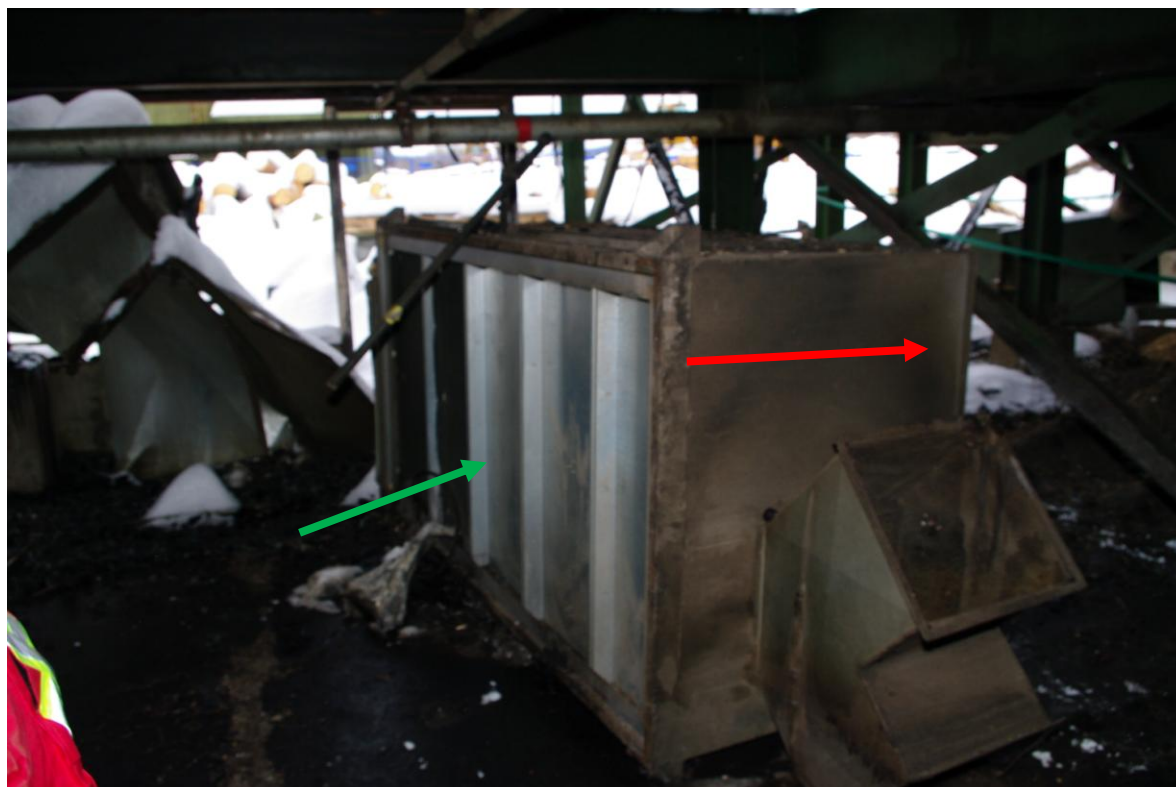
Photograph V11

Looking at a heating unit in the west end of the basement.

Note: the unit was blown in a northerly direction and turned over on its side exposing the bottom (green arrow).

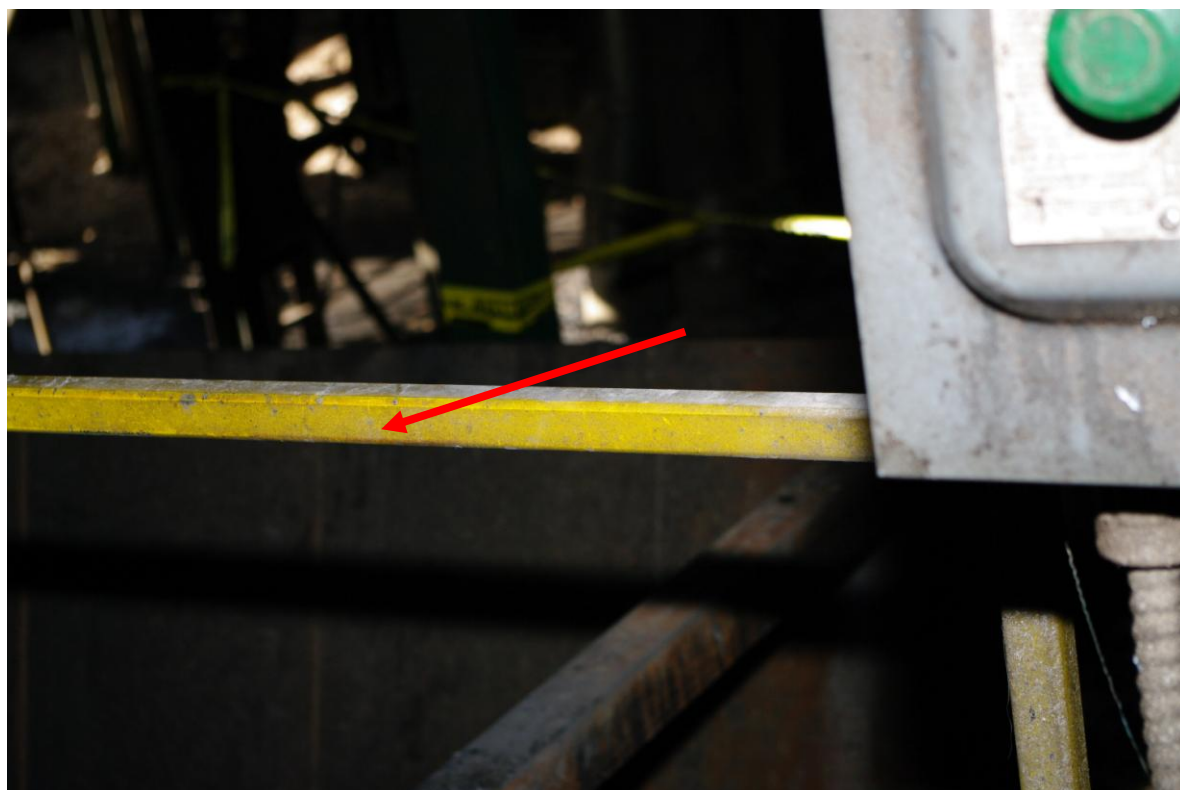
Photograph V13

Looking at the east side of the guardrail used to prevent personnel from falling from the crawl space, in the east side of the mill into the basement.

Note: this side of the rail is relatively clean compared to the opposite side (Photograph V14).

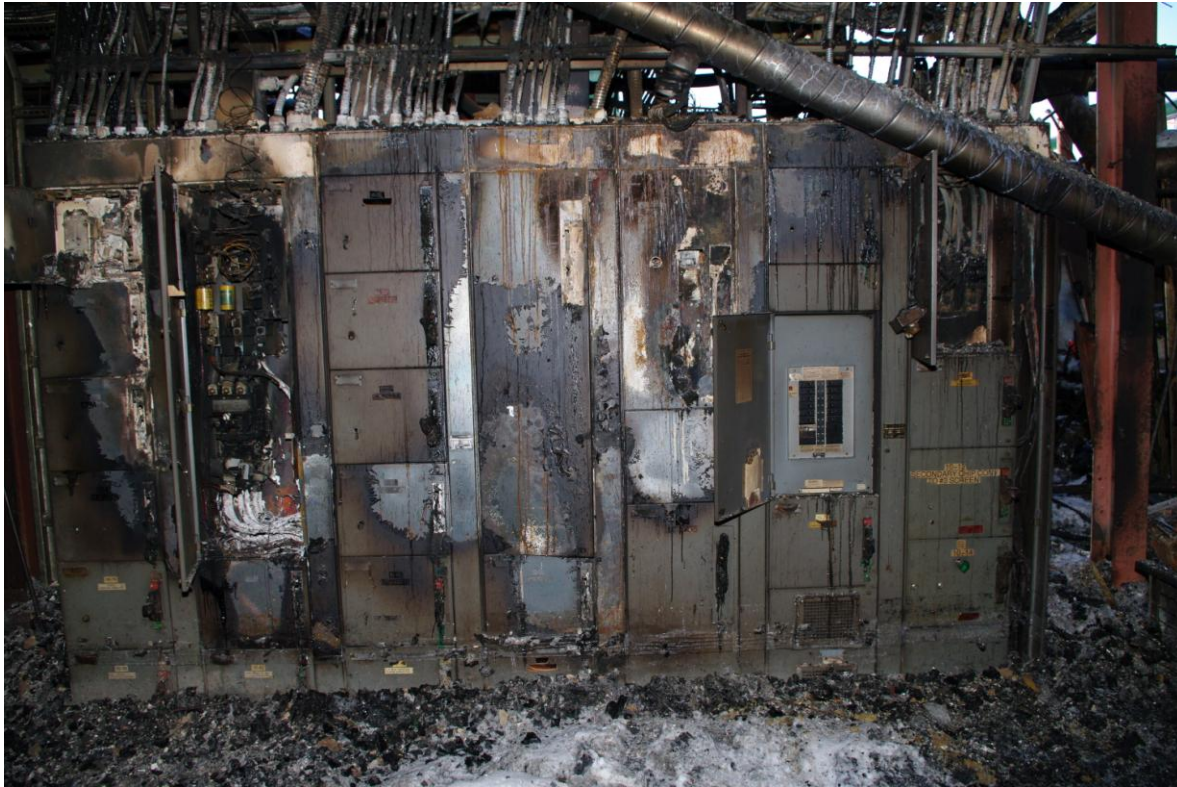
Photograph M1

Note: the burn pattern on the front of the MCC.

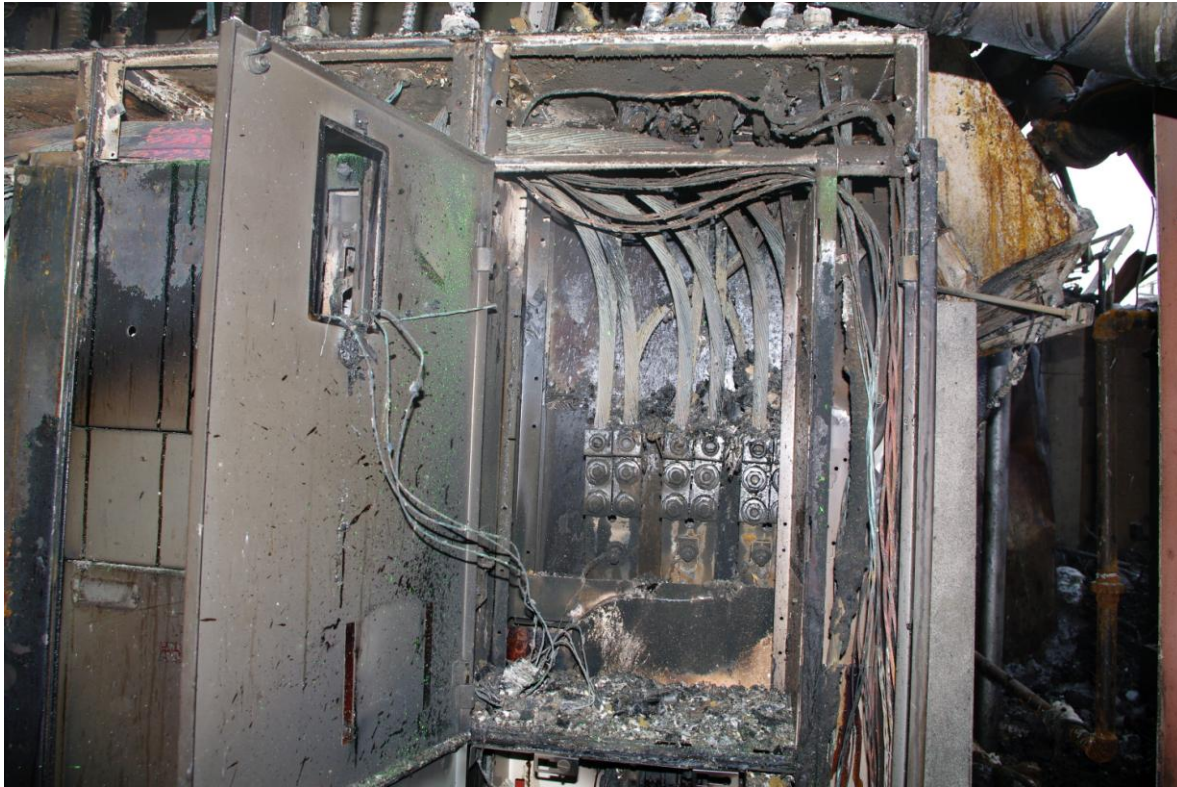
Photograph M3

Note: the interior of this cabinet was extensively burned.

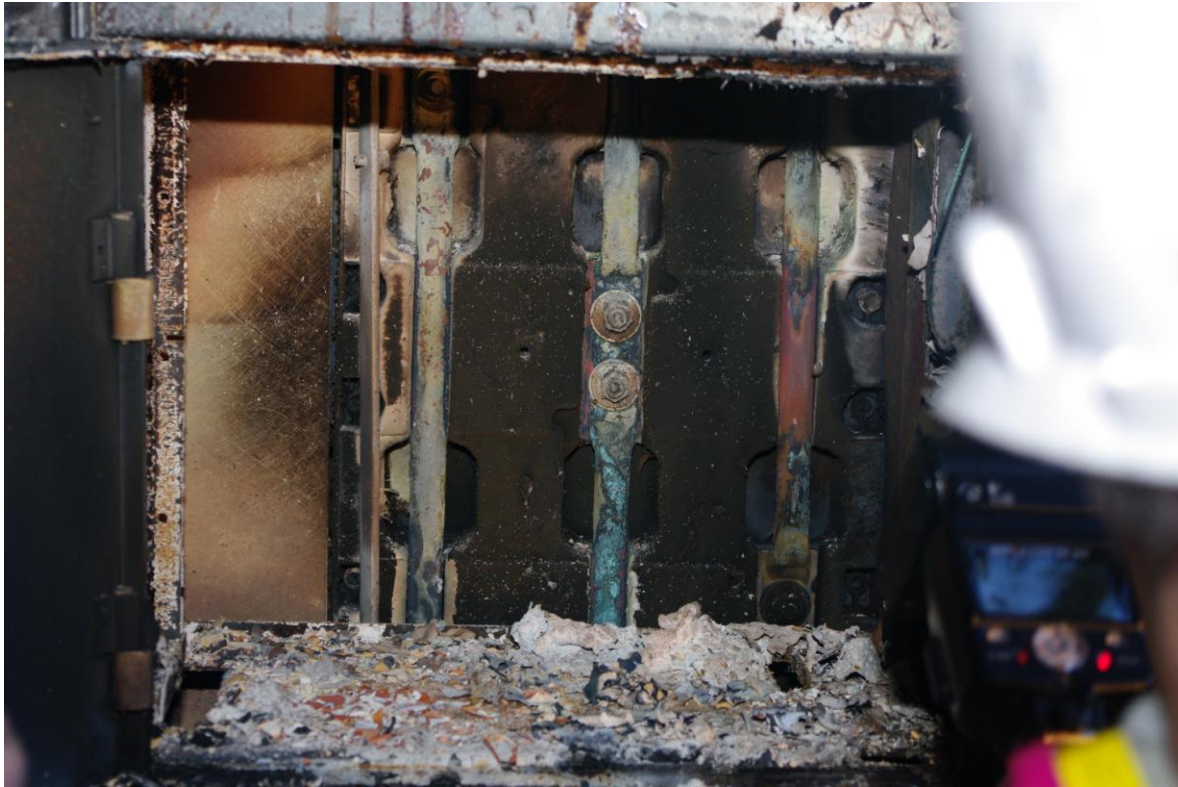
Photograph M5

Note: the extensive burn damage.

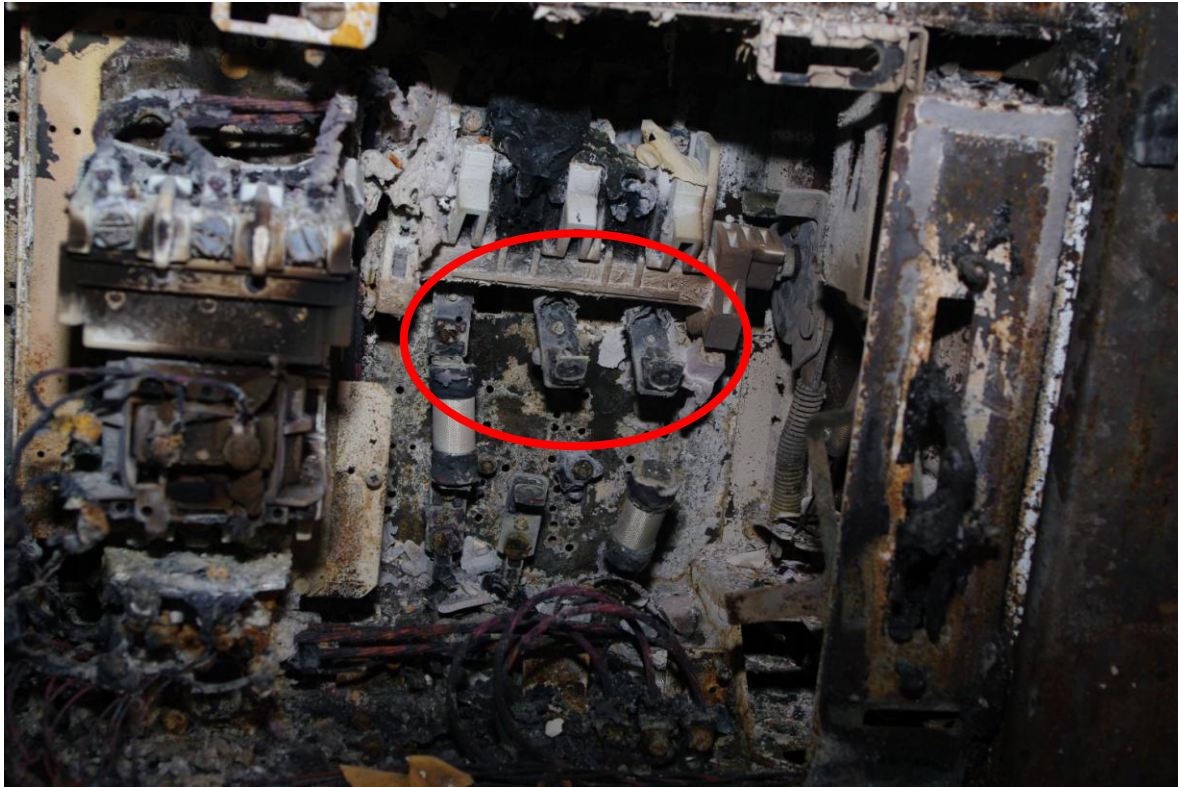
Photograph M7

Note: the interior of the cabinet was completely burned and the tops of the fuse holders were pushed out toward the front of the panel (circle).

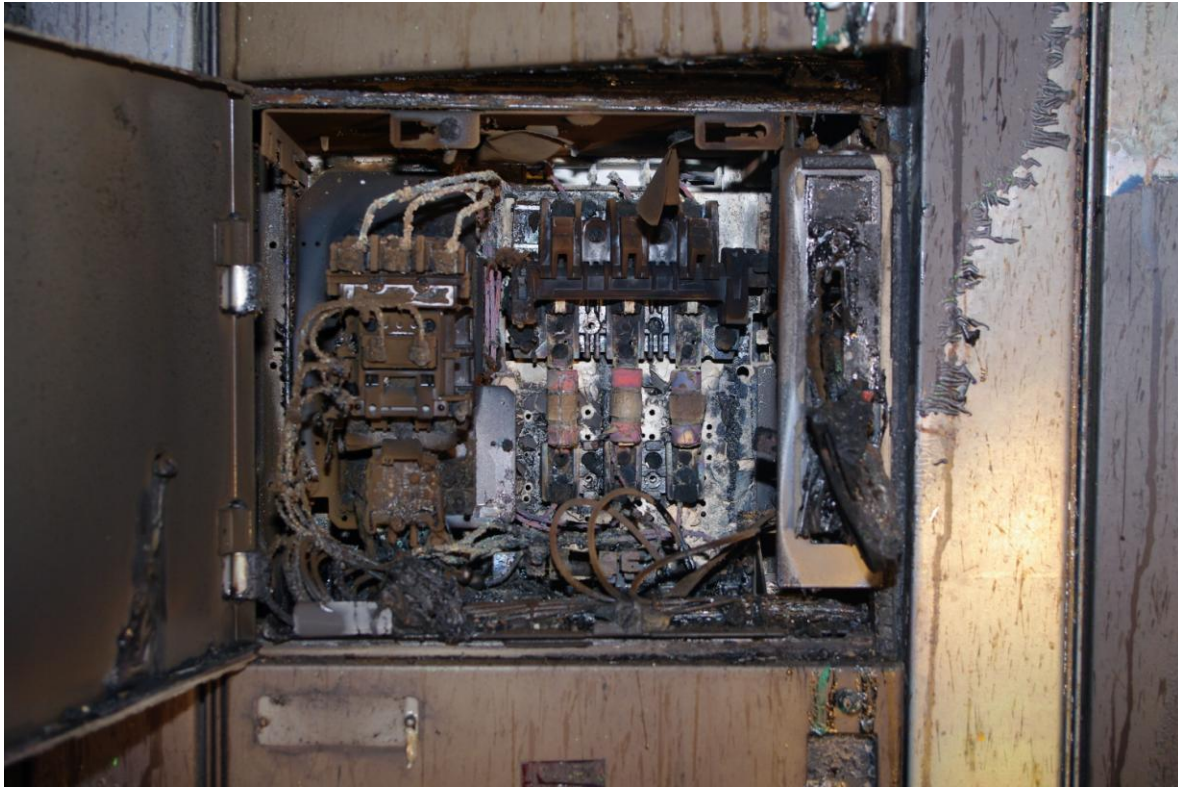
Photograph M9

Note: the condition of this panel was slightly less damaged than cabinet 10-51.

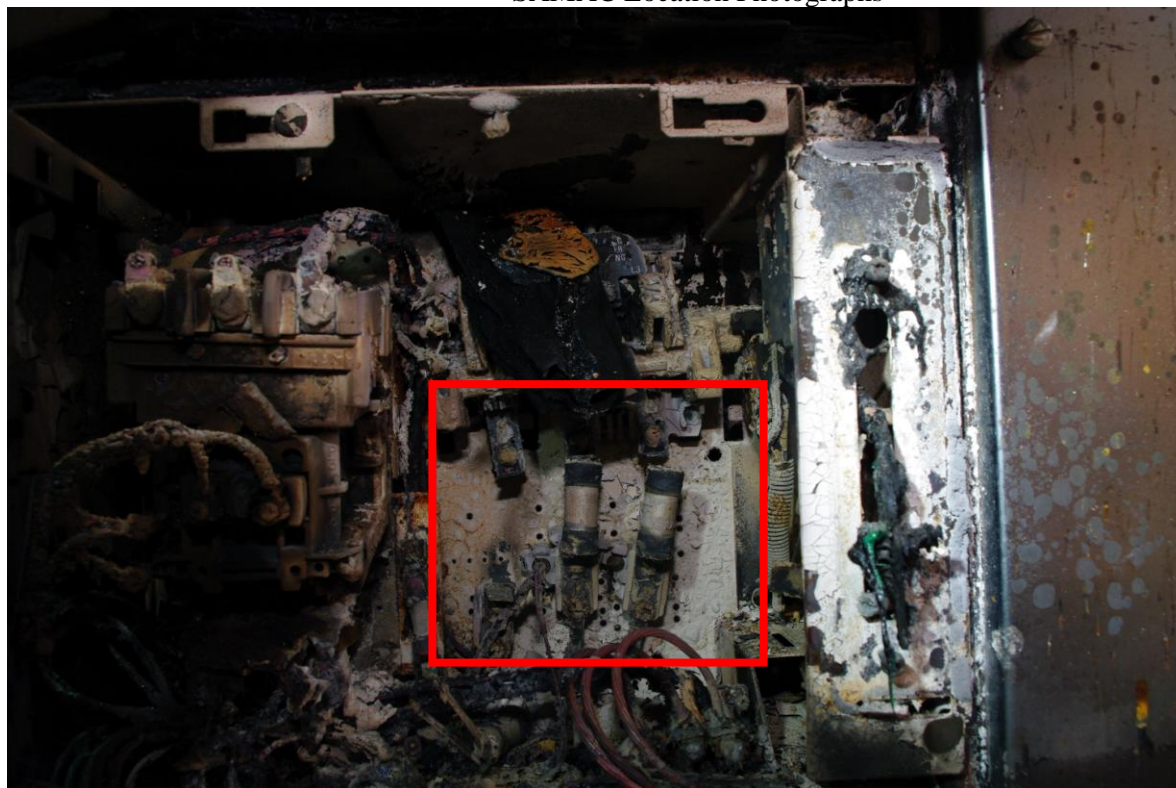
Photograph M11

Note: the interior of the cabinet is heavily damaged and the fuse holders are disrupted (rectangle).

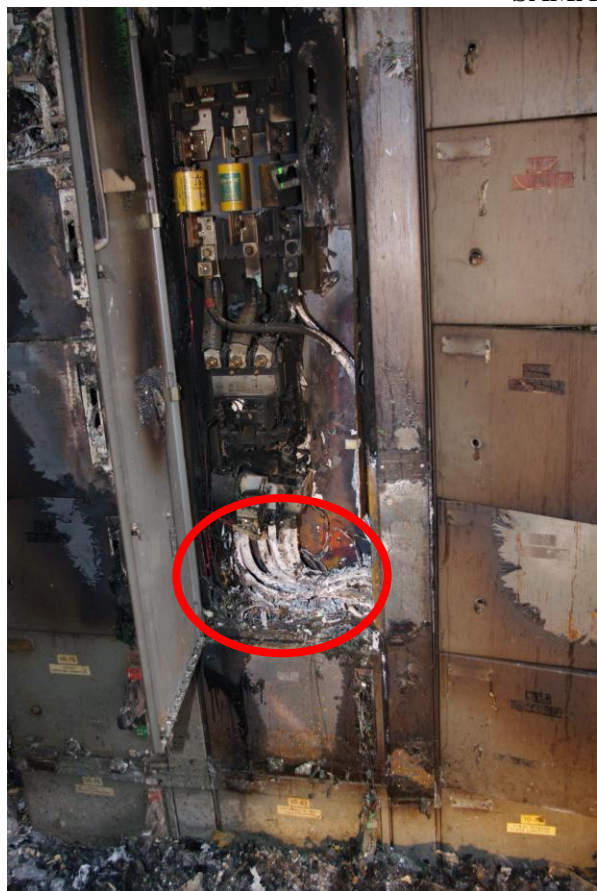
Photograph M13

Note: damage to this cabinet was primarily at the bottom (circle).

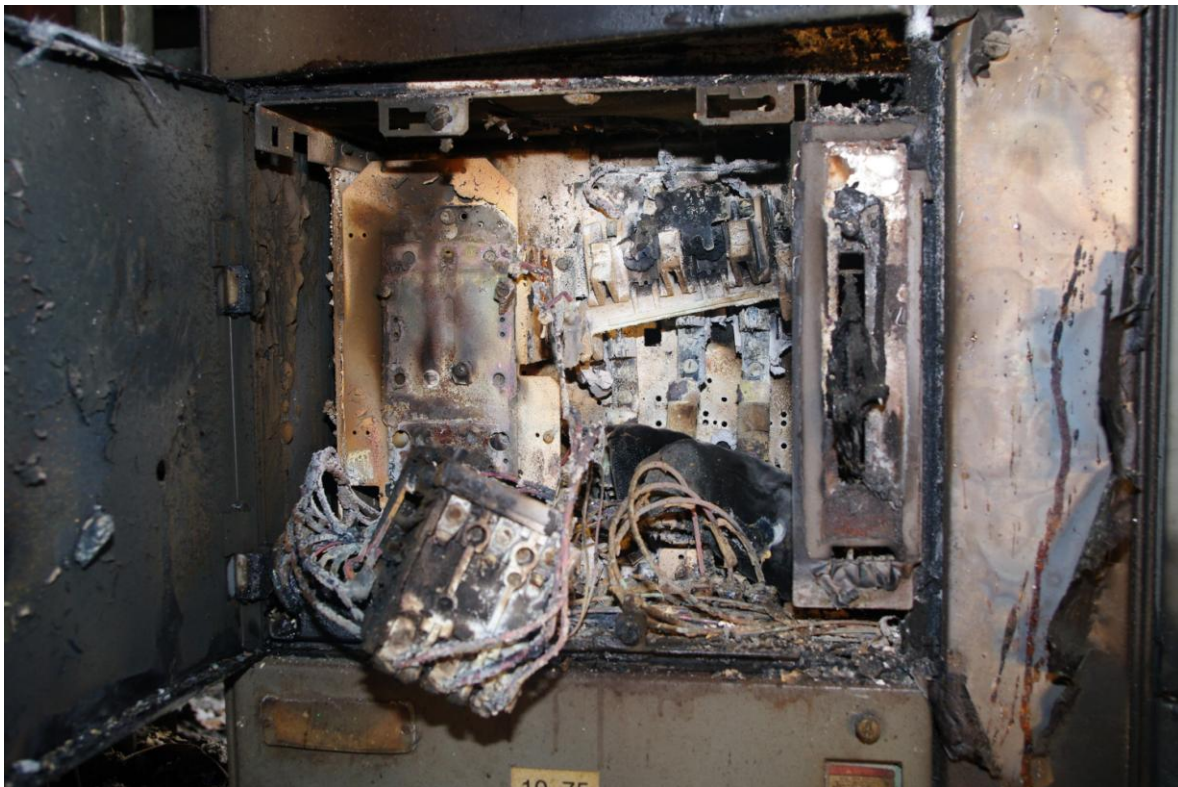
Photograph M18

Note: the damage to this cabinet was primarily at the top.

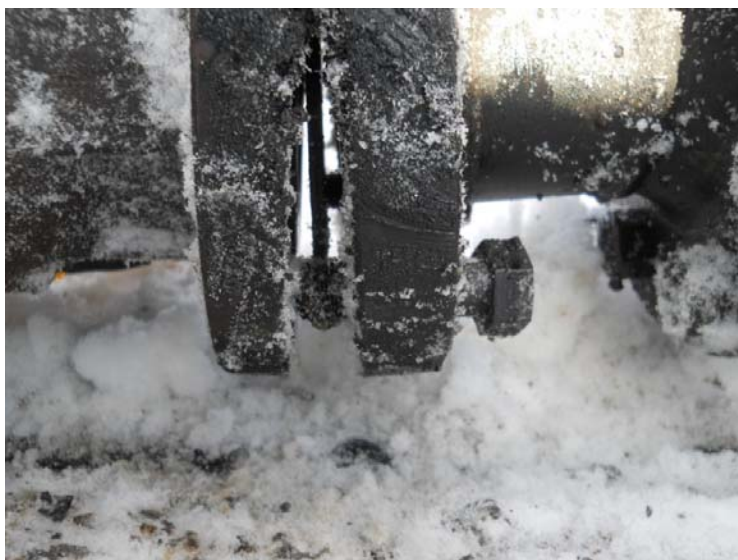
Photograph C1: Broken bolt at valve flange to heat exchanger

Thermal fluid was supplied from an energy plant outside of the sawmill structure to a heat exchanger located within the sawmill structure. The heat exchanger was found to have fallen off its support structure. A flange bolt that was part of the thermal fluid valve train assembly was found to be fractured as shown in Photograph C1. Thermal fluid residue was found in the area of the heat exchanger. There were no other findings that would indicate a failure of thermal fluid piping or thermal fluid leakage.
