## Incident Summary #II-792337-2018 (#10317) (FINAL)

SUPPORTING INFORMATION	Incident Date	December 21, 2018	
	Location	Whistler	
	Regulated industry sector	Amusement Devices - Zip line	
	Impact	Qty injuries	0
		Injury description	NA
		Injury rating	None
	Damage	Damage description	Work required in removing tree resting against the zipline rope.
		Damage rating	Minor
Incident rating	Minor		
Incident overview	Dead tree discovered leaning against zipline rope after wind storm. Zipline was not operating at the time the tree fell		
INVESTIGATION CONCLUSIONS	Site, system and components	<ul style="list-style-type: none"> <li>• Zipline system approximately 1230 m in length.</li> <li>• System has 2 zipline ropes that run parallel with each other over the 1230 m distance</li> <li>• 7/8" diameter wire rope.</li> </ul>	
	Failure scenario(s)	Dead tree failed to remain upright during windstorm.	
	Facts and evidence	<p>As per operating contractors report:</p> <ul style="list-style-type: none"> <li>• A windstorm the previous day made it necessary for the operator to shut down operations in the early afternoon.</li> <li>• During opening inspection the next day, a dead tree (cedar) approximately 8"

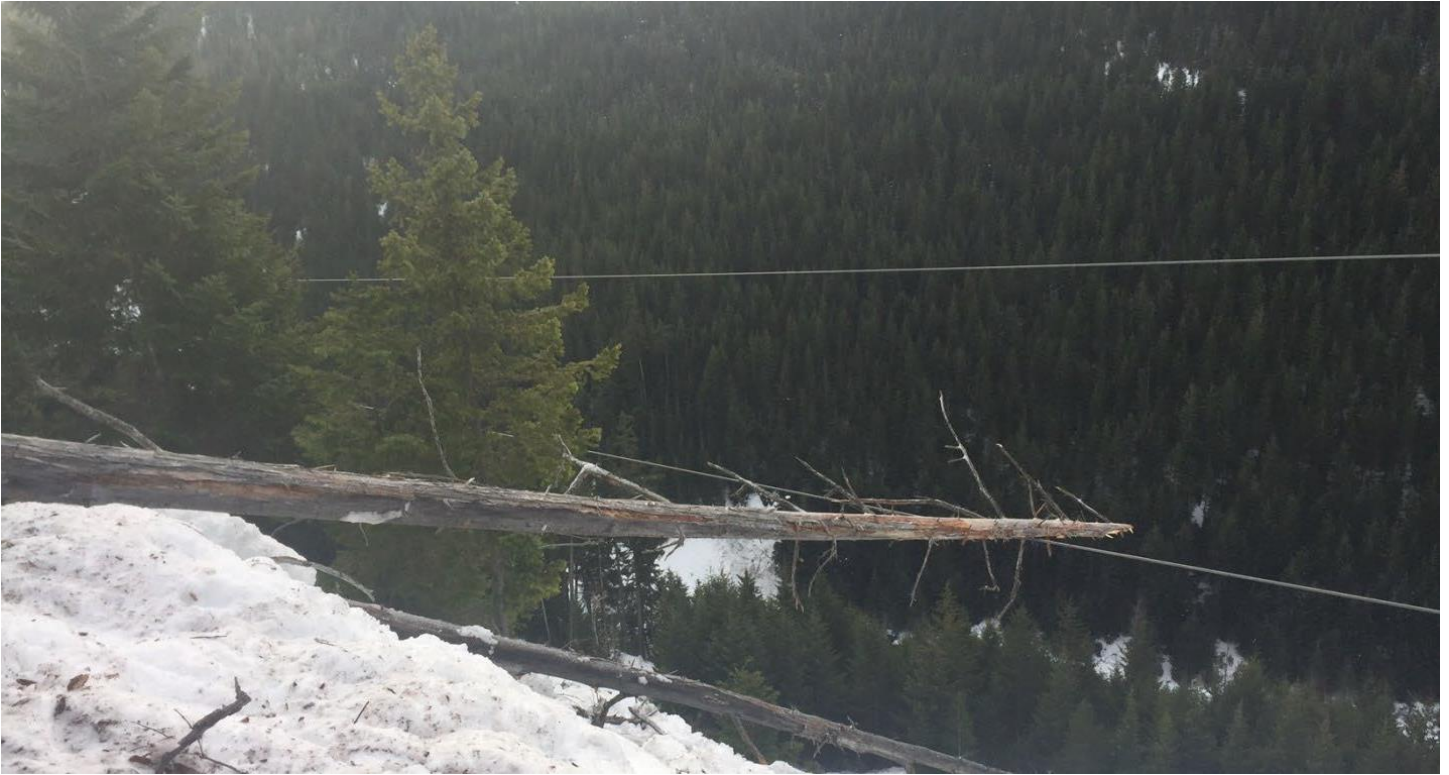
Causes and contributing factors	It is probable that winds were of a magnitude that the likely weakened dead tree fell.

## Tree Resting on Zipline Rope
