Incident Summary #II-859486-2019 (#12904) (FINAL)

SUPPORTING INFORMATION	Incident Date	May 30, 2019	
	Location	North Vancouver	
	Regulated industry sector	Gas - Natural gas system	
	Impact	Qty injuries	None
		Injury description	Not Applicable no injuries
		Injury rating	None
	Damage	Damage description	Damage to the rear door enclosing the combustion chamber of a large boiler
		Damage rating	Major
	Incident rating	Major	
Incident overview	An explosion occurred within the heat exchanger of a commercial boiler which resulted in significant damage to the rear door, diffuser, and other boiler components, rendering it inoperable.		
INVESTIGATION CONCLUSIONS	Site, system and components	<p>Two identical boilers, Boiler number one and two, were used for heating and hot water in a commercial building (Photo 1). The boilers were of the fire tube variety. A fire tube boiler (Diagrams 1 & 2) uses a flame and flue gases to heat water that surrounds the combustion chamber to a desired temperature. The boiler is essentially a heat exchanger where hot gases from a power burner heat a network of tubes that are surrounded by water, transferring the heat into the water. The hot water was used for the

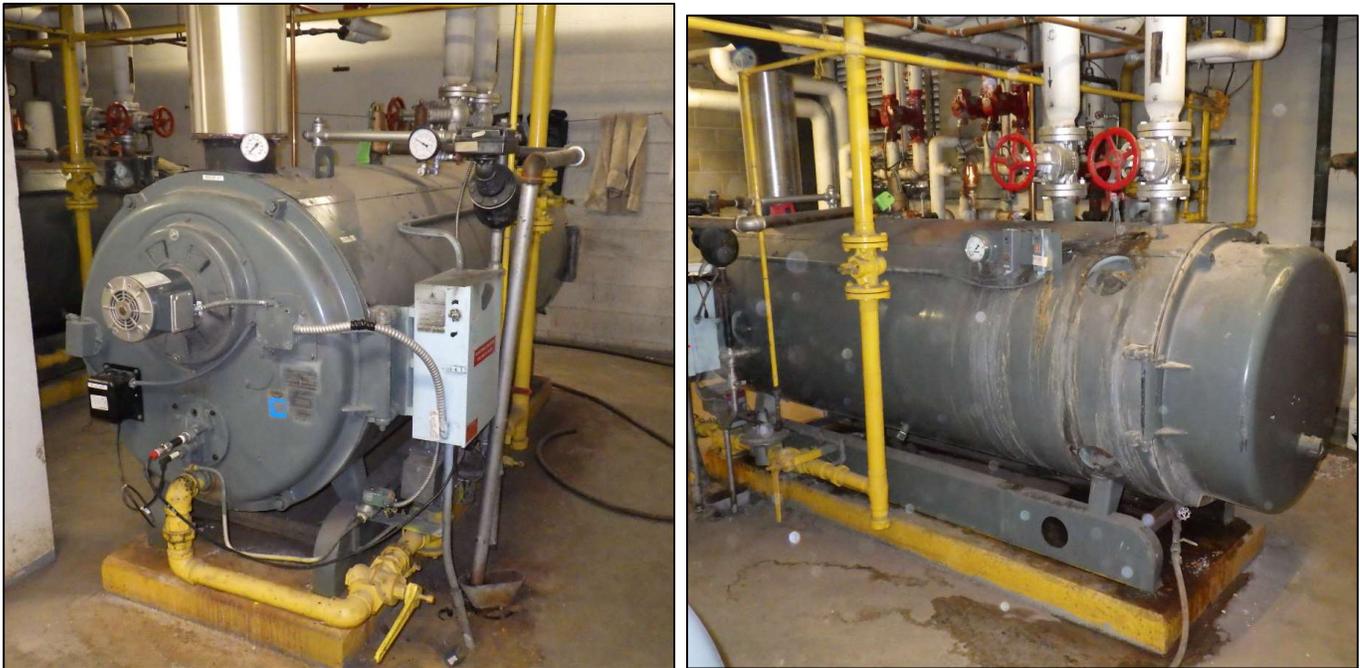
Photo 1: Front view boiler 1 (left) and rear view boiler 2 (right).

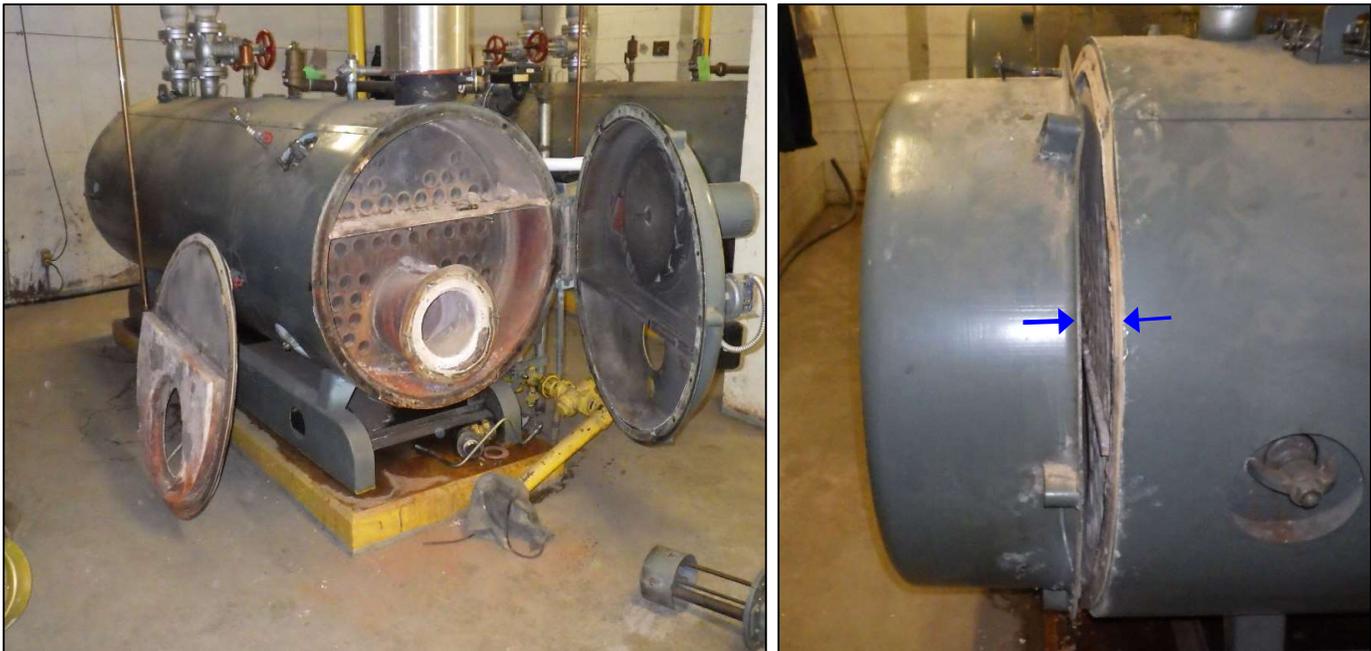
Failure scenario(s)	Boiler 2 was being started and experienced a large internal explosion. The force of the explosion damaged the rear door, partially separating it from the boiler tank, (Photo 2). The cause of the explosion in boiler 2 was due to issues with the pressure regulator and excessive ignitor gap which resulted in excess unburnt gas to accumulate in the boiler, which ignited when contacting the burner flame.	
	Facts and evidence	The following information was determined from interviews with boiler operations and maintenance personnel, document reviews, examination and testing by third party boiler specialist, and external resources.

Photo 2: Boiler 2 front door open with burner removed (left), damaged rear door (right)

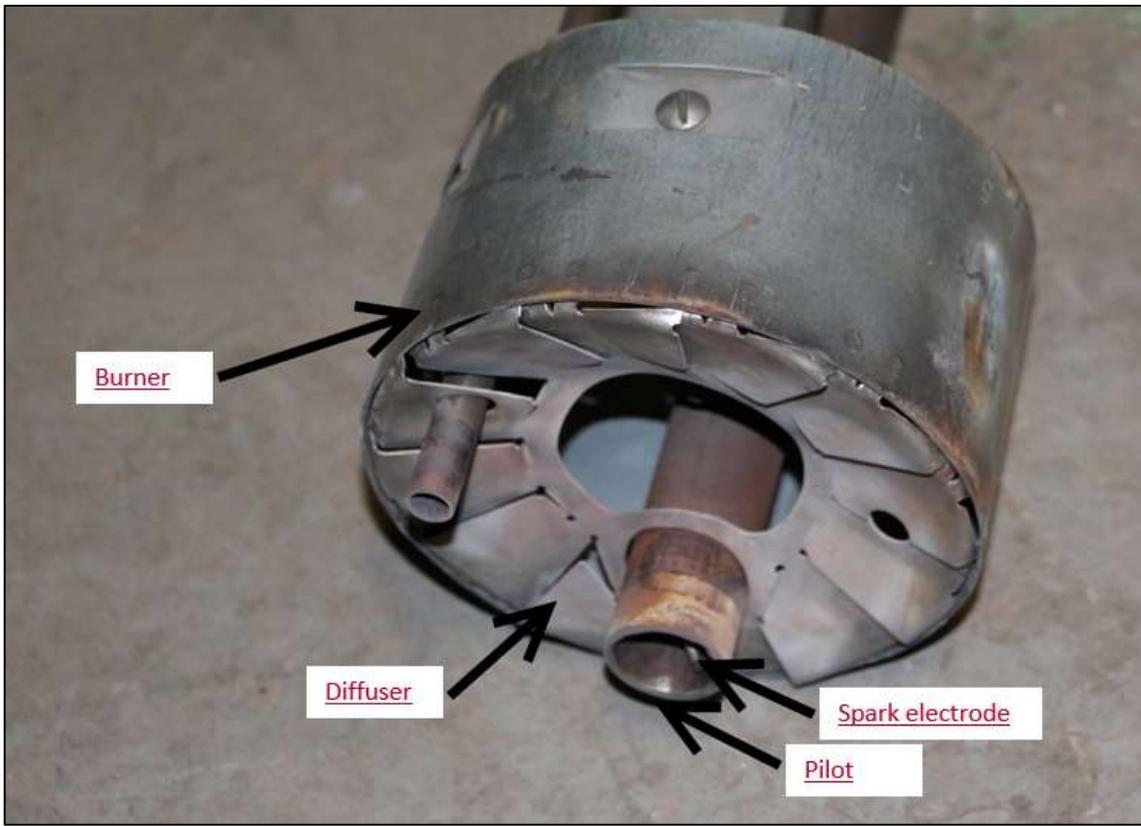
Photo 3: Power burner and its components.

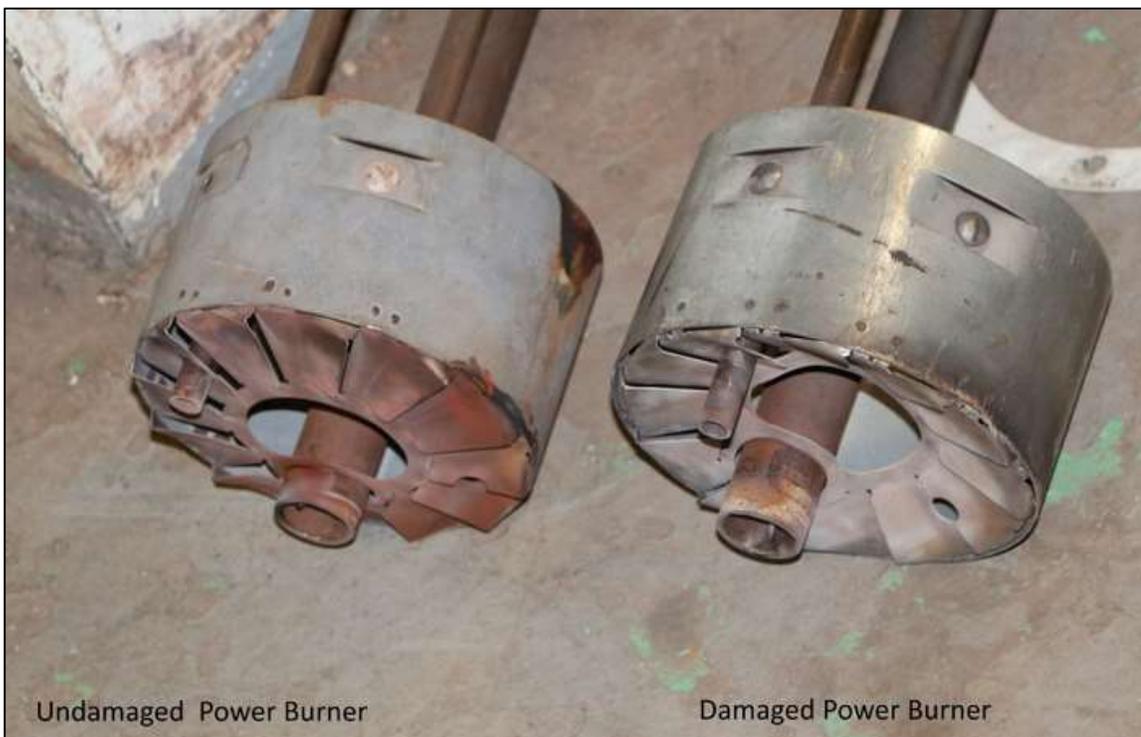
Photo 4: Undamaged power burner (exemplar) compared to damaged power burner. Diffuser deformed due to force of the explosion (fins flattened and pushed in).
