Incident Summary (Reference #5585496) (Final)

SUPPORTING INFORMATION	Incident Date		March 31, 2016	
	Location		Downtown Vancouver	
	Regulated industry sector		Refrigeration system	
	Impact	Injury	Qty Injuries	No injury
			Injury description	N/A
			Injury rating	N/A
	Damage	Damage	Damage description	O-ring of hexagonal threaded plug at the bottom of condenser gave way.
			Damage rating	Moderate
Incident rating		Moderate		
Incident overview		Refrigerant leak detector (AST-IRT-C-R134A) activated an alarm. The shift engineer verifying the amount of concentration below the threshold limit value (TLV) and the exhaust fan turned on, shutdown the unit. Concentration of refrigerant above the TLV and the potential total loss of refrigerant was avoided through timely action by the shift engineer.		
INVESTIGATION CONCLUSIONS	Site, system and components		The refrigeration plant is in a public assembly site and comprises of three individual refrigeration units. Two units, each 740kW with 4900lbs of refrigerant, are identical in configuration and function as heat pumps. Another unit (235kw with 2300lbs of refrigerant) is only for cooling. All units are indirect closed loop systems with R-134A (T

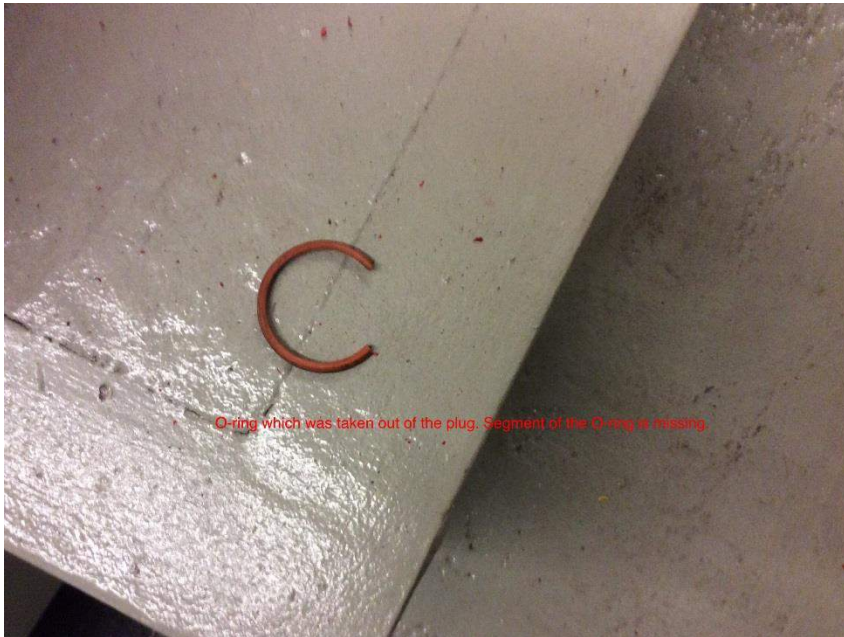
Failure scenario(s)		O-ring of the plug, which is located at the bottom part of the condenser and covered by insulated casing, was not replaced during major maintenance two years back. The O-ring became hard and brittle due to being subjected to constant heating and cooling thermodynamics, eventually failing under operating pressure when the chiller unit started (system pressure is high when compressor is running).

<p>Causes and Contributing Factors</p>	<p>The condenser goes through temperature changes as it is used for cooling in summer and heating in winter. Major maintenance was carried out two years previous. All the O-rings but one for the plug (through which refrigerant leaked) were replaced. O-rings in the condenser are subject to heat and cold which makes O-rings hard and brittle over time and ceases to seal effectively and at some point over the time fails completely to seal. Aging is one of the most important reasons for failure in this incident. If the O-ring was replaced at the last service with the rest, this particular event would most likely not have happened.</p>

O-RING THAT FAILED

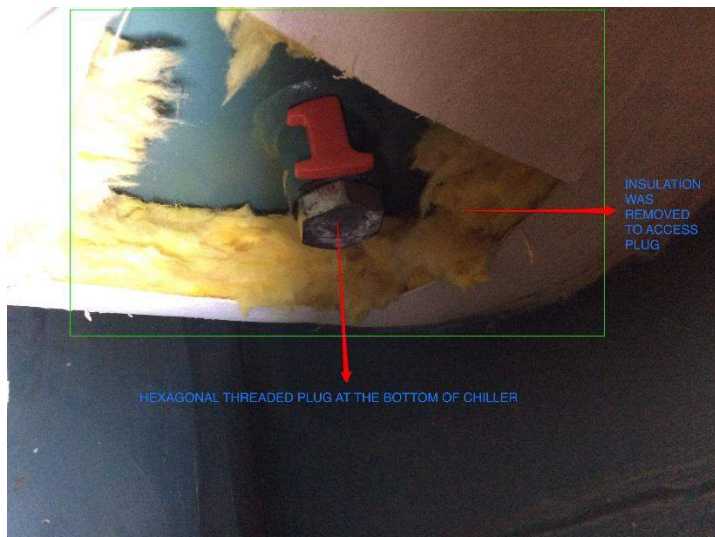
FAILURE OF O-RING OF HEXAGONAL PLUG (AT THE BOTTOM OF UNIT) RESULTED IN INCIDENT

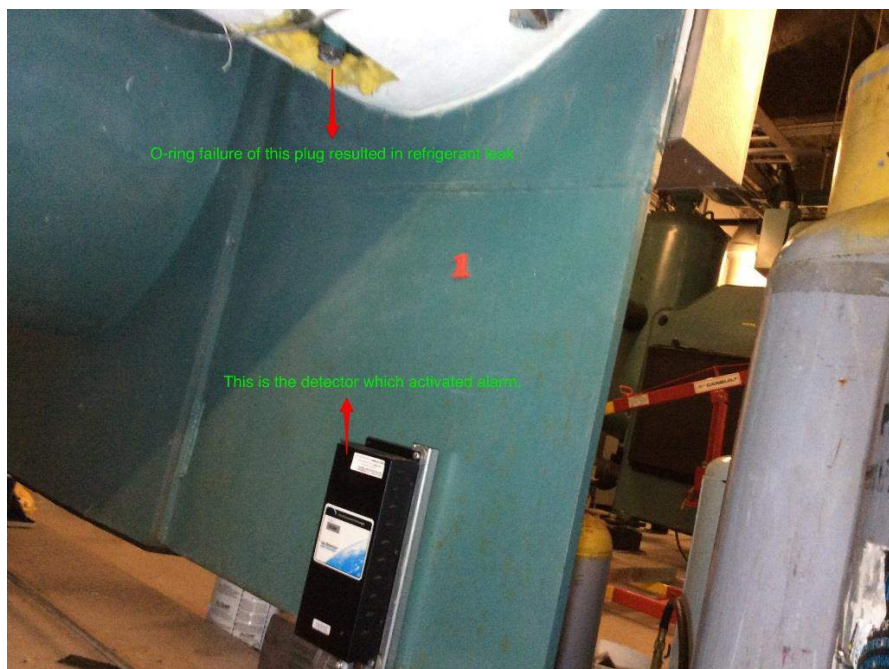
DETECTOR (AT CLOSE PROXIMITY OF THE PLUG) WHICH ACTIVATED ALARM
