Incident Summary (5611933) Final

SUPPORTING INFORMATION	Incident Date		January 26 2017	
	Location		Mackenzie BC	
	Regulated industry sector		Electrical	
	Impact	Injury	Qty injuries	1
			Injury description	Hair on wrist burned off, swelling of right thumb & index finger, black on face, temporary vision impairment seeing colours
			Injury rating	Minor
	Damage		Damage description	Minor damage to MCC disconnect
			Damage rating	Minor
	Incident rating		Minor	
	Incident overview		The employee locked out the edger and tested the lockout. While turning the disconnect back on, an arc flash event occurred.	
INVESTIGATION CONCLUSIONS	Site, system and components		<i>The edger has a number of motors and drives that are locked out on a regular basis. There is a machine lockout procedure that is posted beside the operator. The edger is controlled by an Allen Bradley PLC 5. The PLC, with the edger optimizer control the flow of wood through the machine. Most of the edger controls are done through PLC logic, but there are still "Hard Wired" safeties to ensure the PLC cannot energize the drive while the disconnect is locked out.</i>

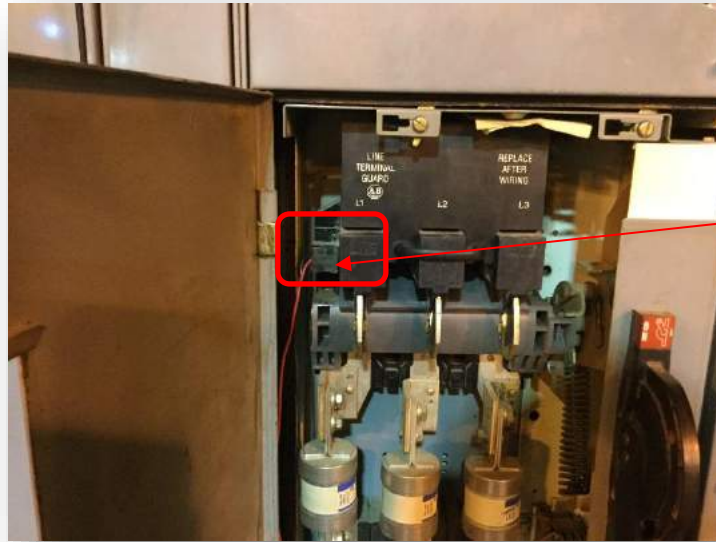
Door Switch is located here

Failure scenario(s)		<i>During the company investigation, it was noticed the MCC bucket door switch was jumped out. This door switch, is a physical set of contacts that opens the control circuit when the disconnect handle is turned off. This ensures the mag relay cannot close with the disconnect in the off position. PLC control power is the source control voltage for the MCC. It is possible for the PLC to energize the motor mag relay even with the disconnect turned off. During the lockout procedure, a test is performed to check the lockout integrity. The theory is the operator hit the start button one extra time, energizing the mag relay. When the operator finished, he removed his locks and turned the disconnect on with the mag relay energized,</i>	
	Facts and evidence		<i>The PLC control voltage was the source of the control power for the edger. The door switch for this bucket was jumped out due to problems with the door switch. This could have been a faulty switch or a problem with the way it was mounted. This was left jumped out for days.</i>

The door switch was found jumped out, allowing the PLC to energize the mag relay with the disconnect in the off position. The operator locked out the machine and tested the lockout. The start button must have been pushed after the stop during the test procedure, energizing the mag. There is no visual means to see if the mag is de-energized. When the operator finished, the individual turned the disconnect on, energizing the 150 HP top head motor, causing an arc flash.

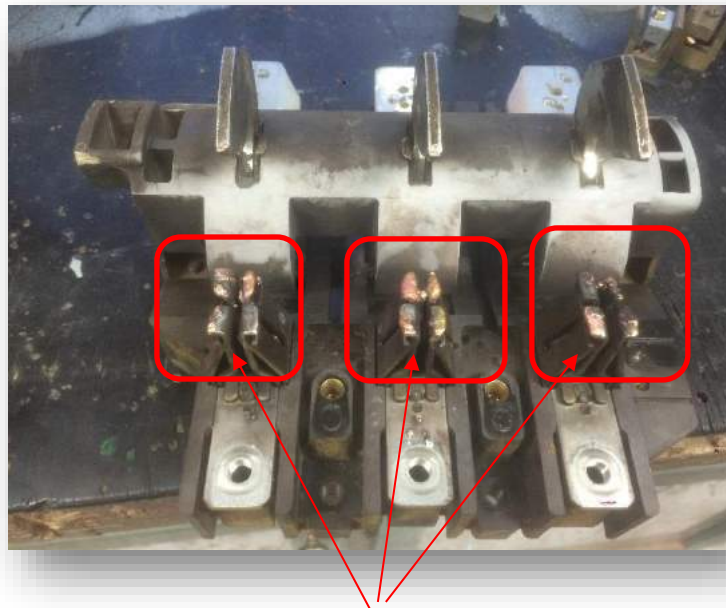
Arc damage to the disconnect.

<p>Causes and contributing factors</p>	<p><i>The door switch was jumped out due to problems with the switch. The maintenance staff did not check the repair work that fixed the door switch. The fix was to remove the door switch from the control circuit. This may have fixed the control issue, but created a new issue. The PLC was the source of the control voltage for the MCC. With the control voltage supplied remotely it is possible for the PLC to energize the mag relay when the disconnect handle is off. In this case it is very likely the operator pushed the start button one extra time during the test procedure. When the operator turned the disconnect back on, the 150 HP motor started, creating an arc flash, damaging the disconnect and injuring the operator.</i></p>
