Incident Summary #II-1314532-2022 (#25810) (FINAL)

| | Location | Crescent Valley, BC | |
| | Regulated industry sector | Electrical - Low voltage electrical system (30V to 750V) | |

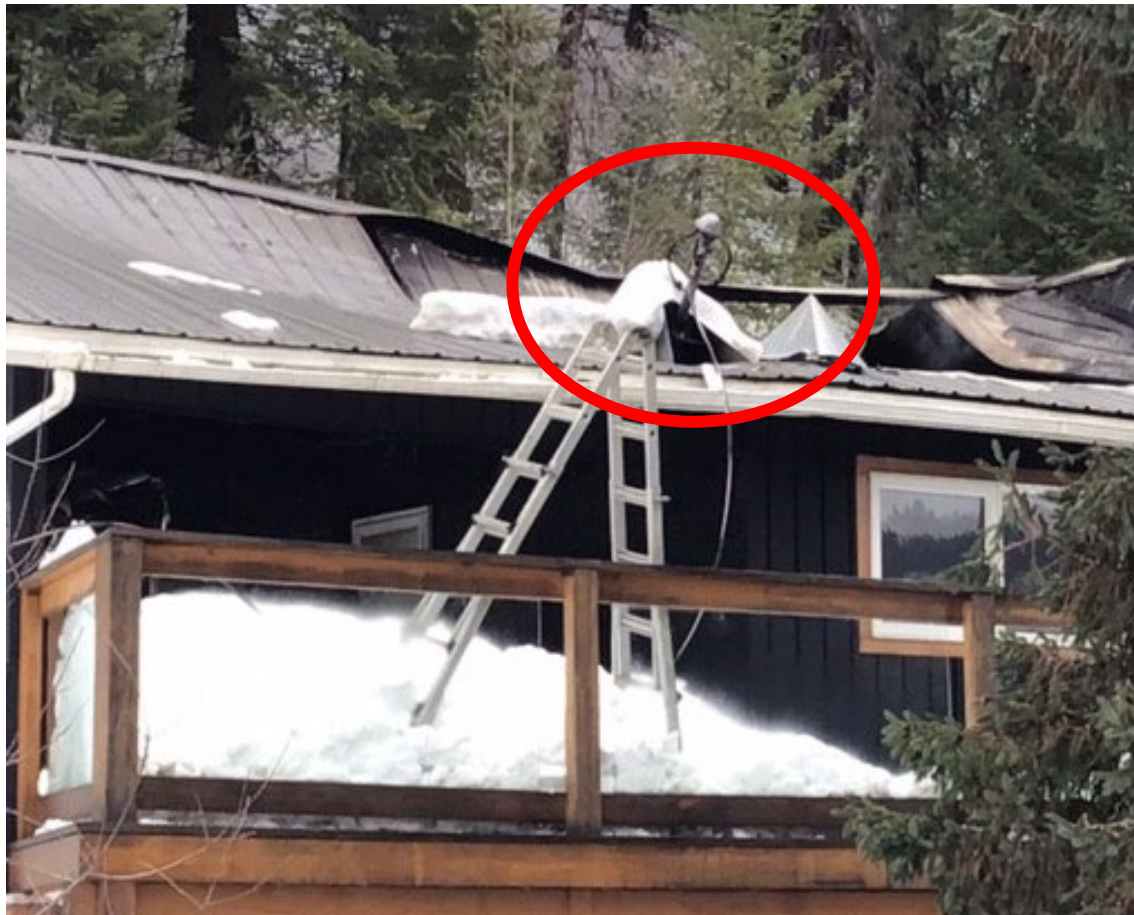
Photo 1: West side of structure revealing roof structure fire damage and bend electrical service mast pipe

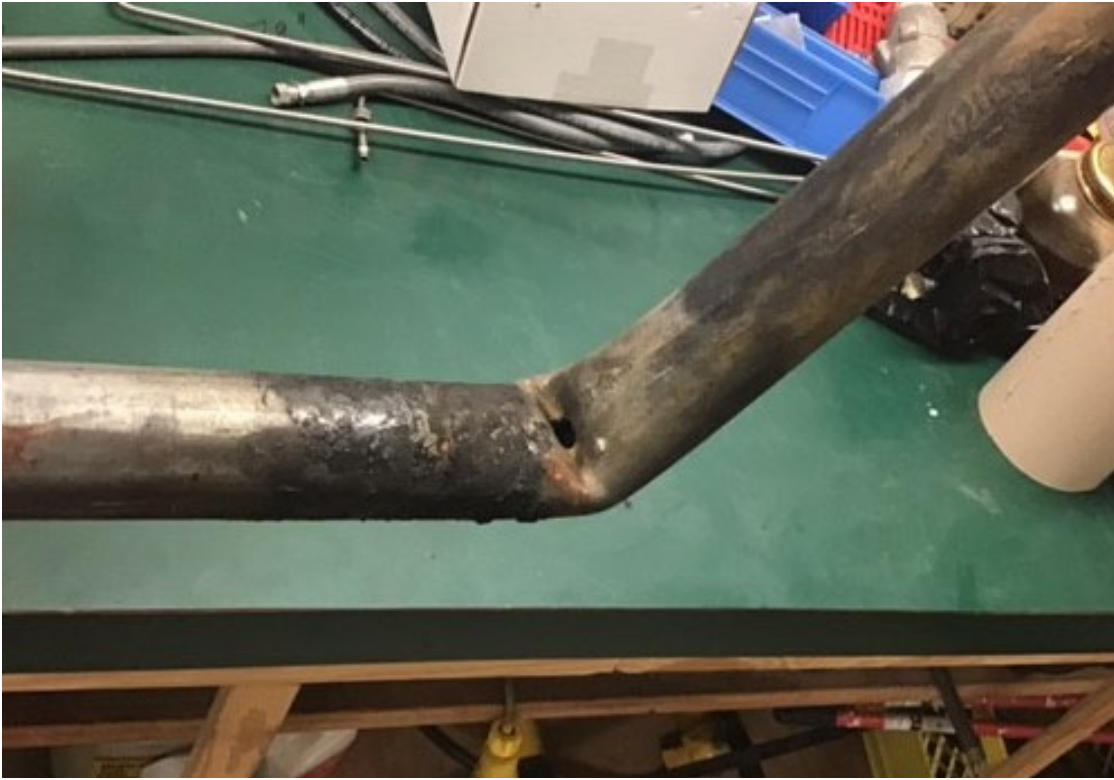
| <p>Facts and evidence</p> | <p>The interior of the mast pipe volume was compromised where the mast pipe was bent. The mast pipe interior surfaces penetrated the service conductor insulation, created short circuit between ungrounded service conductors and a short circuit to ground resulting in an electrical arcing event and molten metallic mast pipe material igniting the combustible wood roof system which escalated and resulted in a structure fire.</p> <p>The geographic area experienced multiple slow sliding events, service repairs and related incidents during the end of January, beginning of February 2022.</p> |

Photo 2: Mast pipe bend area. Hole created by electrical arcing event which would result in molten metal projecting from bend area and igniting adjacent combustible materials.

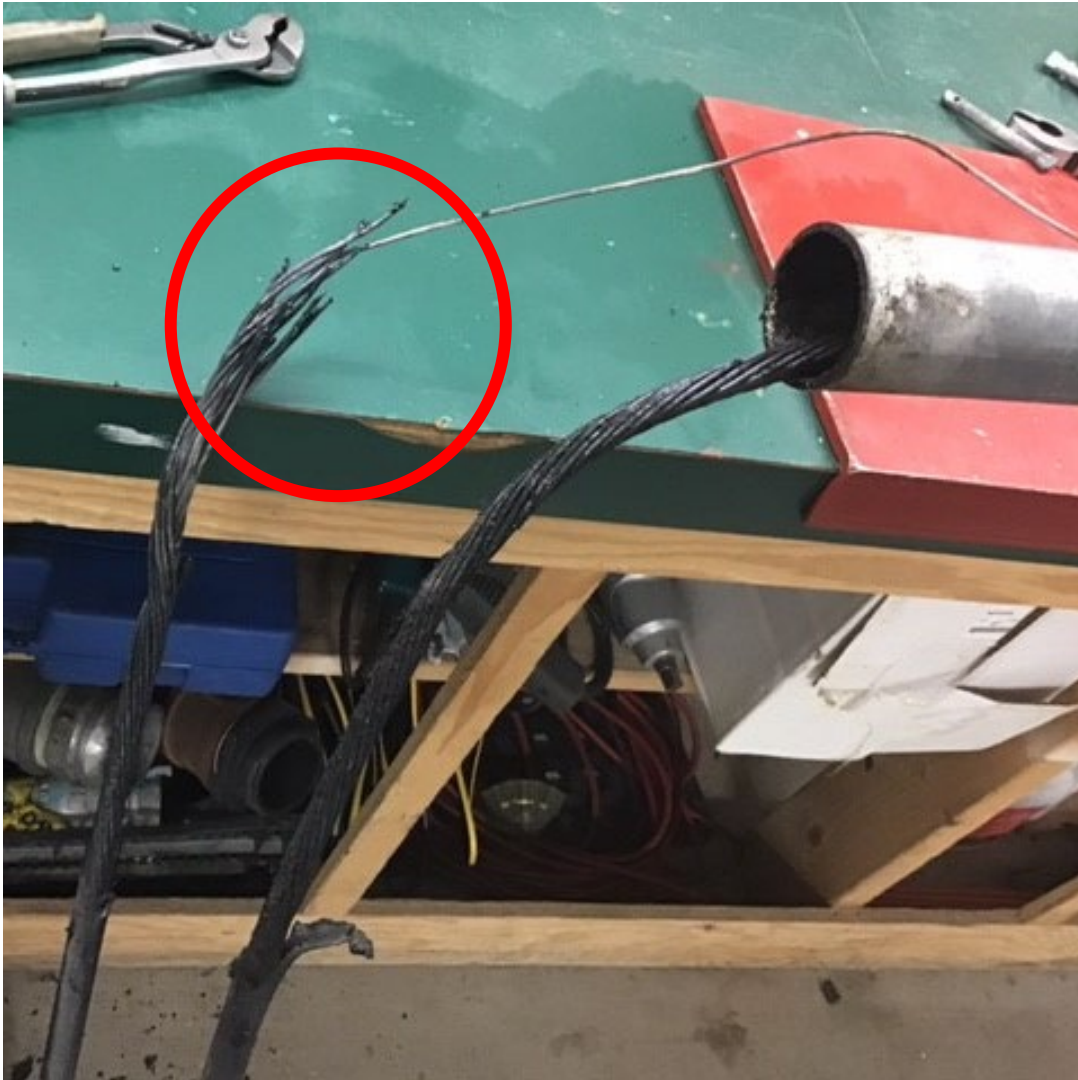
Photo 3: Ungrounded service conductor #1 electrical fault area when withdrawn from mast pipe

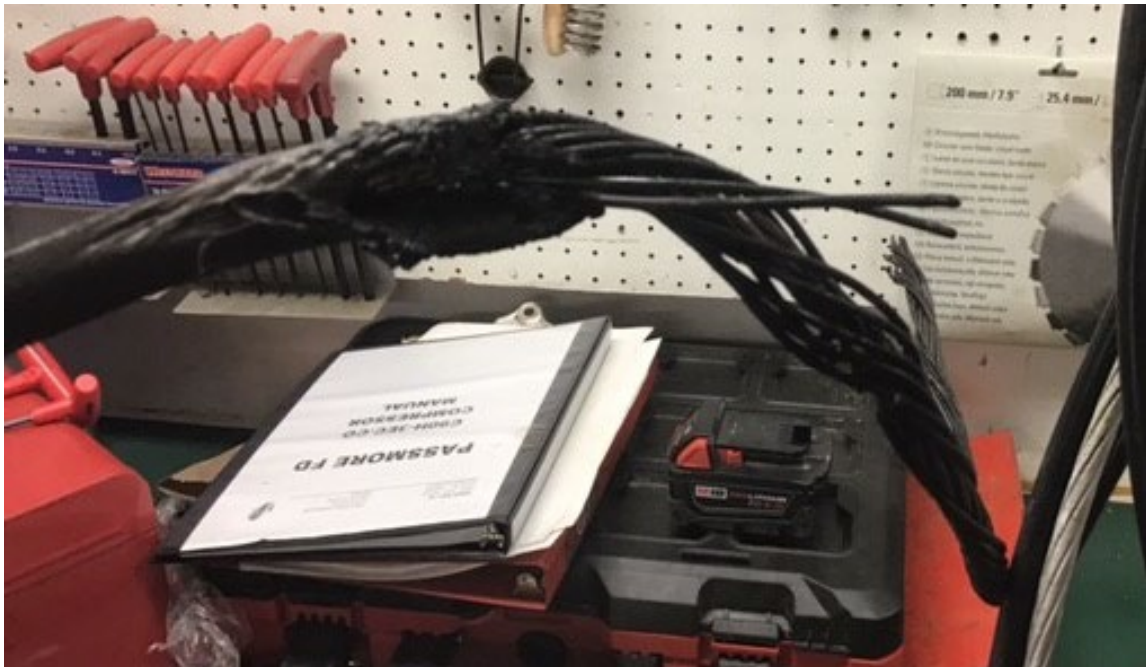
Photo 4: Ungrounded service conductor #2 area of electrical fault when withdrawn from mast pipe

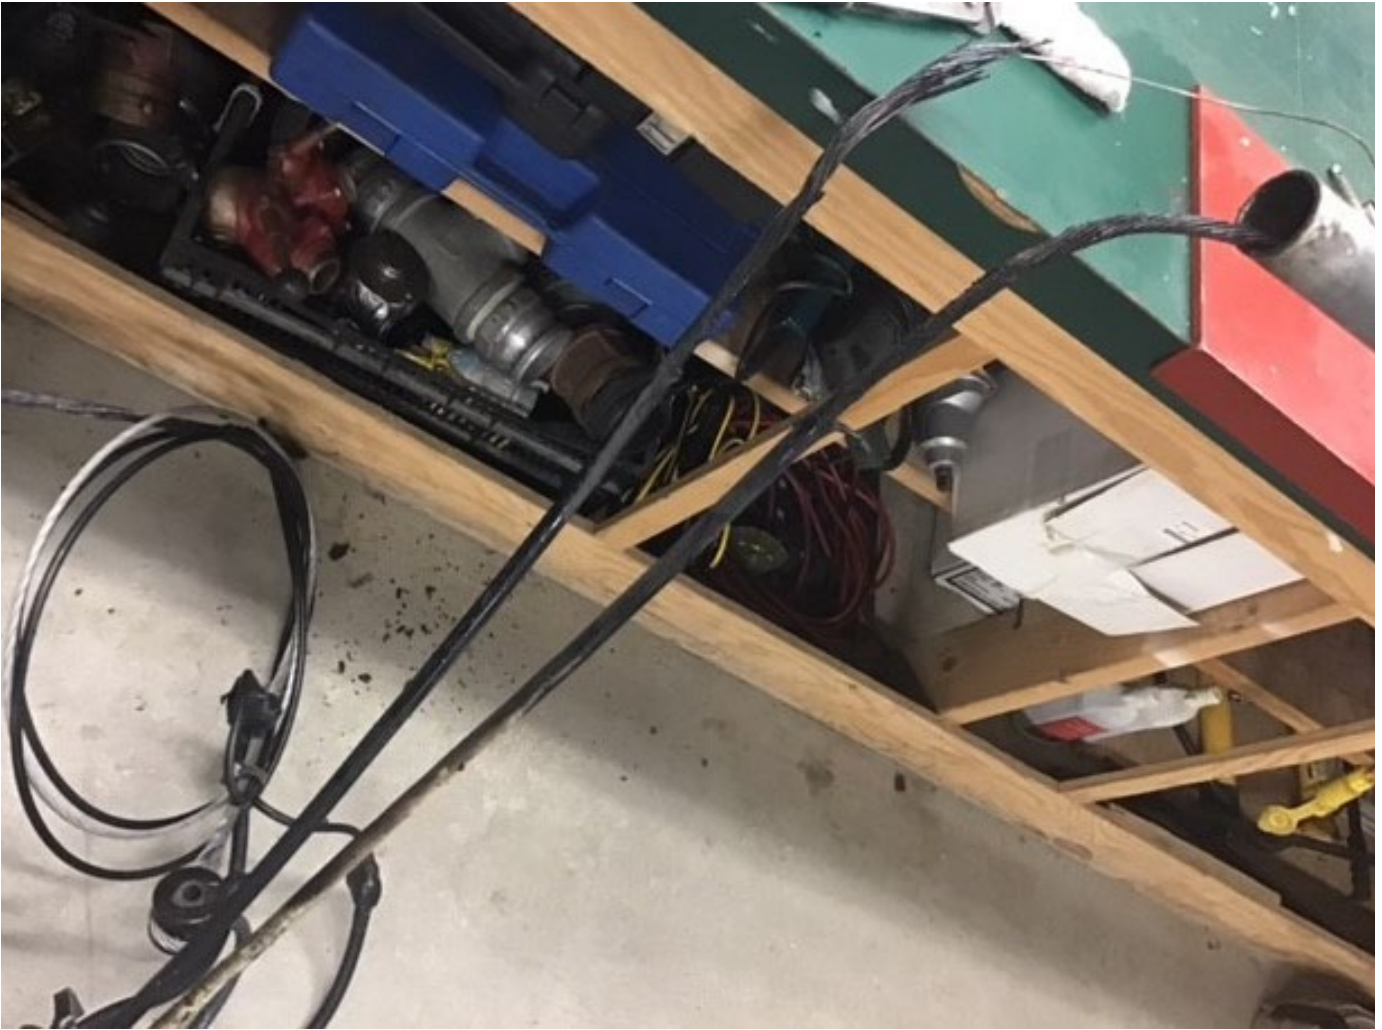
Photo 5: Service conductor withdrawn from mast pipe
