Incident Summary #II-1028261-2020 (#18434) (FINAL)

SUPPORTING INFORMATION	Incident Date	June 19, 2020	
	Location	Vancouver, BC	
	Regulated industry sector	Elevating devices - Construction / personal hoist/ man lift	
	Impact	Qty injuries	0
		Injury description	None
		Injury rating	None
	Damage	Damage description	Landing gate was dislodged from its supporting structure due the car impacting a gate lock. Damage to gate frame/hoarding and gate lock.
		Damage rating	Moderate
Incident rating	Moderate		
Incident overview	During the operation of the hoist, as the operator was going in the up direction, the car struck the 9th floor gate and pulled it from the wood frame.		
INVESTIGATION CONCLUSIONS	Site, system and components	<p>A construction hoist is a temporary elevating device that is normally installed on the outside of a building under construction to provide transporting of construction personnel and construction material.</p> <p>Gates are installed at each landing that the hoist services. Gates are fastened to temporary hoarding that is installed at the edge of the building, along the path of the hoist to prevent construction personnel and construction material from falling from th

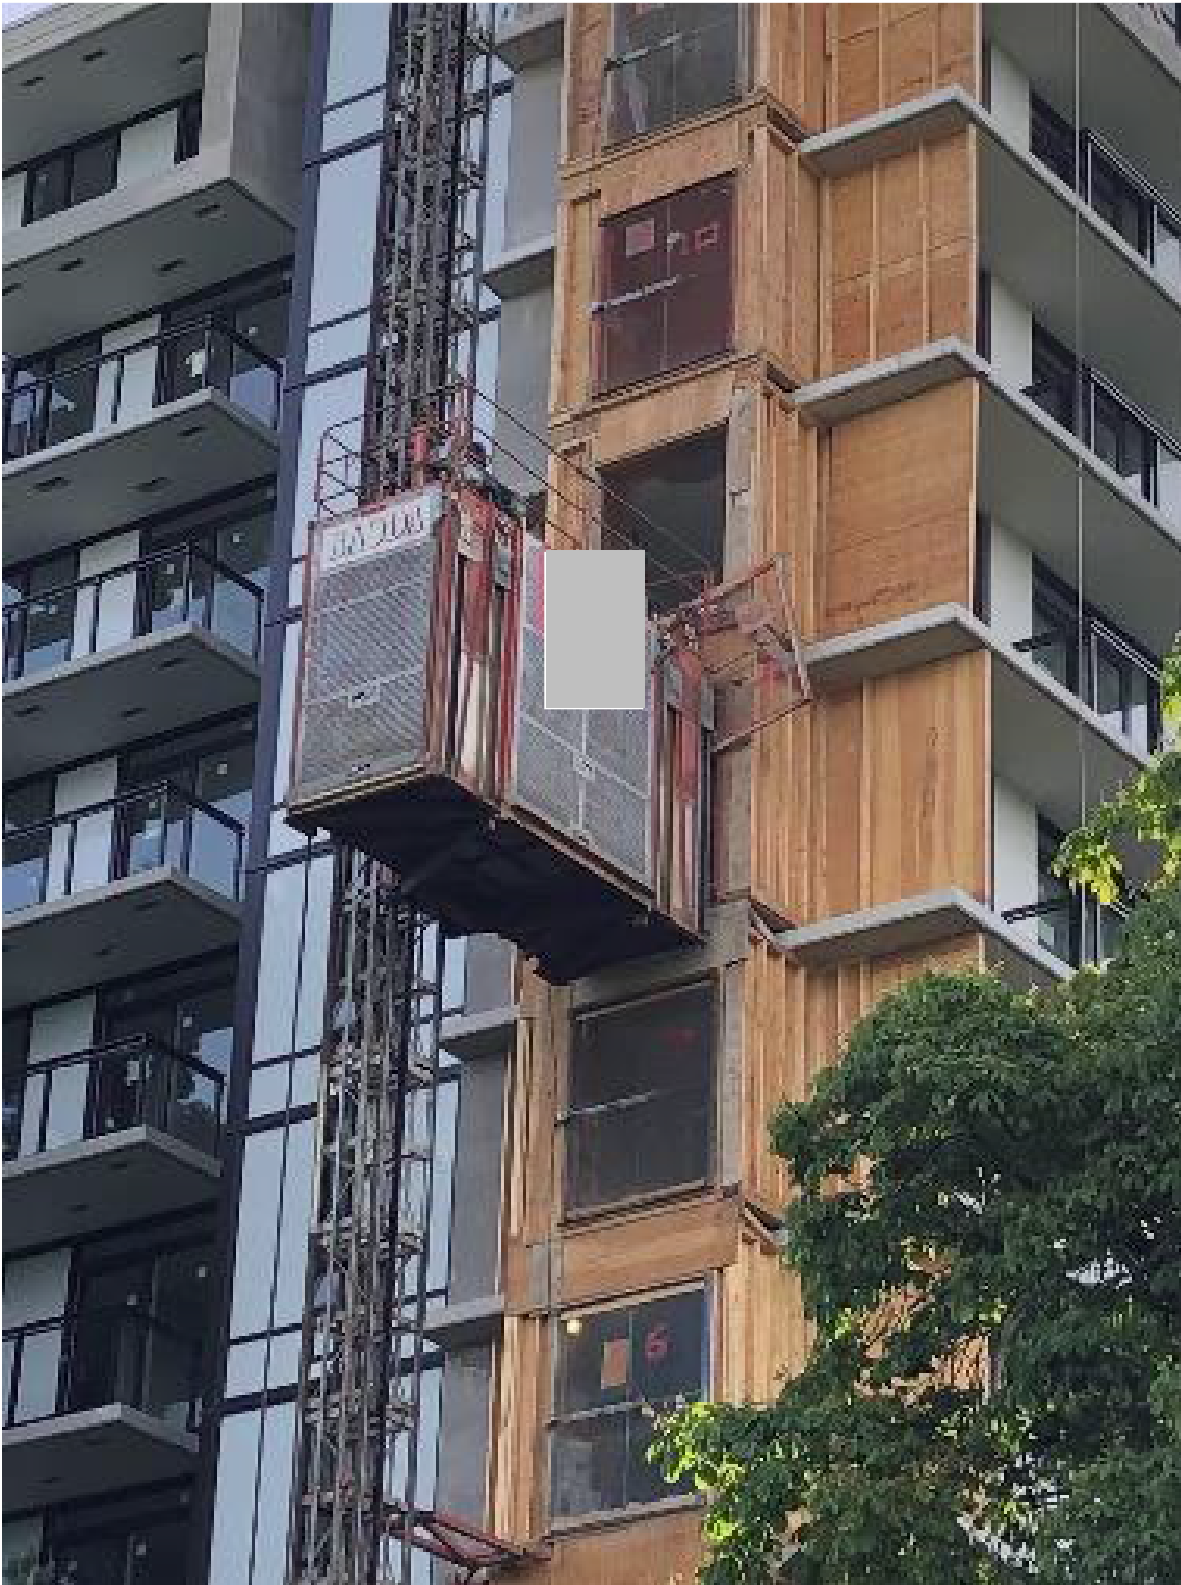
Failure scenario(s)	During the operation of the unit, the opening and closing of the gate caused the screws to loosen/move away from the hoarding structure which resulted in the gate to car clearance decreasing. Due to this decrease in clearance, as the car traveled in the up direction it struck the gate lock. The impact of the car and gate lock broke the gate fasteners and subsequently tore the gate from the hoarding.	
	Facts and evidence	<p>During an inspection in February 2020 it was noted that sill gaps were not within code requirement of 0.5" to 2". The gap was from 2.5" – 2.75" during the inspection. The contractor was informed that they needed to decrease this sill gap to within code requirements. The contractor subsequently installed shims to bring the sill gaps into compliance.</p> <p>Based on my conversation with the elevating devices contractor, they have stated that the screws used were the same screws that were originally installed on the gates which were 2.5" in length. Since the gates were shimmed out by as much as 1" this left only 1.5" of screw engagement. The manufacturer recommends at least 2" of engagement into the wood frame. Based on my conversation with the site, they stated that this information was not conveyed to them.</p>

Gate dislodged from hoarding

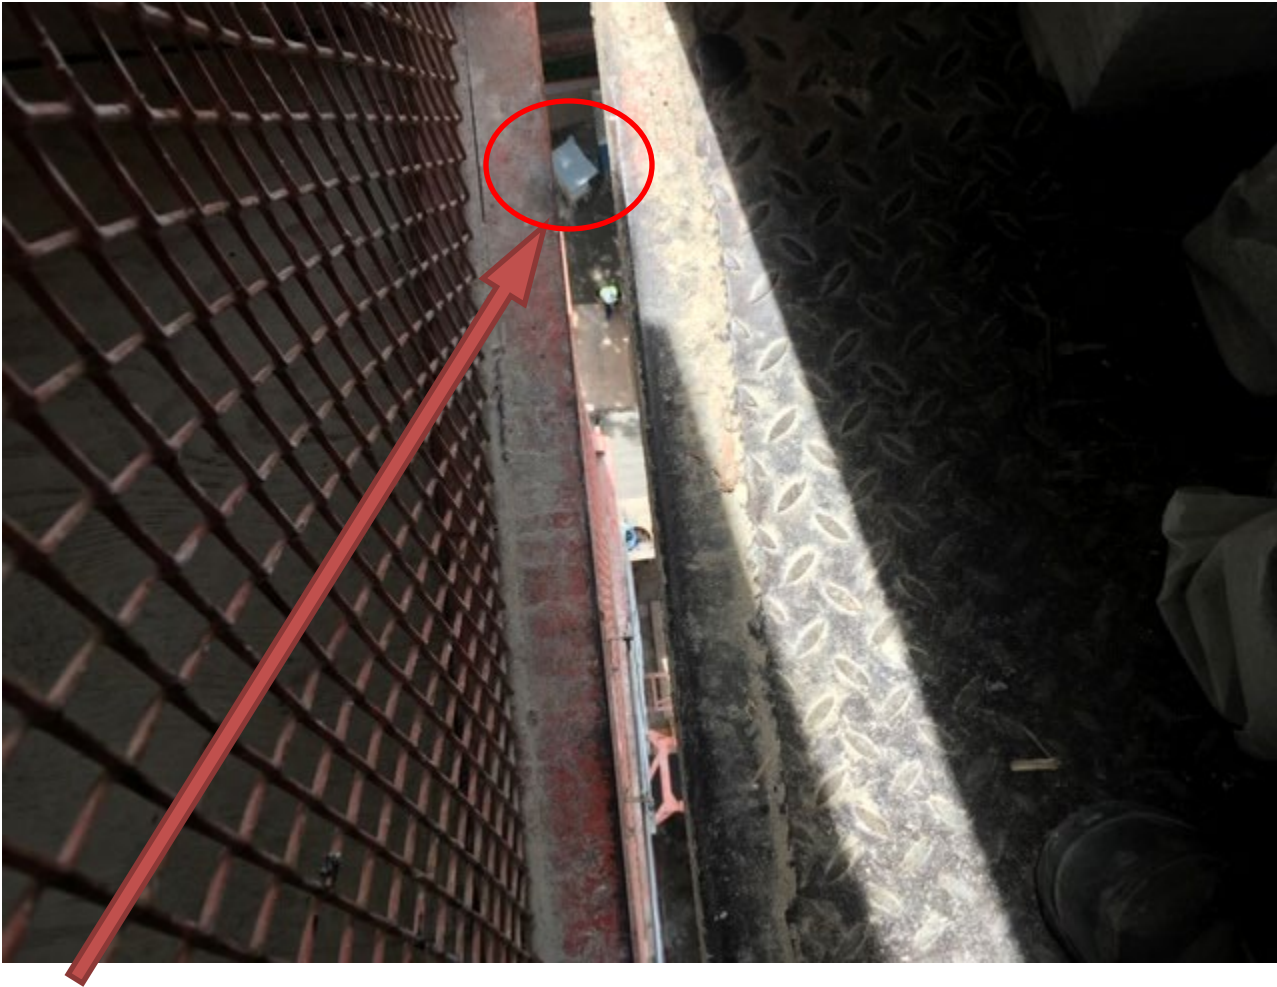
Gate Lock Contact Point – Gate Lock torn from the gate assembly
