## Incident Summary #II-1735538-2024 (# 48950) (FINAL)

SUPPORTING INFORMATION	Incident Date	July 17, 2024	
	Location	Prince George, BC	
	Regulated industry sector	Electrical - Low voltage electrical system (30V to 1000V)	
	Impact	Qty injuries	2
		Injury description	Two people received an electric shock.
			Injury rating
	Damage	Damage description	The adjacent appliance cord was melted and destroyed.
		Damage rating	Minor
	Incident rating	Minor	
	Incident overview	<p>Multiple counter appliances were placed together on the kitchen counter and shared one of the kitchen counter outlets. The power cords of the appliances were pushed behind the appliances. One of the power cords from an adjacent appliance had contacted the rear metal case of the toaster oven. The heat from the toaster oven melted the adjacent power cord which energized the metal case of the toaster oven.</p> <p>The owners of the home on two separate occasions received an electric shock when they came in contact with both the electric range and the toaster oven at the same time.</p>

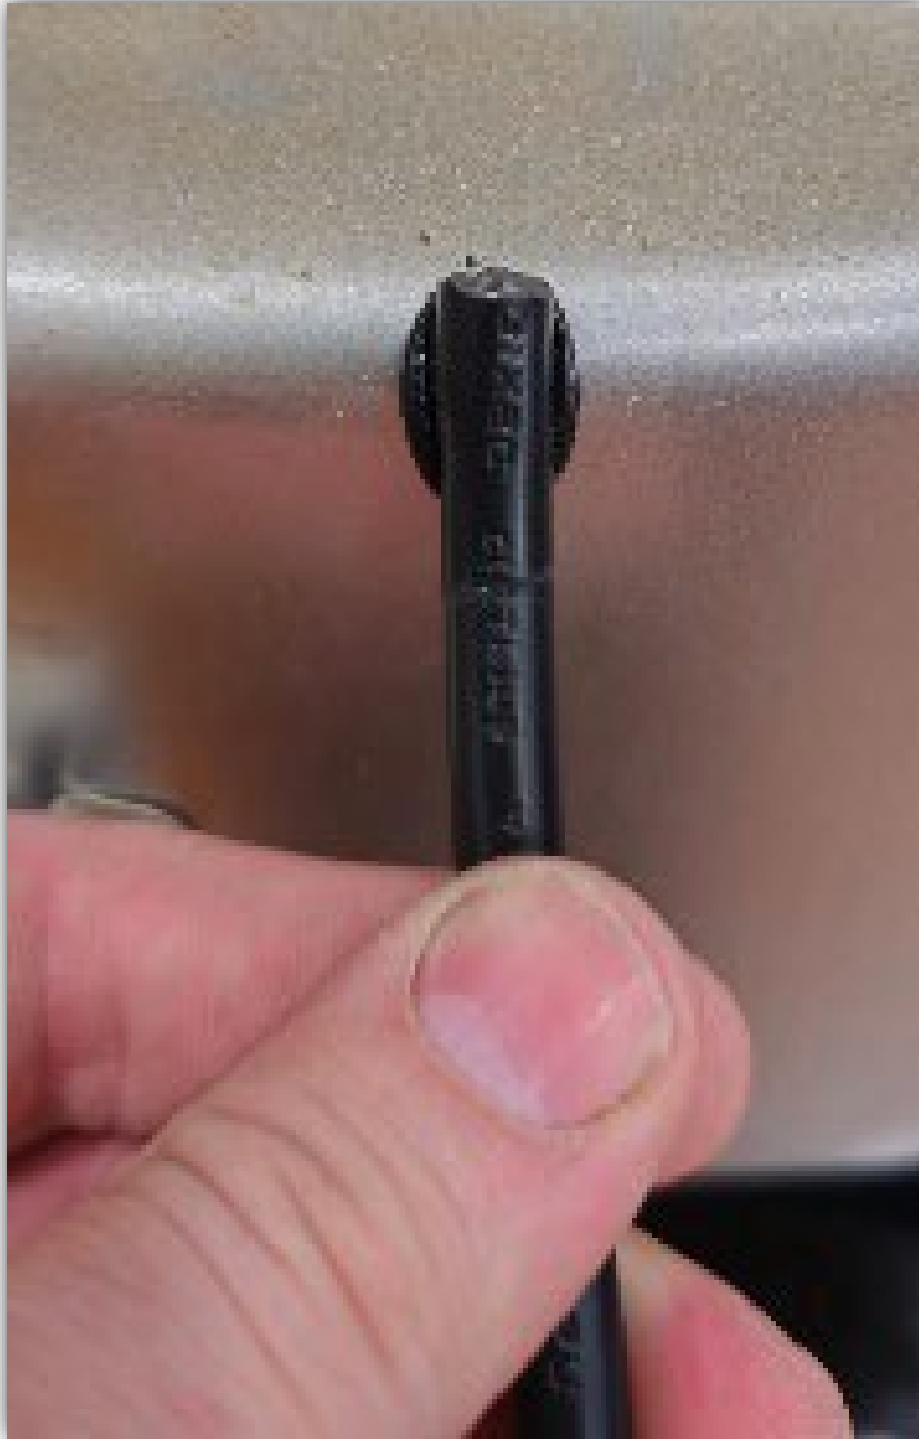
The probable cause of the incident was an adjacent appliance power cord contacting the rear metal case of a toaster oven. The appliance cord melted through and energized the metal case of the toaster oven with 120 volts. In addition, the certified metal toaster oven was approved for use with only a two-prong power cord which does not contain a bonding conductor.

Image 2 - Burnt end of the adjacent kitchen counter appliance.

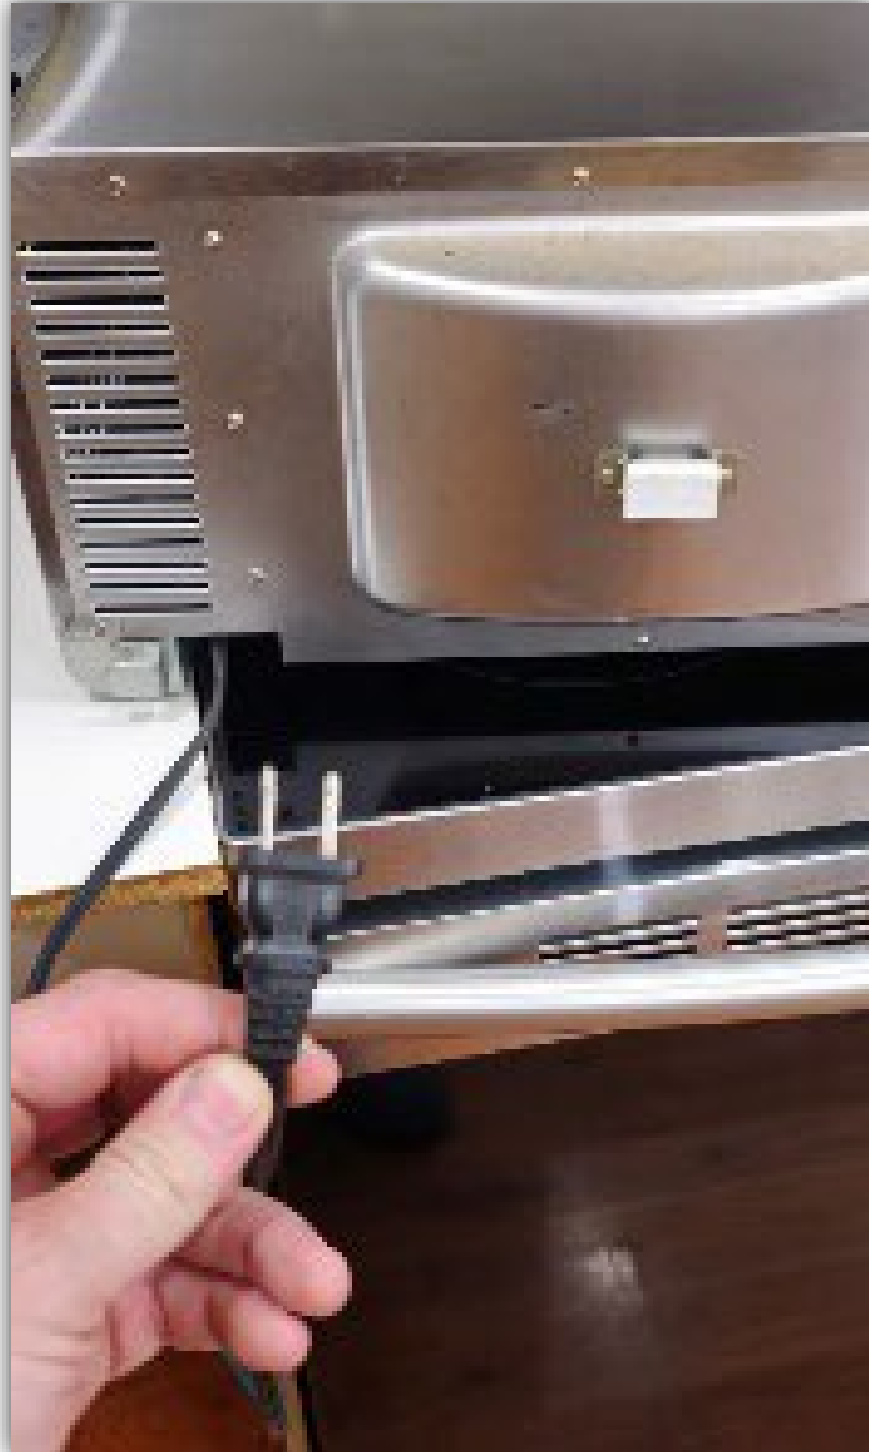
If the metal toaster oven had a three-prong (grounded type) power cord bonding, it is likely the counter outlet circuit breaker may have tripped as soon as the adjacent appliance cord melted into the metal exterior of the toaster oven.

Image 3 - Metal enclosed toaster oven with only a two-prong attachment cord.

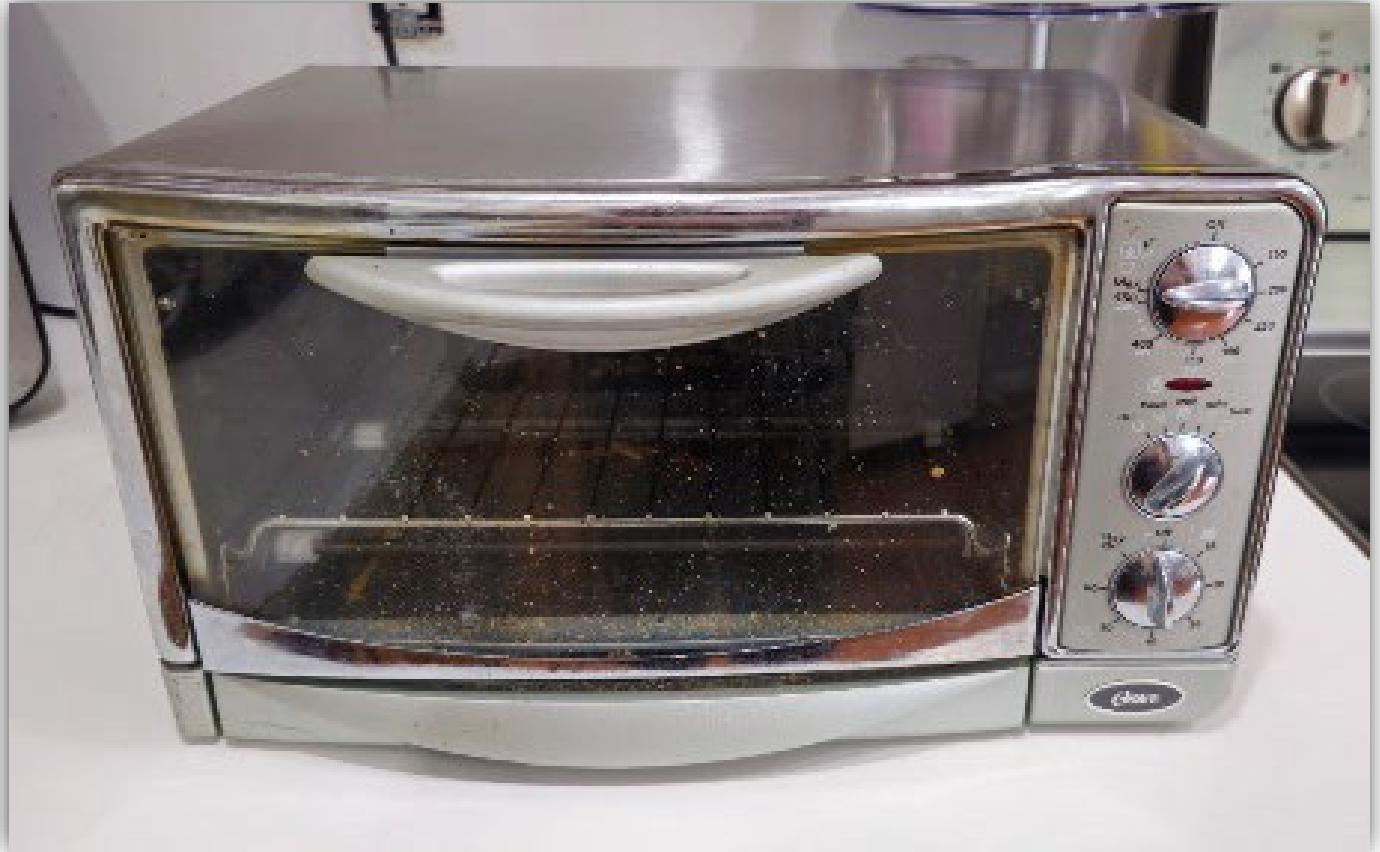
Image 4 - Front view of metal toaster oven.
