## Incident Summary (Reference #5621423 ) (FINAL)

SUPPORTING INFORMATION	Incident Date		<i>August 05, 2017</i>	
	Location		<i>Burnaby</i>	
	Regulated industry sector		<i>Elevating Devices</i>	
	Impact	Injury	Qty injuries	<i>0</i>
			Injury description	<i>No injury to person(s).</i>
			Injury rating	<i>None</i>
	Damage	Damage description	<i>Damage to Escalator; Handrail drive sprocket, handrail track, step chain, step track, step axial(s) and steps.</i>	
			Damage rating	<i>Moderate</i>
Incident rating		<i>Minor</i>		
Incident overview		<i>A piece of the handrail track broke and was able to rotate with the handrail. The plastic track was pushed/pulled along with the handrail and eventually became caught into the handrail drive sprocket. This caused the handrail drive sprocket to flex and make contact with an escalator step. This contact caused a chain reaction on the underside of the step carriage and brought the escalator to a stop.</i>		
INVESTIGATION CONCLUSIONS	Site, system and components		<i>The handrail track is installed under the handrail. This track works as a guide and allows the handrail to rotate with minimal friction continuously around the escalator. The handrail spro

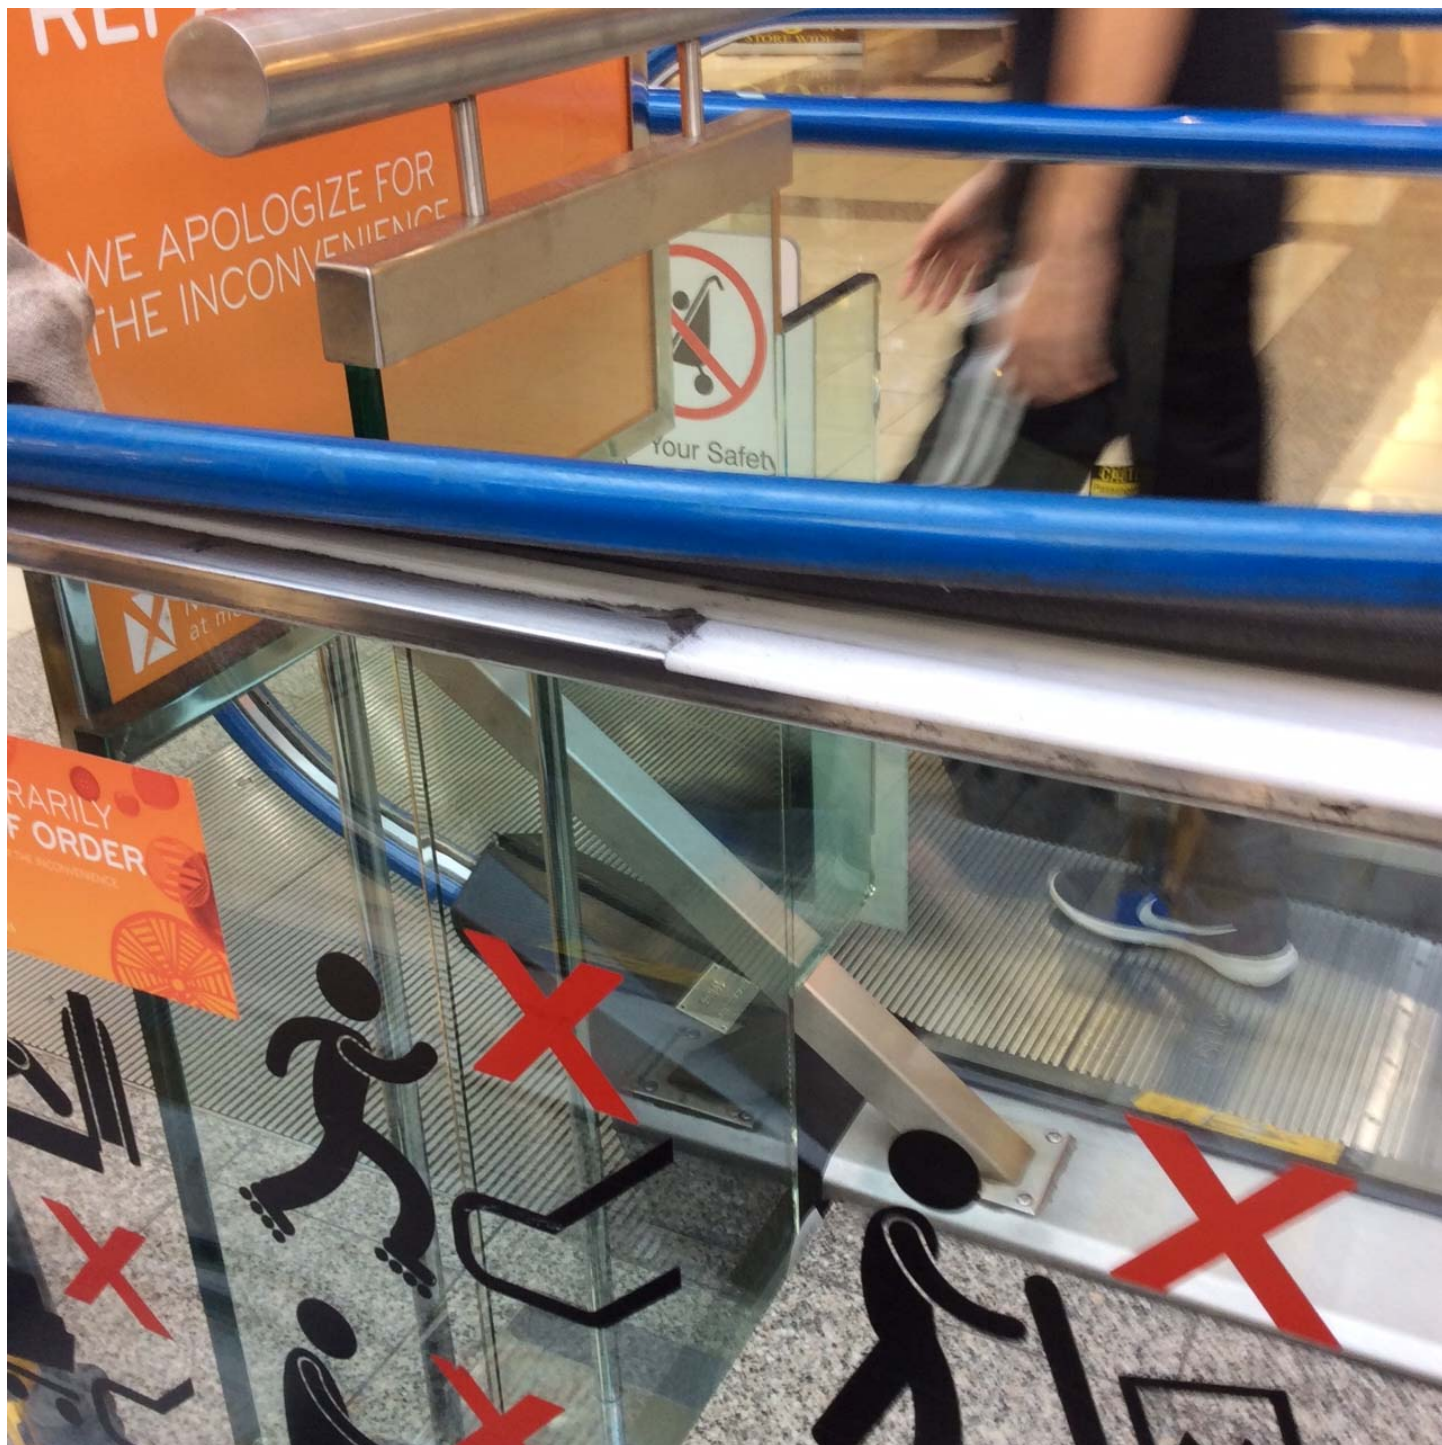
*Handrail track*

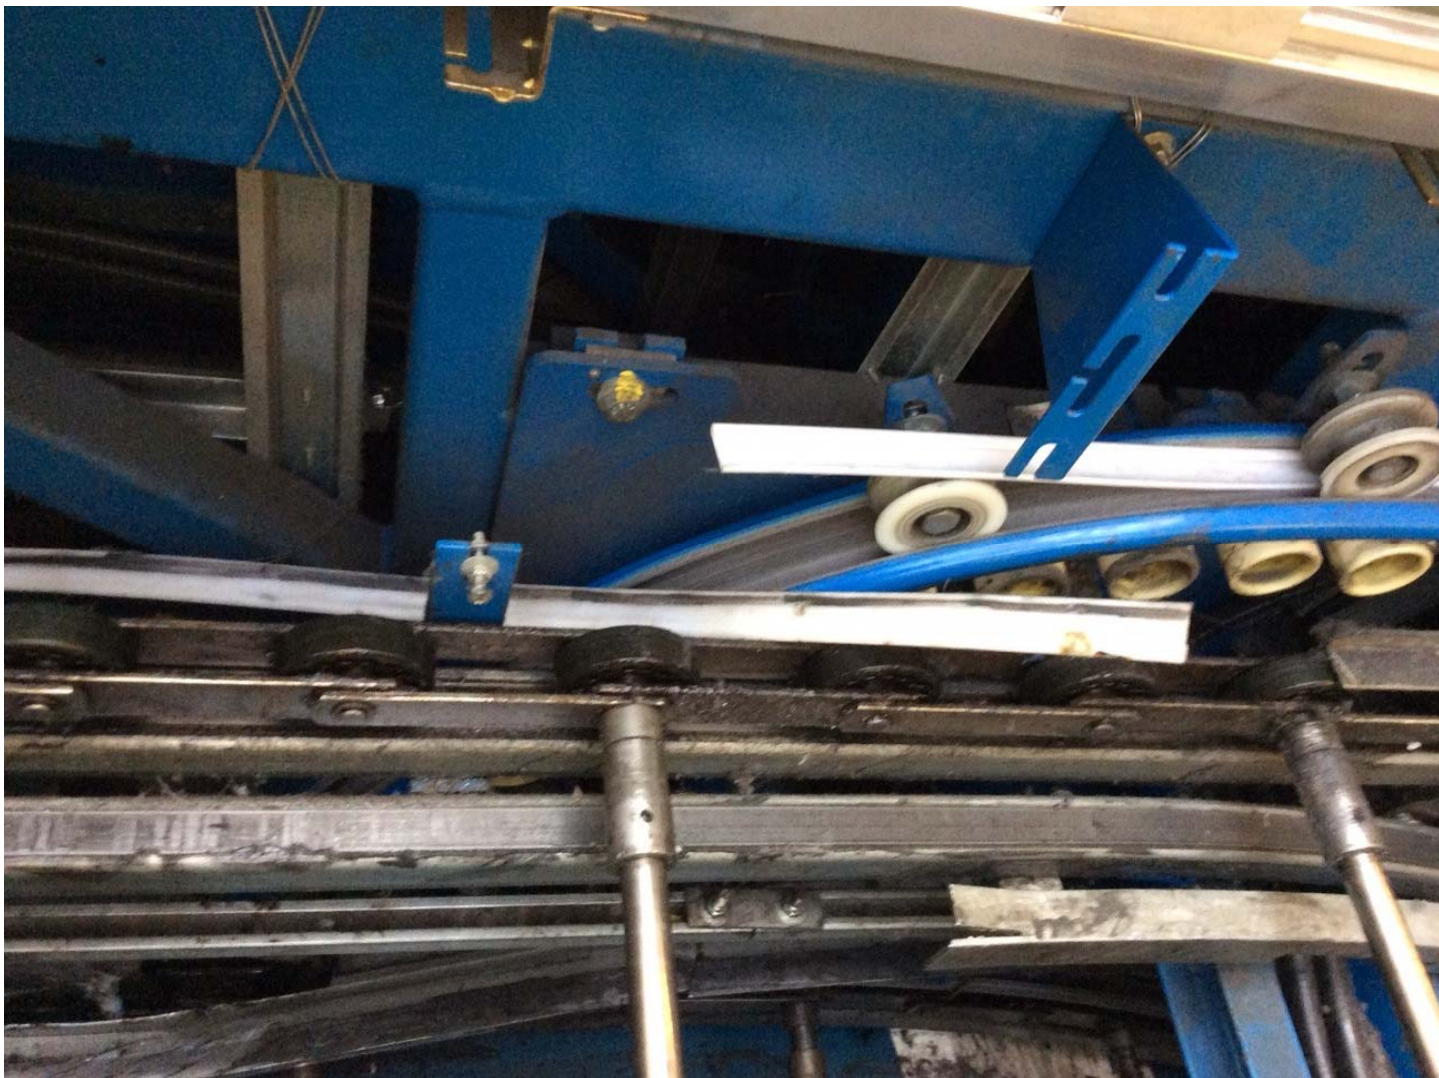
Failure scenario(s)		<i>A piece of handrail track broke and was able to become tangled into the handrail drive system.</i>	
	Facts and evidence		<i>Broken handrail track in handrail drive system.</i>	
	Causes and contributing factors		<i>Integrity of handrail track compromised over the years of service.</i>

*Handrail track pushed/pulled into handrail drive system.*
