Incident Summary #II-744946-2018 (#8566) (FINAL)

SUPPORTING INFORMATION	Incident Date	September 14, 2018	
	Location	Whistler	
	Regulated industry sector	Passenger ropeways - Above surface ropeway	
	Impact Injury	Qty injuries	1
		Injury description	Reported as impact injury to elbow and shoulder. Symptoms reported as discomfort of movement and diminished range of motion (x-rays ruled out fractures).
		Injury rating	Minor
	Damage	Damage description	NA
		Damage rating	None
Incident rating	Minor		
Incident overview	Employee (ropeway attendant) was assisting the loading of bikes at the bottom station. The bike rack caught the attendants jacket and pulled them forward and off of the loading deck. The attendant yelled for a bystander (not employee) to stop the lift. The ropeway was stopped. The jacket ripped releasing the employee and they fell to the ground approximately 2 meters.		
INVESTIGATION CONCLUSIONS	Site, system and components	<p>The detachable grip ropeway is utilized in a downhill mountain bike operation.</p> <p>Passengers and their bicycles are transported by the ropeway.</p> <p>Carriers are configured on the line alternating between passenger carriers which provide seats fo

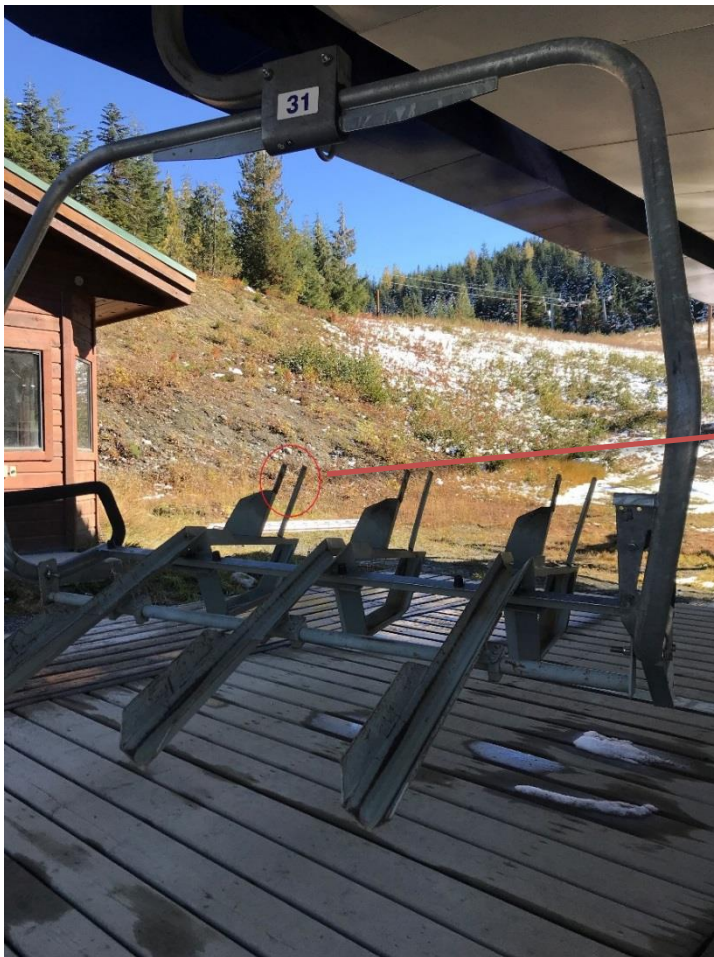
BICYCLE CARRIER

<p>As the attendant moved out of the path of the moving bicycle carrier their jacket became entangled with a pair of narrow steel bars which extend diagonally forward and up (utilized in stabilizing the front wheel of the bicycle) from the front of the carrier.</p> <p>The attendant was dragged forward and off of the front of the loading deck.</p> <p>The attendant yelled for the ropeway to be stopped. A member of the public (not related to the operation of the ropeway) pushed a nearby stop button. The ropeway stopped, The attendant's jacket tore and the attendant fell approximately 2m, landing on their back and right arm.</p>
<p>Causes and contributing factors</p>	<p>It is certain that the attendant was dragged off the loading deck because their jacket became entangled with the diagonal forward facing dowels of the bicycle carrier.</p> <p>It is possible that the attendant was not paying attention to their proximity to the carrier.</p>

Steel Bars that hold the bike in place during transport.
