Incident Summary #II-1289464-2021 (#25109) (FINAL)

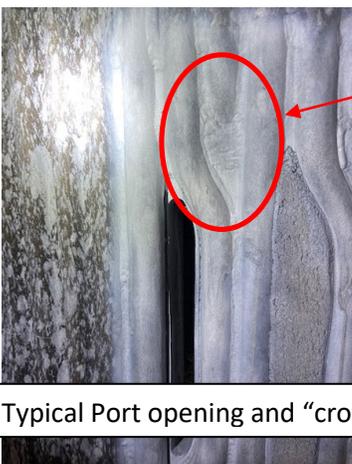
Typical Port opening and "crotch" plate

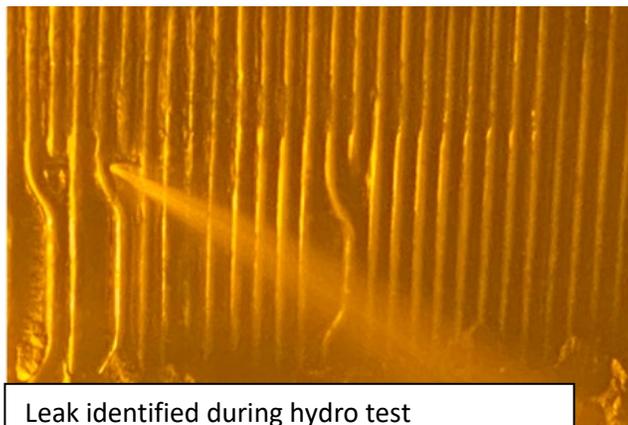
<p>Facts and evidence</p>	<p>The recovery boiler tube leak was located at a primary airport crotch plate on the rear wall, approximately 3ft above the floor tubes. The boiler tube leak was on the hot side of the tube. Upon initial inspection a crack perpendicular to the tube wall was identified to have traversed from the crotch plate, across the attachment weld and propagated into the tube.</p> <p>The leaking section of tube and was removed. The tube section was sent for examination by an independent material testing and analysis laboratory. The failure analysis report identified findings which included:</p> <ul style="list-style-type: none"> • thick scale deposit of iron and copper oxides was found inside the tube adjacent to the leak • metallographic examination showed evidence of thermal degradation on the fire side of the tube indicating that the tube was exposed to temperature above 750 F for an extended period. • the thermal spray coating was spalled from roughly half the tube surface and the carbon steel showed corrosion thinning <p>Tube scaling can cause elevated metal temperatures as it impedes heat transfer to the boiler water. The adjacent primary air port was also observed to be blinded over which may have resulted in air conditions that contribute to thermal cycling.</p> <p>The boiler crotch plates were inspected 15 months prior for cracks, actions were taken to repair or prevent growth of cracks in proximity of a tube or crotch plate fillet weld. Damage mechanisms such as thermal and mechanical fatigue cracking can occur in components known to be affected by thermal and/or mechanical cycling. Fatigue crack damage has a time aspect to it, the more cycles increase the probability of initiation. Rates of fatigue crack growth typically vary over time. Cracks may be found by examination but cannot be 'inspected out' since they may initiate any time after examination of the part.</p>

Leak identified during hydro test

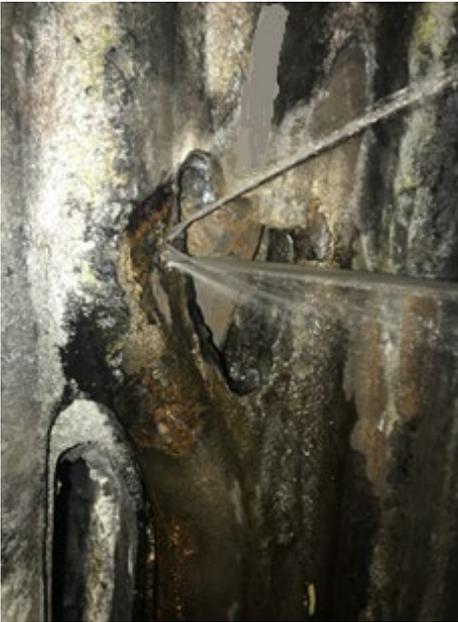
Leak with crotch plate removed

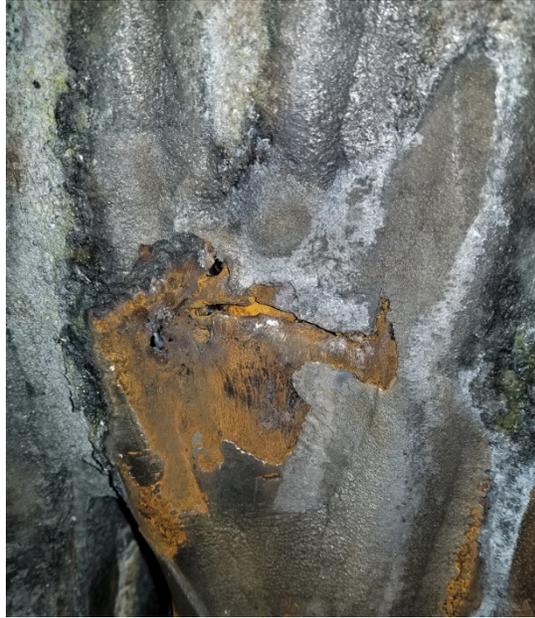
Crotch plate intact

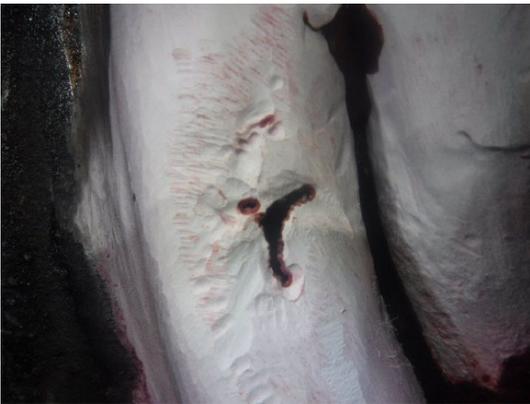
<p>Causes and contributing factors</p>	<p>It is highly likely that the tube failure occurred because of a thermal fatigue crack that traveled across the attachment weld and into the tube. Heavy Scale inside tube contributed to the failure by causing elevated metal temperatures.</p>

Boiler tube after indication was ground out.
The crack was through wall.

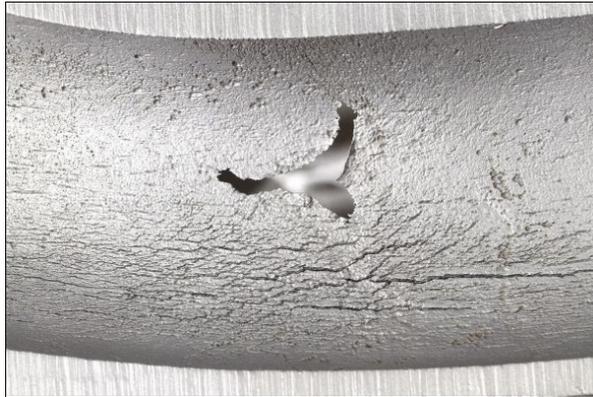
Failure location after cleaning.
