Incident Summary (5603257)

SUPPORTING INFORMATION	Incident Date		August 4, 2016	
	Location		Victoria	
	Regulated industry sector		Zip line	
	Impact	Injury	Qty injuries	2
			Injury description	One person sustained a broken wrist and back injury and a second person sustained a concussion.
			Injury rating	Moderate
	Damage	Damage	Damage description	Failure of zip line anchor bolt. Damaged zip line cable.
			Damage rating	Major
Incident rating		Major		
Incident overview		It was reported to BCSA that a zip line tension anchor bolt failed. The failure caused the complete release of the zip line cable. One person was riding the zip line at the time of the failure, the release of the cable caused this person to fall to the ground several meters. A second person was holding on to the zip line cable at the loading area deck of the zip line when the failure occurred causing them to be thrown several meters off of the loading area deck to the ground.

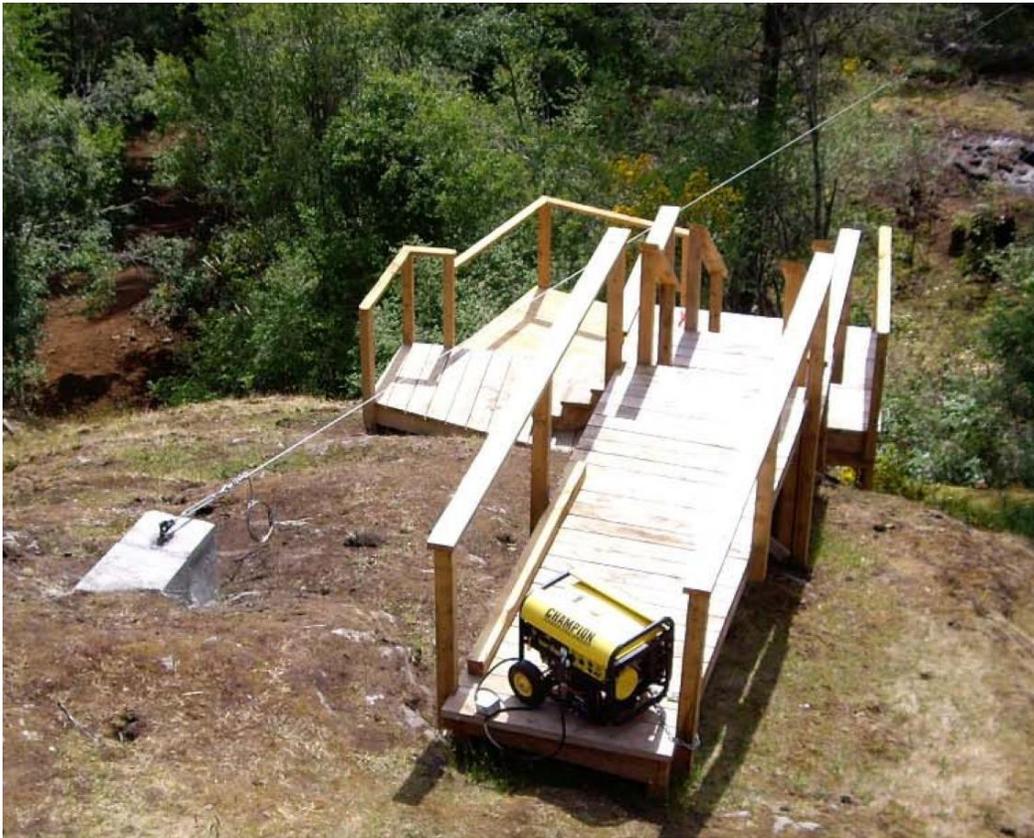
Figure 1: Overhead image of the installed zipline anchor and loading platform in 2007.

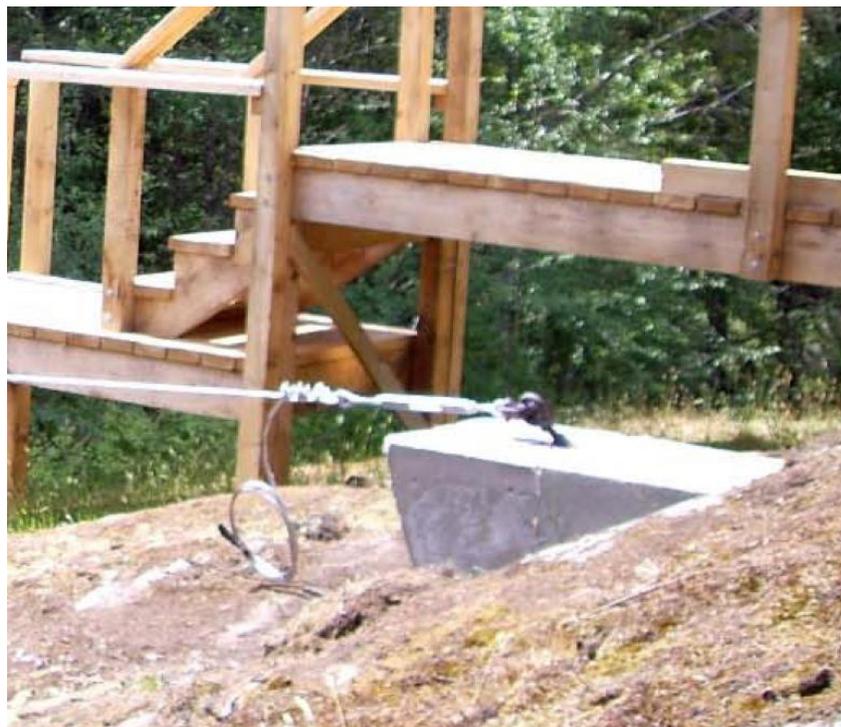
- Original designer stated that loading was assumed to be in line with the eyebolt threaded shaft/embedded rod

- eyebolt was loaded at an angle of 47.1 degrees

Figure 2: Side image of the zipline anchor and eyebolt in 2007 showing the angle between the applied load and the eyebolt threaded shaft

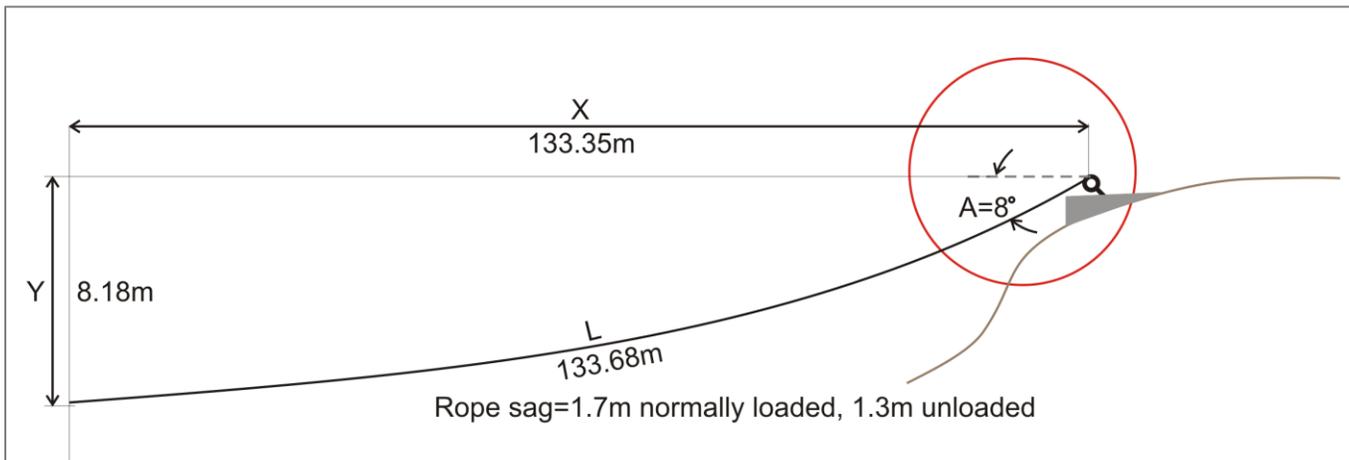
Figure 3: Profile of Zipline as Measured Following Incident

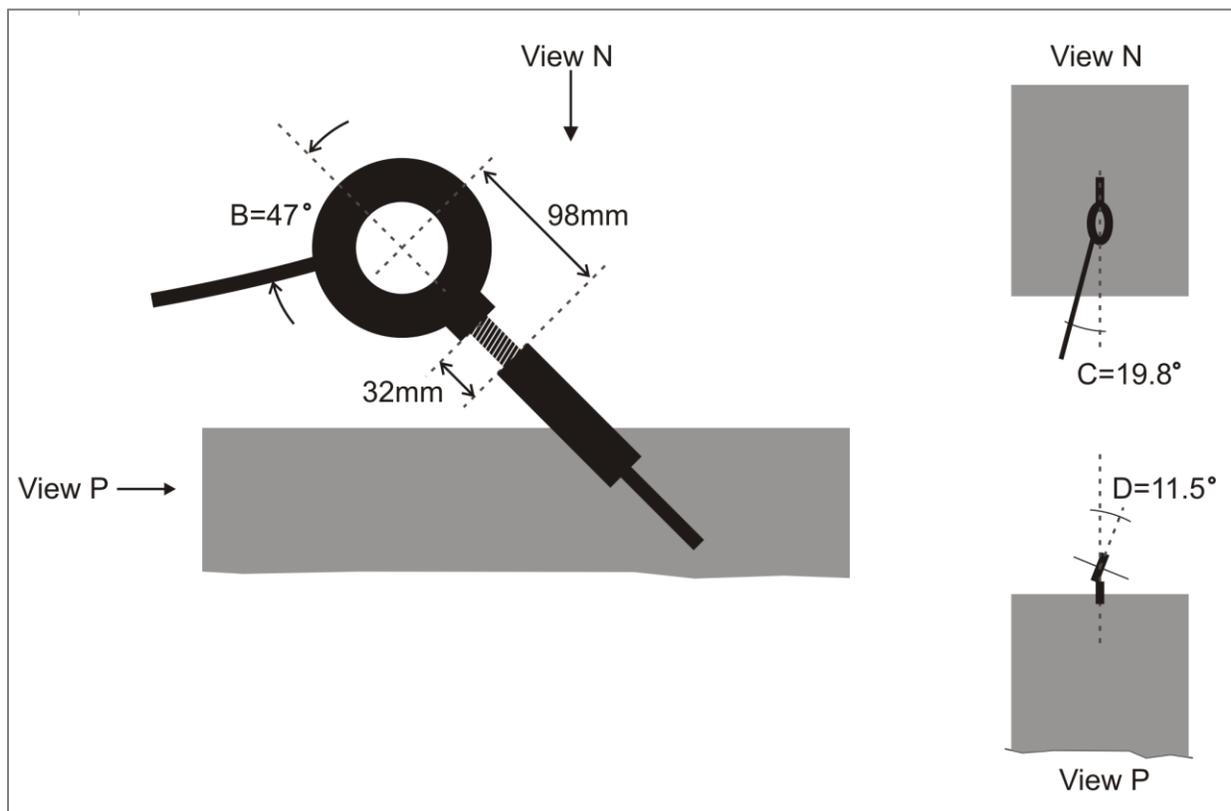
- eyebolt shoulder was not threaded and seated flush onto anchor surface

- eyebolt was loaded such that the direction of pull was 11 degrees from the plane of the eyebolt

- a model of the zip line was created and estimated the loads at the eyebolt/anchor could have been 33.4KN (1/2" cable only) and 43.4KN (including person + wind).

concluded that the eyebolt was overstressed in this orientation.

Figure 4: Orientation of the Eyebolt and Anchor relative to Zipline Cable

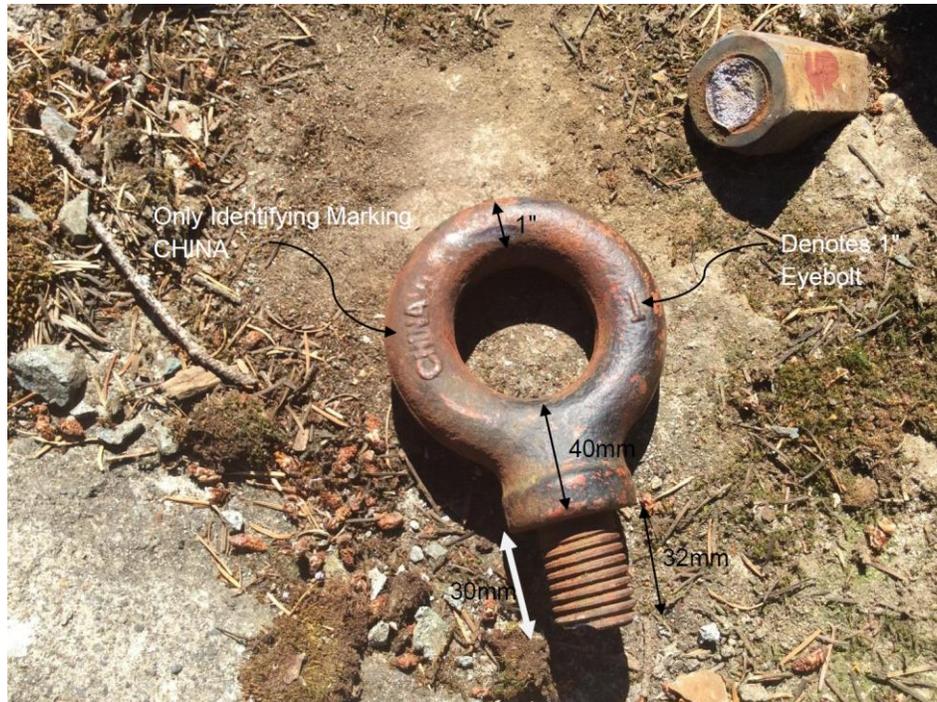
- A deflection of approximately 3 degrees was measured in the loading plane of the eyebolt. This deflection reflects the amount of material deformation prior to failure.

-Cracks were present in several anchor bolt thread roots near the fracture, and corrosion was present in most bolt thread roots.

-The cracks were straight and roughly horizontal, and filled with corrosion deposits, indicating fatigue cracks that were present for some time.

Figure 5: Fractured Eyebolt. Image shows approximately 30mm of threads were protruding from the anchor.

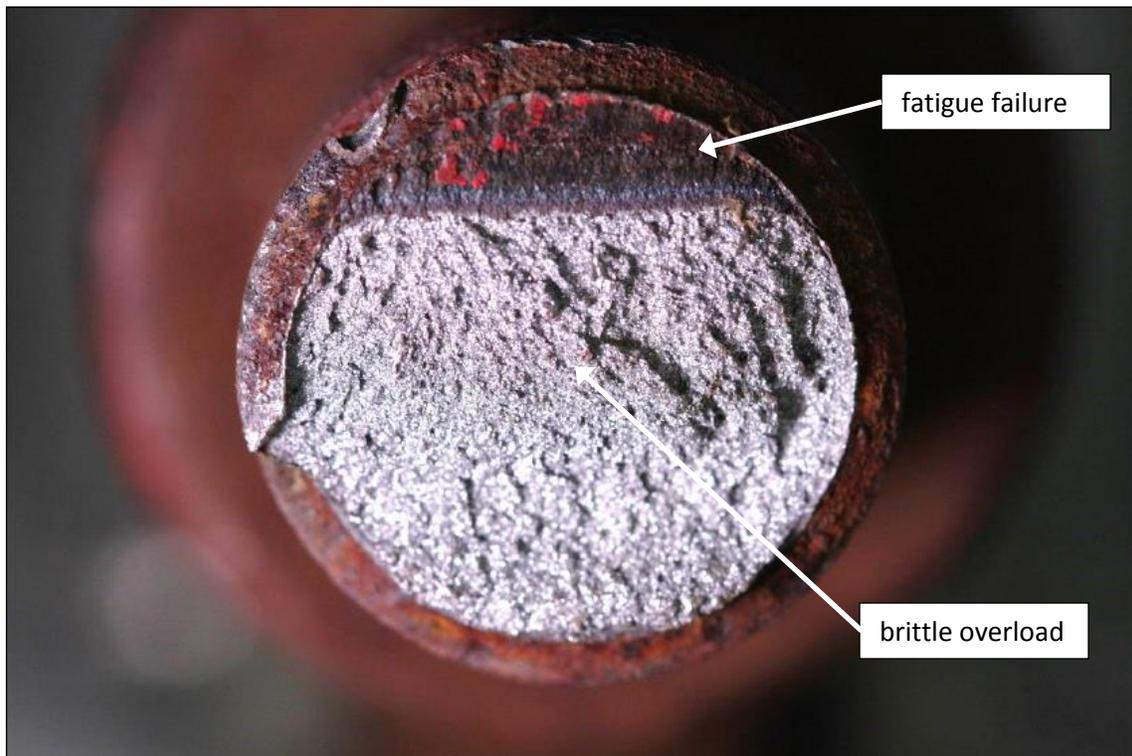
-The strength of the eyebolt, estimated from hardness testing, was 20% lower than typical for similar as-rolled or annealed grade steel.

-The low ductility (ability to deform) appearance of the failure area of eyebolt indicates heat treatment practices were inadequate to maintain the typical ductility for this grade of steel. Ductility of material allows for 'slow' failures that may be detected by inspection prior to complete failure.

-23 % of the bolt diameter was corroded and dark-coloured, indicating that a crack was present to that point for at least several weeks, likely months. The flat smooth surface and straight lines across this region are typical of progressive crack growth due to fatigue. The remainder of the fracture face was shiny and crystalline, indicating brittle fracture.

-Cracking in several threads adjacent to the failure indicated the service the eyebolt was in exceeded its fatigue strength.

Figure 6: Fractured Surface of Eyebolt Threaded Shaft.
(Photo, material and fracture surface analysis conducted by Acuren Group Inc – Richmond).

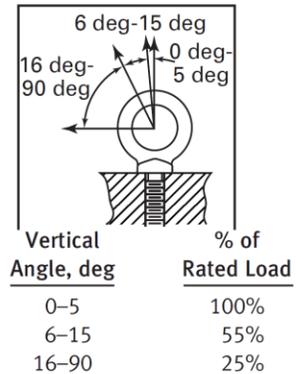
ASME 30-26 2004 Fig. 6

(e) Eyebolts not shouldered to the load shall only be used for in-line loads (see ASME 30-26 2004 Fig. 6).

(f) Only shoulder eyebolts shall be used for angular lifting. When used for angular lifting, the shoulder shall be flush and securely tightened against the load. The working load limit (WLL) must be reduced as shown in ASME 30-26 2004 Fig. 6.

(g) When using shoulder eyebolts for angular lifts, the plane of the eye shall be aligned with the direction of loading. Flat washers may be used under the shoulder to position the plane of the eye (see ASME 30-26 2004 Fig. 6).

Figure 7: Excerpt from ASME 30-26 – Loading of Eyebolts
