## Incident Summary #II-1043261-2020 (#18845) (FINAL)

SUPPORTING INFORMATION	Incident Date		July 21, 2020	
	Location		Coquitlam	
	Regulated industry sector		Electrical - Low voltage electrical system (30V to 750V)	
	Impact	Injury	Qty injuries	0
			Injury description	N/A
			Injury rating	None
		Damage	Damage description	Complete loss of equipment occurred to the metal service conduit and conductors located inside this conduit. . Fire and high heat damage occurred to the structure as well, including the framing timbers, drywall and exterior siding and sheathing
			Damage rating	Moderate
Incident rating		Moderate		
Incident overview		Service conductors within the metal service conduit appear to have failed. The failure of these conductors resulted in extreme thermal temperatures within the service conduit. As a result of the extremely high temperatures damage occurred to the adjacent portions of the structure.		
INVESTIGATION CONCLUSIONS	Site, system and components		Supply service conduit is installed into the top of the meter base. This service conduit passes through the roof and is run inside the stud space of the exterior wall. Inside the service conduit there are three conductors

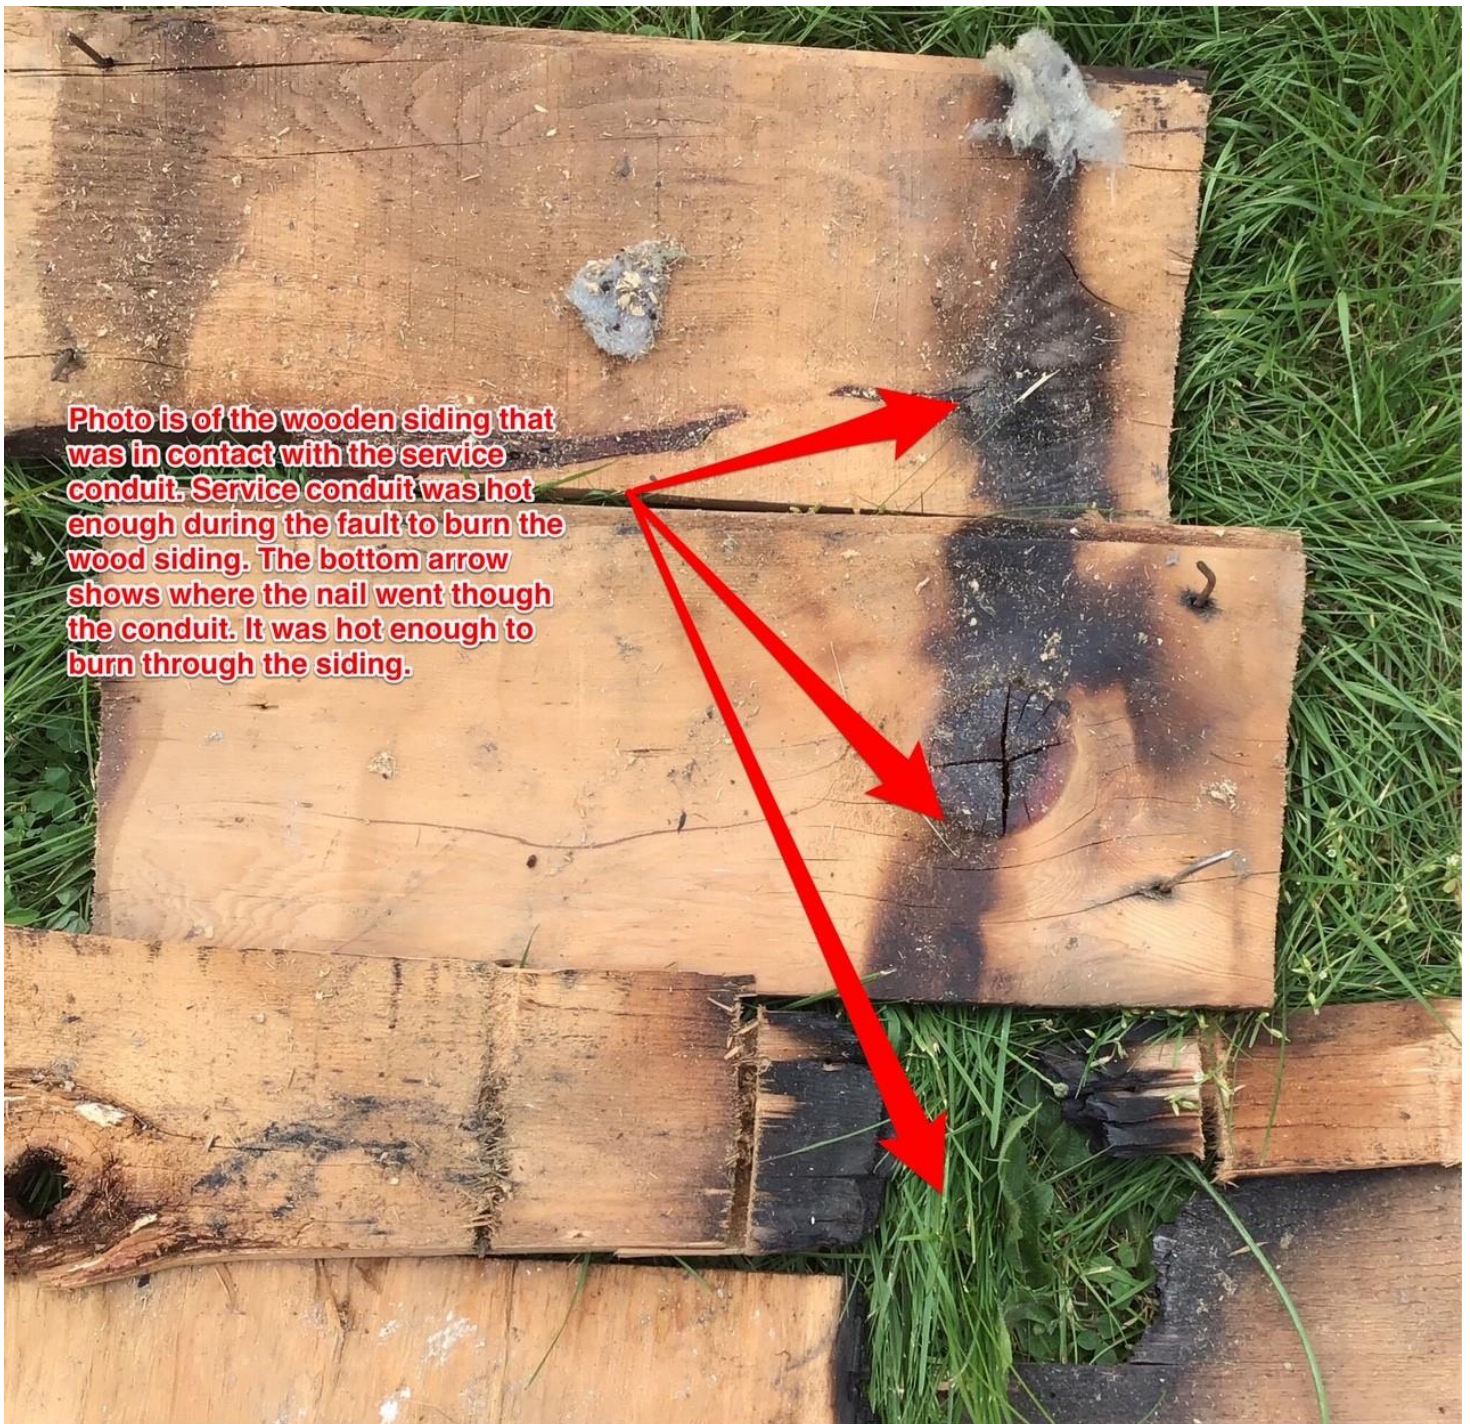
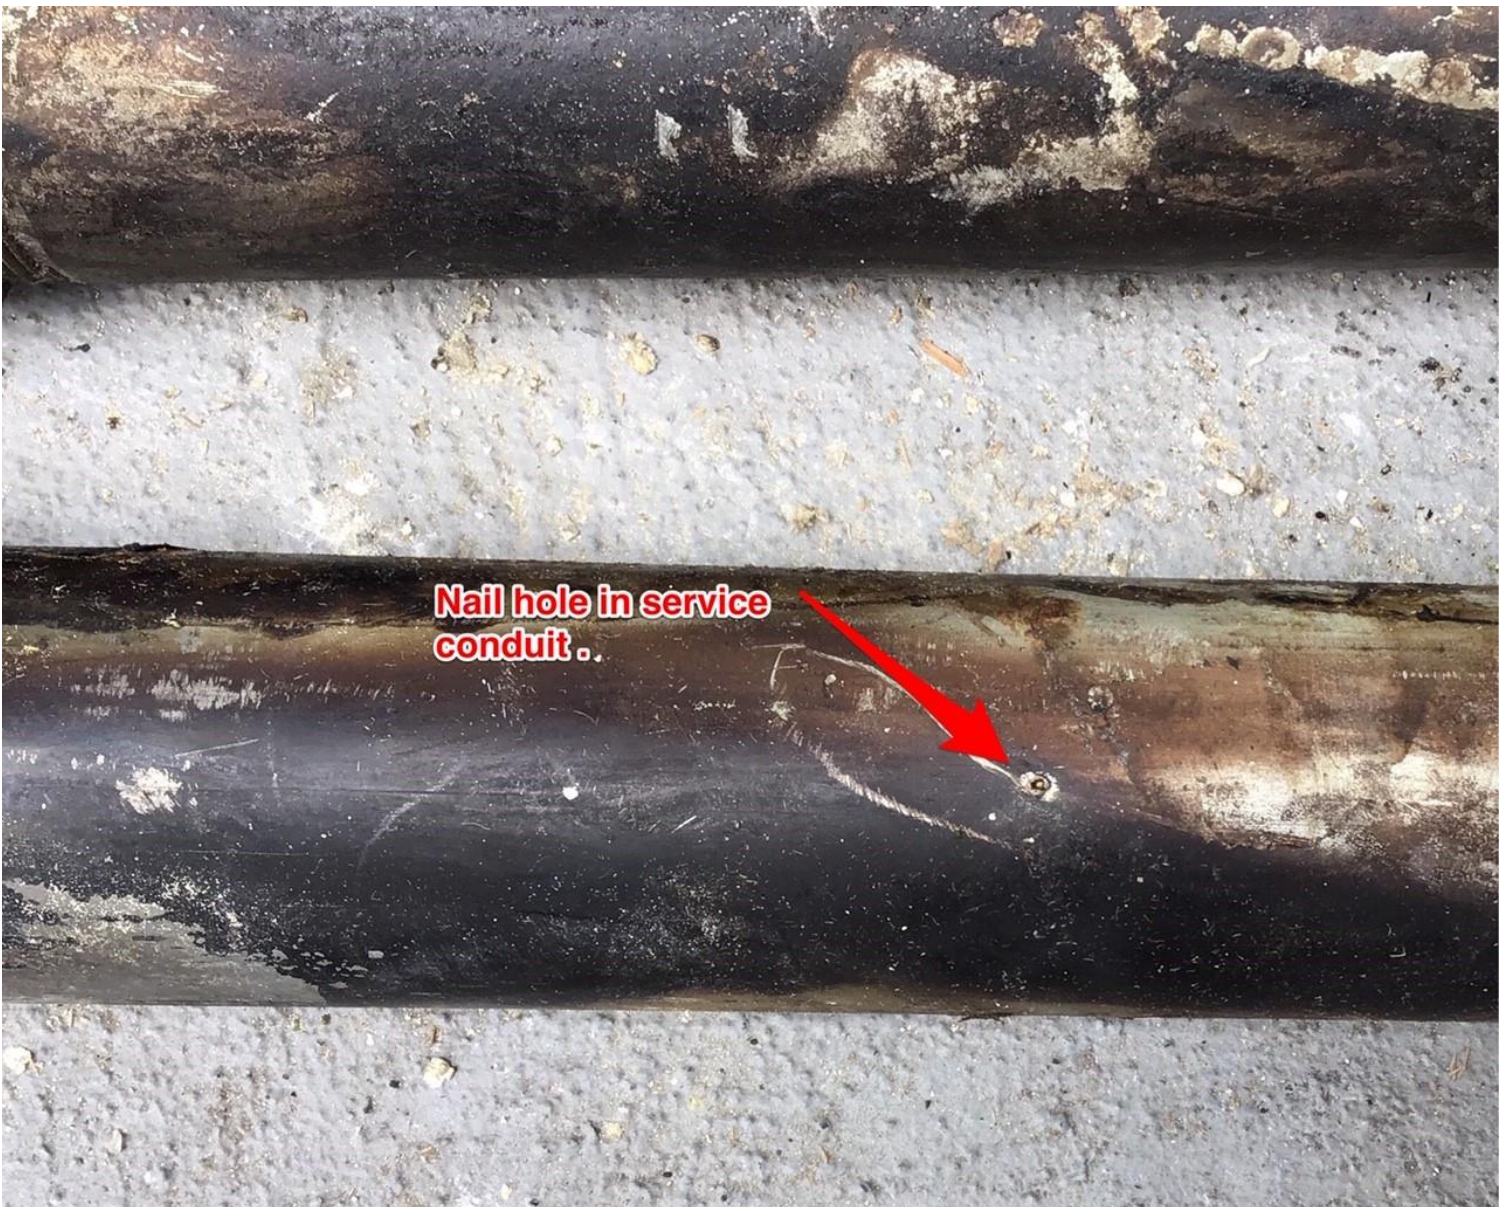
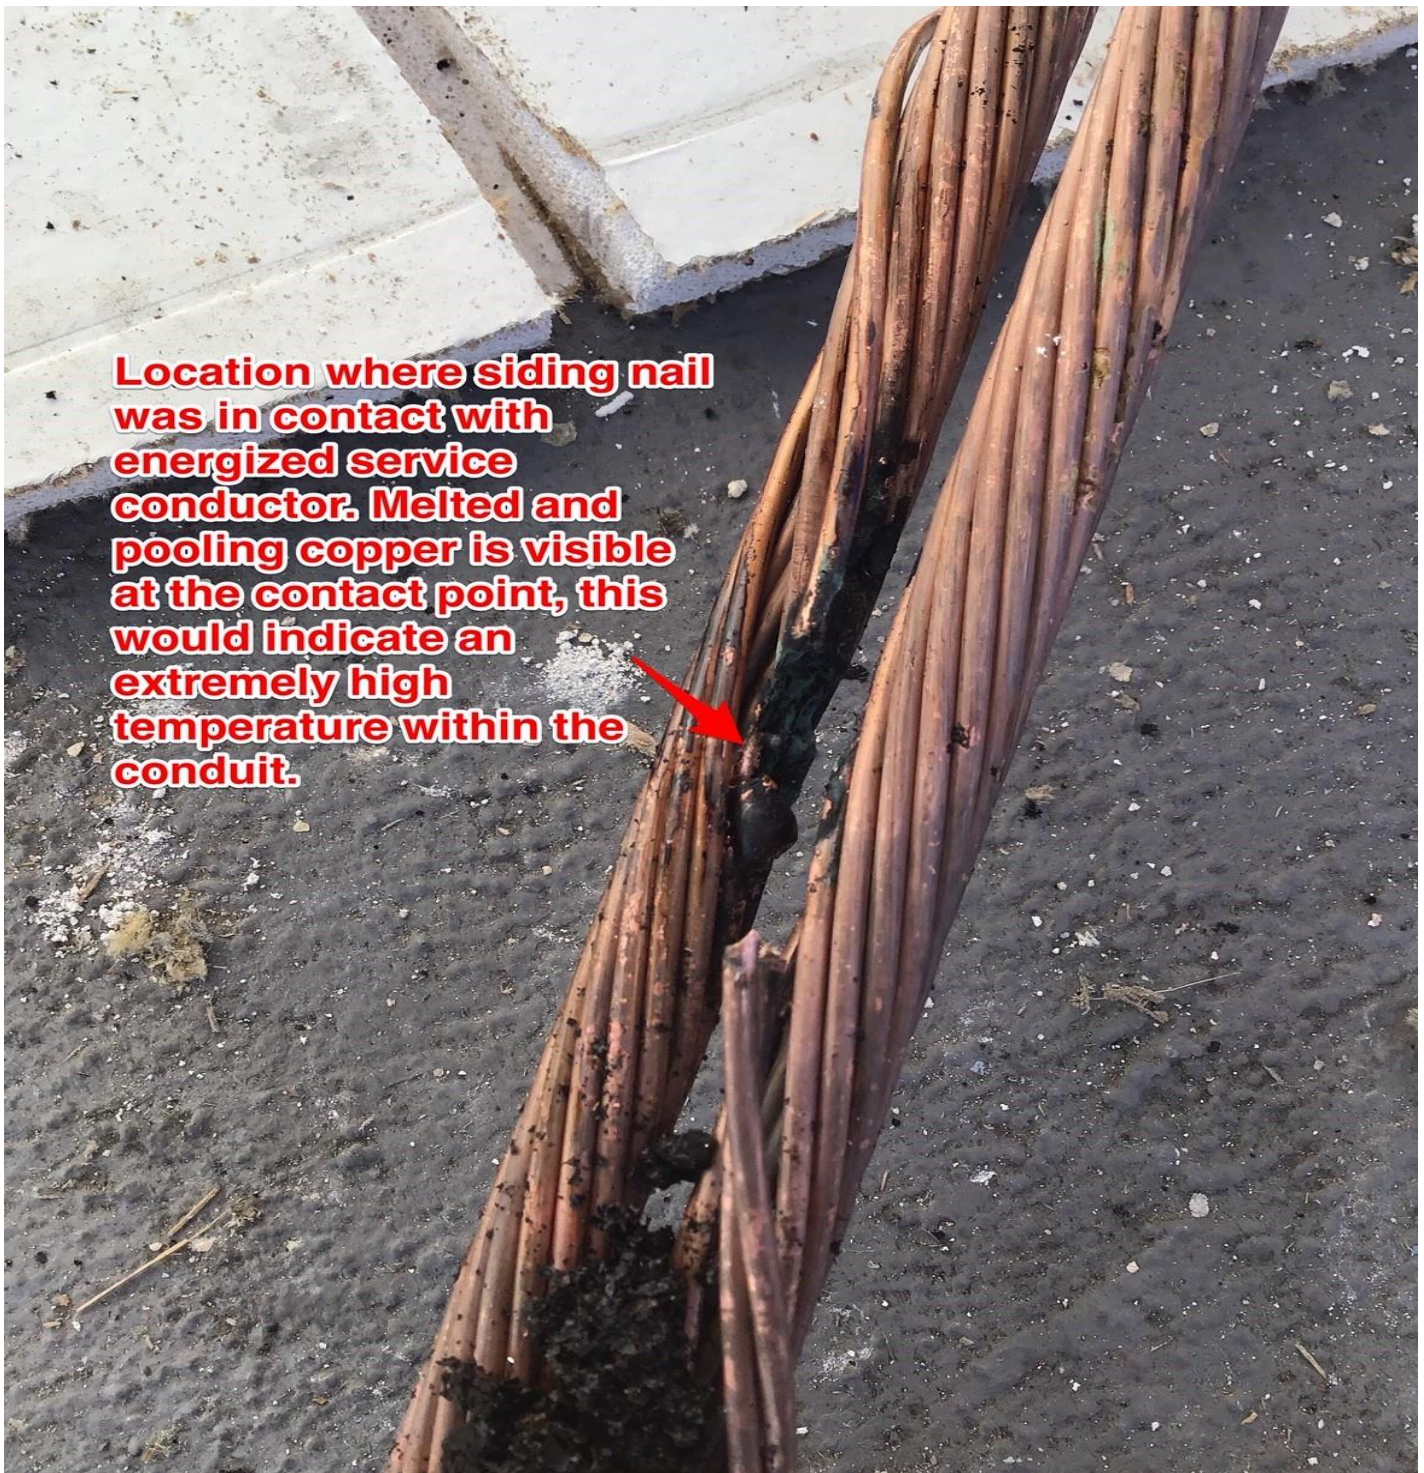
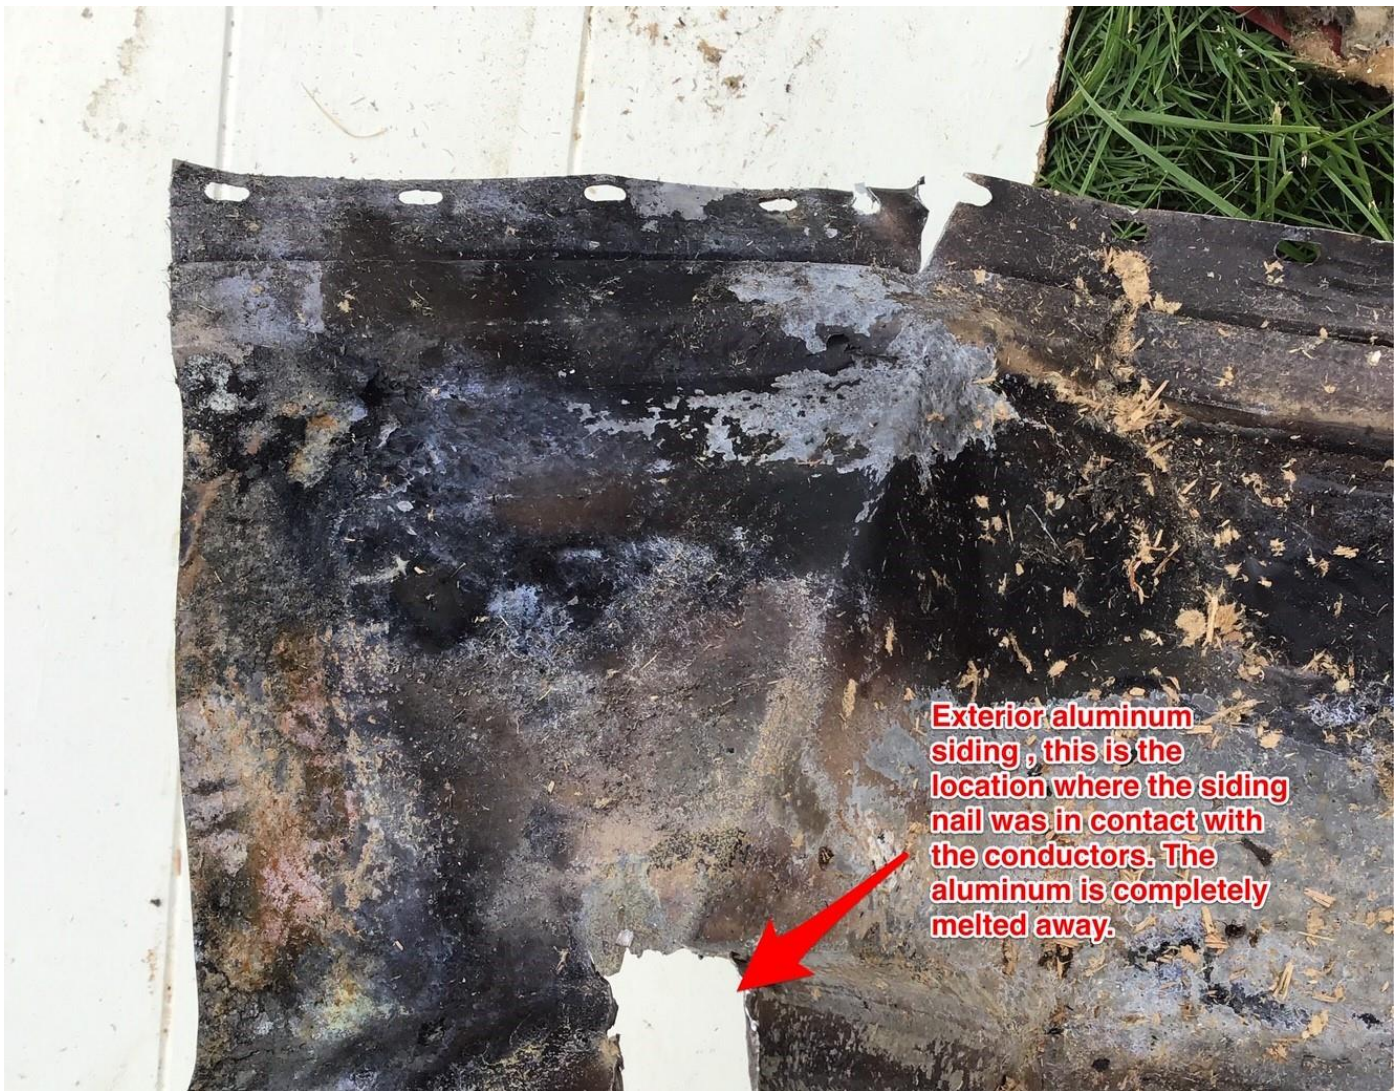
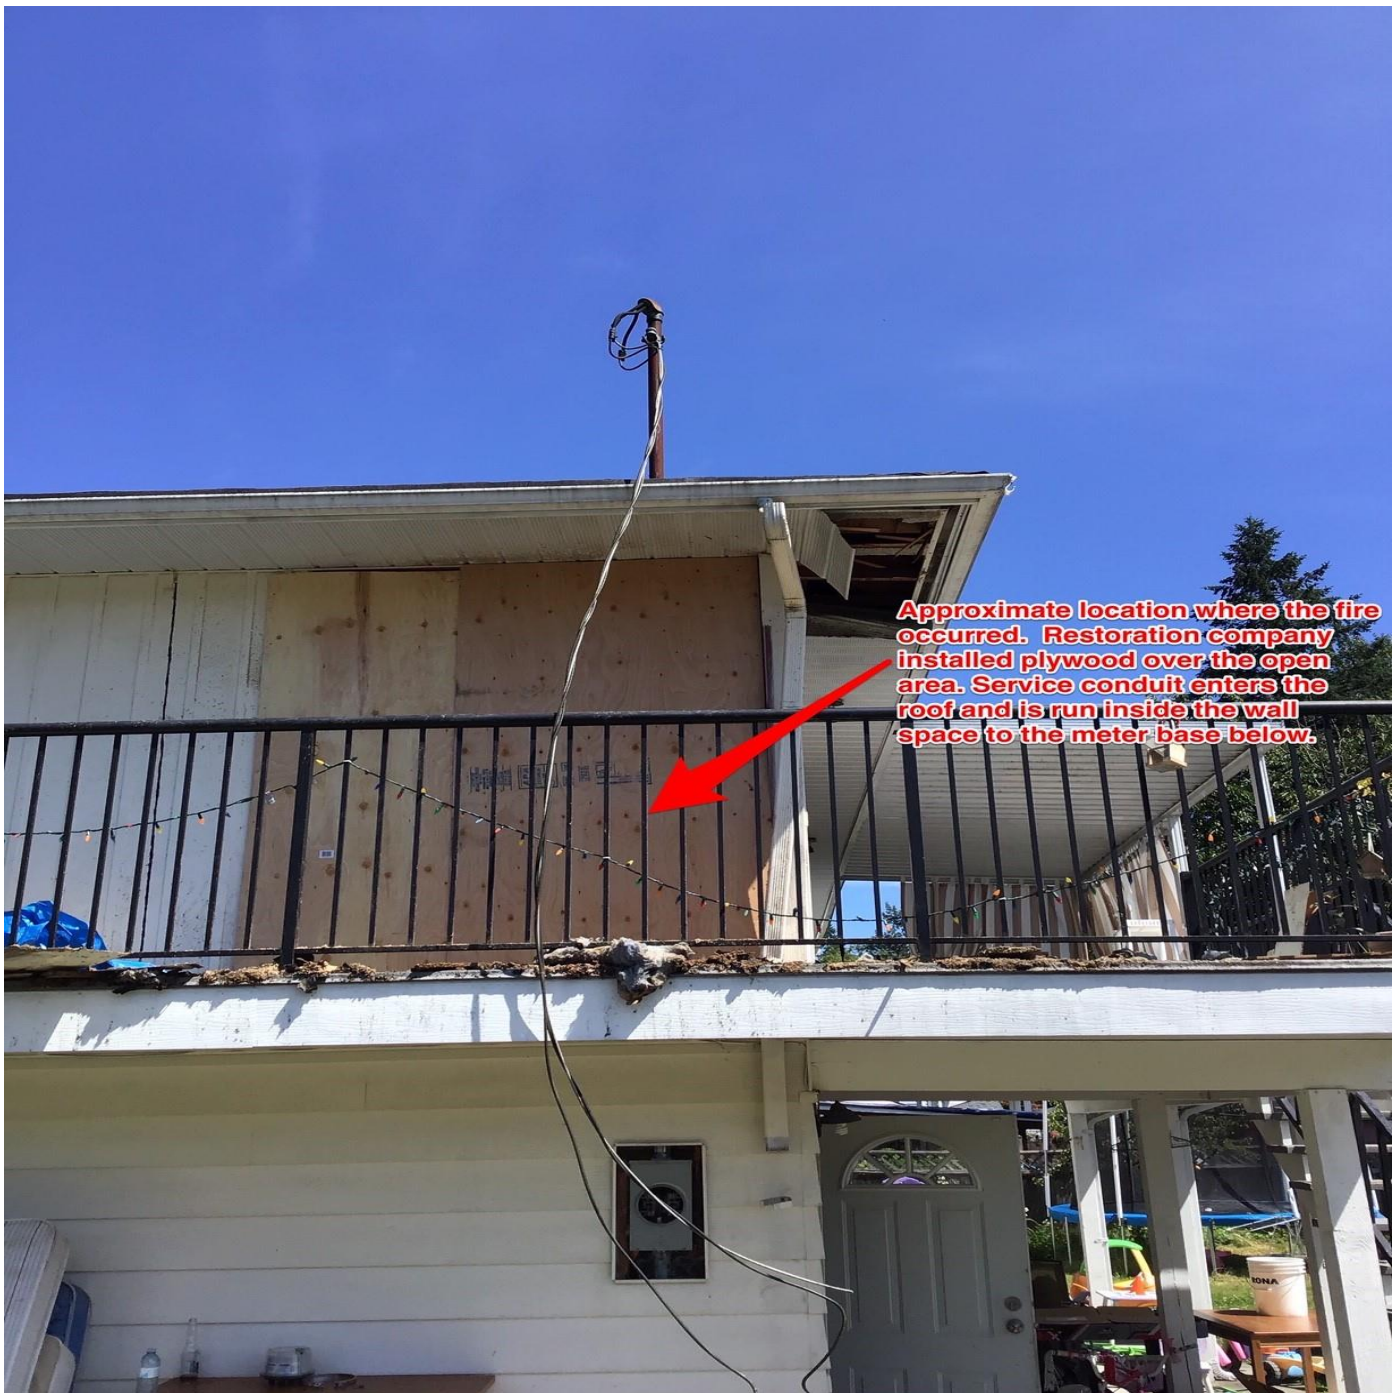
Failure scenario(s)		Renovations to the outside siding of the building were done at some point. The nails used to attach the siding were long enough to penetrate the service conduit inside the wall and the energized conductors within that conduit. A siding nail in contact with the service conductors as well as the metal service conduit would provide a path for fault currents. With these fault currents heat is created and over time the deterioration of the conductor insulation would create higher and higher heat until a failure occurs and in this case a fire with the combustible materials(siding, framing and sheathing timbers).	
	Facts and evidence		<p>The service conductors inside the service conduit displayed a portion of conductor that had burnt away, this would be an area where there was a conductor fault or short circuit.</p> <p>-The conductor insulation had melted in that general area indicating very high heat.</p> <p>-A small hole was identified in the service conduit where the burnt conductors where located.</p>

<ul style="list-style-type: none"> <li>-Siding material both metal(exterior) and wood(beside the conduit) was burnt in this area as well. The nails used to attach the siding were made of metal and were approximately 2 inches long.</li> <li>-Siding nails installed with a pneumatic gun could potentially penetrate conduit walls and conductor insulation.</li> <li>-Siding nails that are in contact with energized conductors and metal conduits could create a path for fault currents and short circuits to develop over time.</li> <li>- Siding internal and external were burnt away</li> <li>-Conduit had a nail sized hole in it at the location of the fire</li> <li>-Conductors inside the conduit showed damage and melting.</li> <li>-Conductor insulation was melted away at the point of fire.</li> <li>-On site discussion with fire crew confirmed there were no other sources of ignition found by their crews.</li> </ul>

<p><b>Causes and contributing factors</b></p>	<p>It is very likely that a siding nail installed through the service conduit and into the service conductors would be the cause of the high heat fault that occurred. The overcurrent protection in this situation that would clear this fault is located on a utility pole further down the road. The amount of resistance in the line and the distance to the over current device would be a contributing factor in why the fault wasn't cleared. A fault that isn't able to be cleared by an overcurrent device would create arcing and high heat and over time a failure, which in this case created a fire and extensive heat damage.</p>
