Incident Summary (Reference #5622240) (Final)

SUPPORTING INFORMATION	Incident Date		July 18, 2017	
	Location		Vancouver	
	Regulated industry sector		Elevating- Elevator	
	Impact	Injury	Qty injuries	0
			Injury description	None
			Injury rating	None
	Damage	Damage description	Significant damage to all major elevator components: Car/ counterweight/ compensating ropes/ sheaves/ buffers/ associated structural members.	
		Damage rating	Major	
Incident rating		Major		
Incident overview		It was reported to BCSA that during maintenance troubleshooting an elevator accelerated in an uncontrolled manner into the elevator shaft overhead.		
INVESTIGATION CONCLUSIONS	Site, system and components		<p>Elevators controllers are designed to control the normal operation of the elevator. Elevator controllers can control speed, braking, acceleration and other functions.. Elevator controllers have circuit boards that control certain functions of the elevator. Each circuit board has a designated slot in the controller. The elevator is designed to operate only with all of the circuit boards in their designated slots.</p> <p>Elevator “motion control devices” are devices meant to shut down and arrest any un

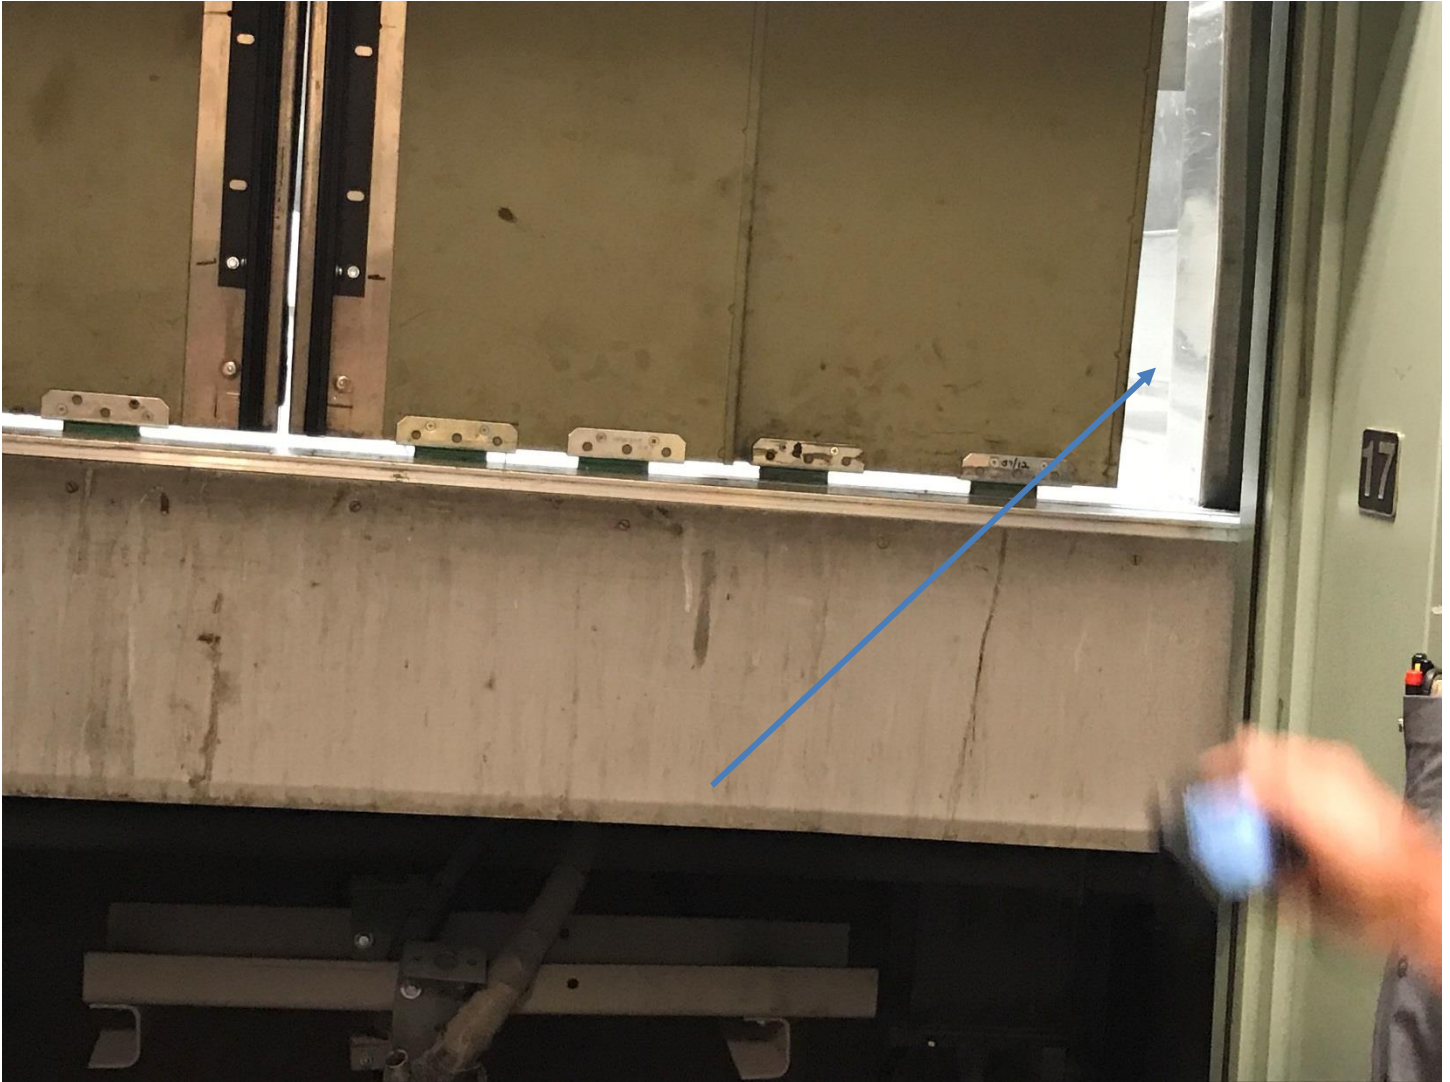
Figure 1- Elevator car above 17 floor landing. Arrow pointing at gap between car door and car door frame- Illustrates that amount of twist (racking) sustained by elevator car due to impact.

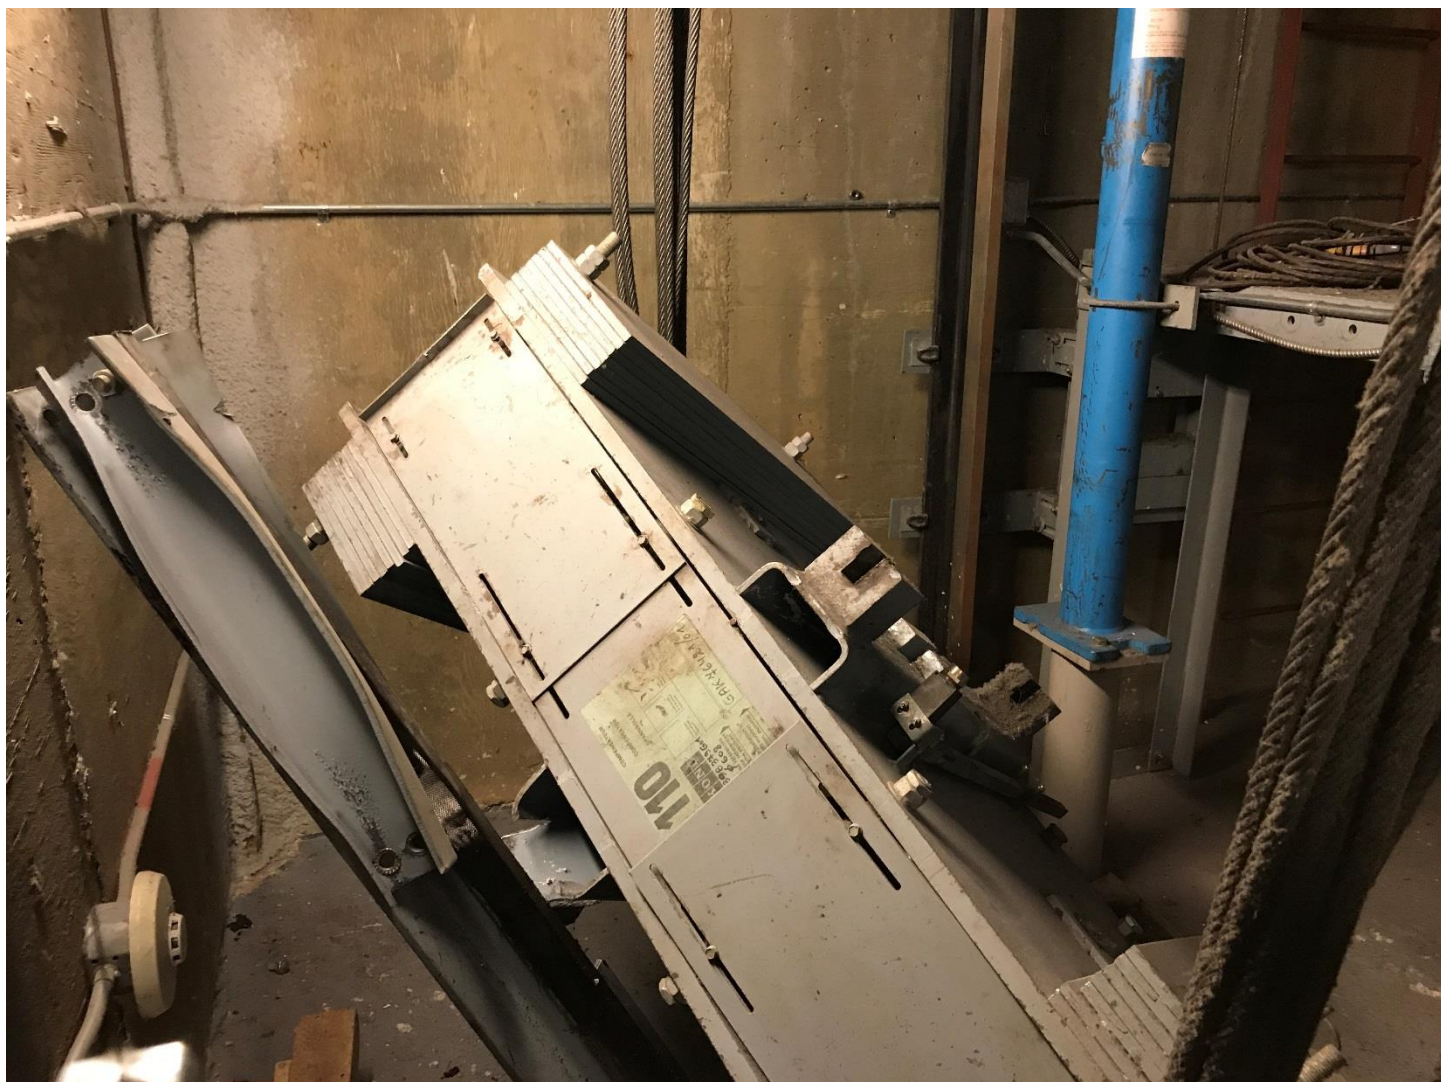
Figure #2- Mono –mass (compensation rope tension device) mounting bracket torn from floor due to impact.
Note slack ropes in the center rear of the photo tangled and damaged.

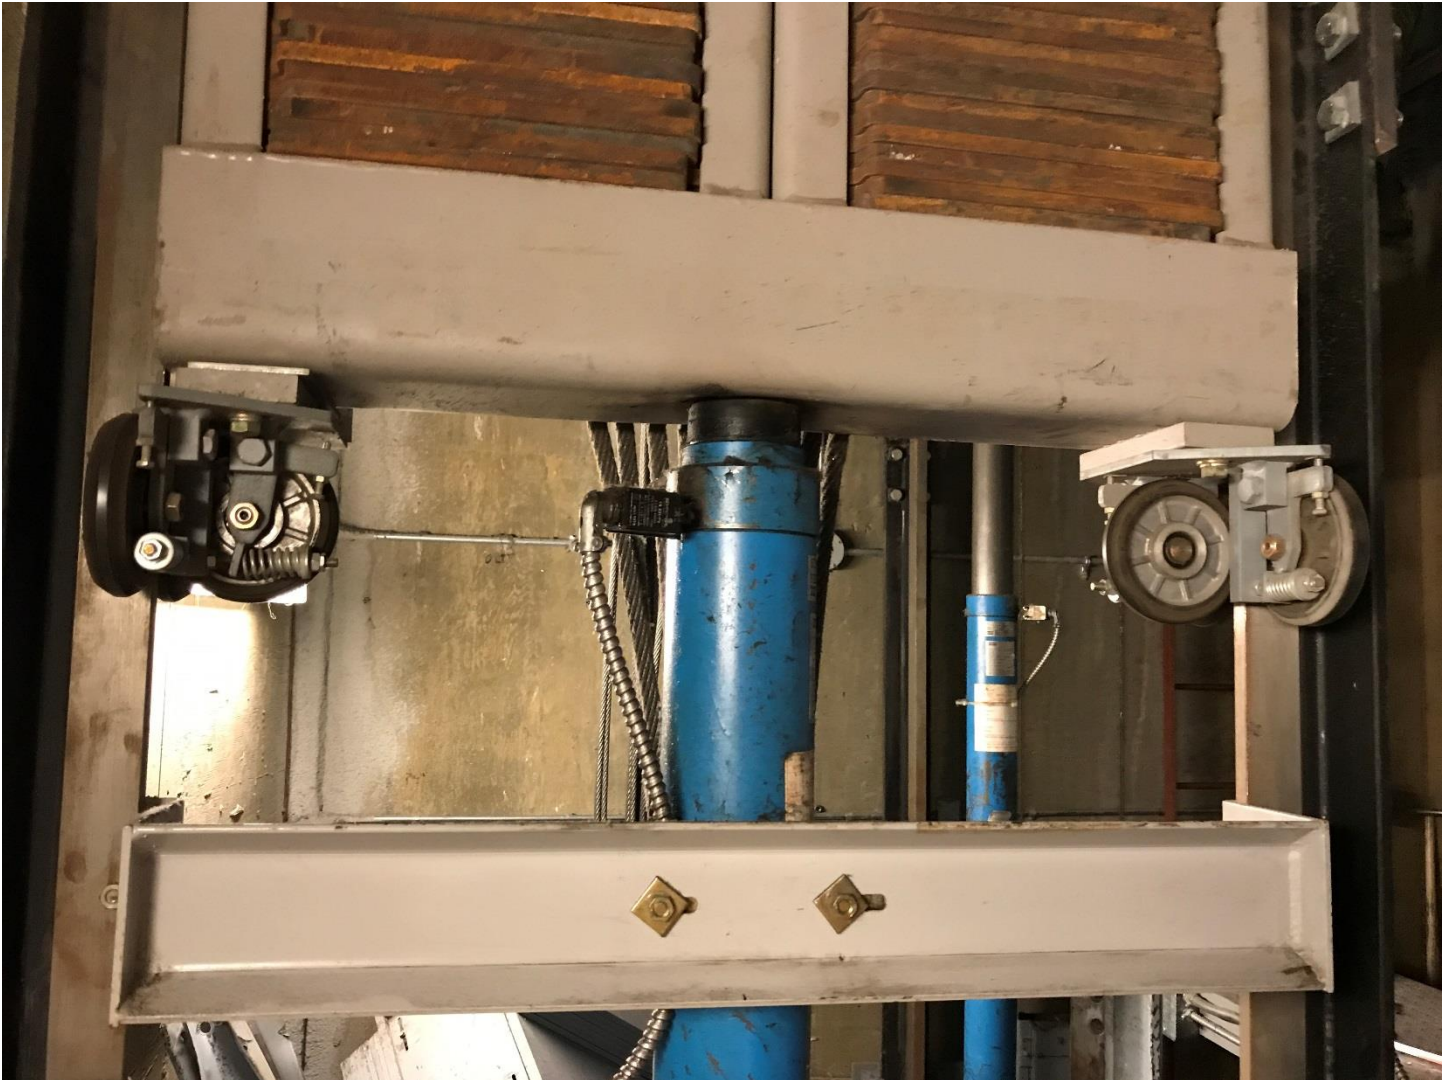
Figure 3- Counterweight buffer- fully compressed and bent due to impact of the counterweight. Counterweight frame bent.

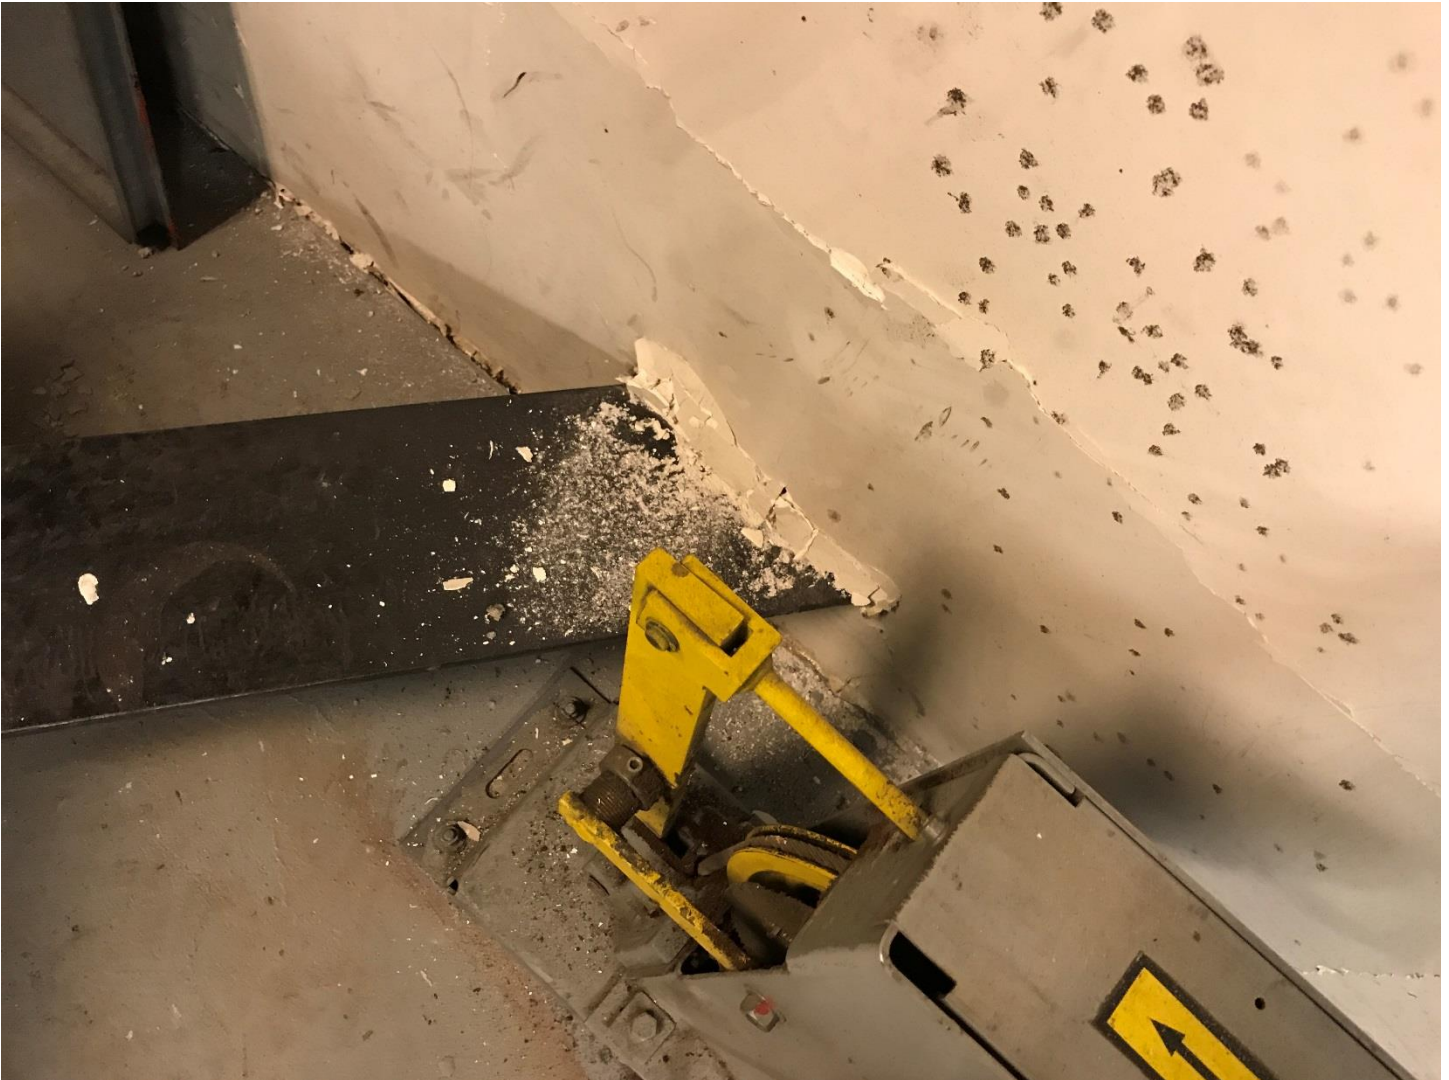
Figure 4- Machine beam in machine room. Machine beam dis-lodged due to impact.

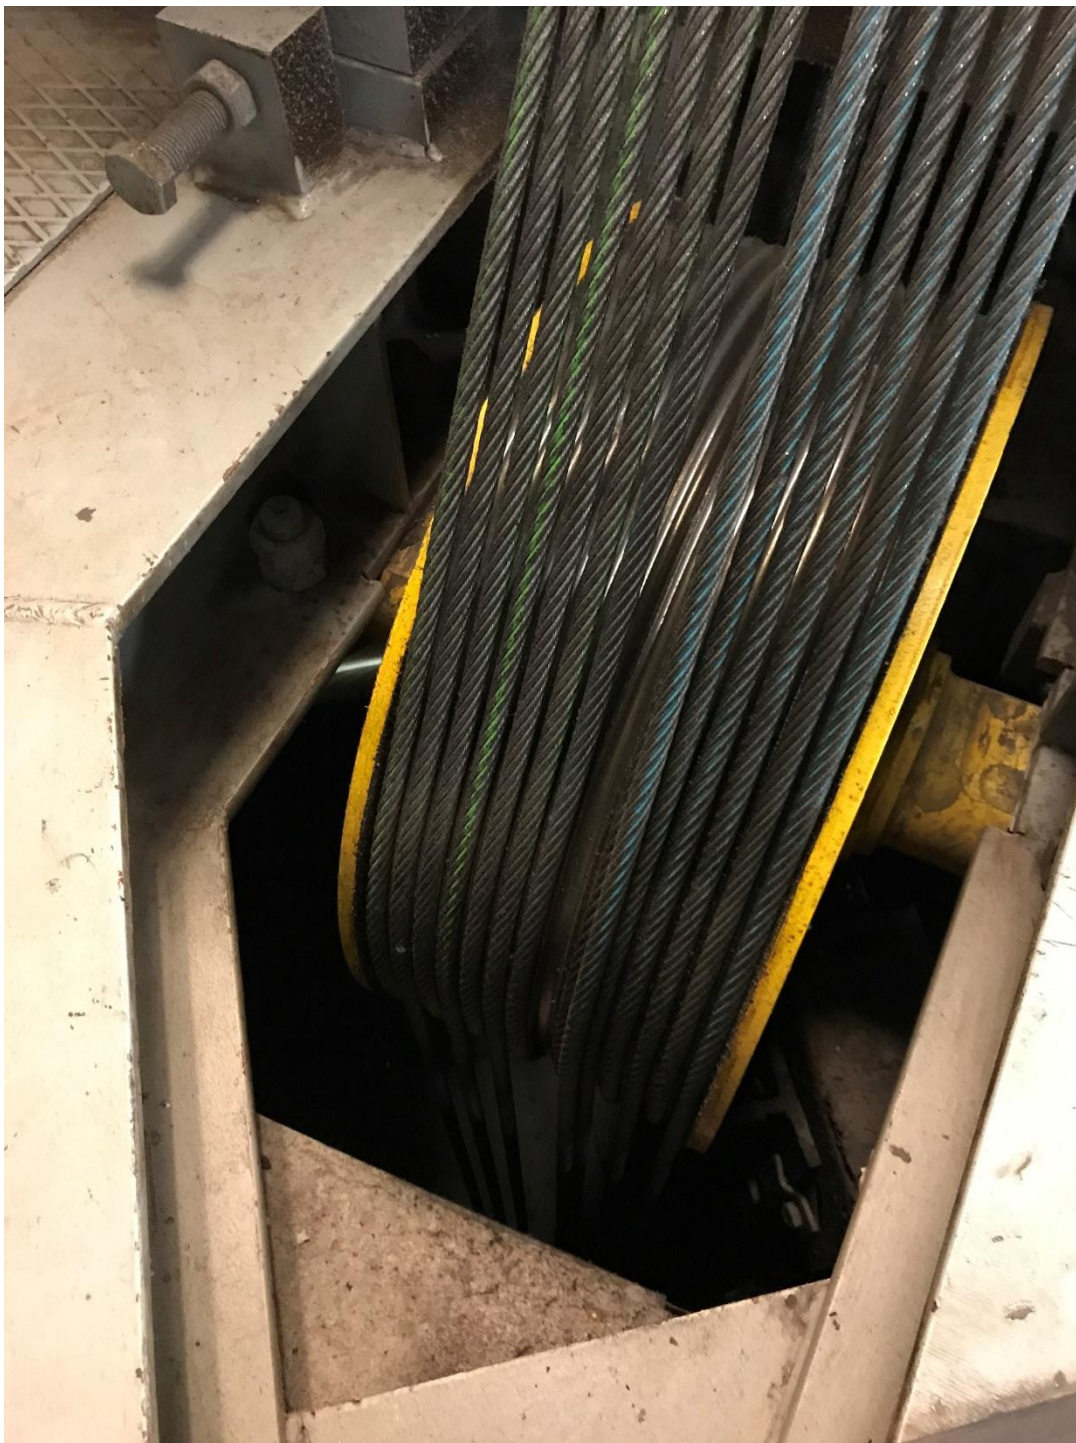
Figure 5- Secondary sheave with ropes displaced from sheave groove.

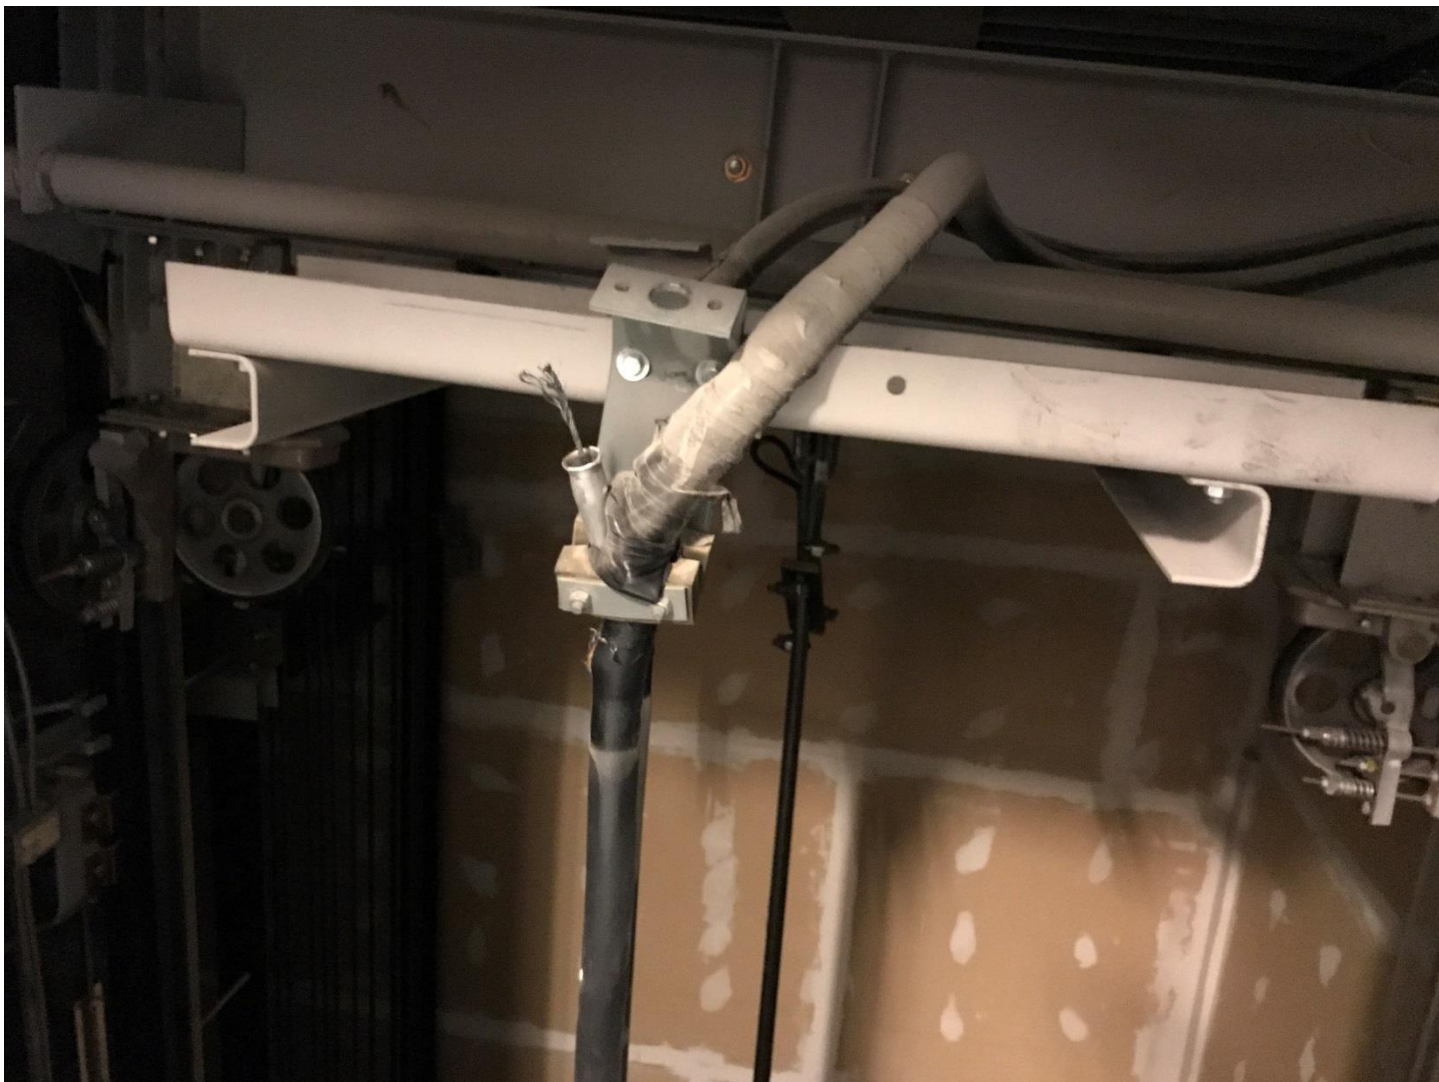
Figure #6- Damaged travelling cable due to impact.

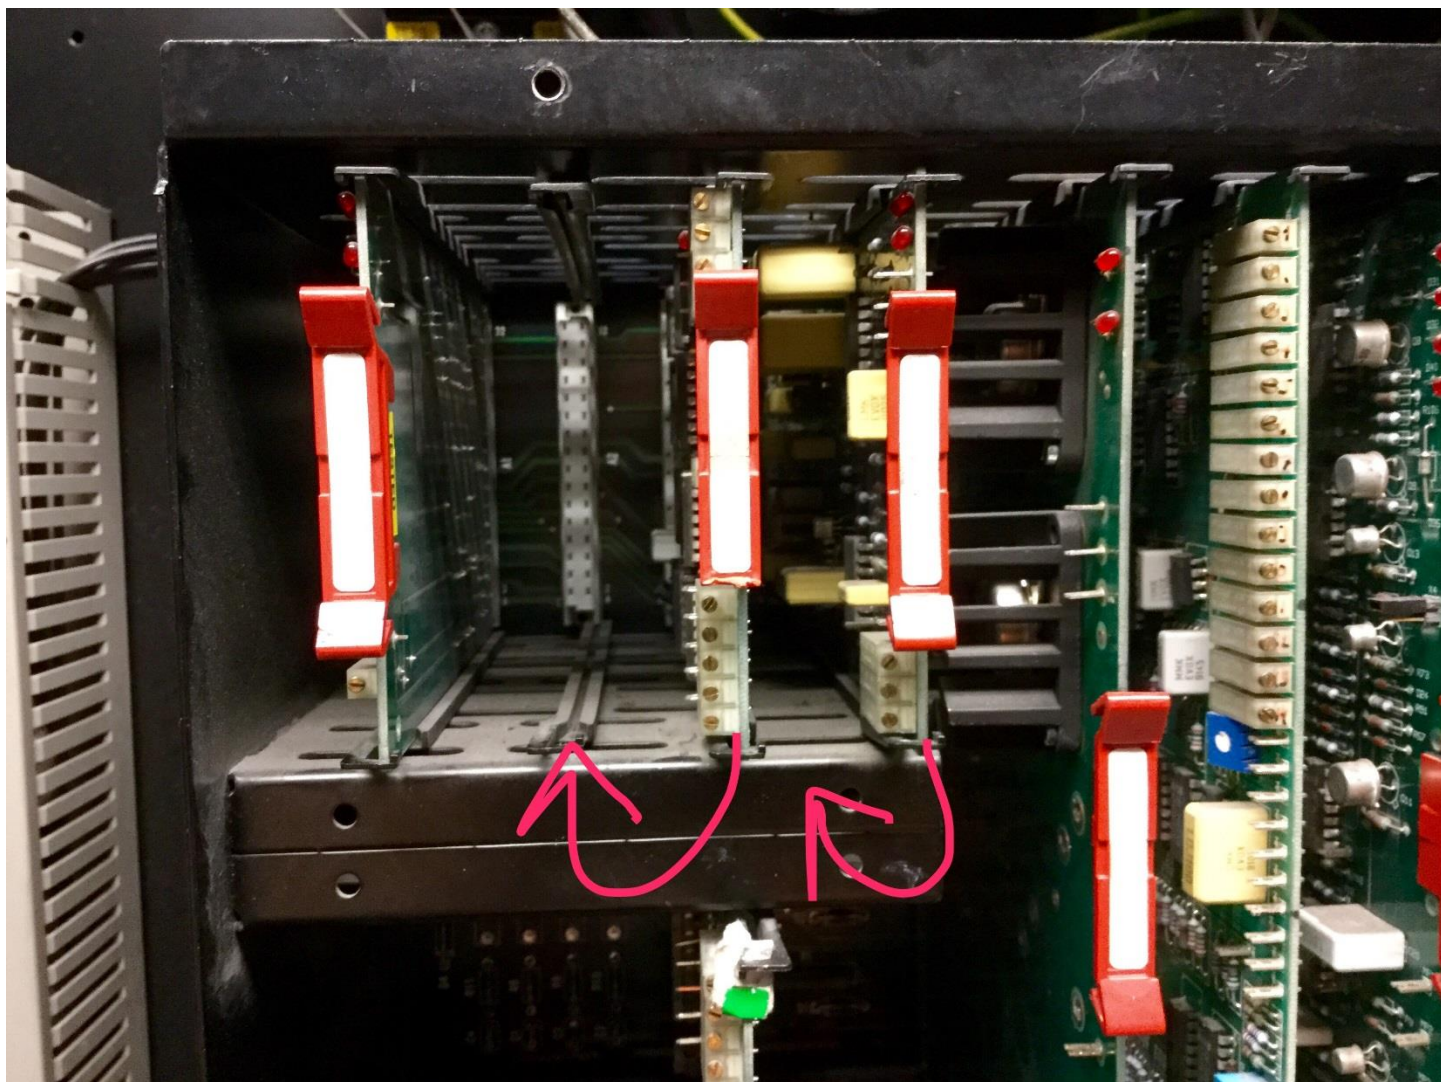
<ul style="list-style-type: none"> • The maintenance assistant stated that: They had removed the controller circuit boards (A3 speed supervision and A4 speed regulator) for cleaning. • Maintenance personnel stated that they were troubleshooting reported elevator speed issues. • Maintenance personnel stated that the elevator car was at the bottom landing. • The maintenance assistant and mechanic stated that: They had inadvertently placed the circuit boards into the incorrect positions in the controller. • The maintenance assistant and mechanic stated that: After the elevator was energized and a run command had been made the elevator ran uncontrolled up, crashing into the elevator shaft overhead causing substantial damage. • Maintenance personnel stated that- Elevator brake coil component had been removed to be used on a different elevator in the building after the incident had occurred. • Maintenance personnel stated that the elevator drive powered through the applied brakes. • Maintenance personnel stated that the entire incident event occurred within a 15 second time frame. <p><i>On-Site Investigation Observations:</i></p> <ul style="list-style-type: none"> • Brake pads and drum were observed not to exhibit signs of hard braking or being driven through (discoloration of brake drum/ brake shoe wear dust/ burnt brake pad odor). • Counterweight buffers completely compressed and damaged. Signs of high speed impact. • Machine room structural members damaged and displaced. Signs of high speed impact. • Hoist ropes dislocated from hoist rope sheaves. • Elevator car observed to be twisted in the elevator shaft. • Uncontrolled motion device was observed to be tripped in “ up direction” indicating that the car had over sped in the up direction. • Damage as shown in attached investigation photos. <p><i>Original Equipment Manufacturer- Field Engineer- Test results and remarks:</i></p> <ul style="list-style-type: none"> • Field Engineer performed controller simulation test- Statement of result:” If the A3 (speed supervision) and A4 (speed regulator) are placed in the locations shown in the attachment the car is not allowed to start (not on automatic nor on inspection).”

<p>Causes and contributing factors</p>	<p>Based on test result performed by the field engineer it is highly unlikely that the inadvertent misplacement of the controller circuit boards (A3 and A4) into the wrong controller slots caused the uncontrolled movement of the elevator.</p> <p>It is plausible that the elevator brake system was inoperable or not providing designed braking power allowing the uncontrolled movement of the elevator.</p> <p>Human error likely contributed to the incident.</p> <p>The cause of this incident is unknown.</p>

Figure 7. Controller circuit boards in correct slots. Arrows indicate where boards were reported to have been placed prior to the incident.
