Incident Summary #II-1257863-2021 (#24115) (FINAL)

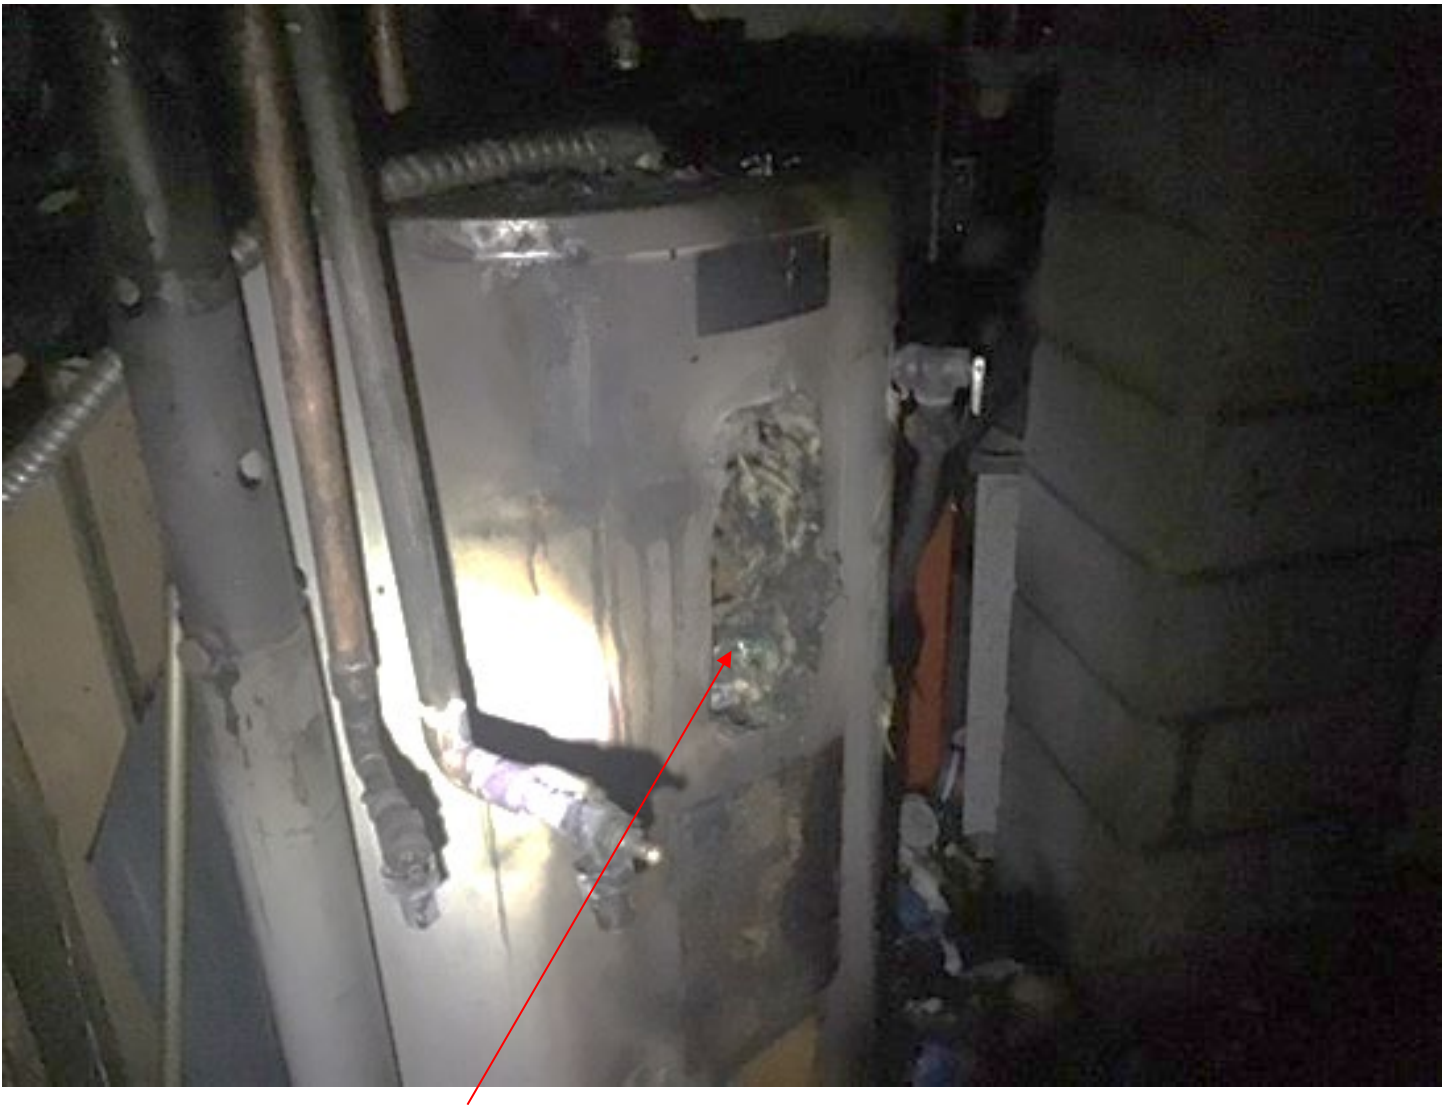
Domestic hot water tank – top element area, cover missing.

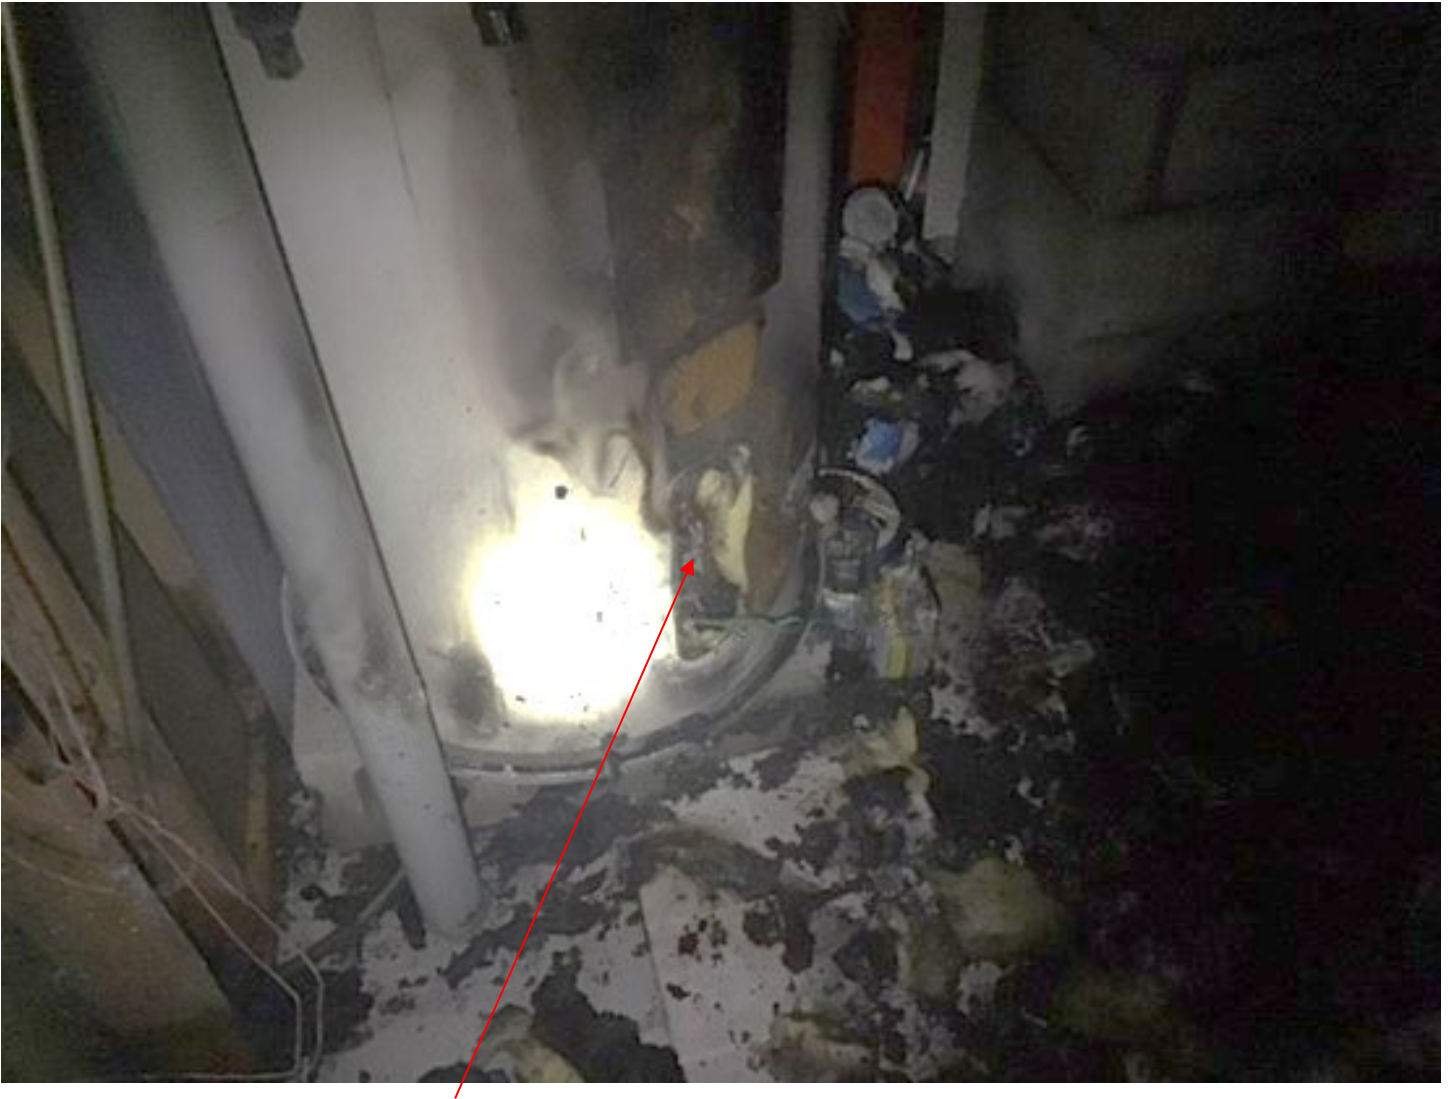
Domestic hot water tank - bottom element area, cover missing.

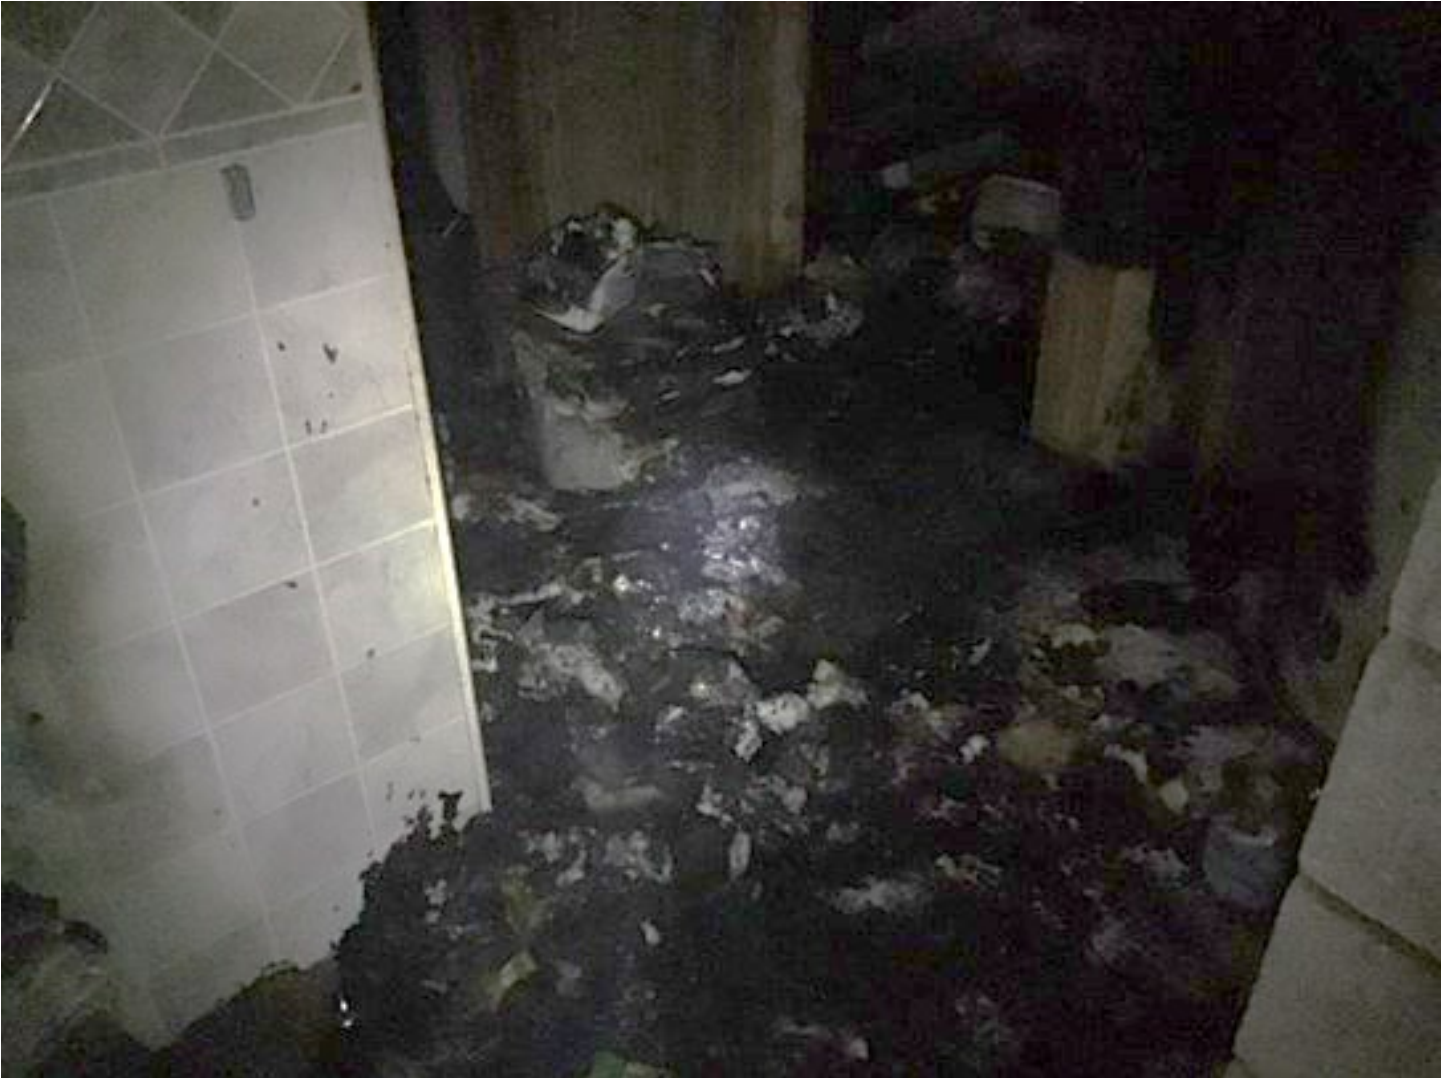
Area around base of domestic hot water tank – burnt toilet paper, tissue, paper towels.

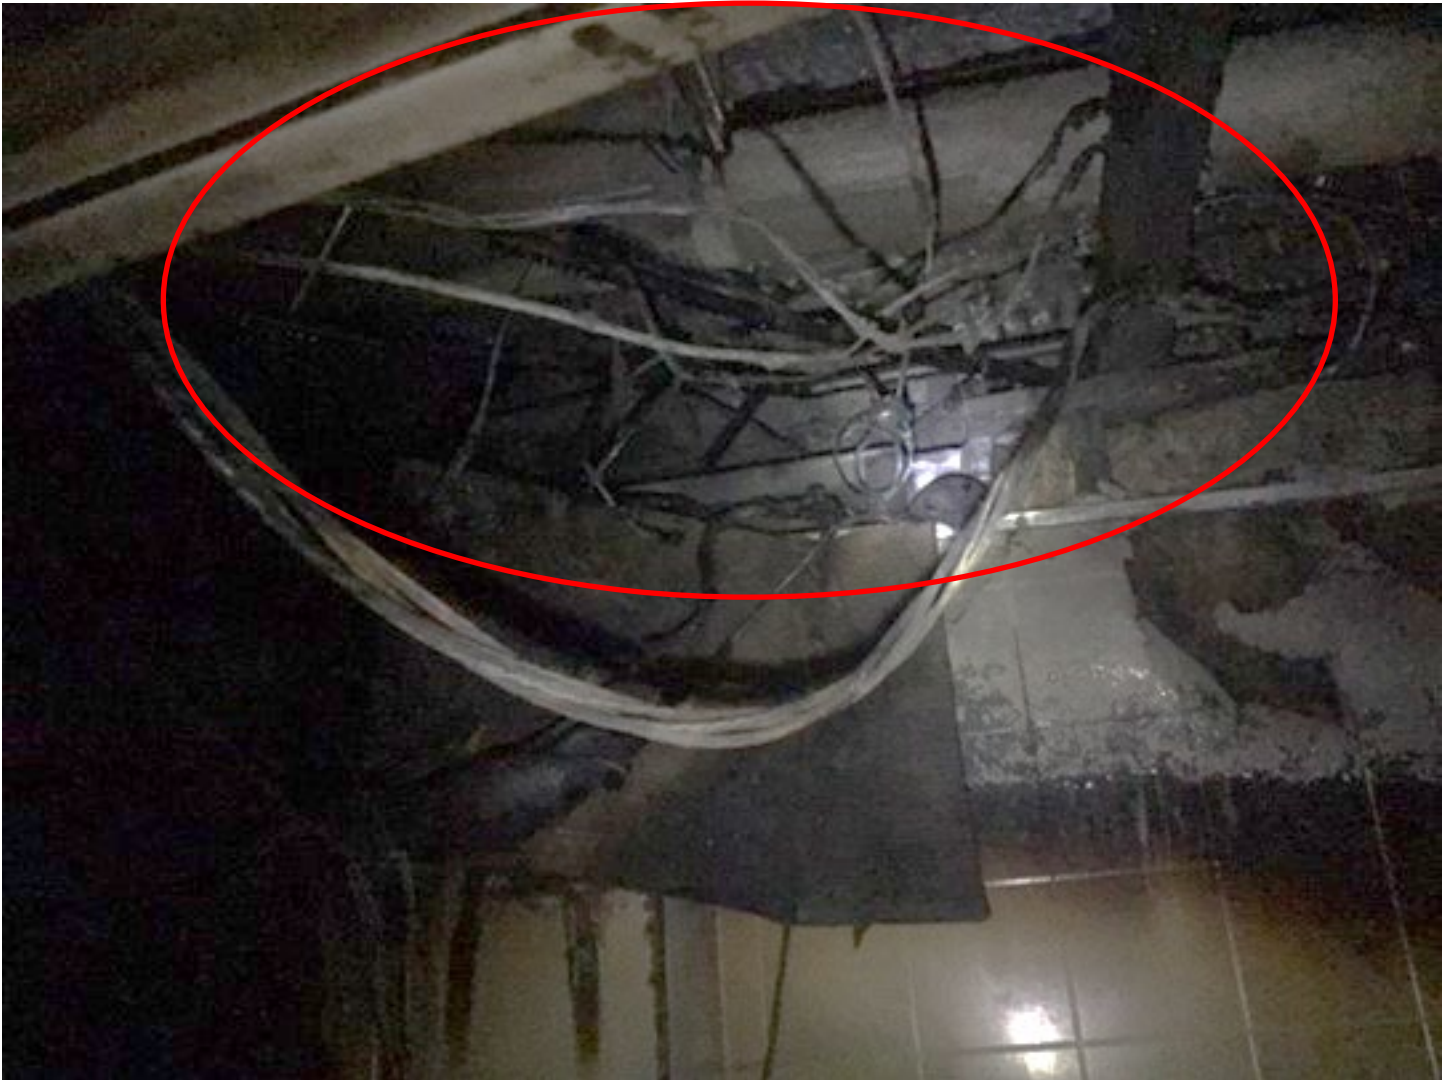
Area and main level floor joists above domestic hot water tank – fire and smoke damage.

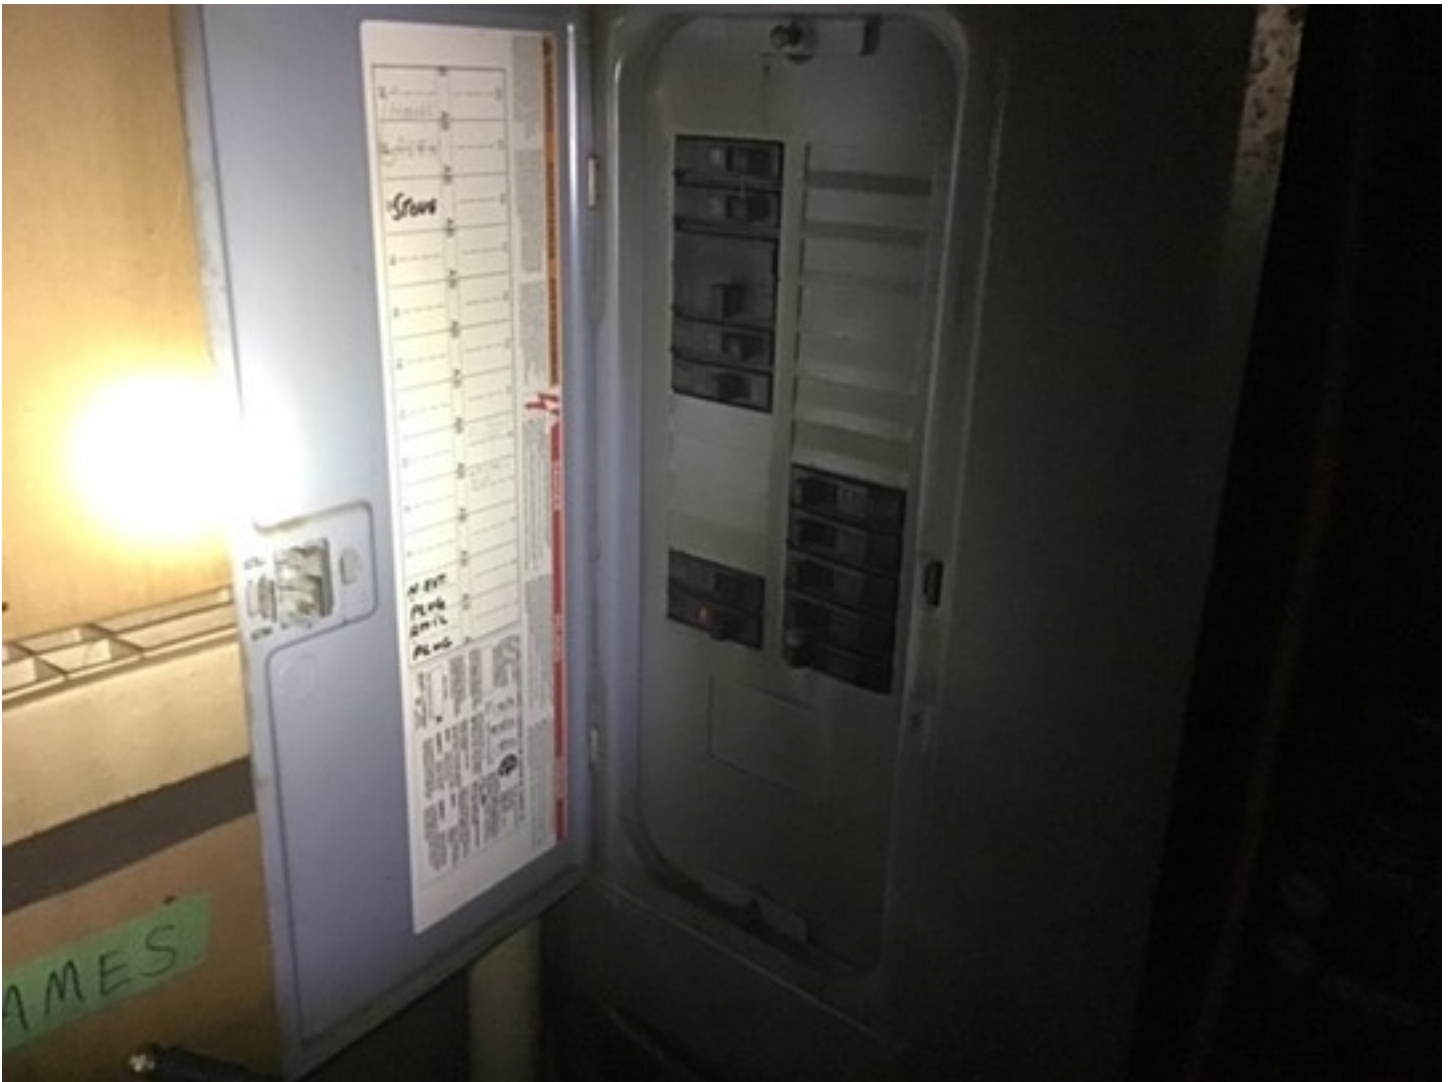
Dwelling subdistribution – 100A 120/240V panel board, located adjacent to domestic hot water tank.

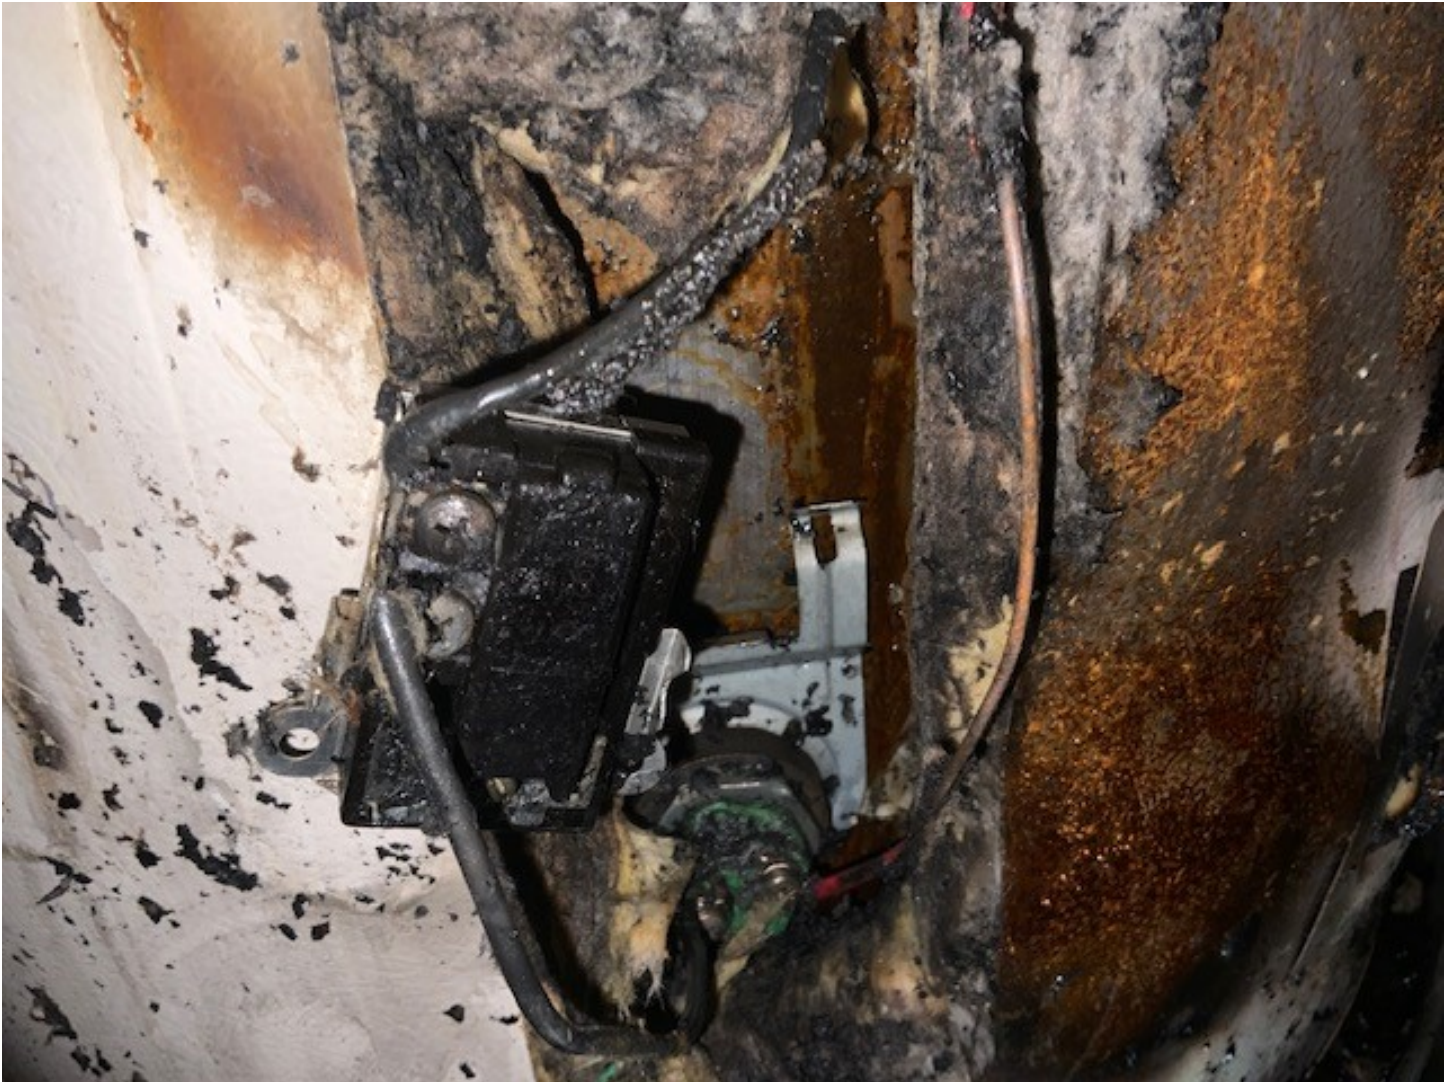
Failure scenario(s)	All indications point toward the domestic hot water tank providing an ignition source to adjacent, stored combustible materials. The ignition source likely being a failed heating element or heating element conductor termination; resulting in a high impedance electrical arcing, electrical overtemperature condition.	
	Facts and evidence	Evidence obtained from photographs and interviews indicate the fire incident area of origin to be in and about the area of the domestic hot water tank. Photographs obtained by the Regional Fire/Rescue personnel during fire suppression reveal the heating element and thermostat covers were previously removed and placed on top of the hot water tank.	
	Causes and contributing factors	Though not conclusive, all indications point toward a component failure on the domestic hot water tank which resulted in a high impedance electrical arcing, overtemperature condition which in turn ignited a large volume of stored tissues, paper towel, toilet paper. The combustibles were placed in contact with and adjacent to the hot water tank. The hot water tank heating element and thermostat covers had been previously removed and not secured back into position at some point prior to the incident. Had the covers been secured into position any electrical arcing or sparking likely would be contained behind the cover, not projecting past the tank enclosure and not providing an ignition source to combustible material.

Photograph obtained by Regional Fire/Rescue – upper element and thermostat as found during fire suppression, cover previously removed.

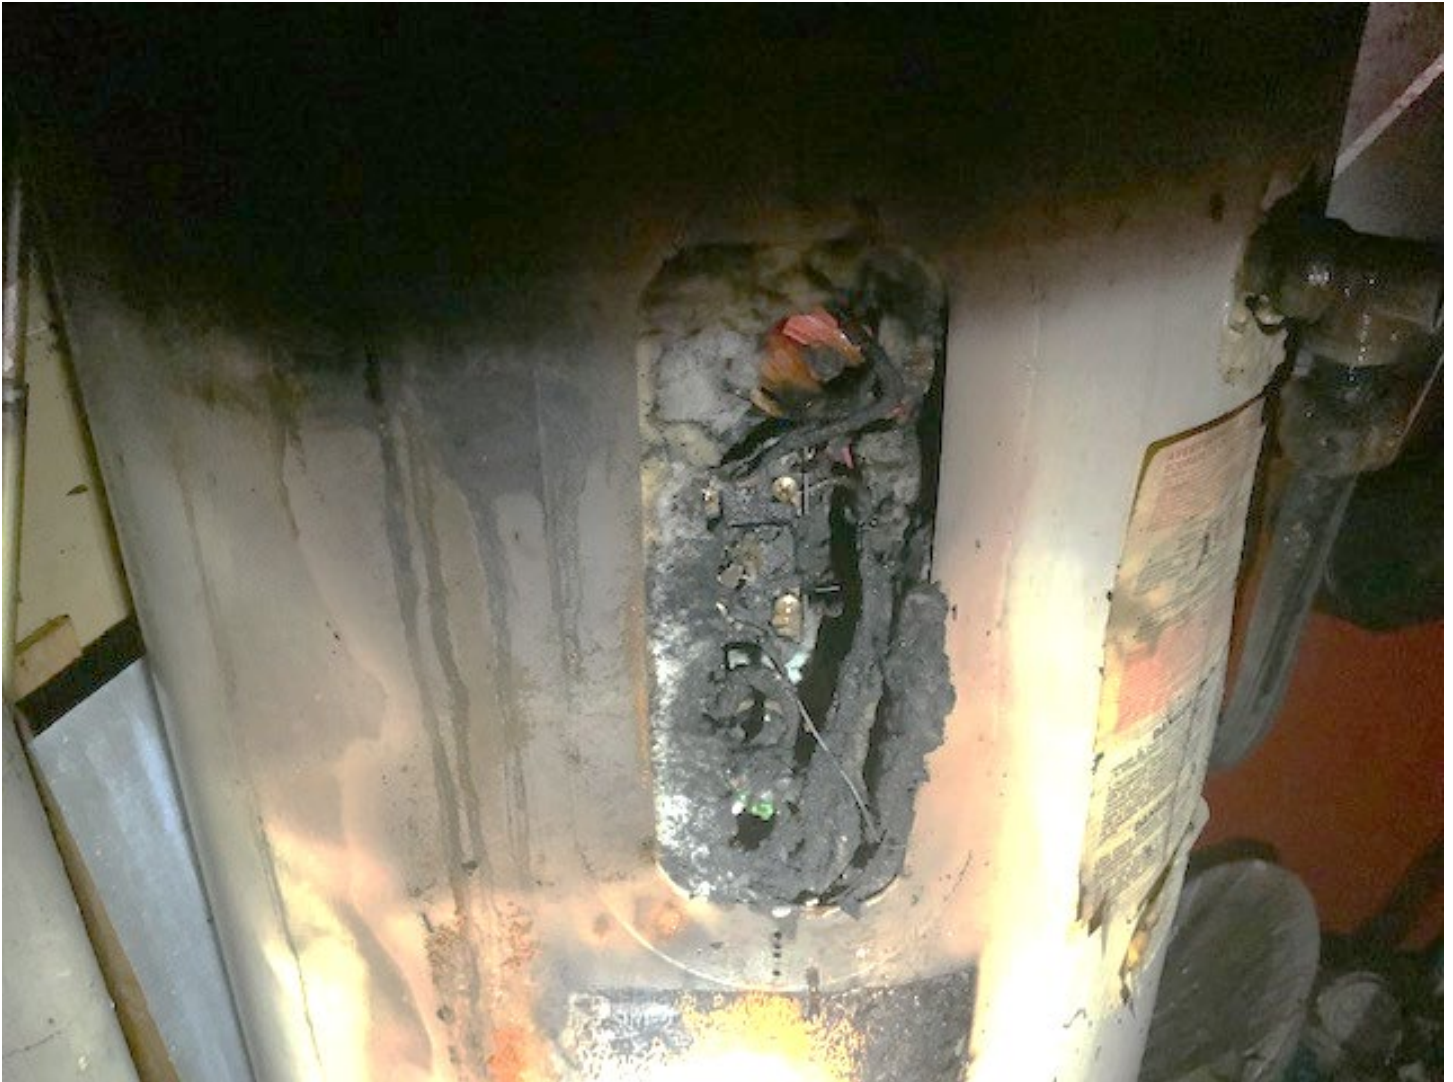
Photograph obtained by Regional Fire/Rescue – upper element and thermostat as found during fire suppression, cover previously removed.
