Incident Summary (Ref # 5623079)

SUPPORTING INFORMATION	Incident Date		Sep 4, 2017	
	Location		Aldergrove	
	Regulated industry sector		Refrigeration system	
	Impact	Injury	Qty injuries	0
			Injury description	None
			Injury rating	None
	Damage		Damage description	A piping fitting failed resulting in release of approximately 5 pounds of ammonia (NH3) in the machinery room
			Damage rating	Minor
	Incident rating		Minor	
	Incident overview		Nipple (fitting) between oil separator and its relief valve cracked and failed to hold ammonia in the piping which resulted in the exhaust ventilation system to be activated.	
INVESTIGATION CONCLUSIONS	Site, system and components		<p>Ice rink facility has a mechanical room separate and self-contained from the ice arena.</p> <p>In an ammonia refrigeration system, ammonia in a gaseous state is compressed through the compressor to high pressure high temperature ammonia gas. The compressed gas heats as it's pressurized. The hot gas enters an oil separator where the ammonia gas and compressor oil is separated so that oil is not carried over with the ammonia gas to the coils and other components. The hot ammonia gas is directed to through coils where th

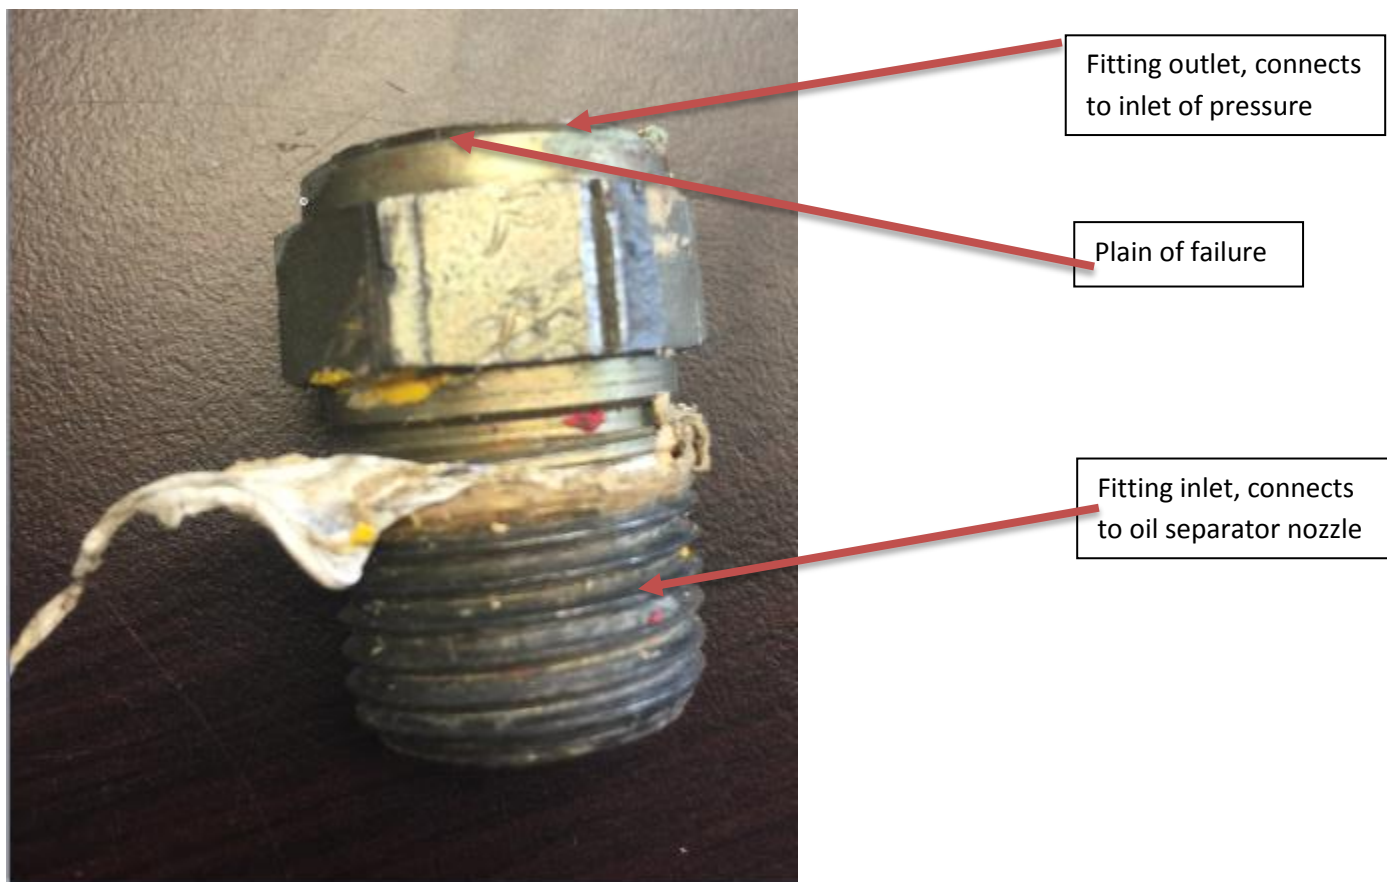
Causes and contributing factors	<p>It is likely that a combination of vibration induced cracking and incompatible fitting material caused it to crack open.</p>

Picture # 1: Close-up view of failed fitting (1/2 inch nipple)

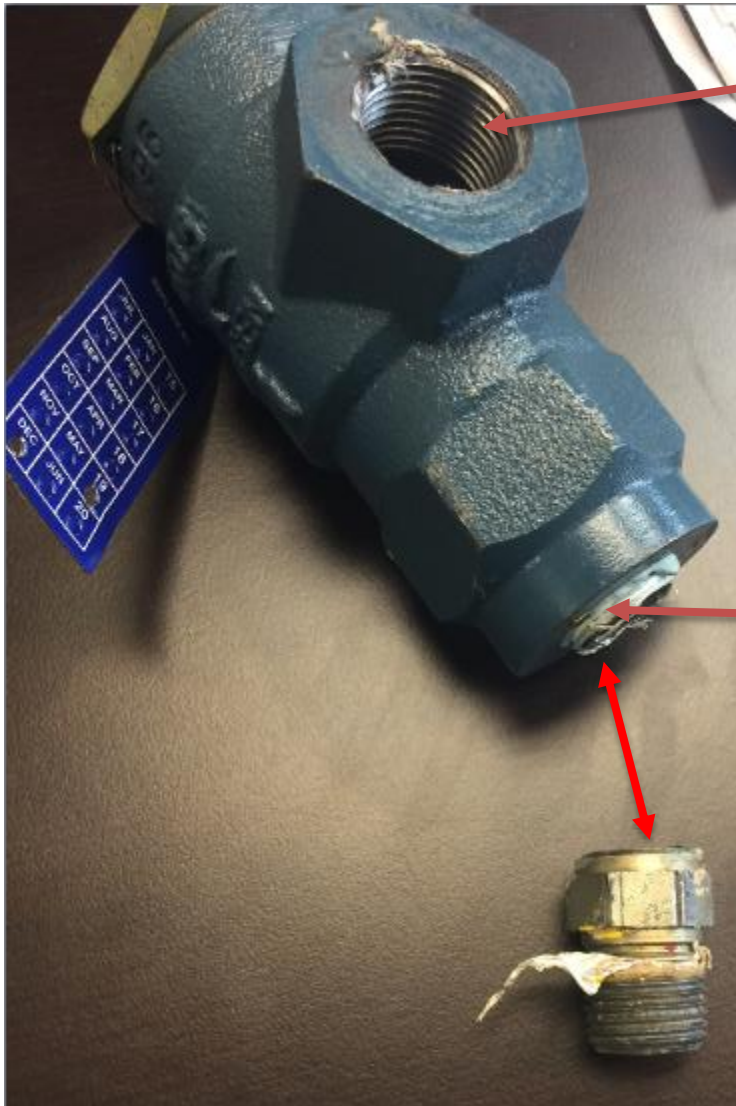
Picture # 2: cracked nipple and associated ammonia relief valve

Pressure relief
valve outlet, 3/4

Pressure relief
valve inlet, 1/2 inch.
Broken threaded
portion of nipple
can be seen inside

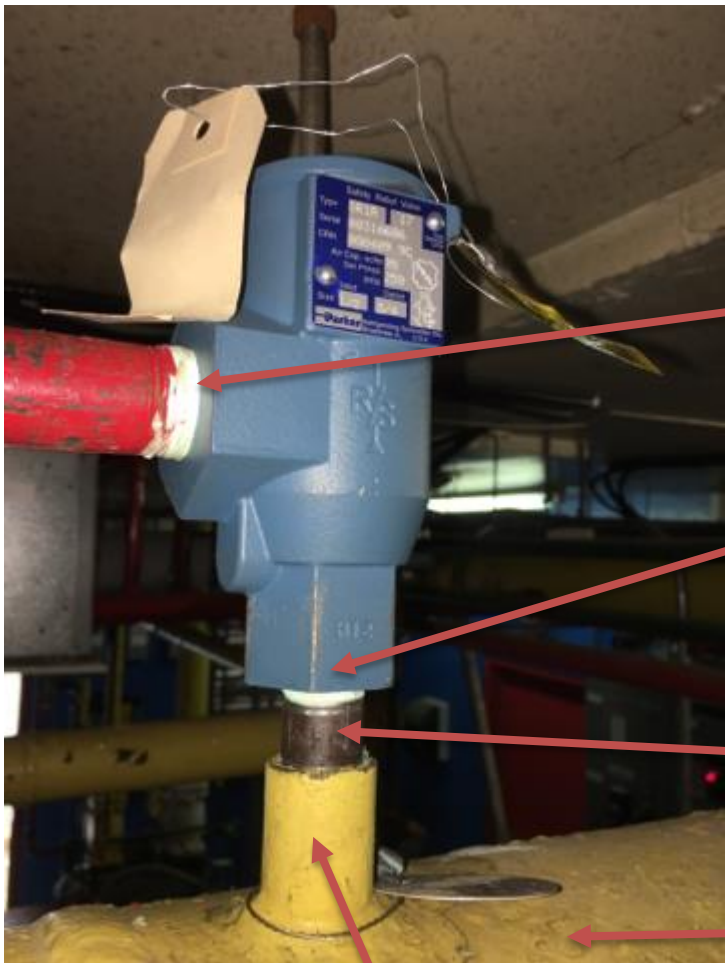
Pressure relief valve outlet

Pressure relief valve inlet

Oil separator

Nozzle on oil separator

Picture # 3: replaced fitting and pressure relief valve

Forged steel fitting (nipple)
– correct type installed
