Investigation Report

Lakeland Mills Ltd. – Explosion and Fire – April 23, 2012

BC Safety Authority – Incident Investigation – Jurisdiction and Role

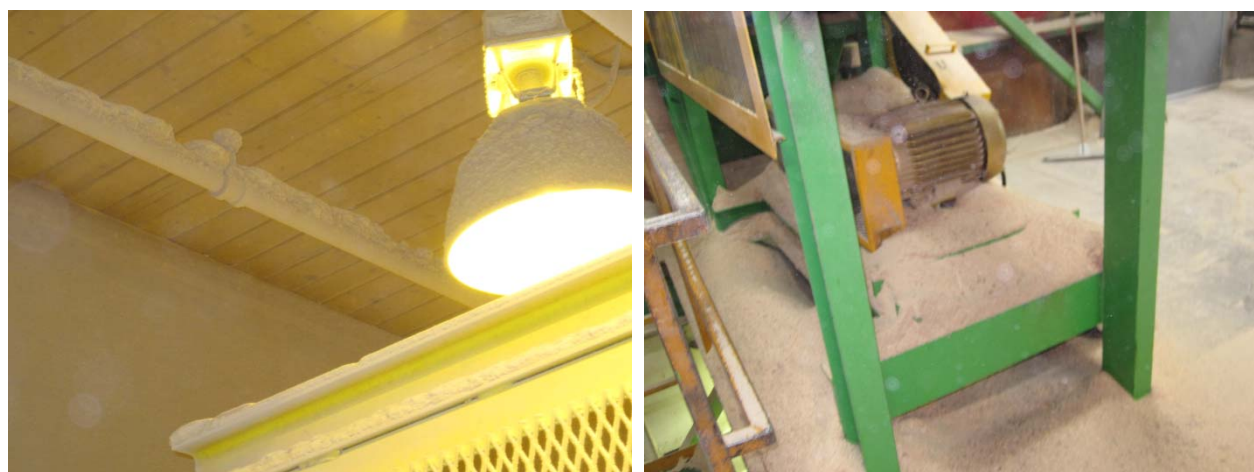
The Prince George Fire Rescue Service provided the following photographs that document combustible dust accumulations from their November 29, 2011 inspection.

Photograph 2: Combustible dust accumulations on high bay (metal halide or high pressure sodium bulb) light assembly, ceiling mounted piping and other horizontal surfaces.

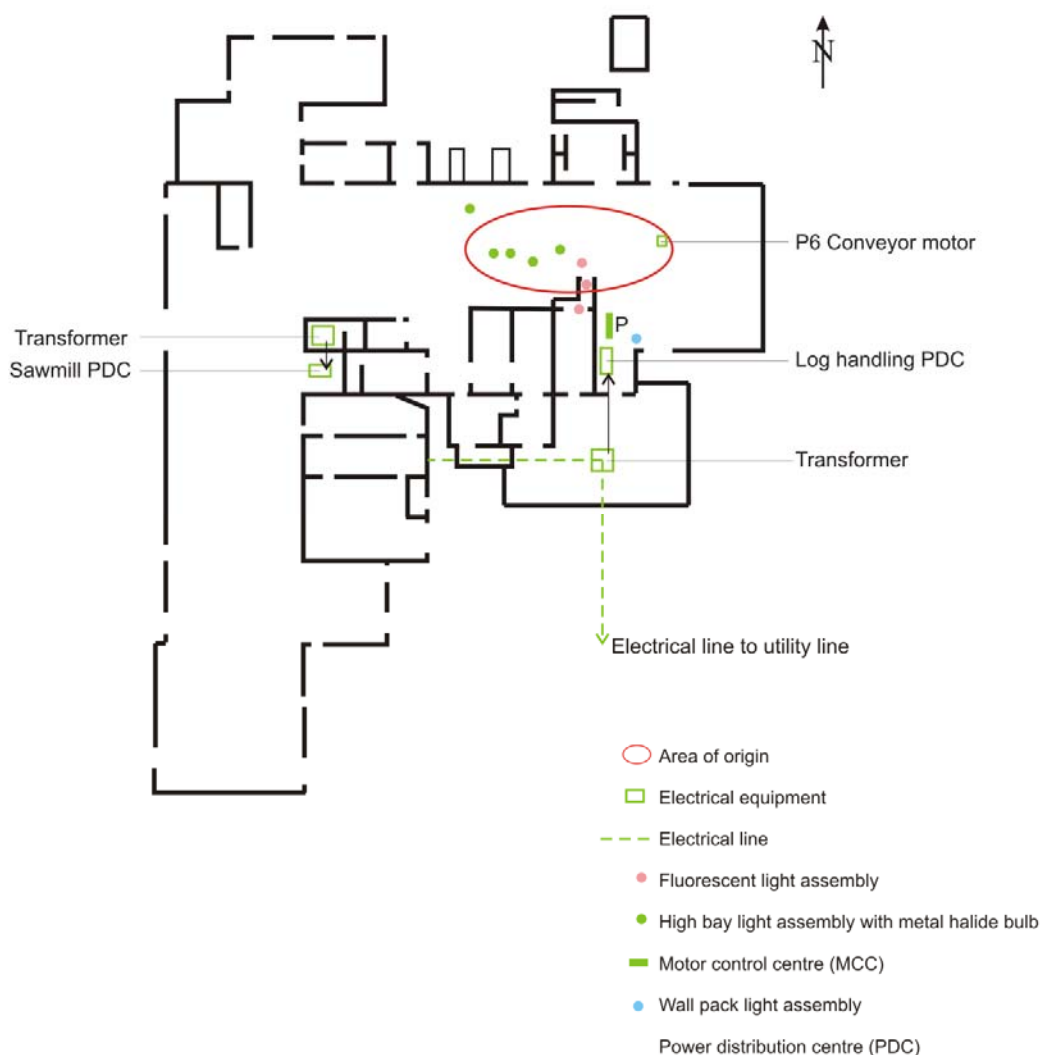
- P6 Conveyor Motor
- Light Assemblies
 - High Bay
 - Fluorescent
 - Wall Pack
- Wiring supplying power to other electrical equipment was routed through the area of origin.

Figure 3: Plan view of mill - electrical equipment within or near the area of origin - from supplied diagrams and investigation findings.

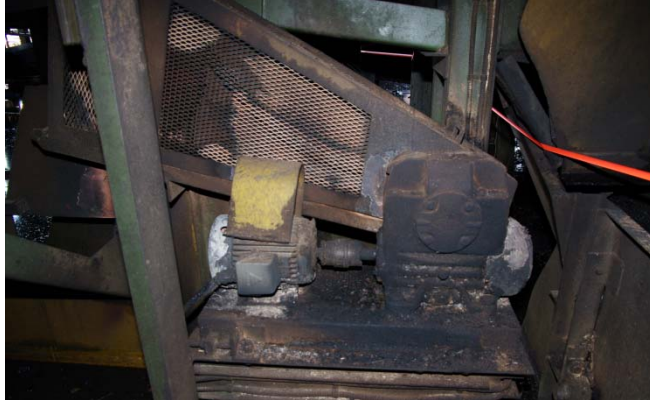
Hazardous accumulations of wood dust were found packed within the junction box and cooling fins of the motor as shown in Photographs 6 through 11. Although this contamination presents ignition hazards and would have impeded proper cooling of the motor, there were no signs of the motor having ignited the packed dust or having overheated during operation. It is therefore considered unlikely that failure or overheating of the motor during operation provided the ignition source for the incident.

Photograph 6: P6 motor assembly, shaft and guard, gear reducer and chain guard as found. Note that the yellow shaft guard was installed over the shaft connecting the motor and reducer.

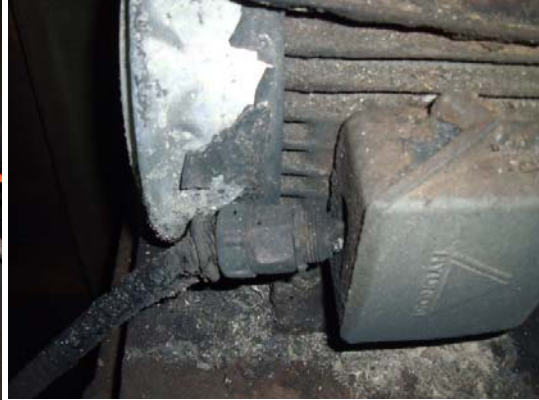
Photograph 7: P6 motor found with wire sheath not connected to the motor junction box.

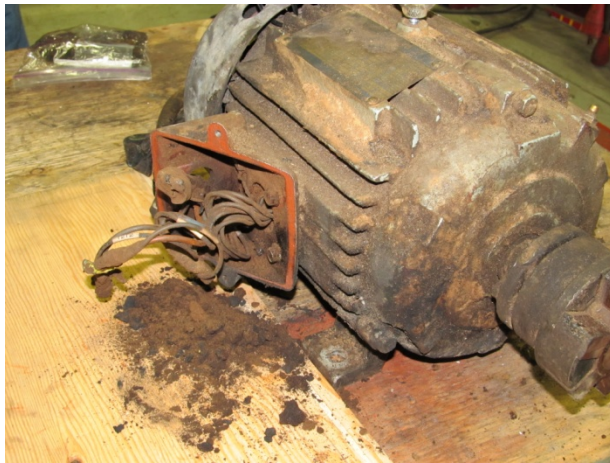
Photograph 8: P6 motor – wood dust found within junction box.

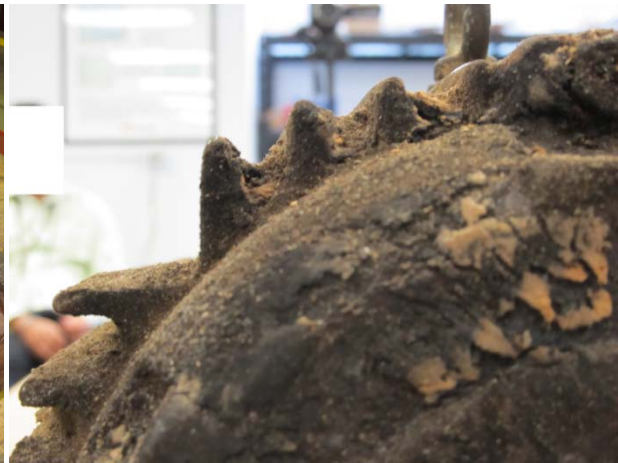
Photograph 9: P6 motor – end view top quarter – wood dust found contaminating cooling fins.

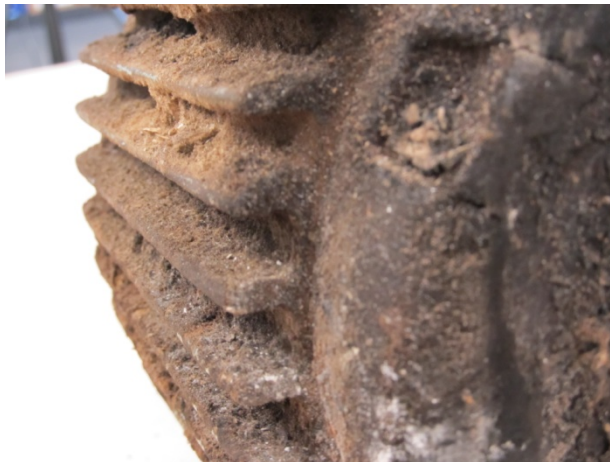
Photograph 10: P6 motor – view of side cooling fins -wood dust contamination.

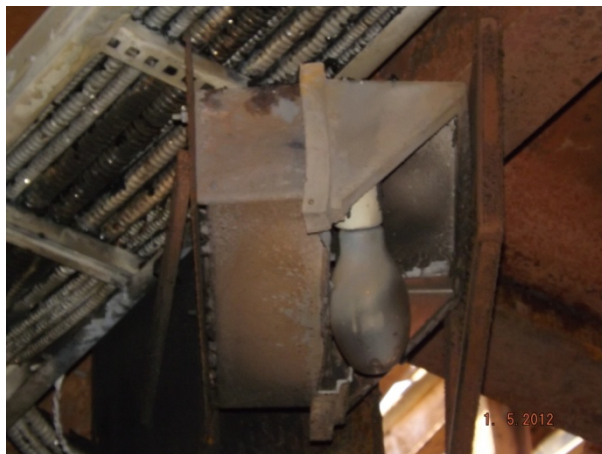
Photograph 12: Wall pack light assembly with missing cover found near the area of origin. The installed bulb is possibly a metal halide or high pressure sodium type.

Metal halide and high pressure sodium bulbs are often used in high bay and wall pack light assemblies (as shown in photographs 12, 13 and 16) and can have maximum surface temperature ratings of 450-500°C, depending upon the output rating of the bulb. Ballast maximum surface temperature ratings can be as high as 250°C.

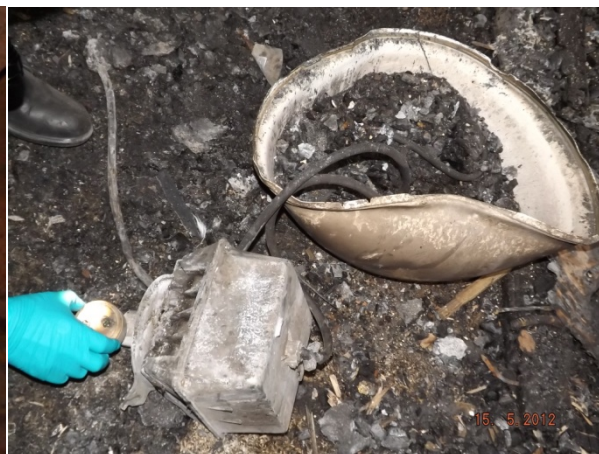
Photograph 13: High bay light assembly found within the area of origin with metal halide bulb.

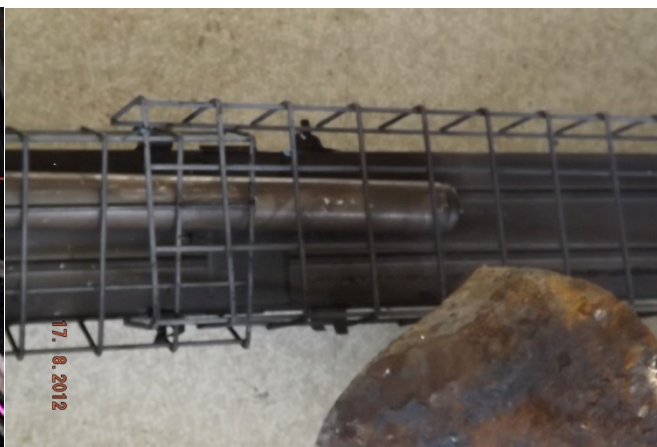
Photograph 15: Fluorescent light assembly found within the area of origin.

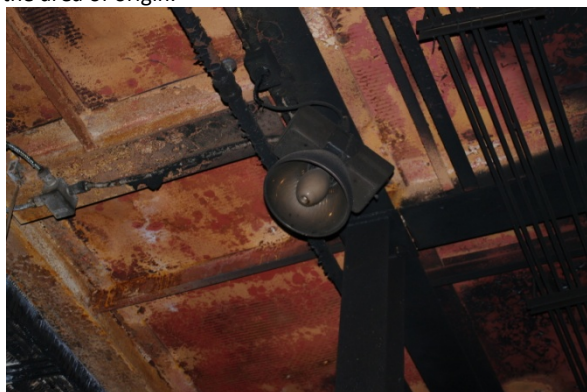
Photograph 16: Open style high bay light assembly found near the area of origin with possible metal halide or high pressure sodium bulb.

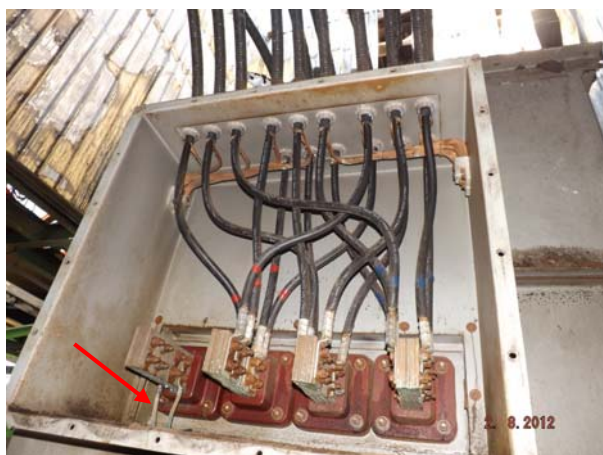
The neutral connection of the transformer supplying the log handling PDC was found severed, leaving the transformer neutral floating as shown in photographs 17 through 20. Arc damage was observed at cable ends as well as on the transformer enclosure. WorkSafeBC commissioned an evaluation of the severed transformer neutral cables which confirmed the presence of arc damage as well as mechanical overload and cutting. The evaluation also concluded that the damage appeared relatively old (months or years) and had likely been present for a considerable period of time preceding the explosion.

Photograph 17: Three-phase transformer feeding the log handling PDC. Neutral terminal and severed cables are identified by the red arrow.

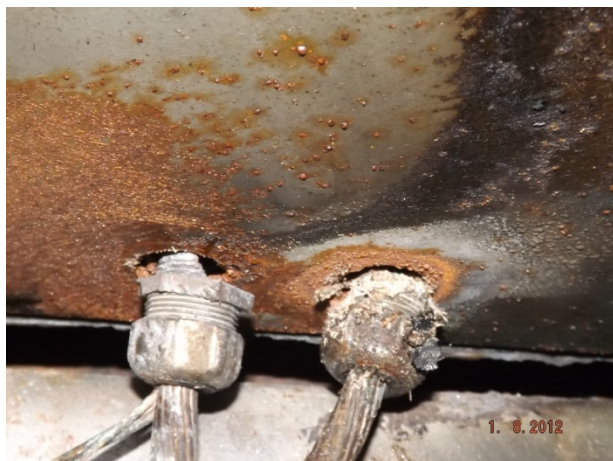
Photograph 19: Damaged neutral cables at the under-side of the transformer enclosure - external feed-through location.

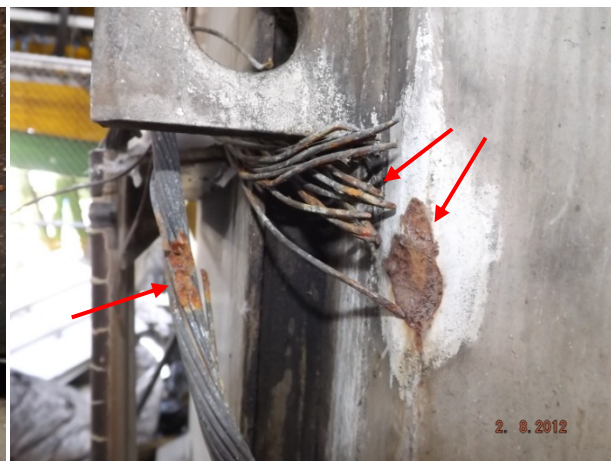
Photograph 20: Arc damage between transformer neutral cables and exterior of the transformer enclosure.

It was observed that the transformer circuit did not incorporate ground fault protection. The arc damage to the neutral cables was likely caused by ground faults within the circuit some time prior to the explosion, leading to the failure or disconnection of the neutral connection. The floating neutral condition would have left the electrical system vulnerable to overvoltage conditions, increasing the risk of electrical equipment failure while inhibiting the distribution system from safely detecting and responding to such failures. The floating neutral condition increased the risk of generating possible electrical ignition sources within a potentially combustible environment.

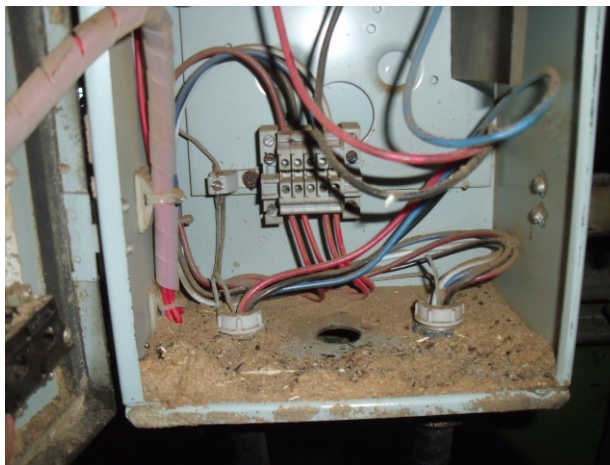
Photograph 21: Unfilled opening in lower center of enclosure contaminated with combustible wood dust.

As shown in photograph 21 above, unfilled electrical enclosure holes allowed for combustible dust to contaminate the enclosure, exposing the combustible dust to possible ignition sources. Ignition of combustible dust within an enclosure could lead to the ignition of a combustible environment outside of an enclosure. Unfilled electrical enclosure holes increased the risk of combustible dust ignition within or near the area of origin.

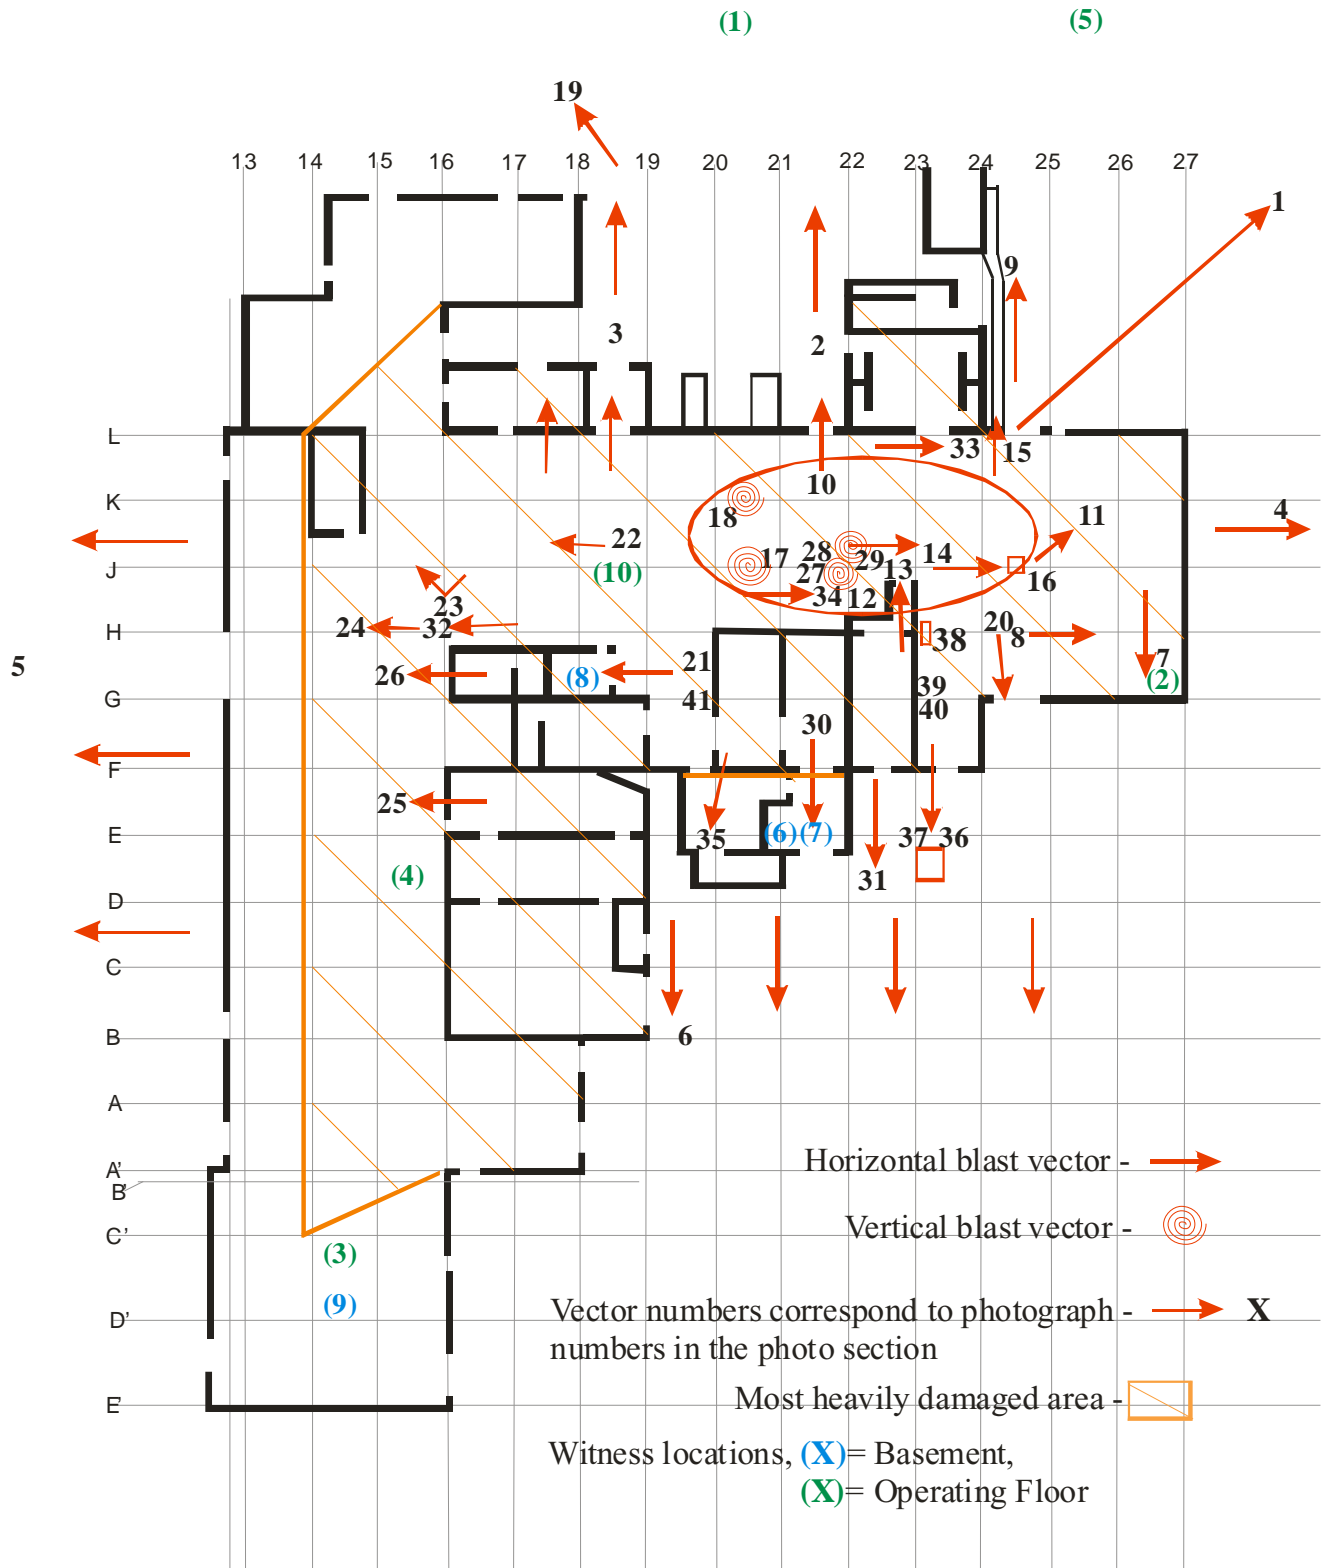
Figure 3:
Blast vector and witness location plan (not to scale)

Note: the bold numbers in the plan correspond to photograph numbers in the photograph section; the red arrows show the blast direction indicated by the post-blast positions of the objects shown in the various photographs. The bracketed numbers indicate the locations of witness discussed in Section 4.4.

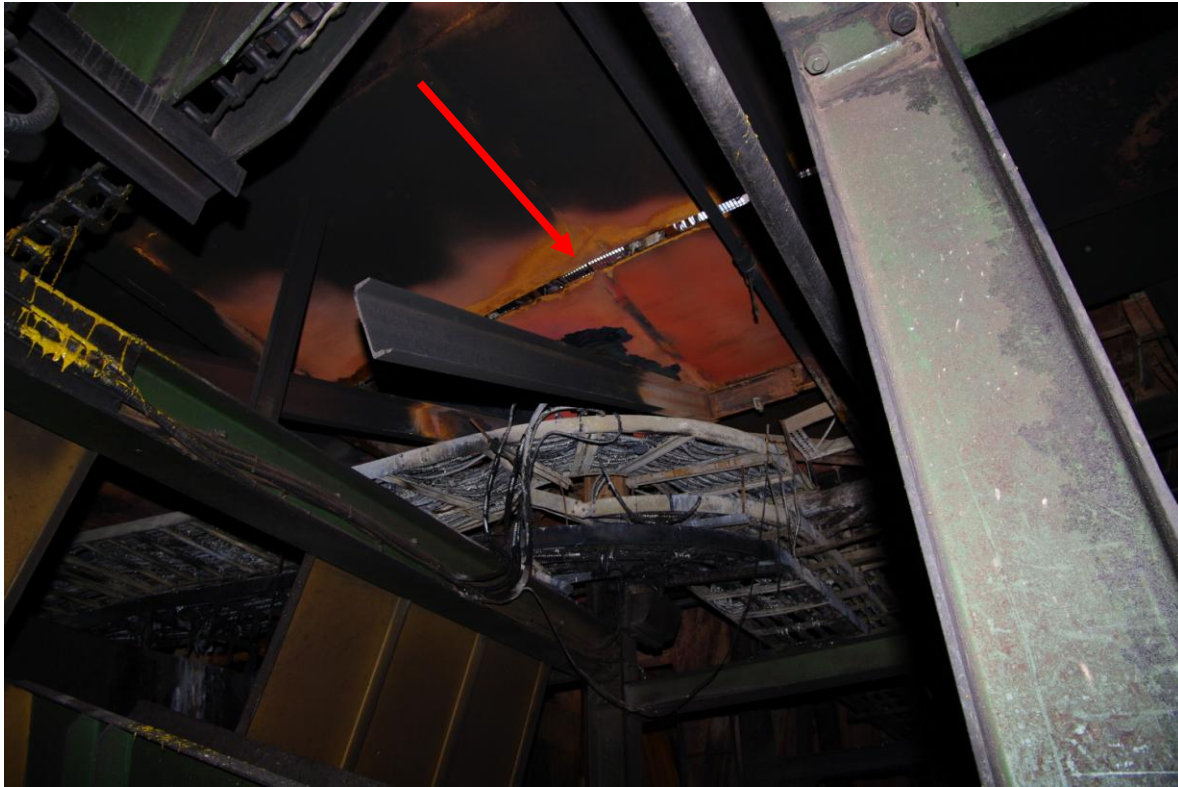
Photograph 7

Facing SE looking at broken weld and separation of floor plates, grid G-27.

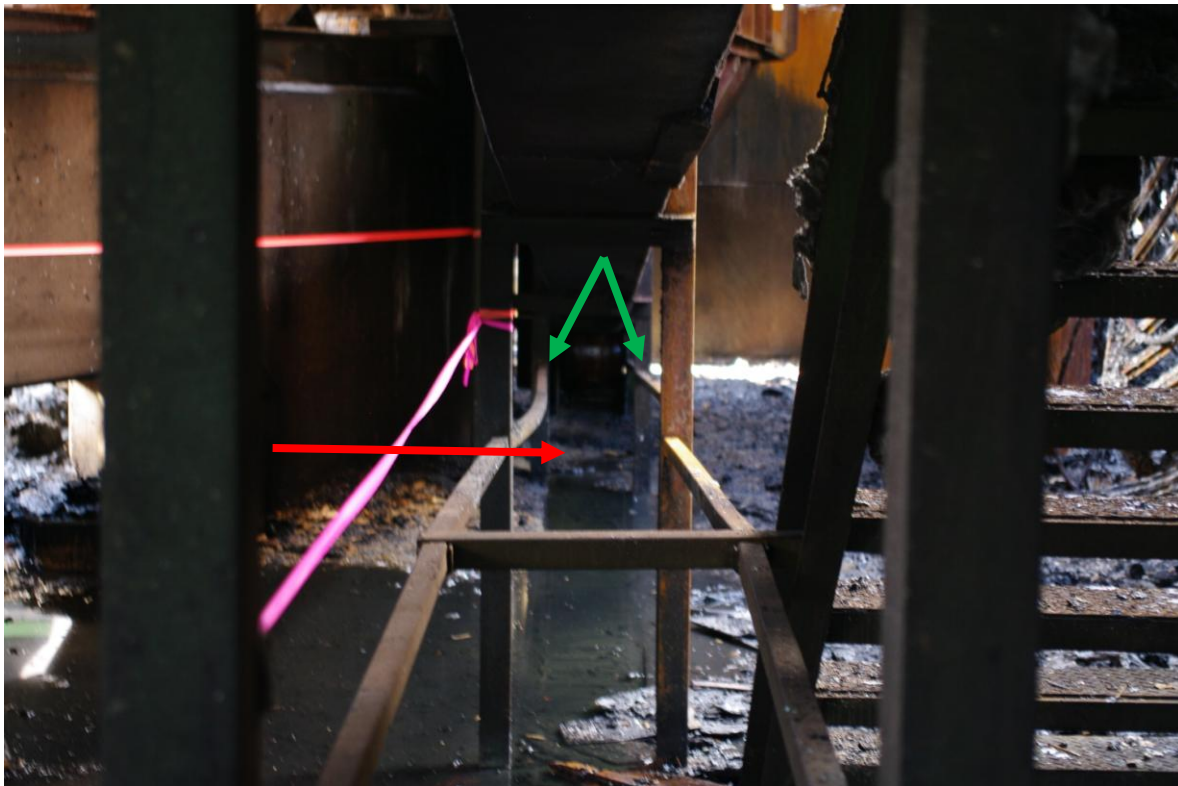
Photograph 8

Facing north looking at bowed railings (green arrows), grid H-24/25.

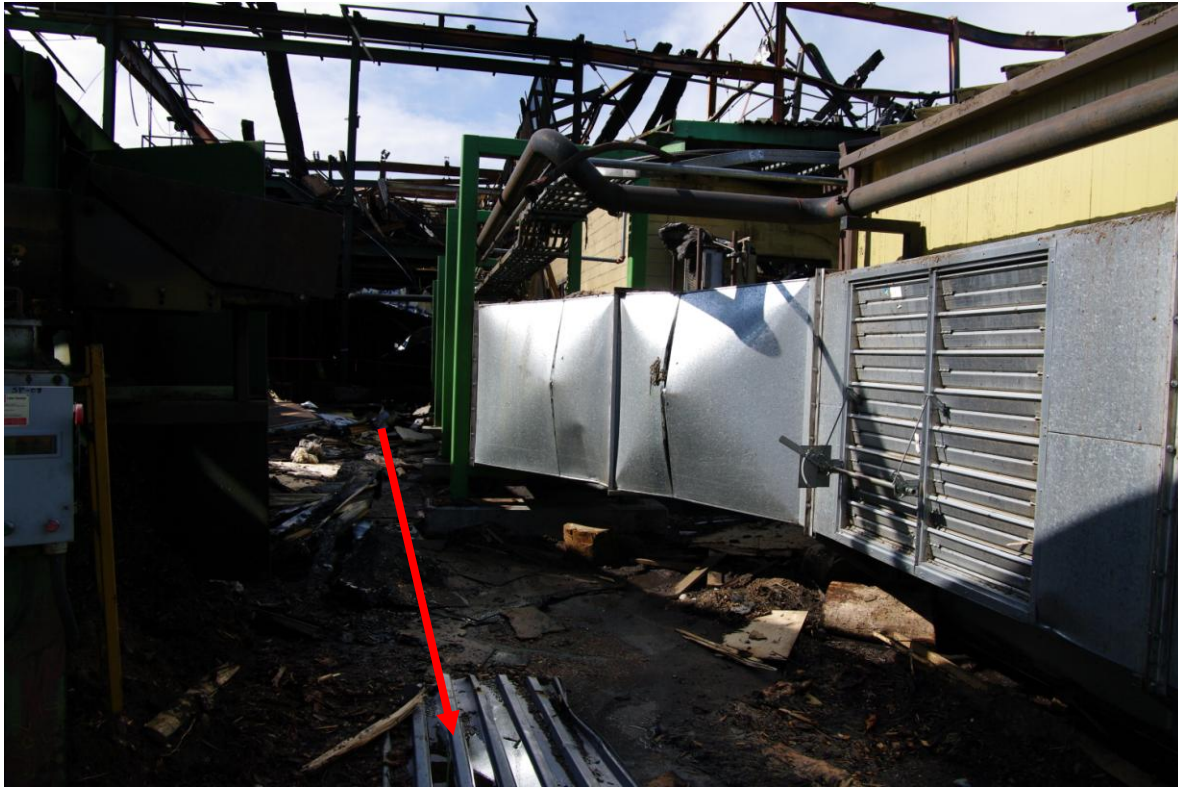
Photograph 9

Facing south
damage to vent
trunking, north grid
24/25.

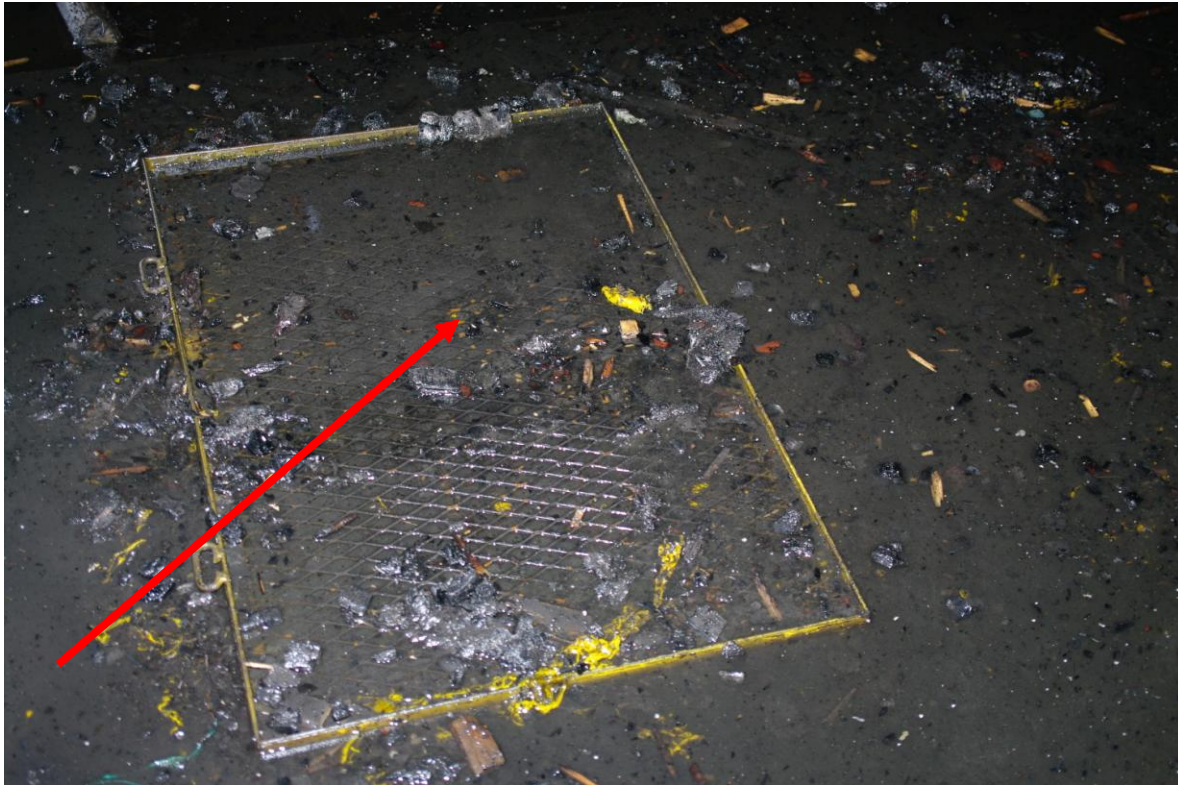
Photograph 11

Looking at a protective screen on basement floor displaced east of its original position, grid J-25/26.

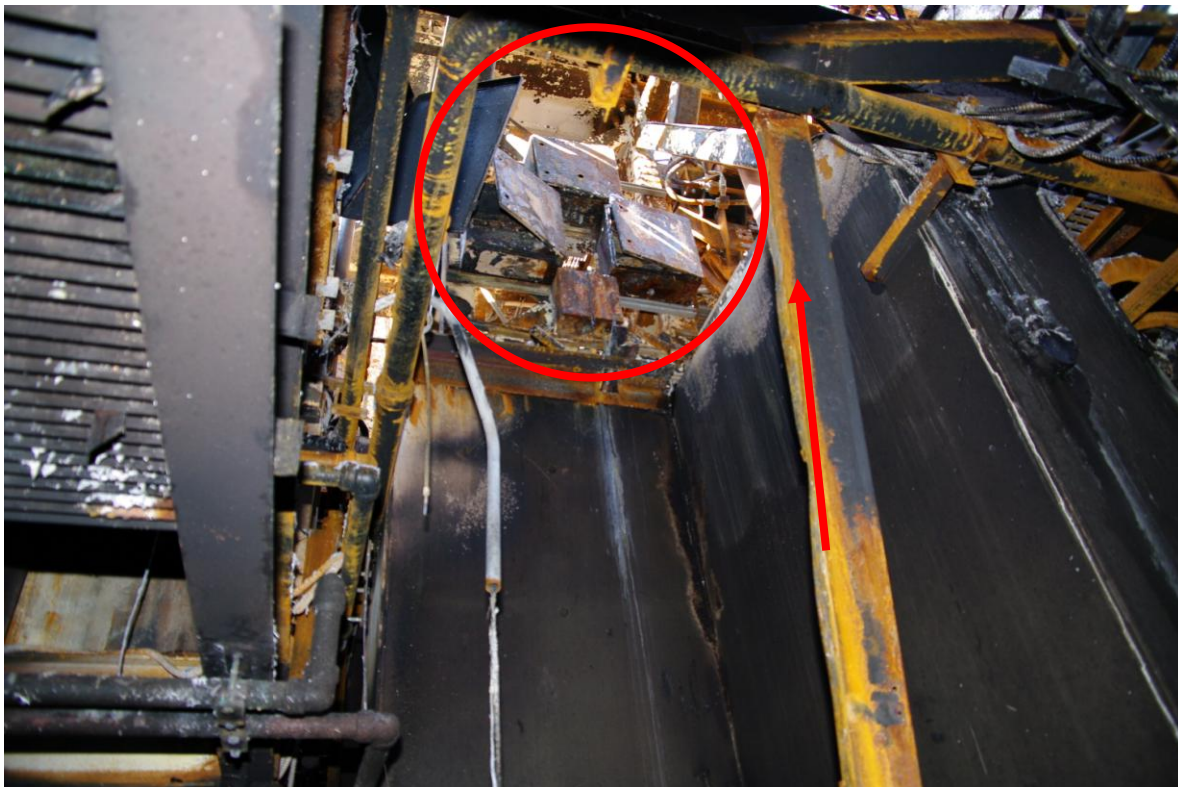
Photograph 12

Looking up from basement to operating floor; cabinets blown open (circle), grid H/J-22.

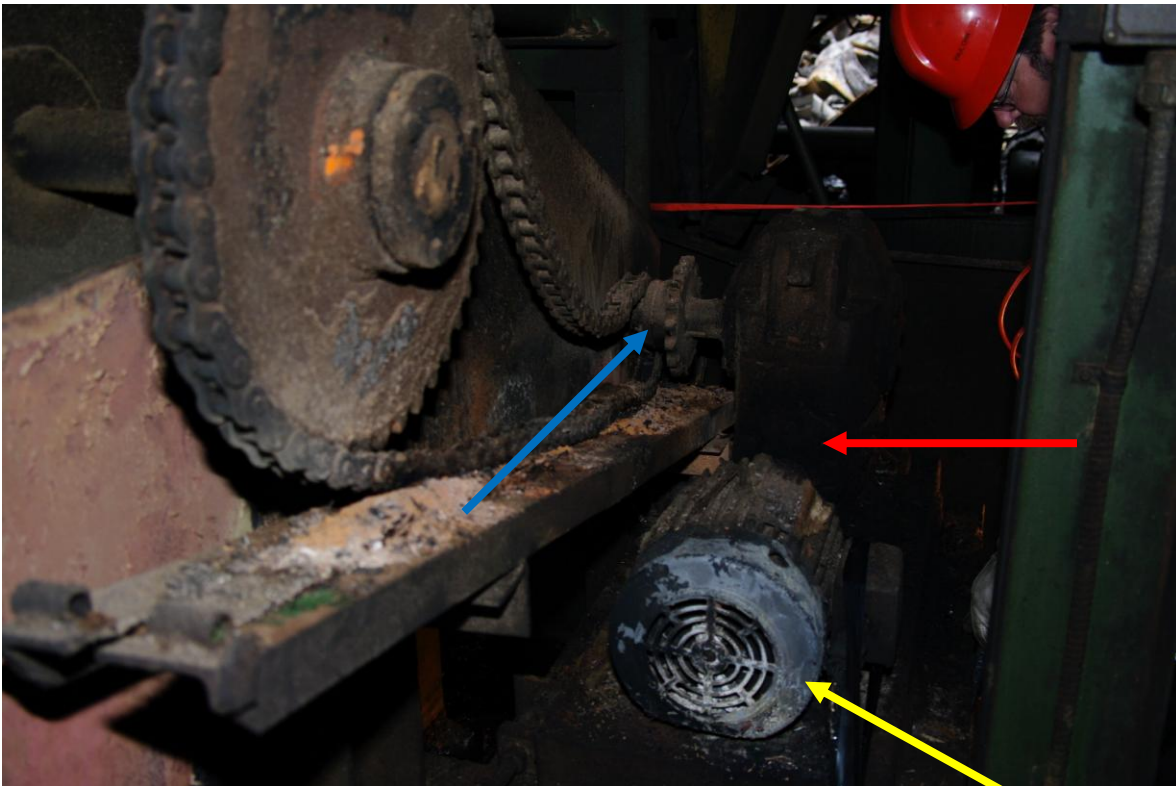
Photograph 16

Facing south looking at the motor to conveyor 6P, J-24.

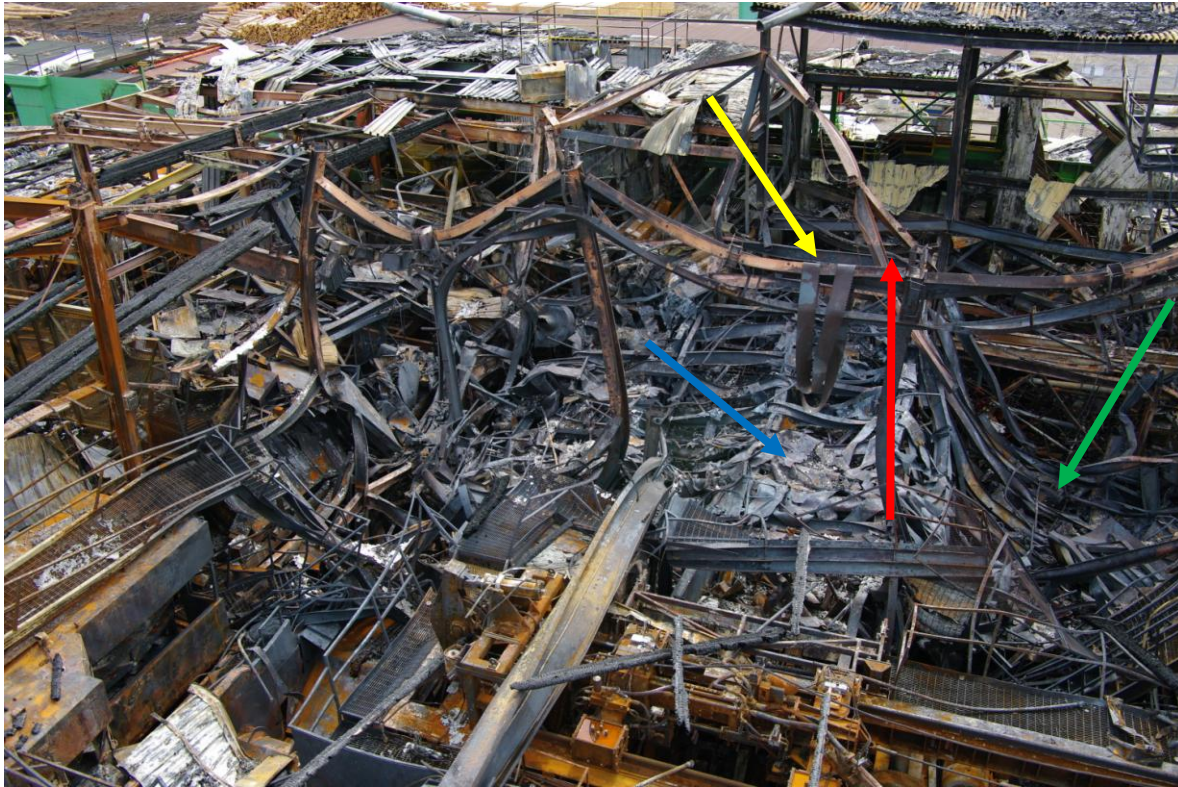
Photograph 17

Facing south looking at the area where an extensive amount of collapse occurred (green arrow) at grid J-20.

Note also: the pile of band saw blades on top of the rubble below the hanging blade (blue arrow).

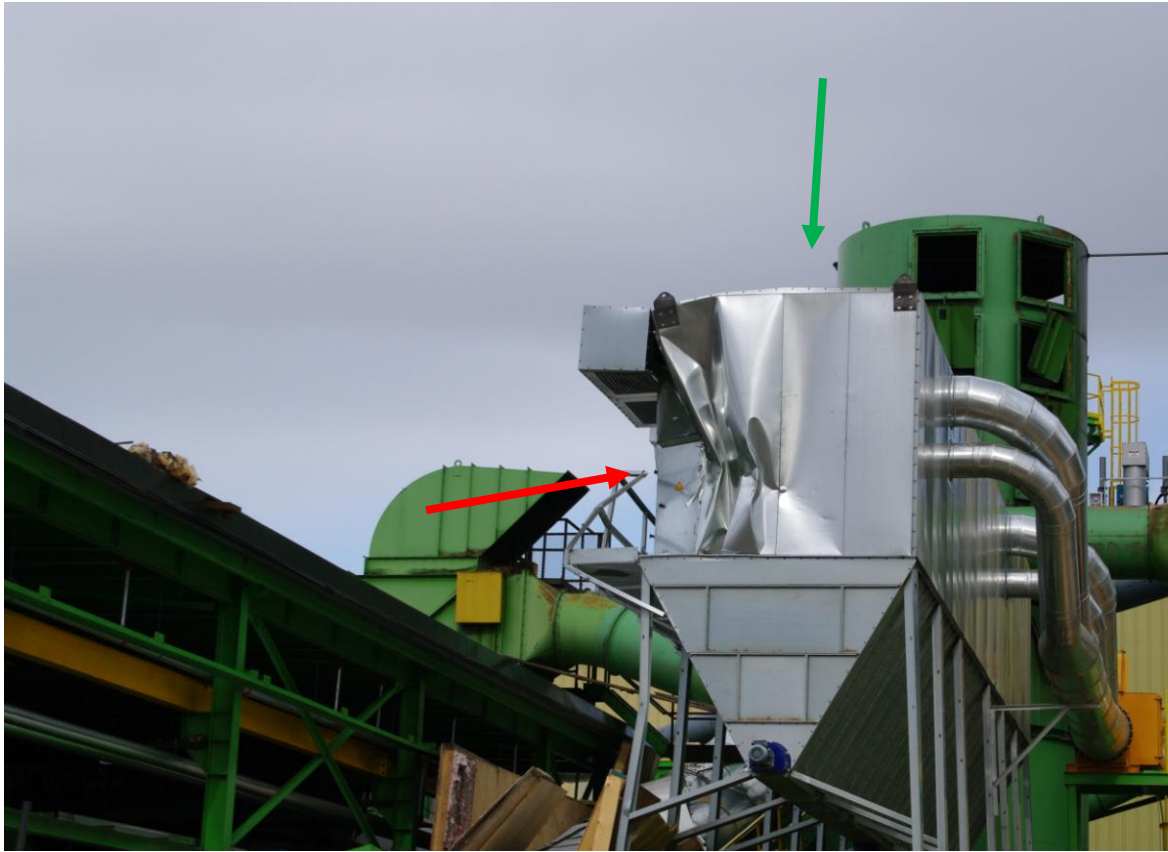
Photograph 19

Facing west looking at the southeast corner of the bag house filtration system (green arrow), north-grid 17/18.

Note: impact damage to the southeast corner of the unit.

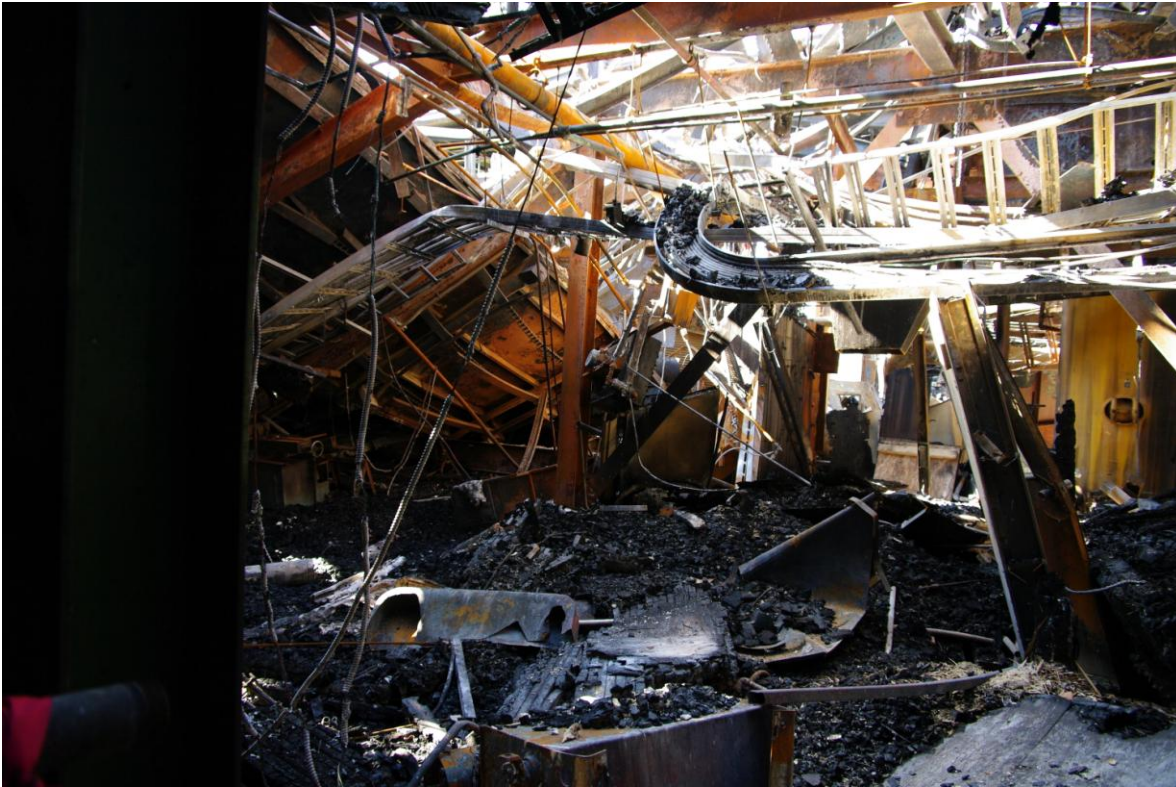
Photograph 21

Facing south looking at the area in the basement where the greatest amount of collapse from above occurred, grid G - 19/20.

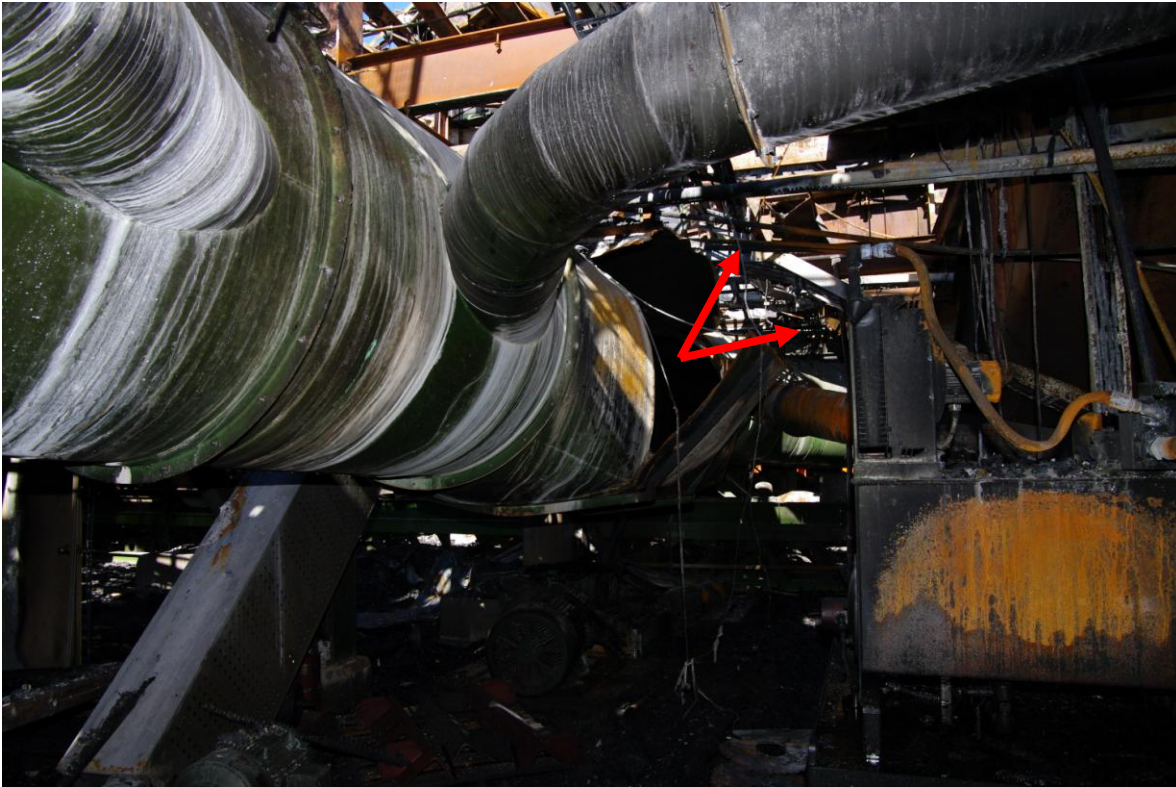
Photograph 23

Facing west looking at damage to the dust extraction trunking, grid H-16.

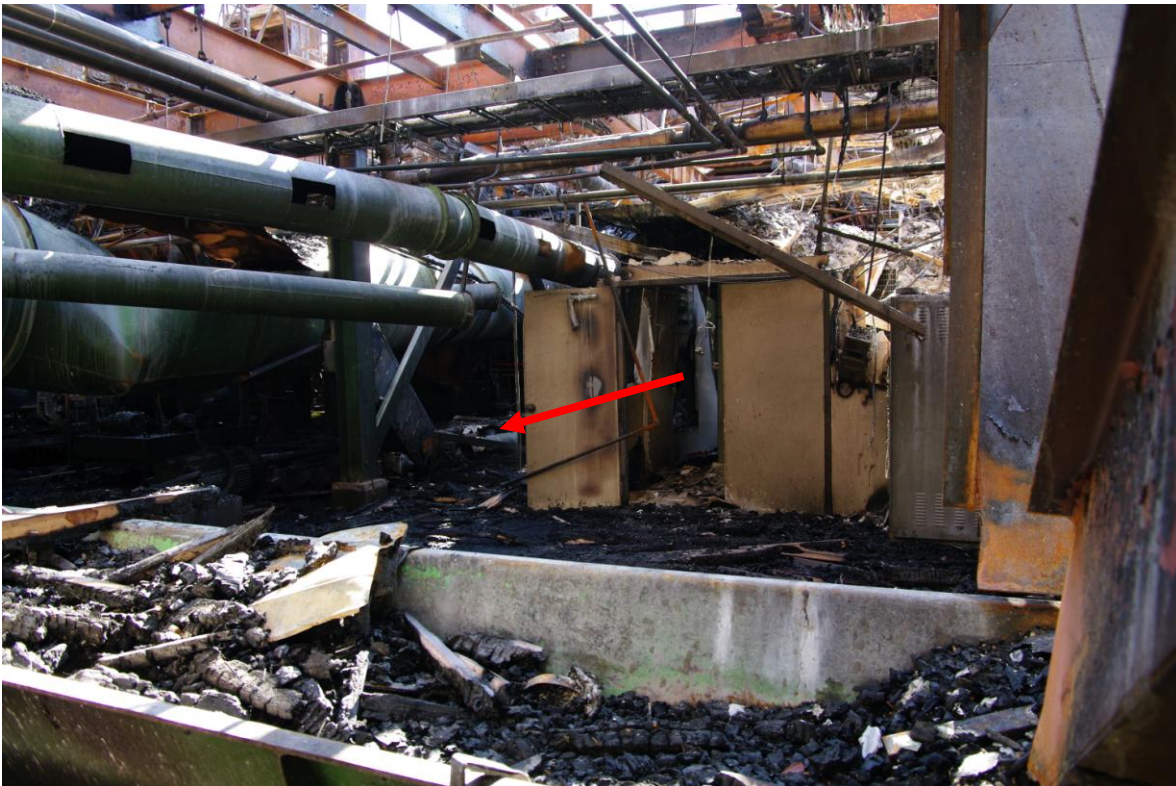
Photograph 26

Facing east looking at doors of an electrical vault displaced open east to west, grid G/H-16.

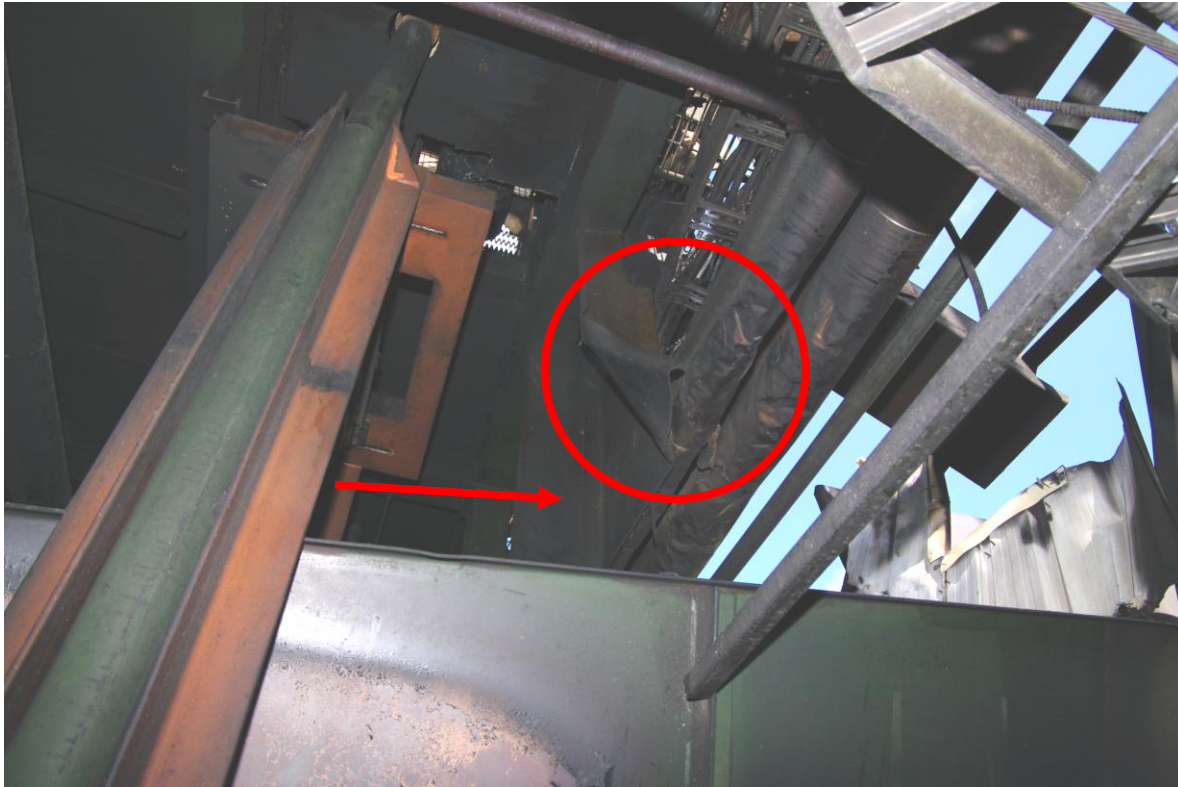
Photograph 33

Facing north looking at bent steel framing below the basement ceiling (circle) displaced west to east, grid L-24.

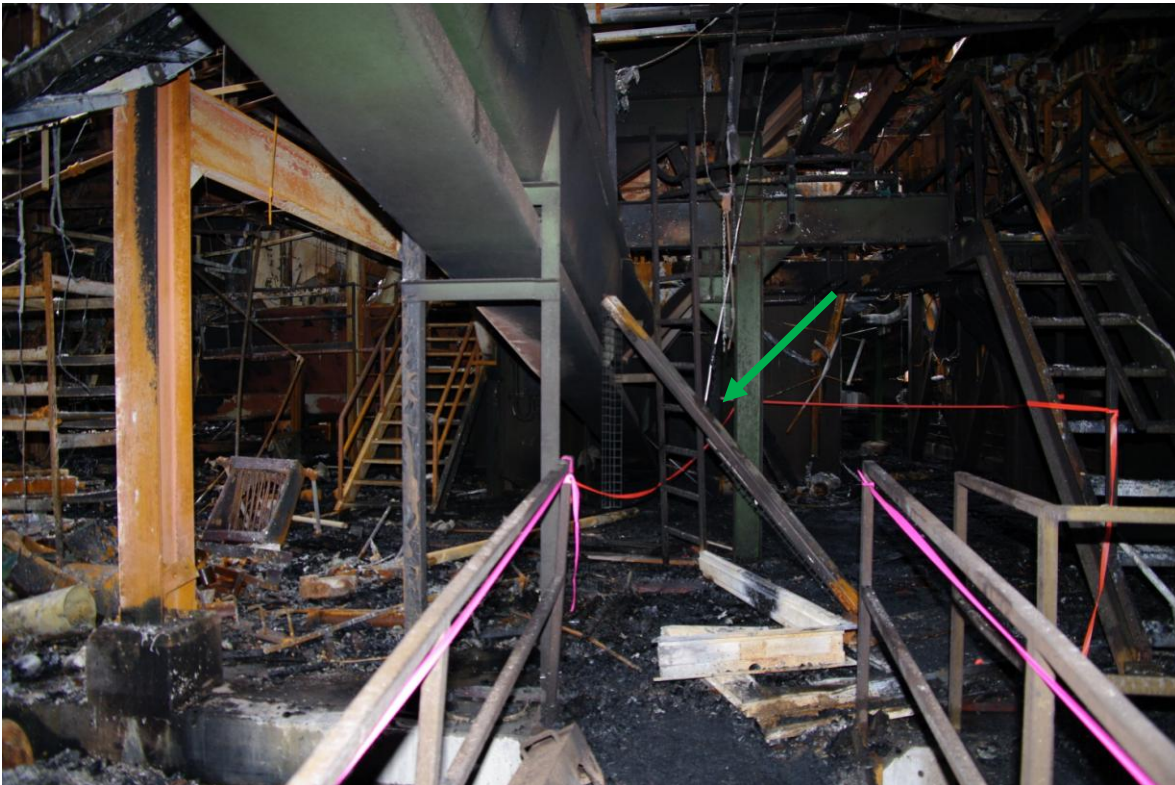
Photograph 44
Looking at examples of unprotected fluorescent lighting (arrow) (this and following photograph), grid J-23.
