Incident Summary #II-1551465-2023 (#35432) (FINAL)

SUPPORTING INFORMATION	Incident Date	May 12, 2023	
	Location	Vernon	
	Regulated industry sector	Electrical - Low voltage electrical system (30V to 1000V)	
	Injury	Qty injuries	0
		Injury description	N/A
		Injury rating	None
	Impact	Damage description	A fire occurred in a single-family dwelling that destroyed the exterior attached shed and covered entry to the backside of the garage. Structural damage to trusses and roof to attached garage and modular home noted. Damage to the dwelling itself was noted mainly contained to the attic spaces with heat and smoke damage within dwelling areas as well as ceilings.
			Damage rating
	Incident rating	Major	
	Incident overview	<p>An exterior shed attached to the main structure was utilized as storage for personal items that included tires, propane tanks, exterior patio furniture, metal brackets, spray cans and other items.</p> <p>A fire occurred within the shed that extended to the interior attic areas of the dwelling and attached garage.</p>

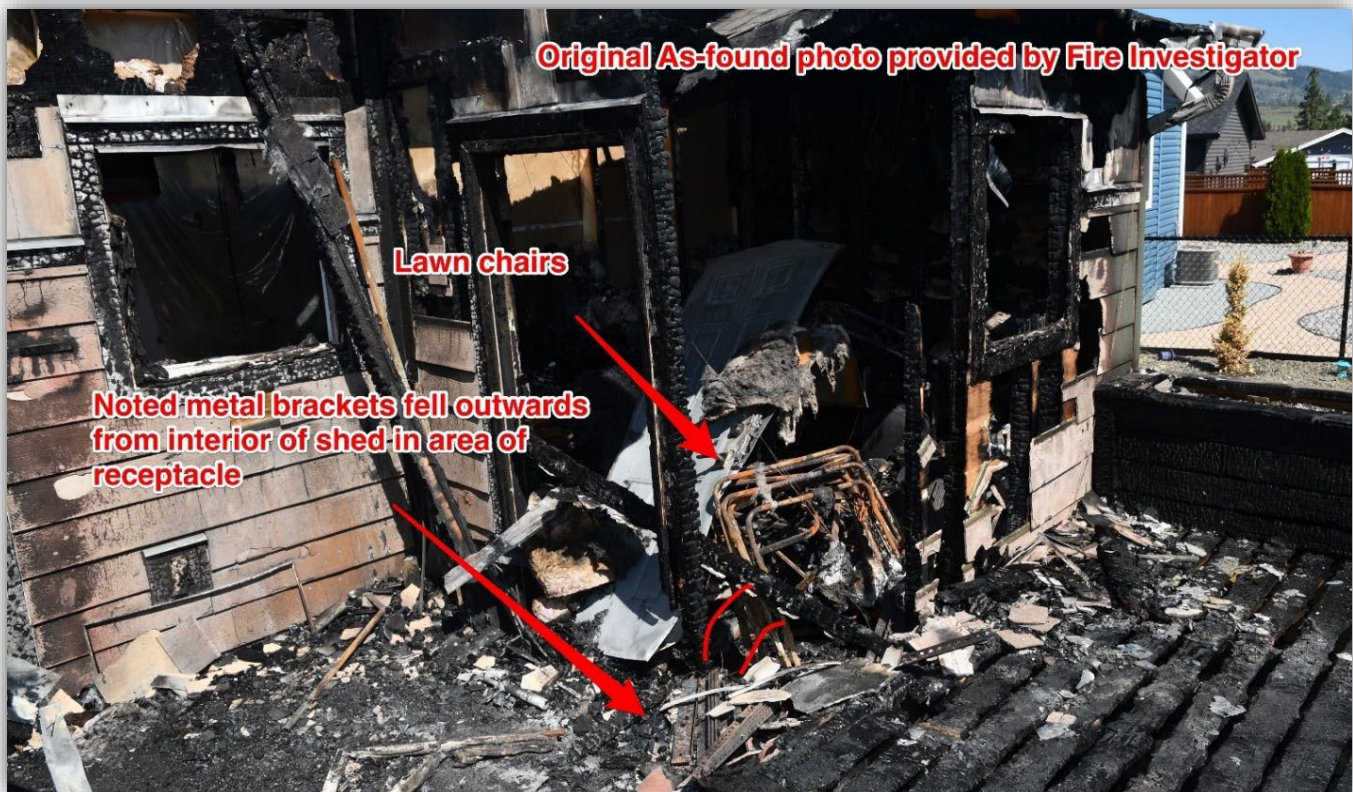
Image 1 - Original as-found on site prior to sifting through and removing electrical evidence on Monday May 15 (Image provided by Fire Investigator).

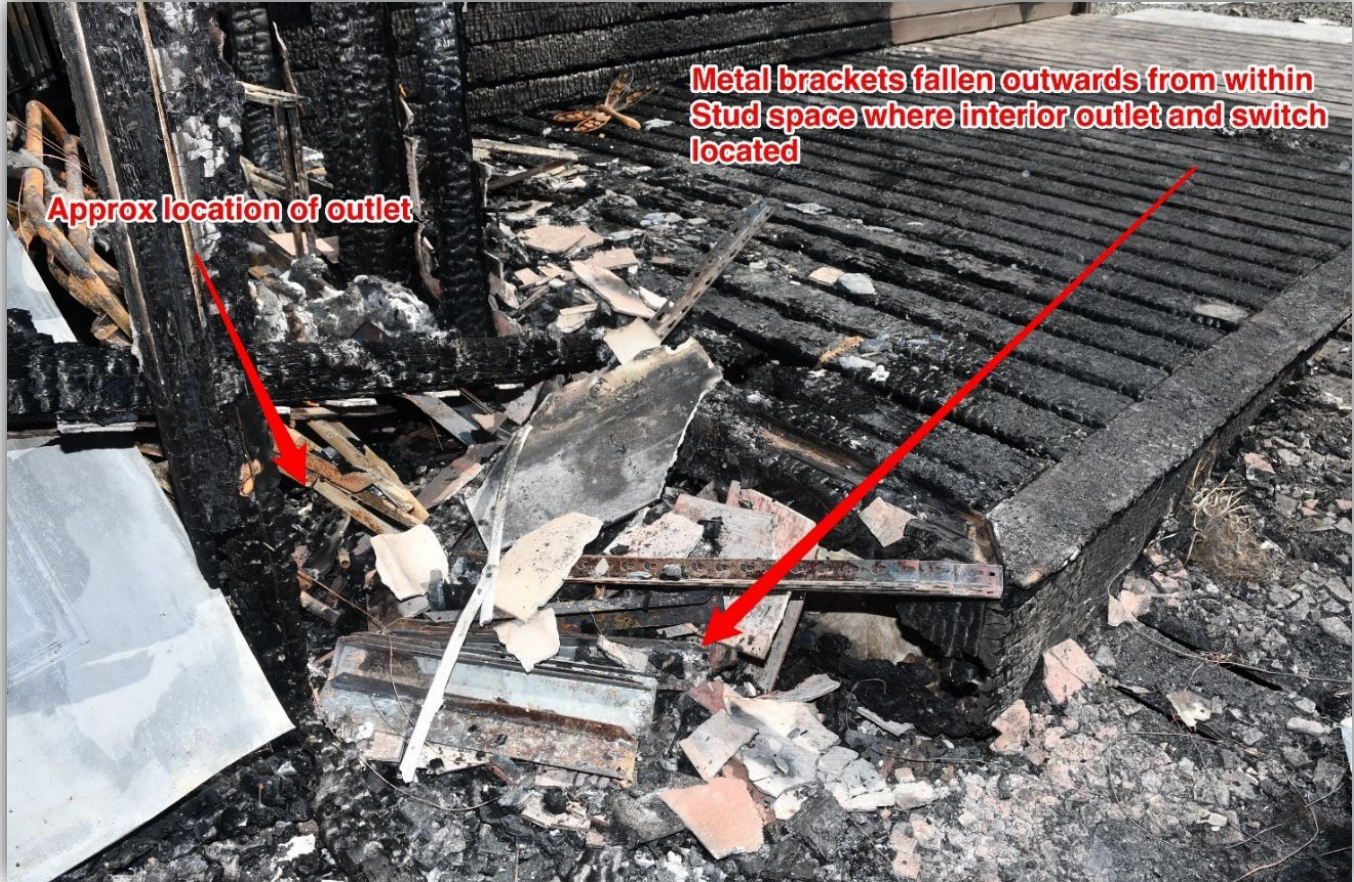
Image 2 – Site prior to Fire Investigator site review on Monday May 15 (*Image provided by Fire Investigator*).

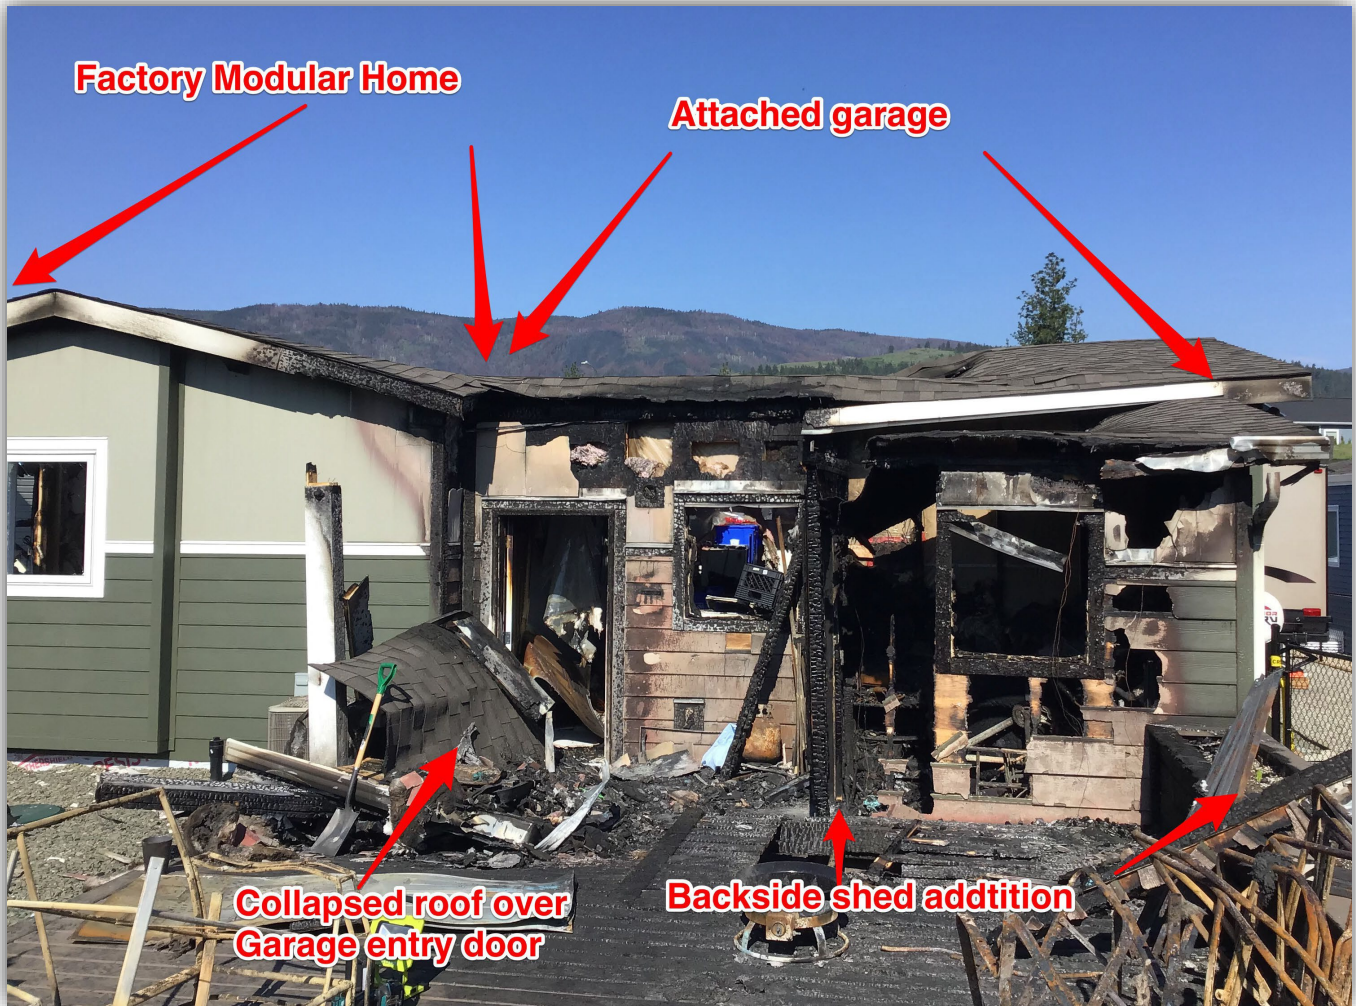
- The 'shed' located on the backside of the garage with a covered roof over the back garage door entry had deepest charring/ damage of the structure indicating the origin, once the fire burnt through the ceiling area, it travelled into the garage ceiling attic space and spread from that point. The damage extended into the main dwelling attic space and through the roof. Due to the weight of the water applied during the fire-fighting efforts, the ceiling in various areas collapsed under excessive weight and moisture.

Image 3 - Site view from backyard Tuesday May 16 showing shed, garage area and dwelling to left.

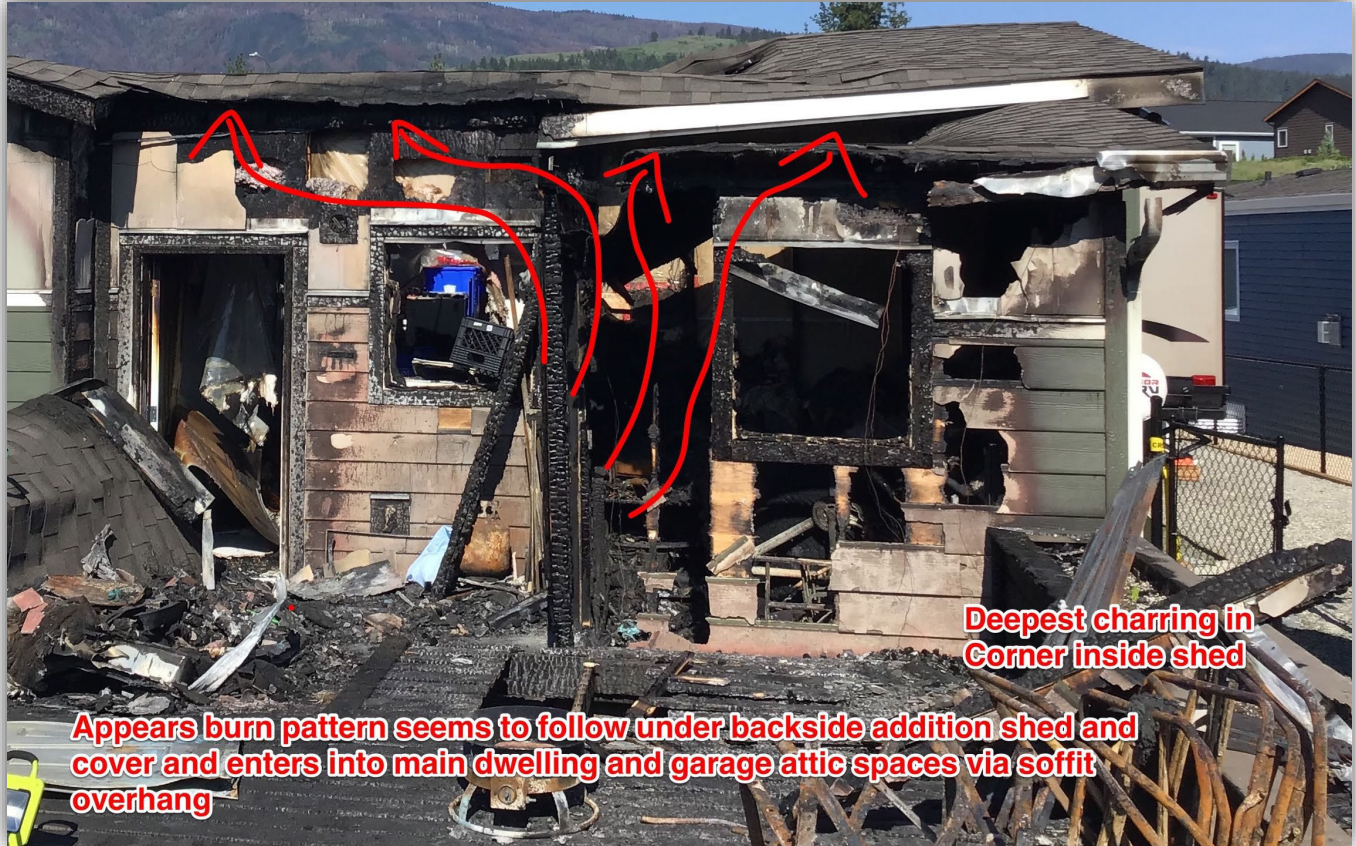
Image 4 - Lines provide proposed fire travel from shed location and access into garage and dwelling attic through soffit area.

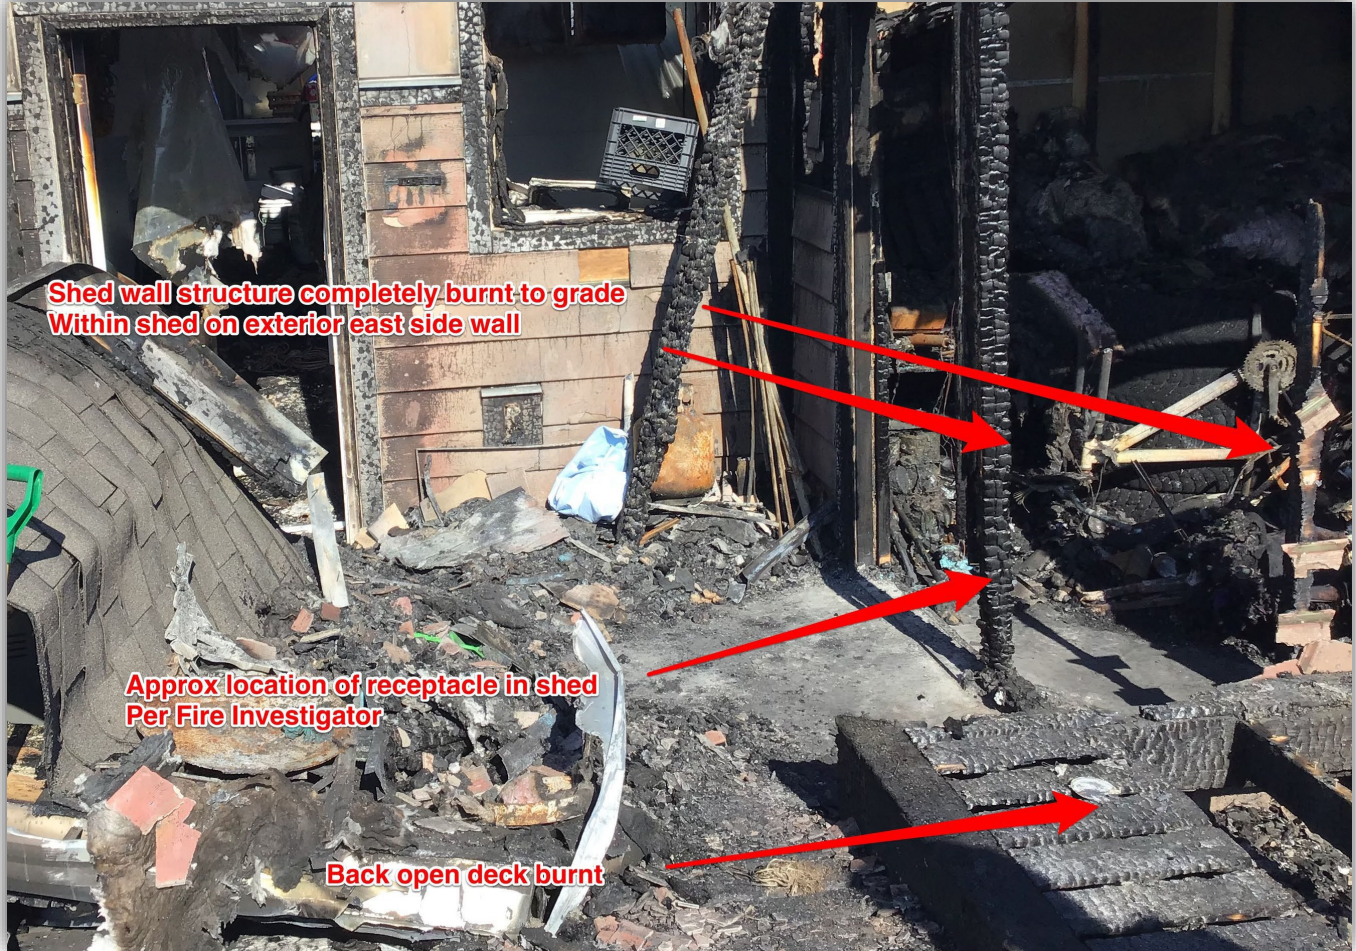
The origin of the fire leads to the shed where considerable fire damage was noted at a low level destroying the exterior wall structure extending to the roof framing and as far downwards as burning the exterior patio wood deck structure. All other areas of fire extended into the dwelling and garage attic/truss areas.

- The shed structure had completely burnt all the wood structure located near the doorway where an outlet was noted by Fire Department. The evidence of the outlet was removed from scene by the Insurance companies fire investigator.

Image 5 - Back entry area: covered back open area roof laying on ground to left with shed location to right where most fire damage occurred. Extensive heat noted along upper wall area of garage and major fire damage to shed and wood decking.

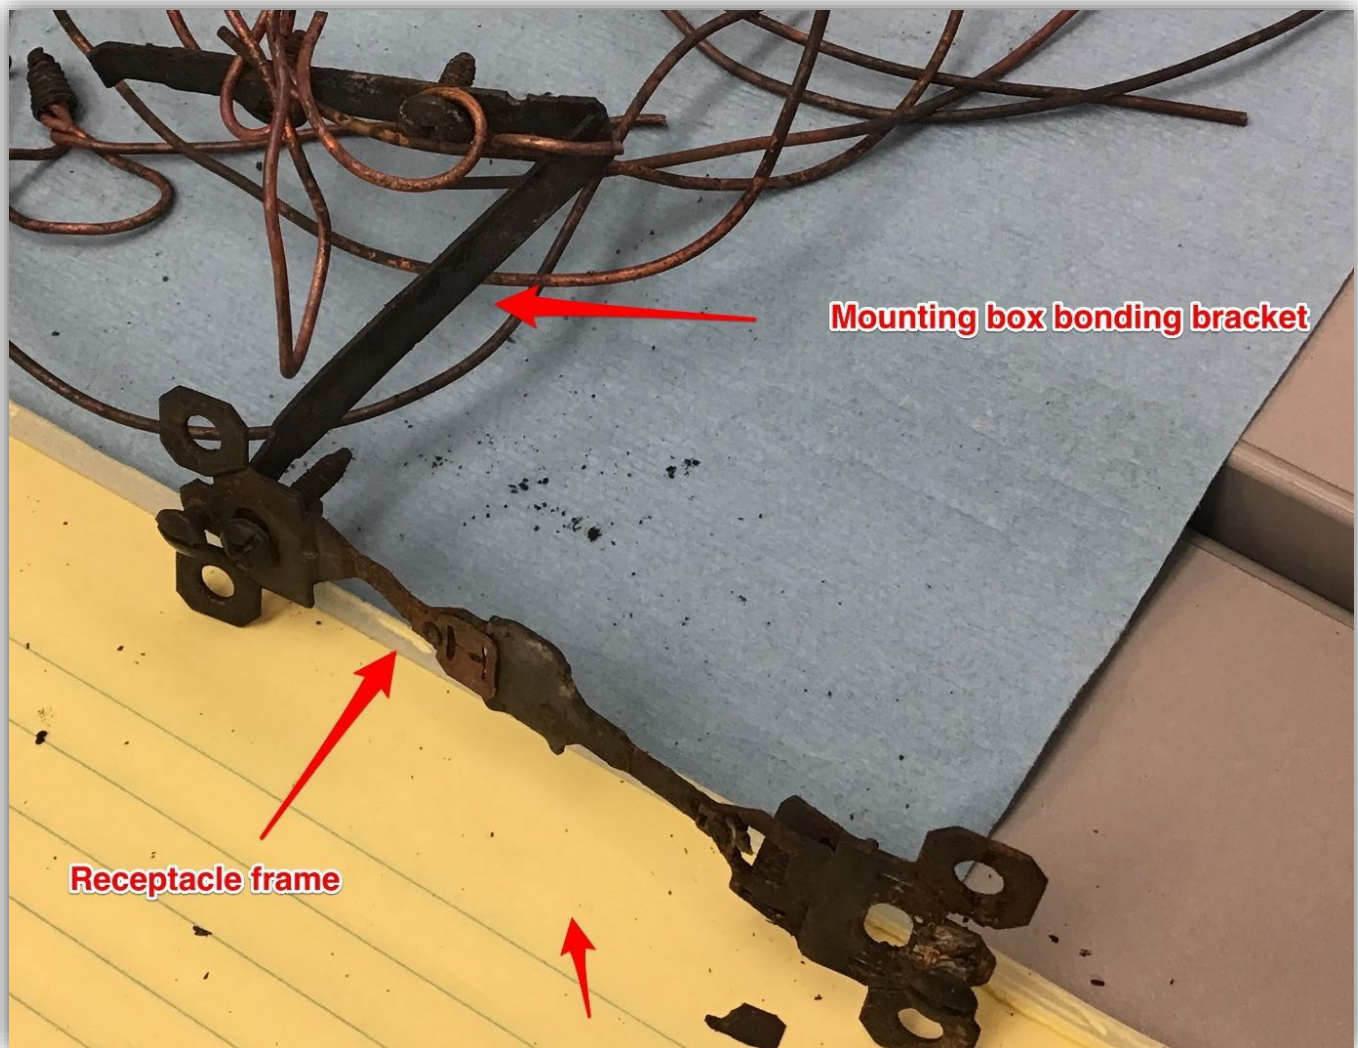
- On review of the receptacle, it was noted the wiring connections were done to acceptable industry standards with proper splicing and connections to the box and receptacle, no loose connections noted.

Image 7 - Photo notes receptacle box was a plastic style box with approved bonding strap. The wiring within the receptacle was noted as using good industry work practices with good wiring connections between conductors and to the receptacle. No loose connections were noted.

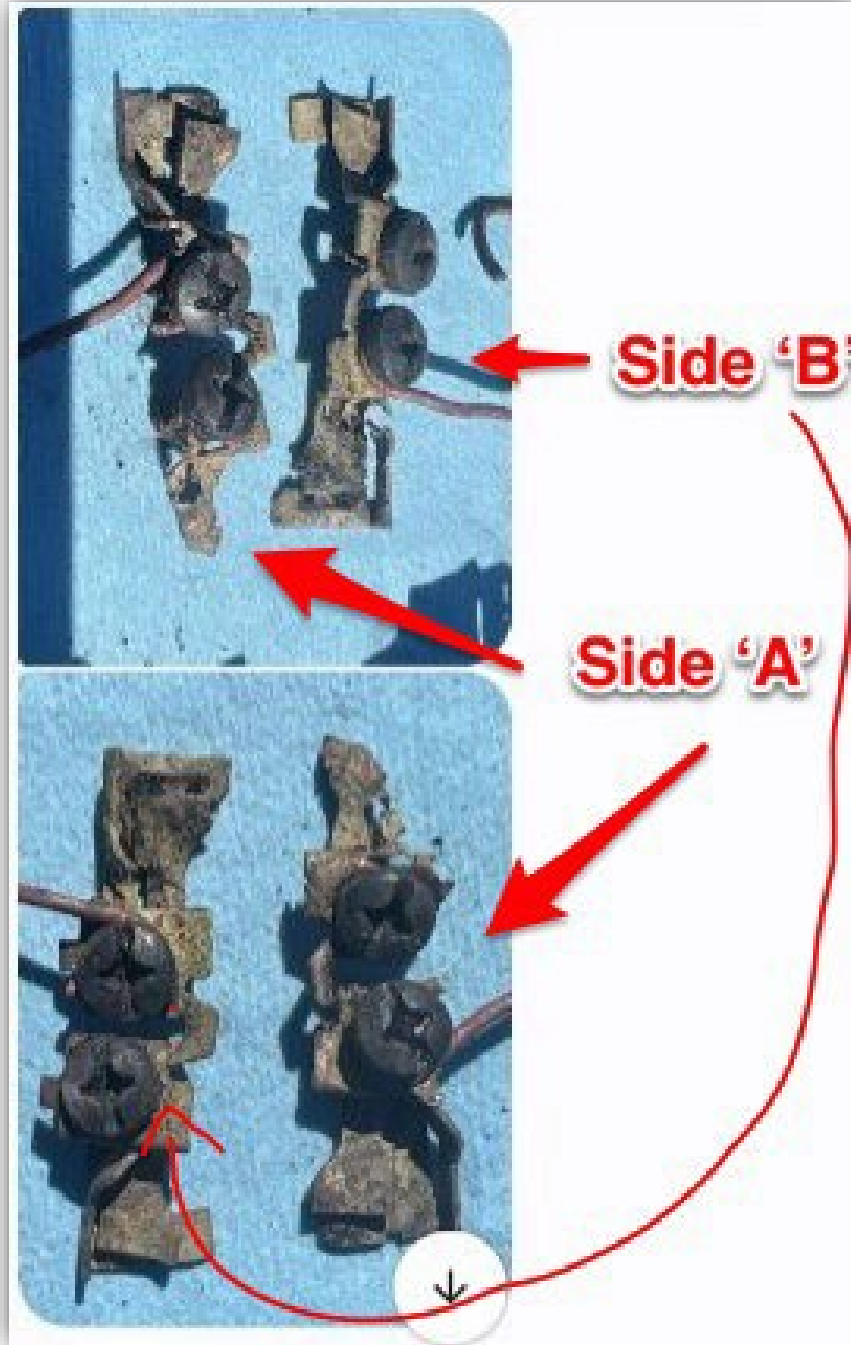
- The line and neutral connection terminals noted one socket of the receptacle had more notable heat damage than the other socket with melted/ damaged strap that noted likely shorting.

Based on the evidence reviewed and extent of damage the origin of the fire was likely in the location of the electrical receptacle. Although direct cause could not be determined, the electrical system could not be ruled out.

Image 8 - Remaining receptacle line and neutral terminal connections noting more heat damage on one socket over the opposite end.

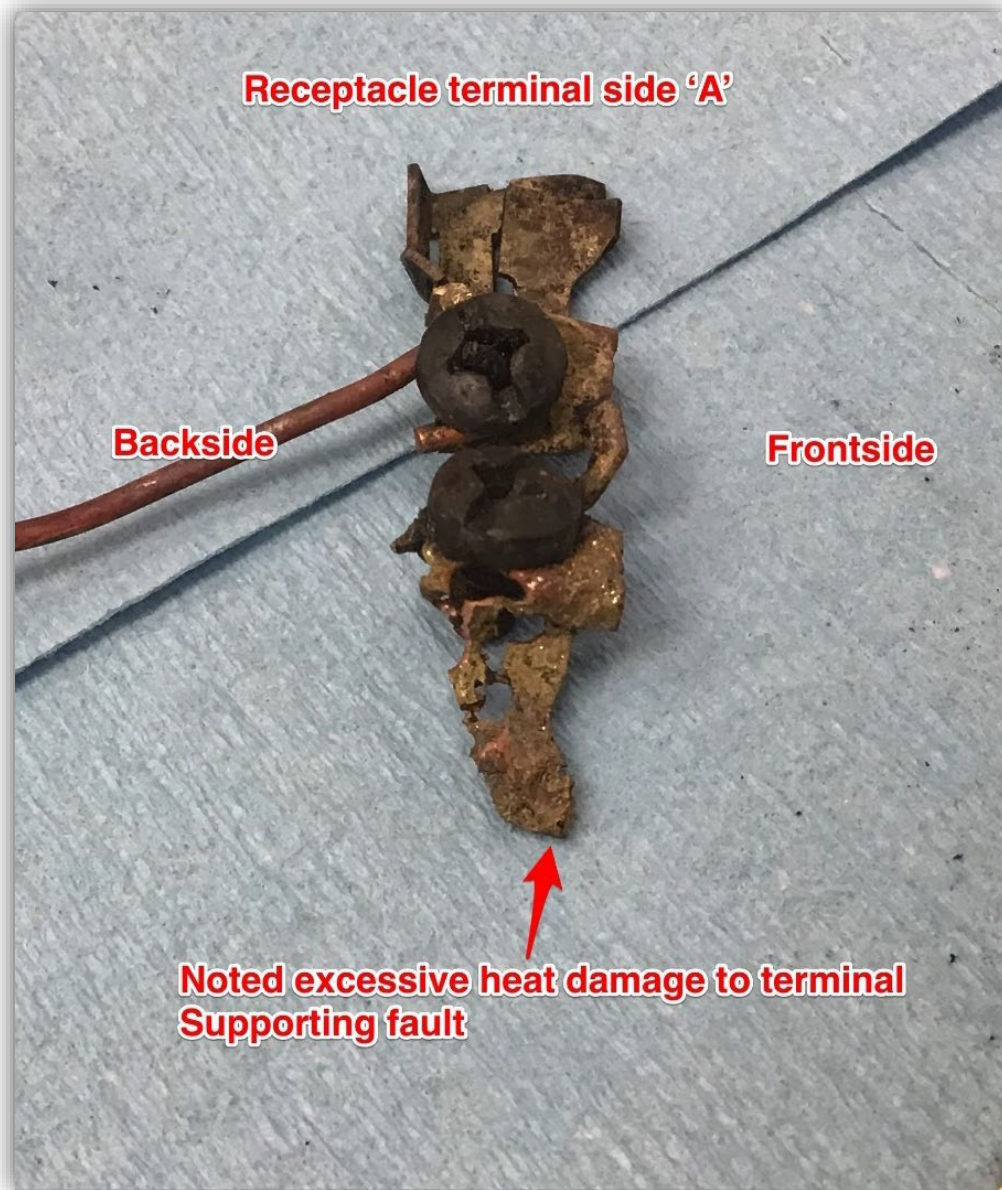
Image 9 - Close up view of other side of receptacle terminal notes more heat/fault at one end than the other.

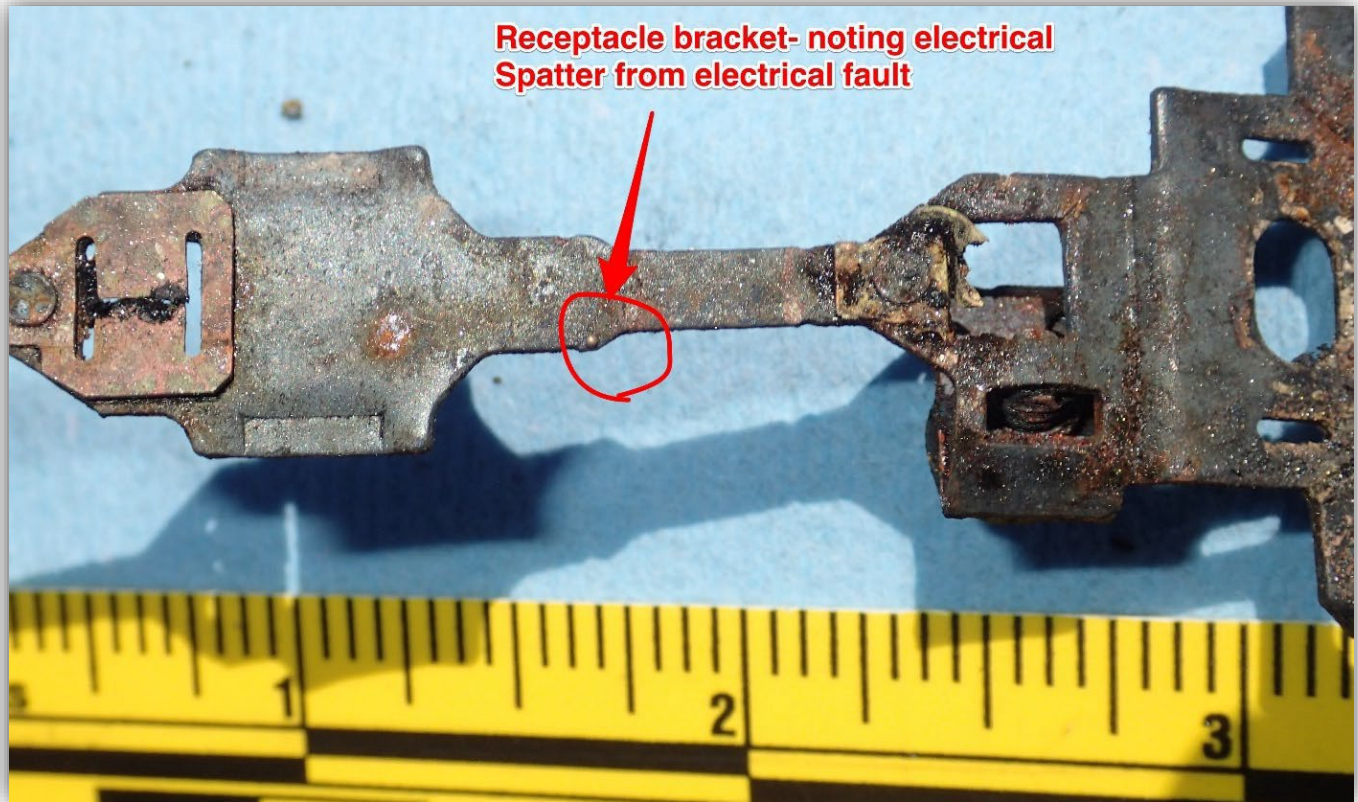
Image 10 - Noted electrical fault spatter on receptacle bracket supporting electrical fault (Image provided by Fire Investigator).

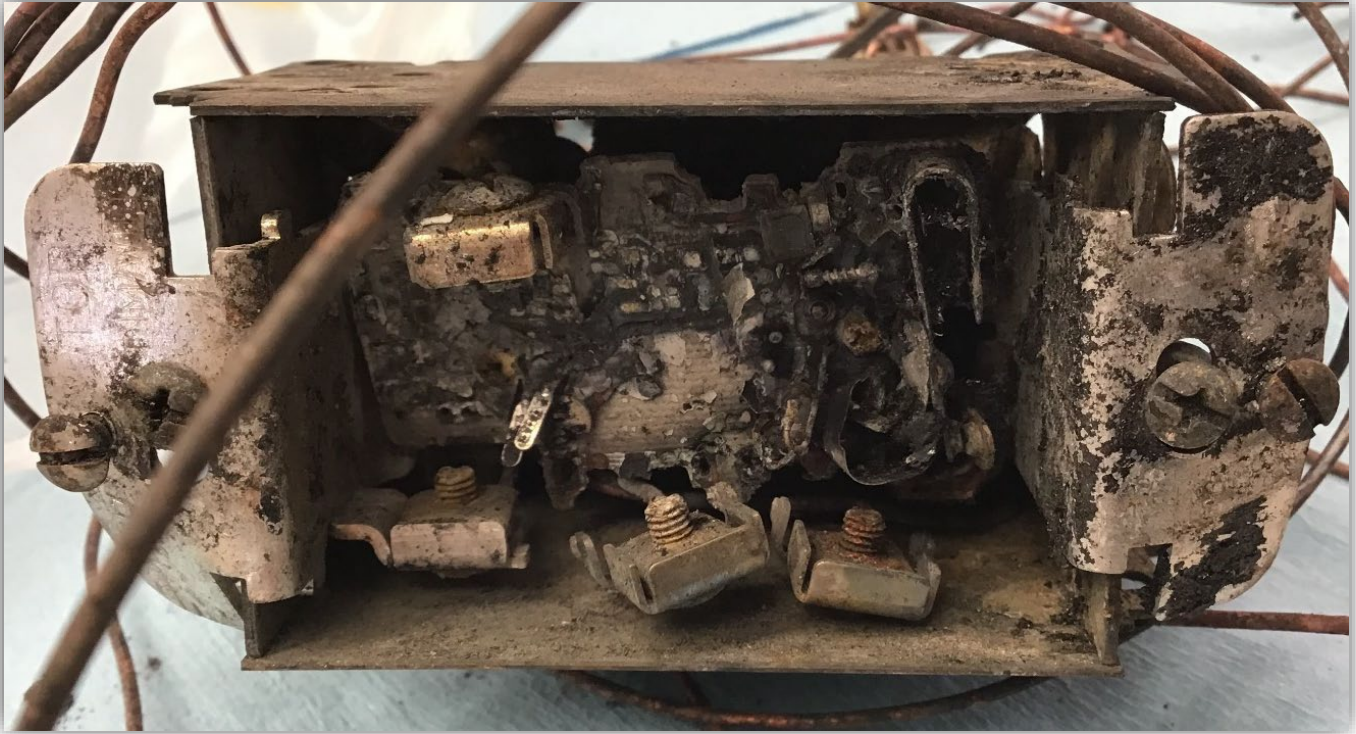
- Exterior electrical noted a dimmer switch for under soffit recessed lighting, exact location of switch not confirmed. Damage to dimmer switch was limited, aluminum mounting brackets not severely damaged, only internal components and plastic cover.

- On review of the 'dimmer' switch, the damage to the switch did not indicate as the source as the aluminum mounting bracket remained without melting from heat.

Image 11 - Damaged Dimmer switch- for reference only. Aluminum mounting bracket in one piece with no melting noted from extensive heat.

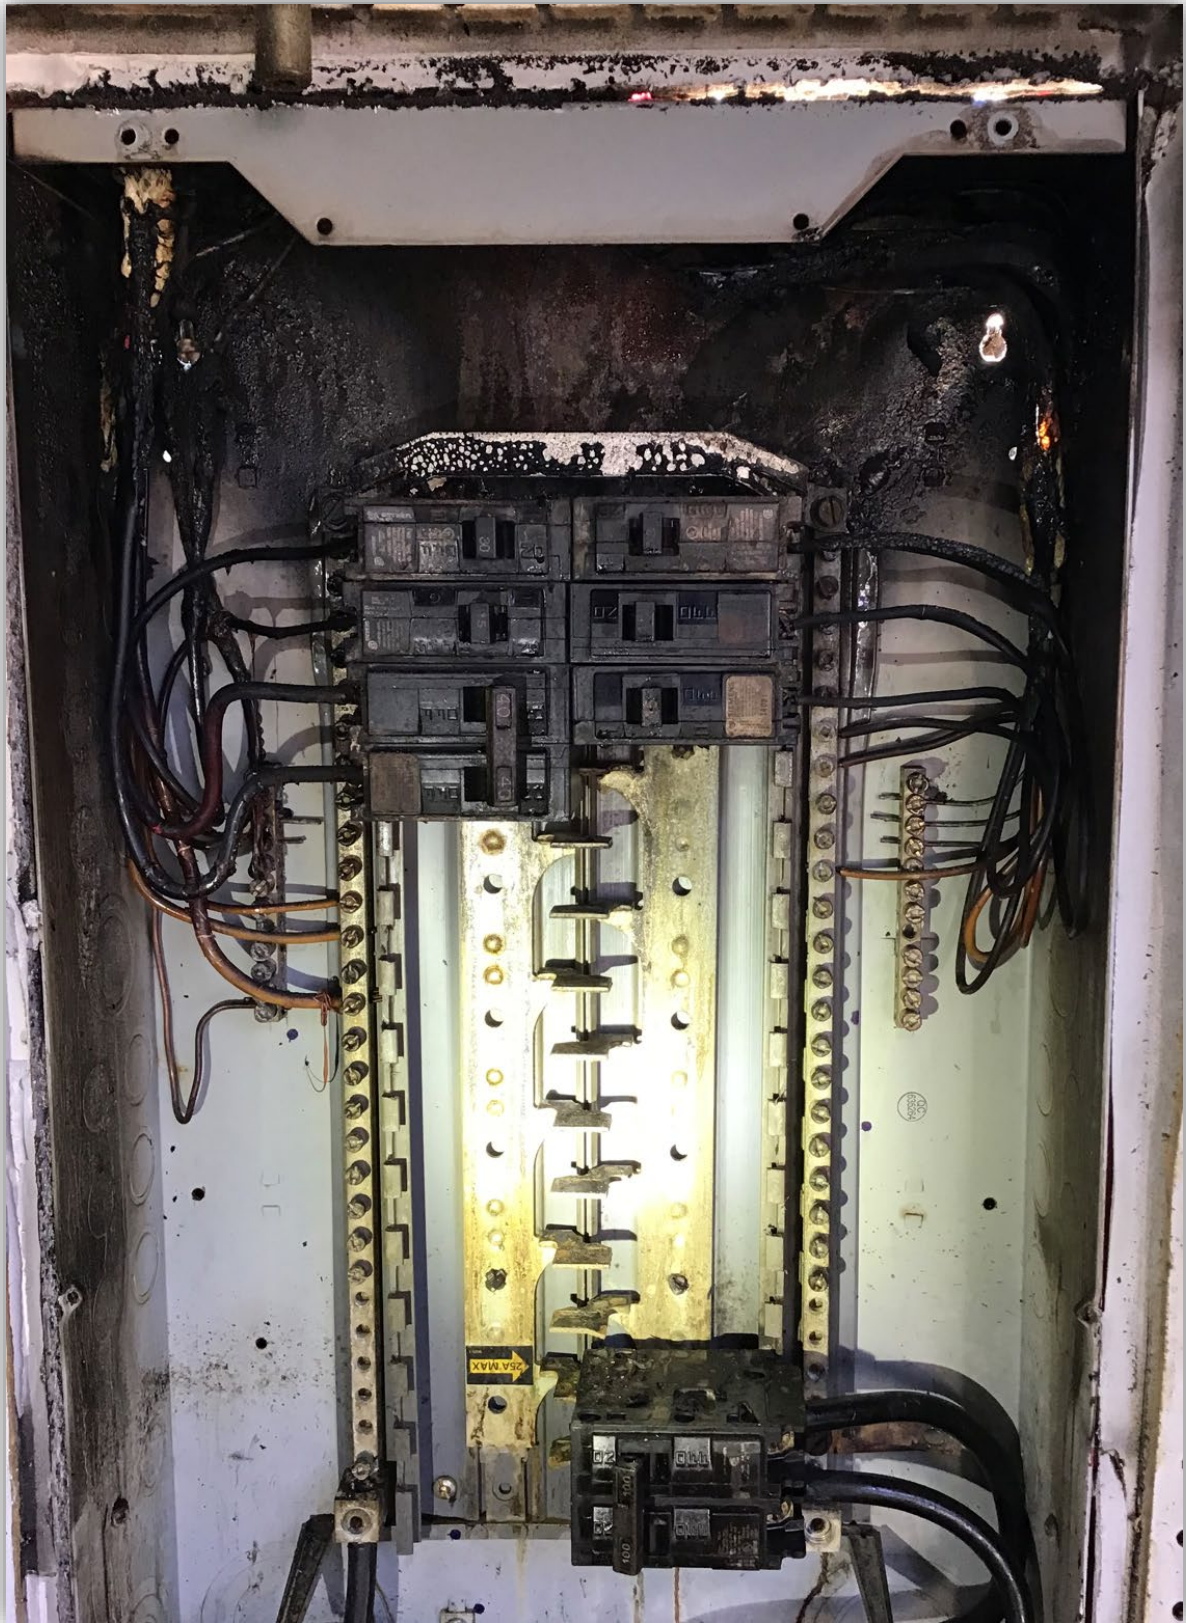
- Garage sub panel, siemens 100AMP 120/240volt 24/48cct combination panel, bond jumper removed, with 4x 1 pole 15AMP, 1x 1 pole 30AMP, 1x 2 pole 40AMP breakers, no arc fault circuit interrupter (AFCI) protection noted in panel for receptacle circuits.

- Damage to garage panel was noted mainly due to fire burning through wall from within attached shed. Panel and feeder cable noted no noticeable evidence of cause, all branch wiring exiting top of panel were destroyed.

- Garage panel noted no AFCI breakers installed, exterior shed wired from garage panel and garage/shed are attached to main dwelling.

Image 12 - Garage Electrical Panel received the most damage coming from above and behind the panel area. There were four one pole 15AMP breakers installed and no arc fault circuit interrupter (AFCI) overcurrent devices installed for wiring of receptacle circuits.
