## Incident Summary #II-967938-2020 (#16365) (FINAL)

SUPPORTING INFORMATION	Incident Date	January 12, 2020	
	Location	Mackenzie	
	Regulated industry sector	Boilers, PV & refrigeration - Refrigeration system	
	Impact	Qty injuries	0
		Injury description	None
		Injury rating	None
	Damage	Damage description	Ammonia compressor seal failure
		Damage rating	Minor
Incident rating	Insignificant		
Incident overview	An intermittent compressor shaft seal leak resulted in multiple ammonia releases . which activated low level (<50 ppm) ammonia detector alarms. The premises were not evacuated as the release was contained in a well ventilated mechanical room and the detector did not initiate a high level evacuation alarm.		
INVESTIGATION CONCLUSIONS	Site, system and components	<p>Ice arenas use an ammonia compression refrigeration system for ice making. The refrigeration plant is in a public assembly site-ice rink with a plant capacity less than 50 kW's. It is not subject to continuous supervision but is monitored by qualified personnel and an alarm monitoring system.</p> <p>The plant is an indirect closed loop vapour compression refrigeration system. The ammonia compression system uses two singl

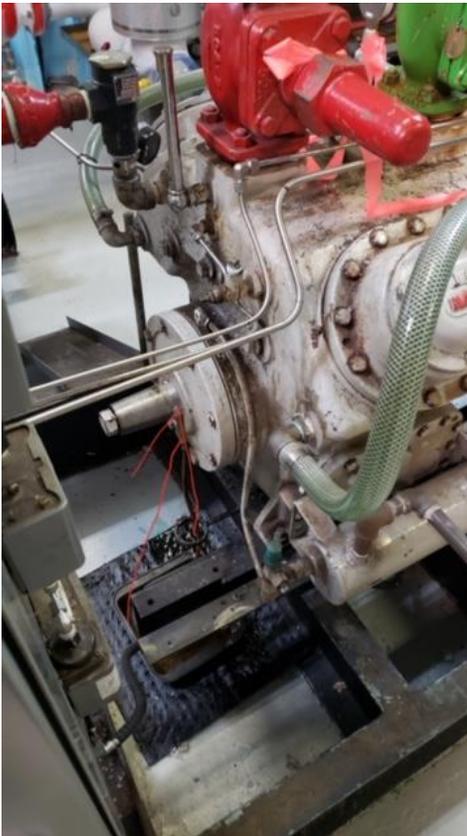
Failure scenario(s)	The compressor had been subject to idle use for extended periods during its service at a previous location. The seal was nearing the end of its recommended service life. Seal wear resulted in ineffective sealing allowing ammonia from the compressor crankcase to leak into the room.	
	Facts and evidence	On 6 occasions, over 4 days, low level ammonia alarms less than 50 ppm were responded to by facility staff. The intermittent ammonia releases were contained within the compressor room area but on one occasion an ammonia odour was reported in the public assembly area. On each occasion the alarm was silenced after the ammonia concentration was dissipated by the mechanical room exhaust system. Facility refrigeration operator(s) looked for the source of the leak each time and eventually identified a small leak on a valve after the 5 <sup>th</sup> alarm occurrence which happened 3 days after the first alarm. A Refrigeration contractor was contacted and arrived the following day. The refrigeration contractor located the primary ammonia

<p>leak at the compressor shaft seal, the compressor was isolated and ammonia removed from the compressor pending repair. The seal leak was very minor as it only occurred for a short time when the compressor started up and that there was no evidence of oil bypassing the seal was evident. Typical seal leaks result in an accumulation of oil around the seal location. A visual inspection of the seal components during the subsequent repair failed to identify any obvious defect. Shaft seals are subject to wear through normal operation and are inspected and maintained every 8,000-12,000 hours of operation, according to manufacturer's recommendations. This compressor was serviced and inspected within the manufacturers recommended time period but was nearing the manufacturers recommended service interval.</p> <p>The compressor was previously used at another site and installed recently at this site. A review of the history of previous compressor use found that it was in-service for only 2-3 months a year and subject to extended idle time. Extended idle time can be detrimental to seal operation and its life expectancy. The compressor was serviced and inspected within the manufacturers recommended time period.</p>

<p><b>Causes and contributing factors</b></p>	<p>It is likely that that seal wear from normal operational and previous extended idle time contributed to the seal's failure prior to the maximum service interval period recommended by the manufacturer.</p>
