Incident Summary #II-1657916-2024 (#43177) (FINAL)

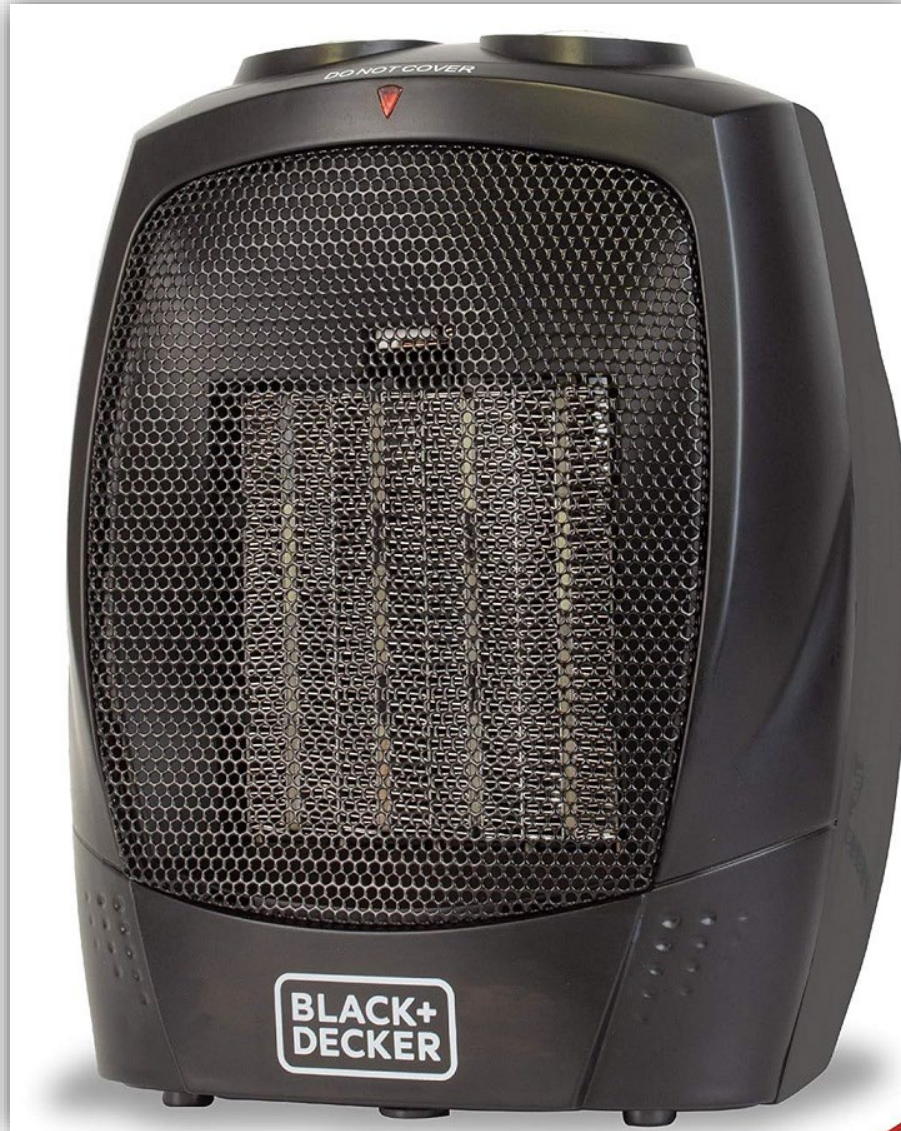
Image 1 - Exemplar image of the portable heater model in use at the time of the fire.

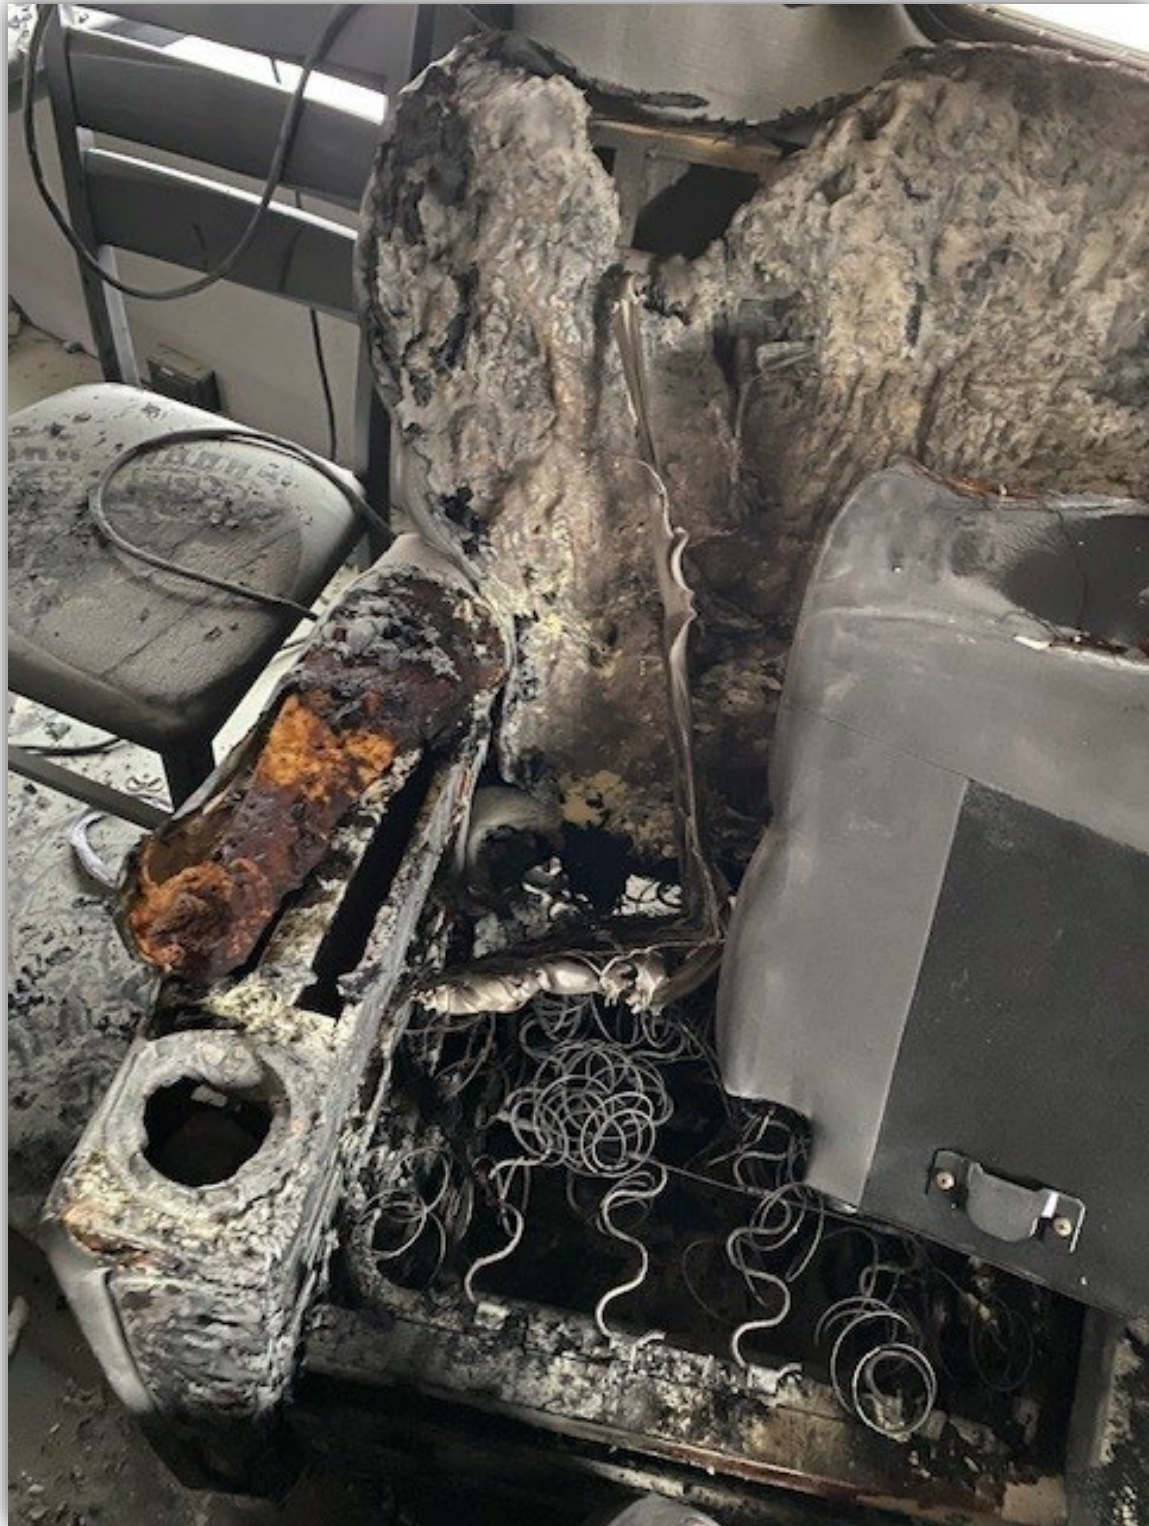
Image 2 - Upholstered couch, which appears to have been the point of origine for the fire.

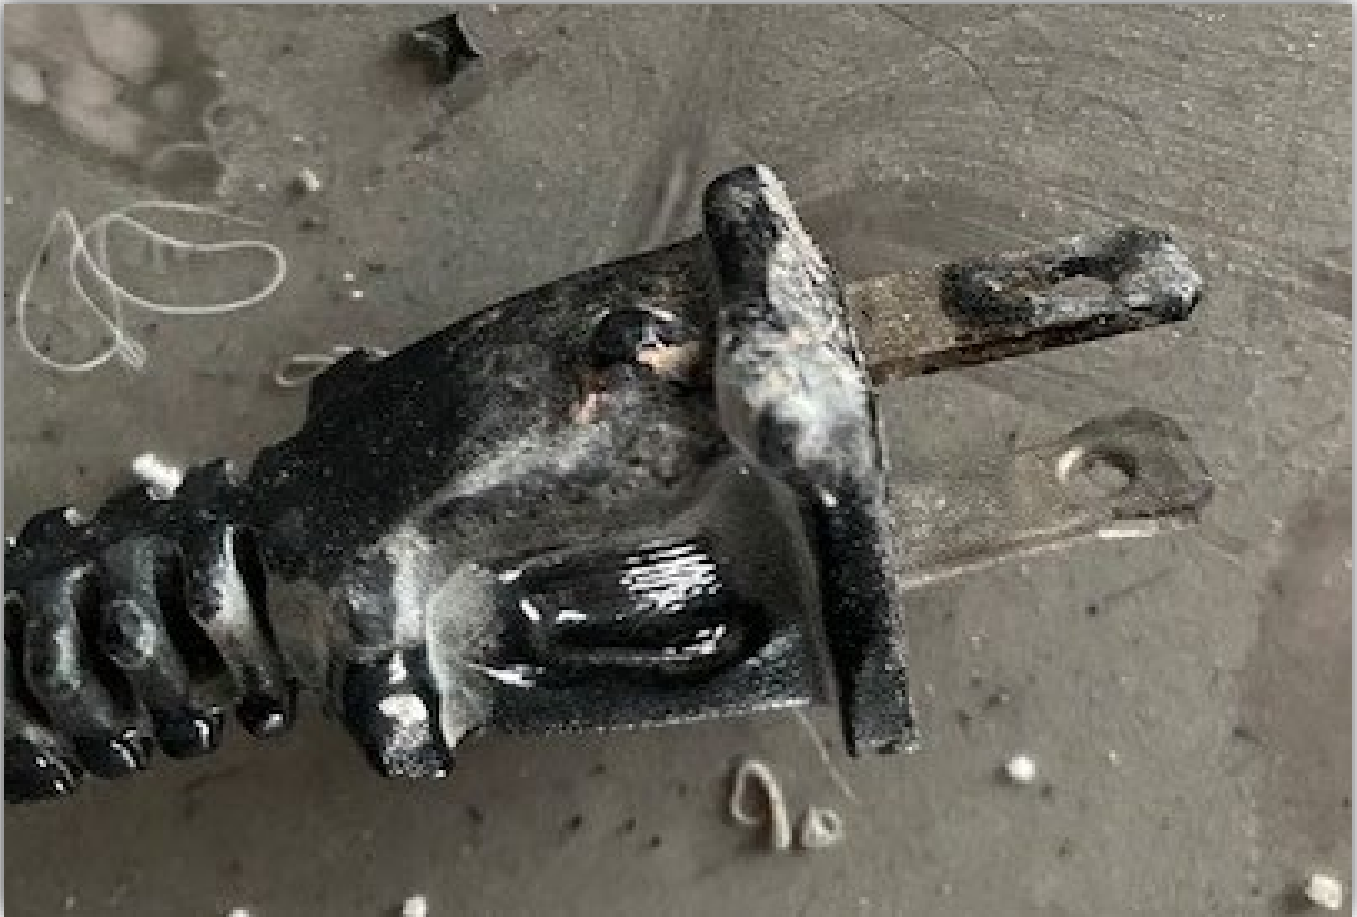
Image 3 - Portable heater plug-end showing charring on the line voltage prong, as well as localized melting of the plastic receptacle body around that prong.

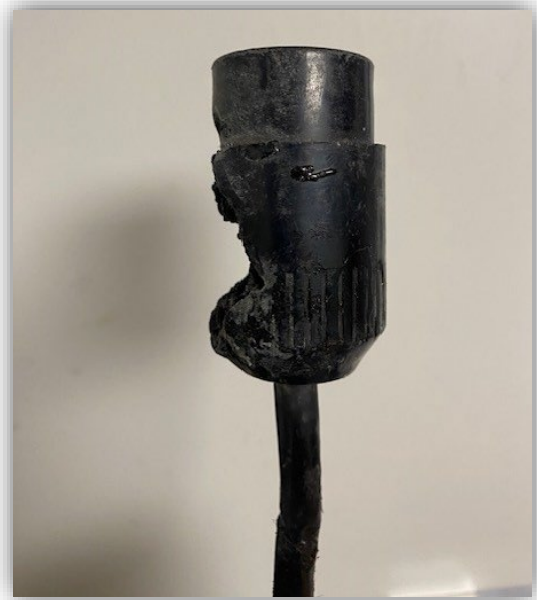
<p>Causes and contributing factors</p>	<p>It is very likely that the line voltage conductor of the extension cord was improperly terminated to the aftermarket receptacle-end, resulting in repeated arcing. Because the circuit breaker protecting the 120V receptacle that the portable heater and modified extension cord were connected to did not have arc-fault protection, it's probable that repeated arcing resulted in the observed melting of that receptacle-end.</p> <p>It is also very likely that the aftermarket receptacle-end was laying on the floor of the RV underneath the upholstered couch at the time the fire started.</p> <p>After the receptacle-end had partially melted away around the line voltage terminal, continued arcing likely generated enough heat to ignite the nearby upholstered couch.</p>

Image 5 - Localized melting of receptacle-end.

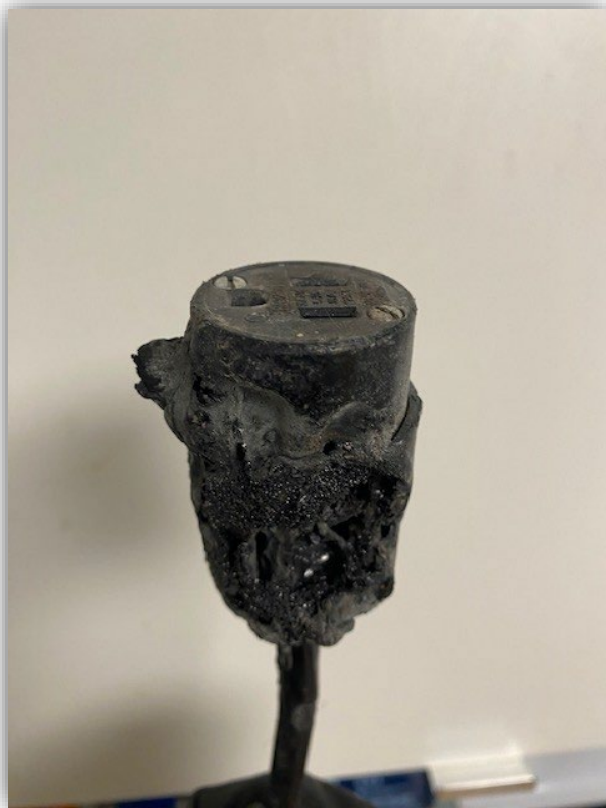
Image 6 - Melting around line voltage terminal.

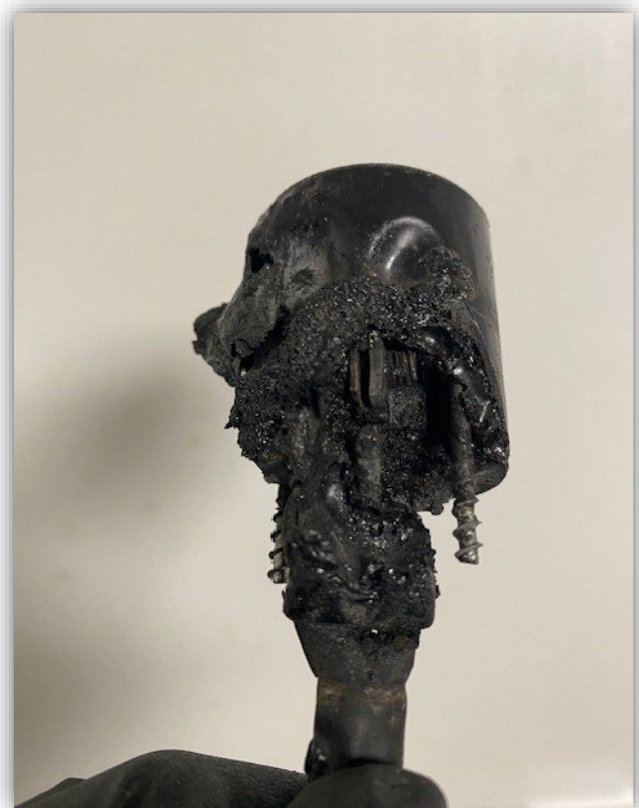
Image 7 - Localized melting inside the receptacle-end.
